### PERMIT INFORMATION

<b>Permit Number:</b> C-1996-084 <b>Mine Name:</b> Lorencito Canyon Mine <b>Operator:</b> New Elk Coal Company, LLC <b>Operator Address:</b> Mr. Mark Gray 12250 Highway 12 Weston, CO 81091	<b>County:</b> Las Animas <b>Operation Type:</b> Surface <b>Permit Status:</b> Permanent Cessation <b>Ownership:</b> Private
	<b>Operator Representative Present:</b>  Nick Mason
<b>Operator Representative Signature:</b> (Field Issuance Only)

### INSPECTION INFORMATION

<b>Inspection Start Date:</b> April 14, 2022 <b>Inspection Start Time:</b> 10:45 <b>Inspection End Date:</b> April 14, 2022 <b>Inspection End Time:</b> 12:45	<b>Inspection Type:</b> Coal Partial Inspection <b>Inspection Reason:</b> Normal I&E Program <b>Weather:</b> Clear
<b>Joint Inspection Agency:</b>  None	<b>Joint Inspection Contacts:</b>  None
<b>Post Inspection Agency:</b>  None	<b>Post Inspection Contacts:</b>  None
<b>Inspector(s):</b>  Connor Drinkard  Jared Ebert	<b>Inspector's Signature:</b>

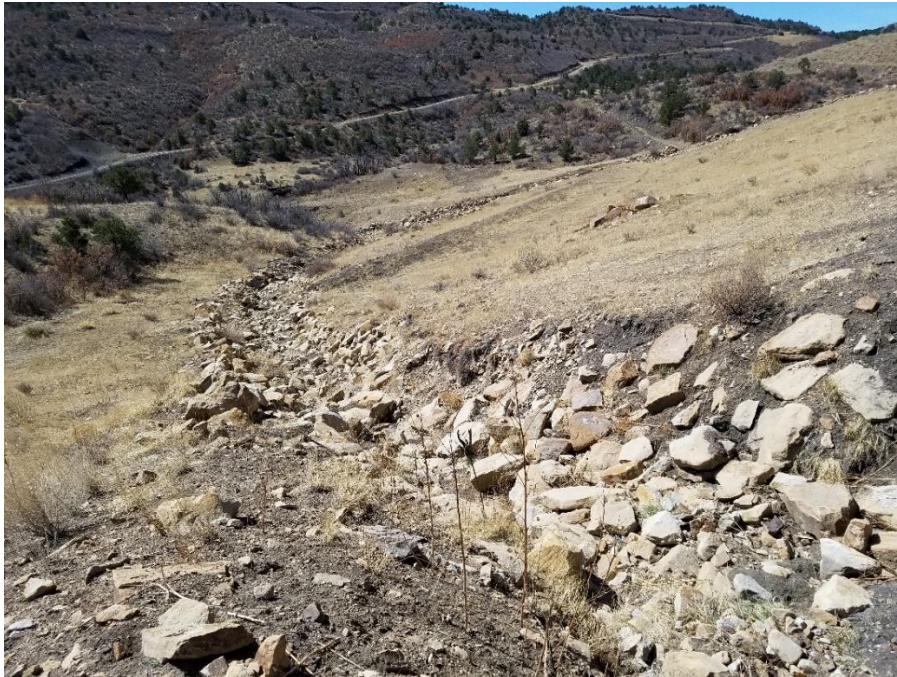
Fill 007 was overall stable and vegetated but several erosion features were observed that should be monitored and addressed. These include a rill near where Ditch D76 enters Fill 007.

**Figure 1. Fill 7 western drainage looking southwest.**

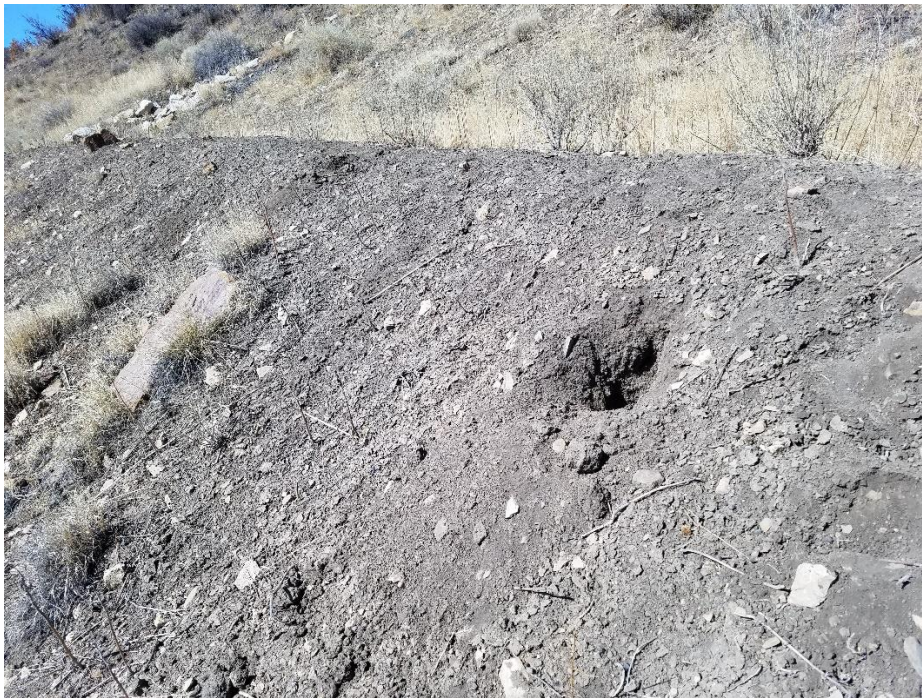
Fill 009 was overall stable and vegetated but several erosion features were observed that should be monitored and addressed. These include an animal hole on the face of Fill 009 northeast of where Ditch D75 enters the fill area on the inter-bench embankment. Vegetation was sparse in this area, and NECC should either stabilize the area or monitor it to ensure future rills and gullies will not form at this location.

**Figure 2. Animal hole in embankment of bench on Fill 009 near where Ditch D75 enters the fill.**

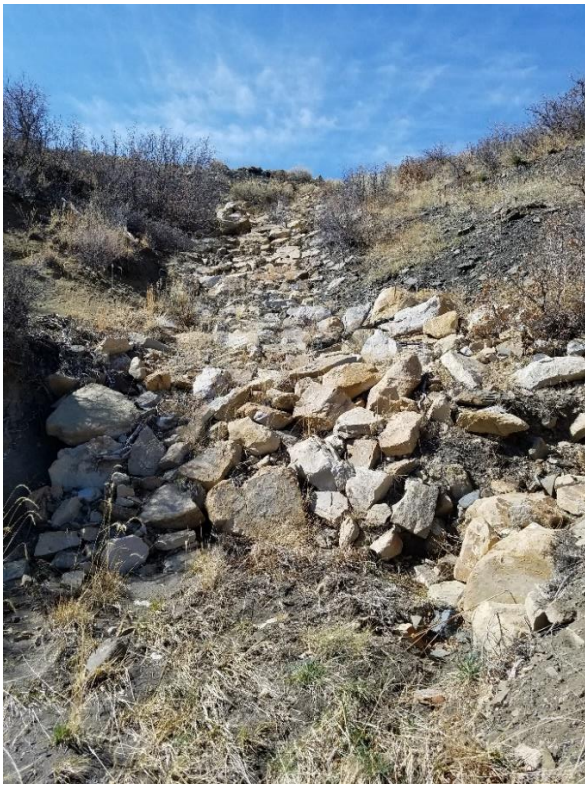
Erosion was observed on Ditch D14 where it discharges into Ditch D96. NECC will need to stabilize this area that has steep and eroding sides.

**Figure 3. Drainage ditch D14 where it discharges into D96.**

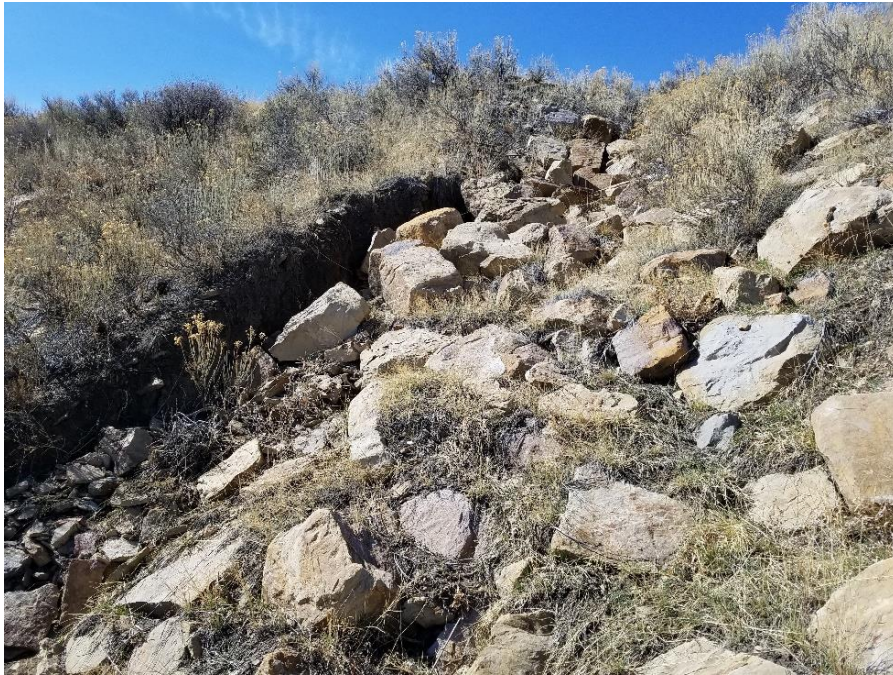
**Figure 4. Drainage ditch D14, side cutting erosion observed. Photo of where D14 discharges to D96.**

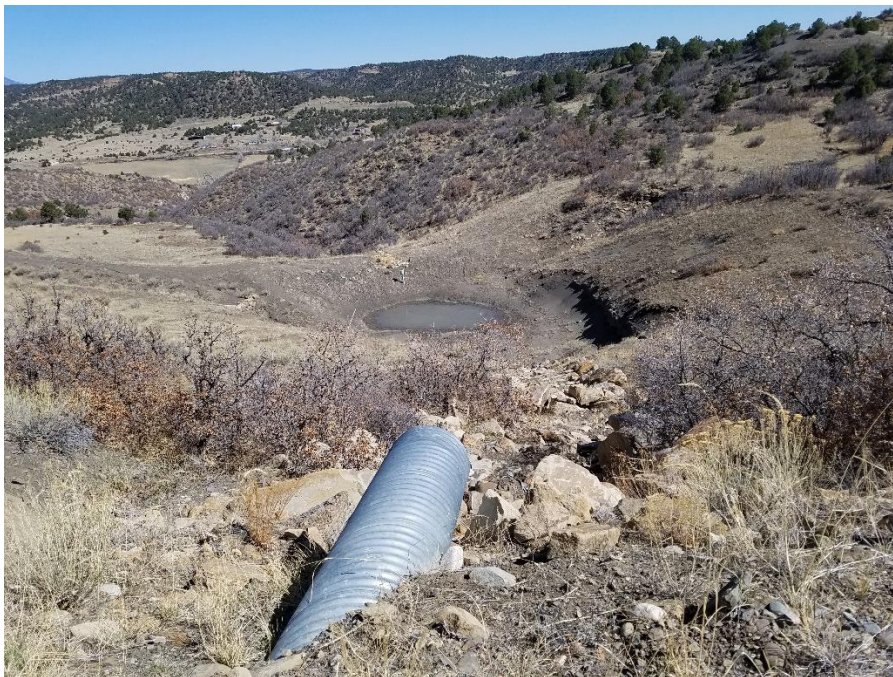
Culvert 2 appeared clear and functional. Pond 009 was holding water but not discharging. The embankment appeared stable.

**Figure 5. Culvert 2 and Pond 009 looking northeast.**

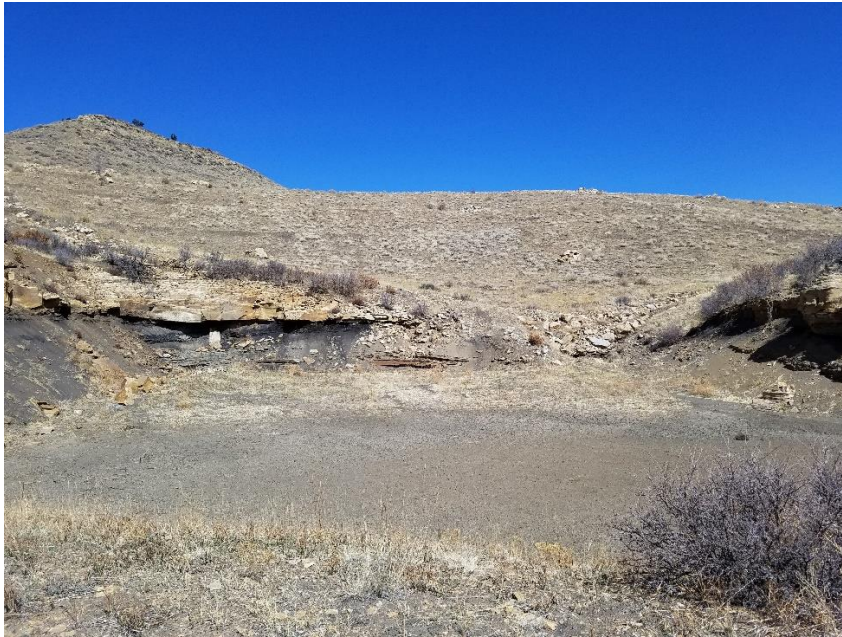
Pond 009a was holding a small amount of water but did not appear to be discharging. The embankment appeared stable.

**Figure 6. Pond 009a looking north.**

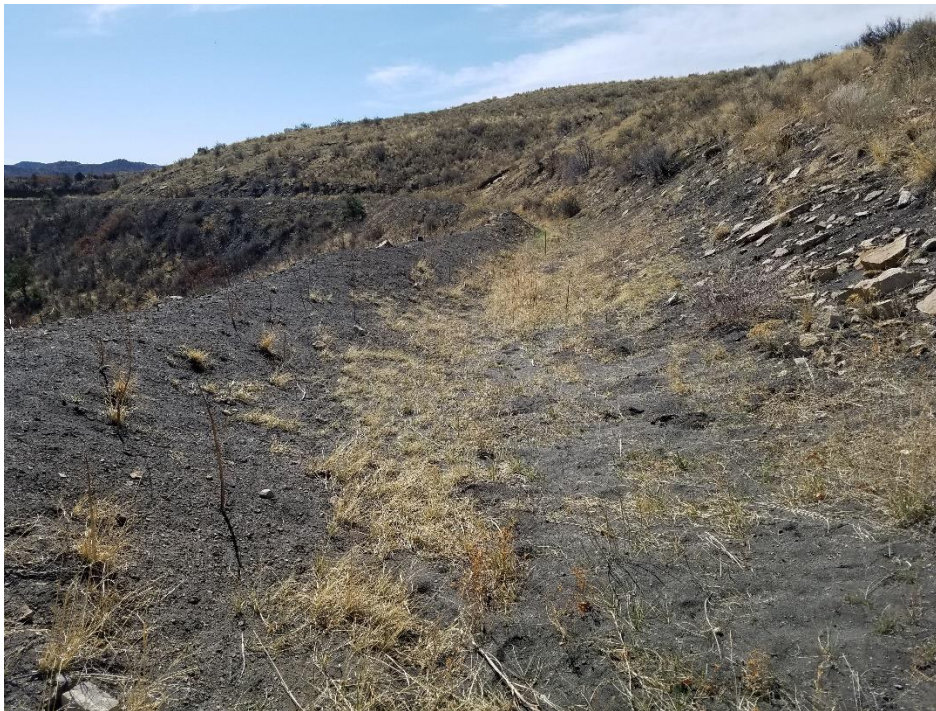
Ditch D4 was inspected and found to be stable.

**Figure 7. Ditch D4 looking west.**

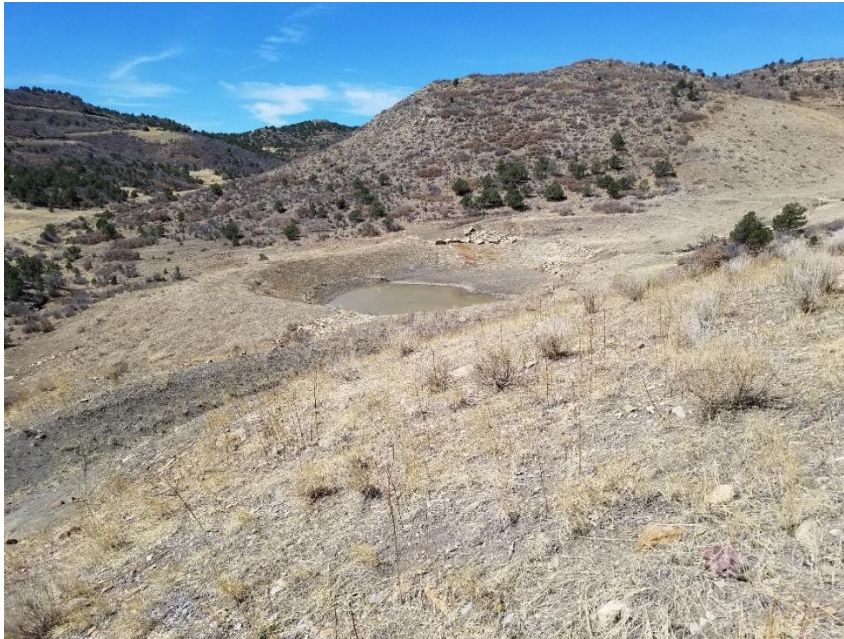
Ponds 006a and 007a were holding water but not discharging. The embankments appeared stable.

**Figure 8. Pond 006a.**

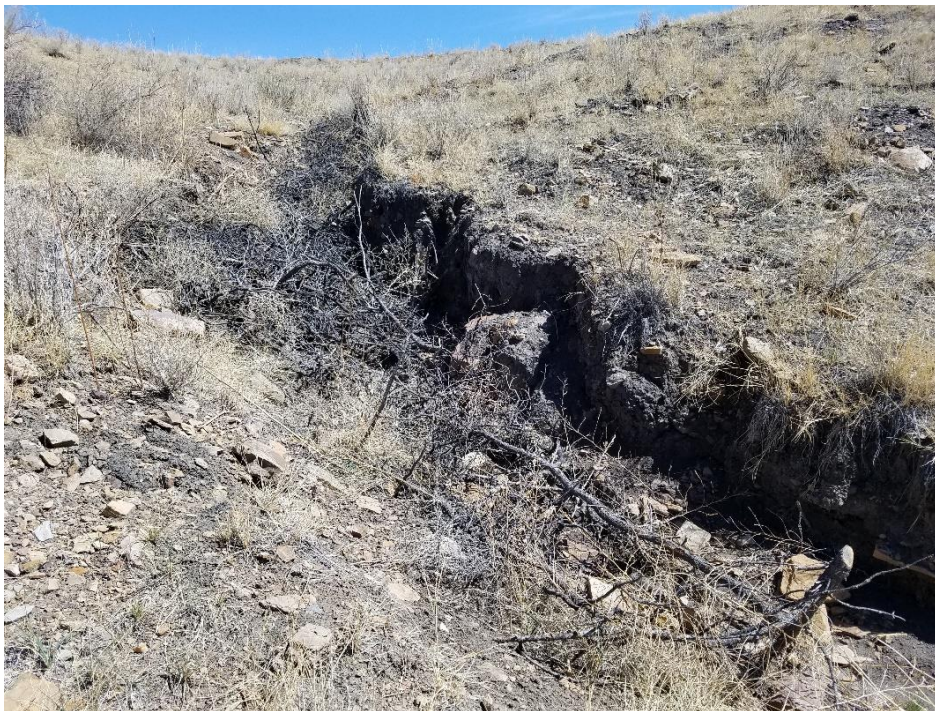
Erosion was observed outside of branches placed in Ditch D7 north east of Pond 006a. Please monitor and address appropriately as needed.

**Figure 9. Ditch D7 looking north.**
