**MINERALS PROGRAM INSPECTION REPORT**  
**PHONE: (303) 866-3567**

<b>MINE NAME:</b> Hatchery Pit	<b>MINE/PROSPECTING ID#:</b> M-2014-043	<b>MINERAL:</b> Gravel, sand and bor for construction	<b>COUNTY:</b> Adams
<b>INSPECTION TYPE:</b> Surety Reduction	<b>INSPECTOR(S):</b> Nikie Gagnon	<b>INSP. DATE:</b> April 7, 2022	<b>INSP. TIME:</b> 10:00
<b>OPERATOR:</b> Albert Frei & Sons Inc.	<b>OPERATOR REPRESENTATIVE:</b> Joel Bolduc and Ben Frei	<b>TYPE OF OPERATION:</b> 112c - Construction Regular Operation	
<b>REASON FOR INSPECTION:</b> Surety Release Requested	<b>BOND CALCULATION TYPE:</b> Complete Bond	<b>BOND AMOUNT:</b> \$1,056,600.00	
<b>DATE OF COMPLAINT:</b> NA	<b>POST INSP. CONTACTS:</b> None	<b>JOINT INSP. AGENCY:</b> None	
<b>WEATHER:</b> Windy	<b>INSPECTOR'S SIGNATURE:</b>

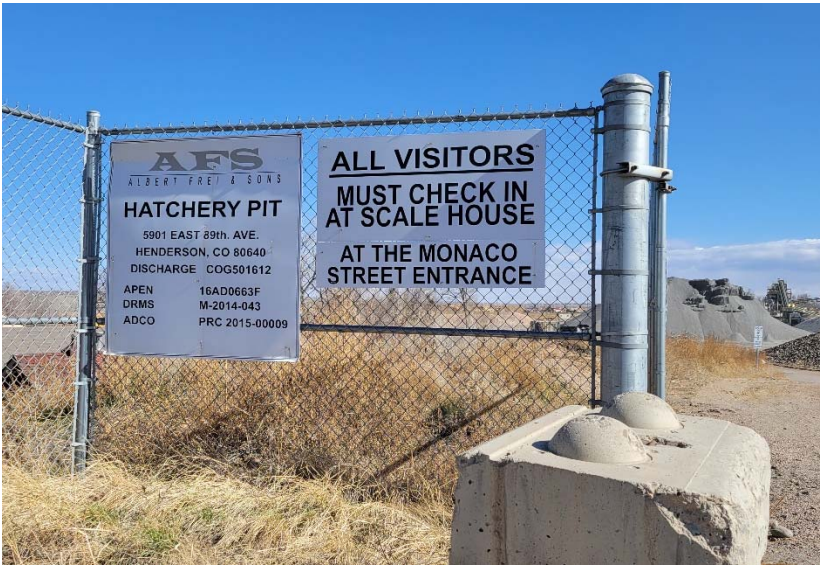
The entrance to the Hatchery Pit is approximately 0.25 mile west of the intersection of 88th avenue and I-76 in Commerce City, CO in Adams County. The pit is a Construction Materials 112c permit and is approved for 53.17 acres. A mine sign was posted at the entrance as required by Rule 3.1.12 (Photo 1).

**Photo 1:** Signs posted at mine entrance on 89<sup>th</sup> Ave.

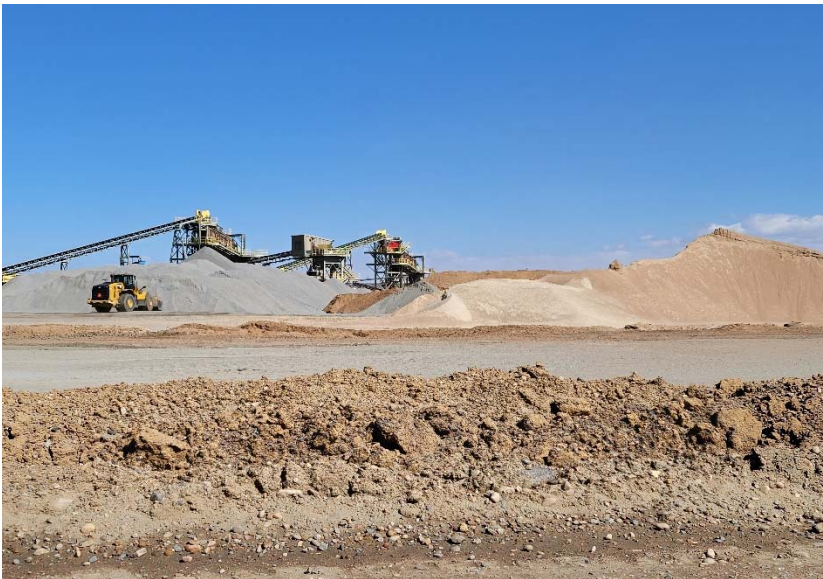
**General Observations:** The site was active and the processing plant was operating during the inspection (Photos 2 & 3). Trucks entered from 89<sup>th</sup> Avenue and exited via a scale house to Monaco Street. The operation was in compliance with the mining plan and confined within the permit boundary at the time of the inspection. The inspection proceeded along a perimeter road, observing the water monitoring wells, the Bull Seep, and the two pre-1981 unlined ponds on site (Photos 4-7). Mined material was stored in stockpiles in the Phase 1 fill area inside the permit boundary (Photos 8-9). A bulldozer was observed moving inert fill material in the Phase 2 area (Photo 10). A new double walled polyethylene waste oil containment tank was installed on the northern side of the permit area (Photo 11). The area around the waste oil and diesel tanks were free of spills and debris at the time of the inspection (Photos 11-12).

**Photo 2:** Looking west at processing facility in Phase 1 area.

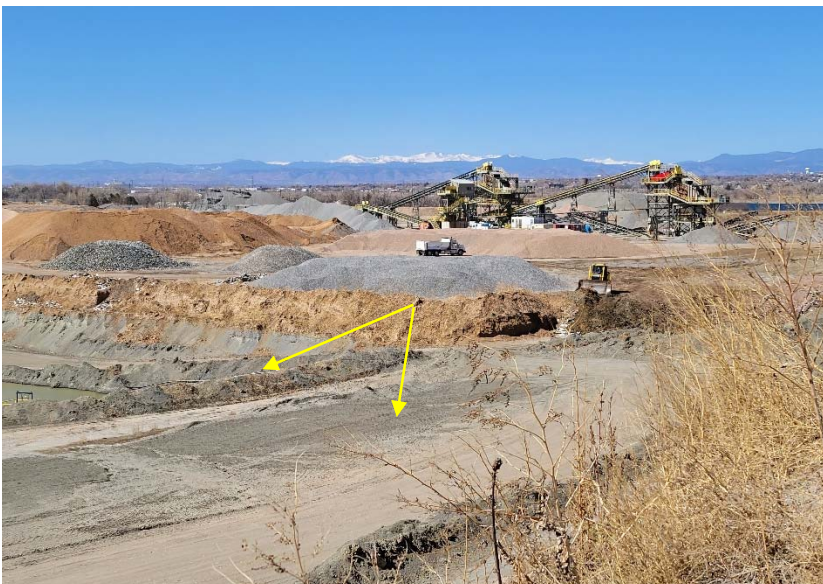
**Photo 3:** Looking west across mine. Stockpiles and processing plant in Stage 1 area. Yellow arrow pointing to Phase 2 pit and compacted liner in foreground.

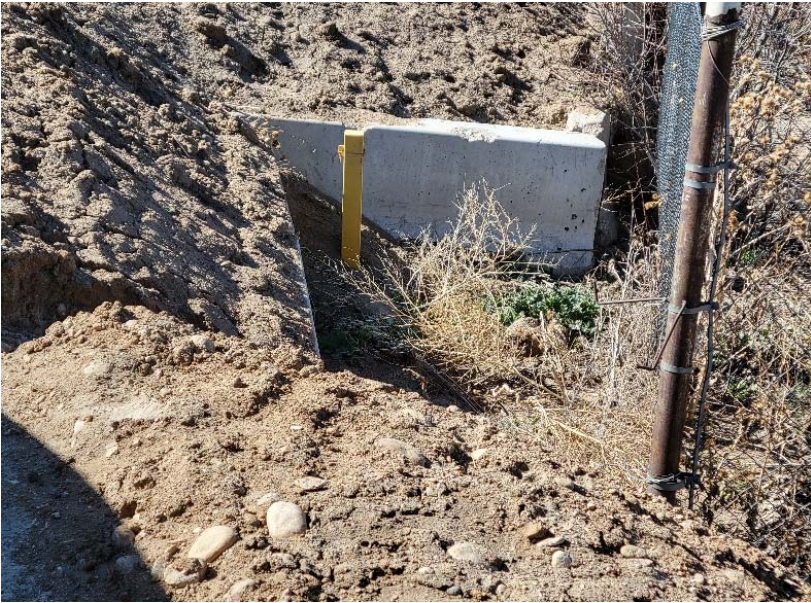
**Photo 4:** Monitoring well MW-5.

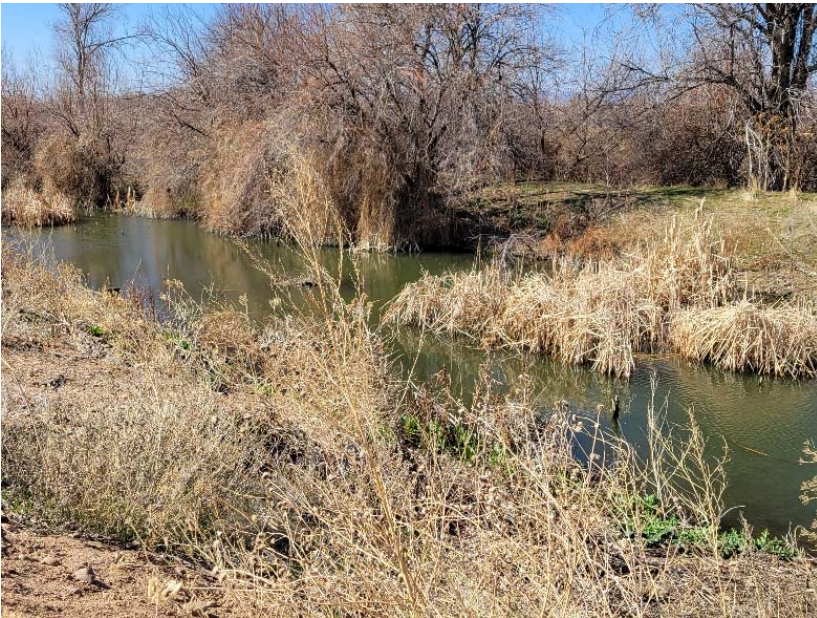
**Photo 5:** Bull Seep.

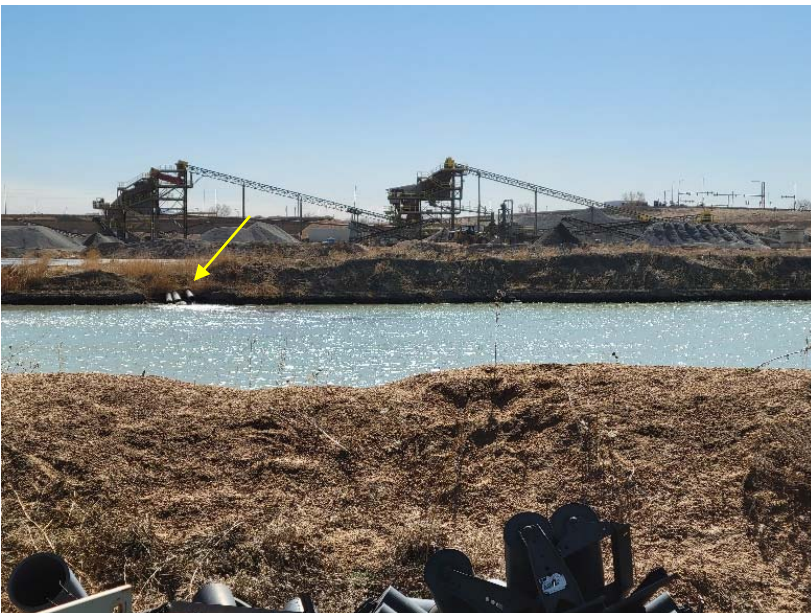
**Photo 6:** Looking southeast across pond, arrow pointing to inlets releasing water from settling pond on far side.

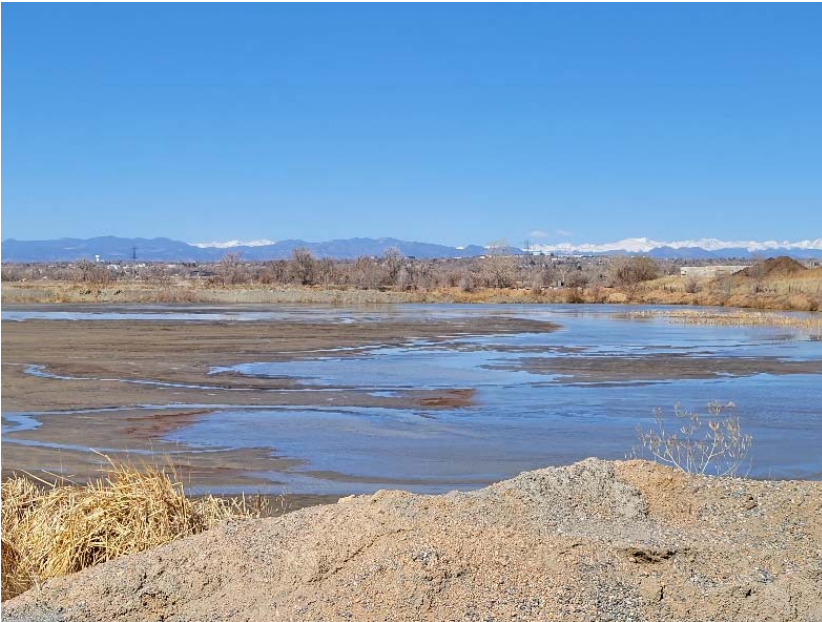
**Photo 7:** Looking west across settling pond, pre-1981.

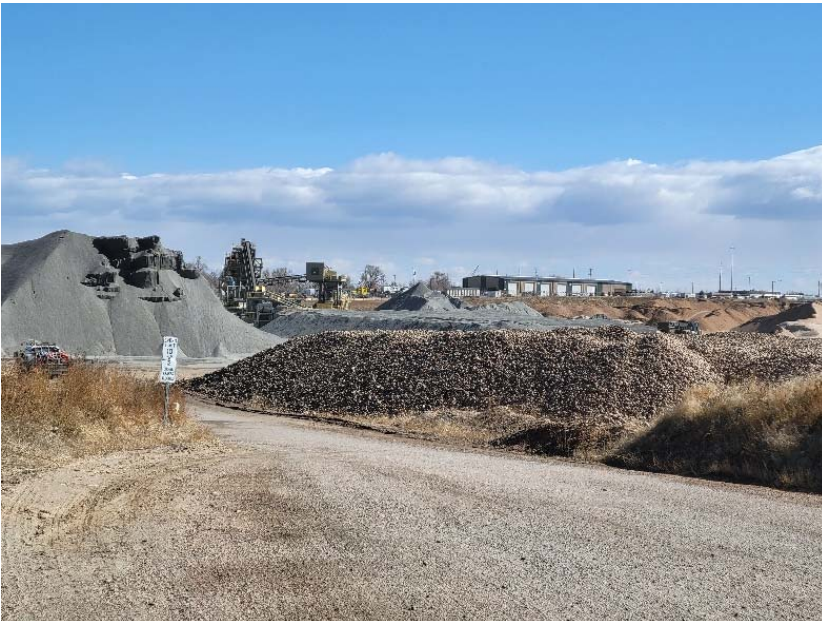
**Photo 8:** Looking north, near mine entrance. Stockpiles staged on Phase 1 fill areas.

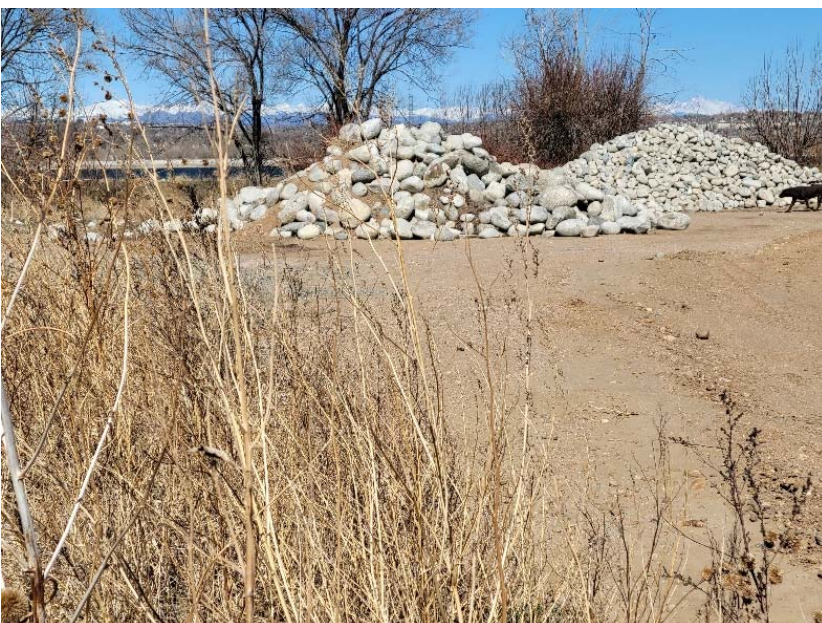
**Photo 9:** Stockpiles staged on Phase 1.

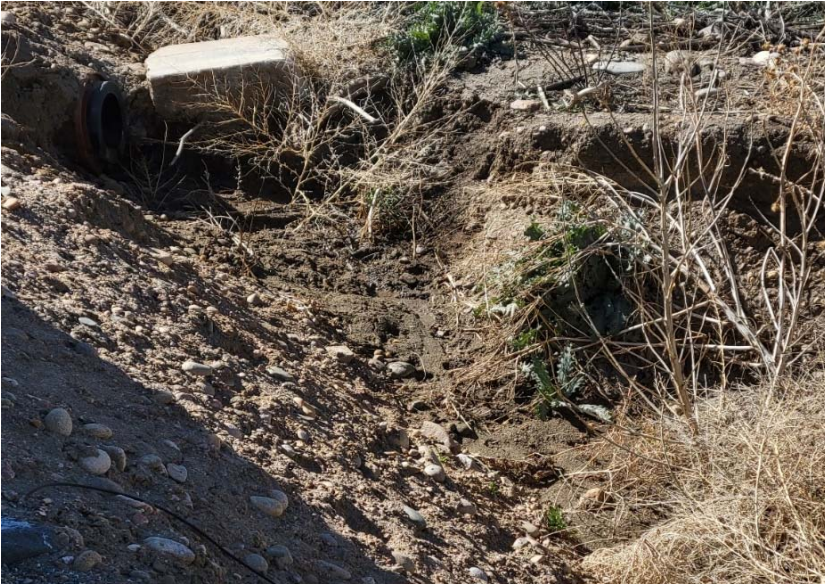
**Photo 13:** Outlet for French drain on south side near mine entrance, no water flowing during inspection.

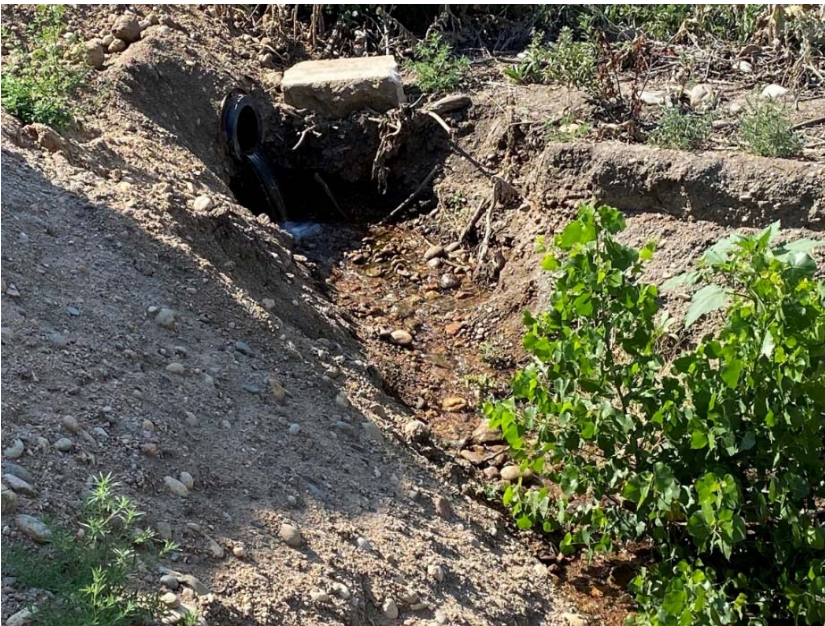
**Photo 14:** Outlet for French drain near mine entrance on south side, water flowing (operator supplied photo).

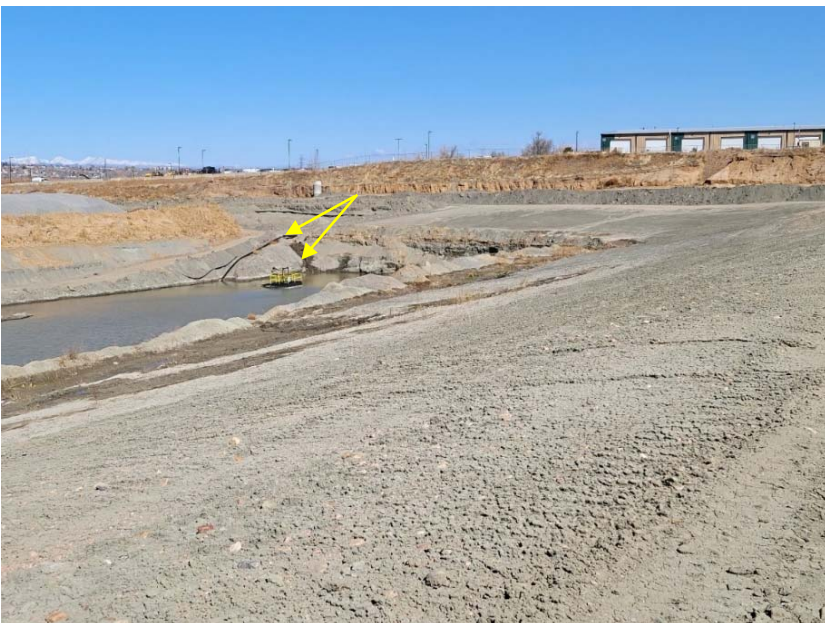
**Bond Reduction Items:** The purpose of this inspection was to evaluate the completion of a clay liner and French drain in the Phase 2 area approved under Technical Revision No. 01 (TR-01) to prevent groundwater from interacting with inert fill material planned to be used as backfill in the pit. The lined pit will not hold water and therefore, as noted in the last inspection, does not require a leak test. Along with the request for a bond reduction, the Division received as-built drawings of the completed slurry wall (Attachment C of the SR-1) and a Phase 2 Liner Construction Report (Attachment D of the SR-1) describing the placement and compaction of the clay liner and installation of the groundwater drain. The French drain was installed at the current water table elevation to channel groundwater around the inert fill in the pit area. The 2021 Liner Construction Report indicates the project is controlling groundwater levels as intended. During the inspection, the two outlet locations for the French drain were observed. No water was draining at the time of the inspection, however, Joel Boldoc, representing the operator, confirmed the drains are exhibiting flow as expected and sent the Division a photo showing water flowing from the drain on a previous date (Photos 13-14, & 18). According to the Liner Construction Report, the slope liner is claystone bedrock of the Denver Formation taken from the bottom of the open pit mine. The material was placed on the slopes and compacted in 10 to 12 inch lifts and keyed into the in-place bedrock. The inspection included walking around the pit to observe the clay liner which was intact, appropriately graded, and no concerning erosional channels were noted (Photo 15-16).

**Hydrologic Balance:** During the inspection, 2-3 feet of water was observed in the bottom of the clay lined pit in Phase 2 (Photos 15-16). Joel Boldoc, representing the operator, stated the water in the pit comes from vacuum tanker trucks which deposit slurry into the pit to be used as backfill. The solids settle into the pit and the water is pumped out weekly into a settling pond in the Phase 1 area (Photo 7). At the time of the inspection, a vacuum truck was observed depositing material into the pit area (Photo 17). The Division

**Photo 15:** Looking northwest across completed compacted clay liner and pit. Yellow arrows pointing to water pump and drain pipeline.

understands that most of the water observed in the pit comes from the vacuum trucks and recommend that the operator run the sump pump in the pit after large storm events, ensuring that stormwater is pumped out within 48-72 hours. The two ponds in the Phase 1 area are pre-1981 regulations.

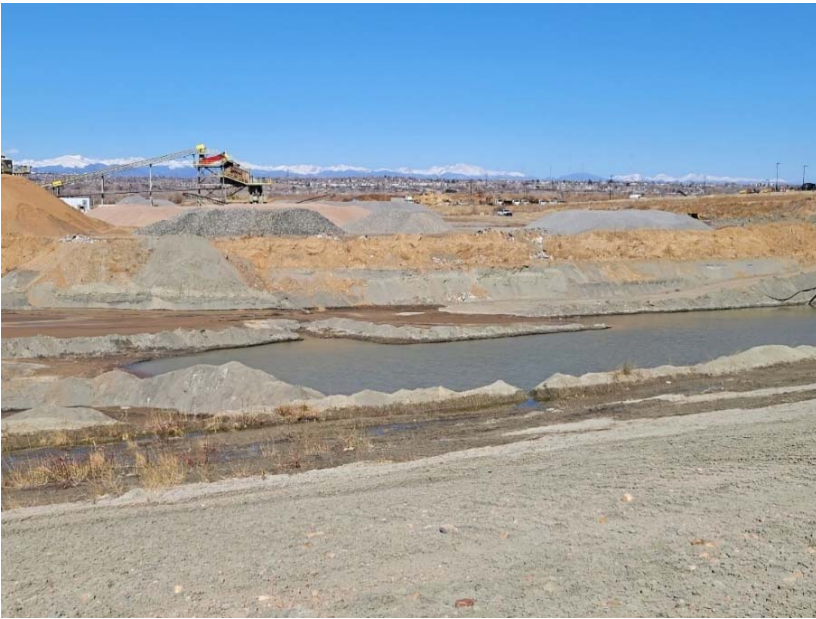
**Photo 16:** Looking west across Phase 2 pit. Water observed in pit.

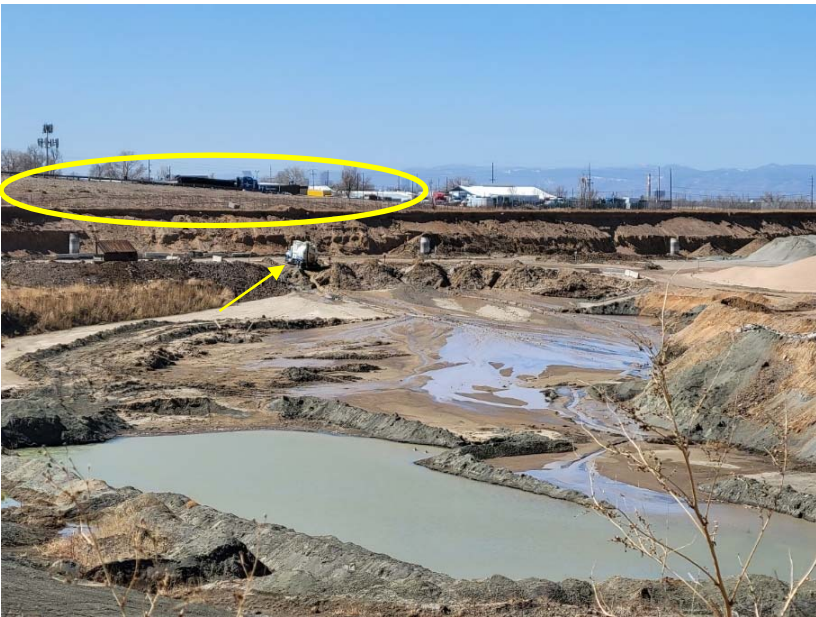
**Photo 17:** Looking southwest across Phase 2 pit area. Vacuum truck on far side draining water into pit. Yellow circle is topsoil stockpile location.

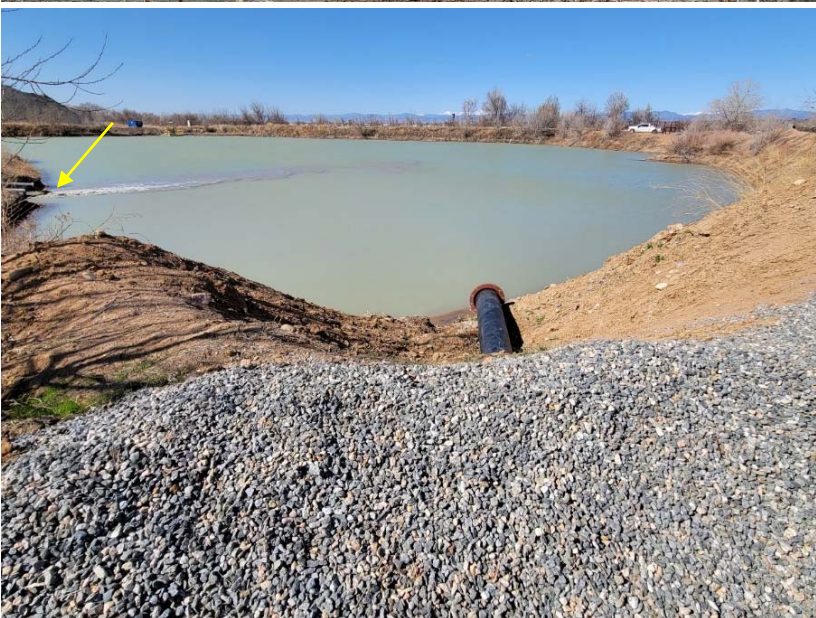
**Photo 18:** Looking southwest, newly installed French drain outlet into unlined pond (pre-1981). Yellow arrow is water coming in through drain pipes from the adjacent settling pond.

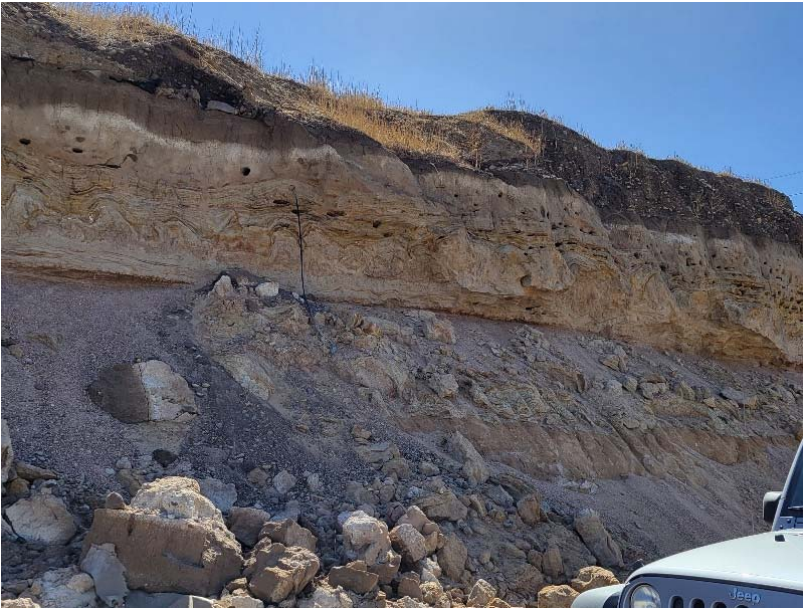
Future Reclamation: At the time of the inspection, topsoil was stored above the highwalls in the Phase 2 pit and no erosion issues were noted (Photos 19-20). Since the last inspection, manholes in the pit area have been completed and Joel Boldoc indicated new sections will be added to the top of the manholes as the pit fills in with inert material (Photo 21).

**Photo 19:** Looking east at high wall and topsoil storage in Phase 2.

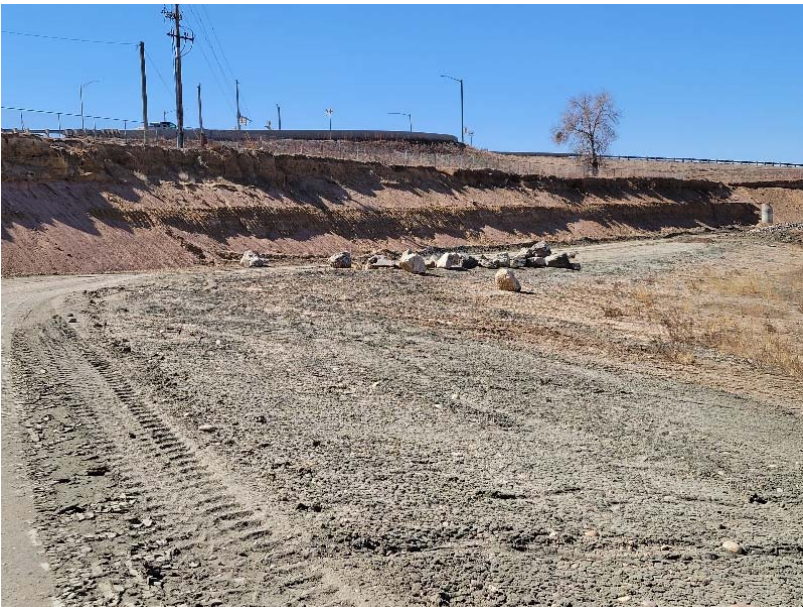
**Photo 20:** Looking south at compacted clay liner, pit wall and topsoil piles along top of pit.

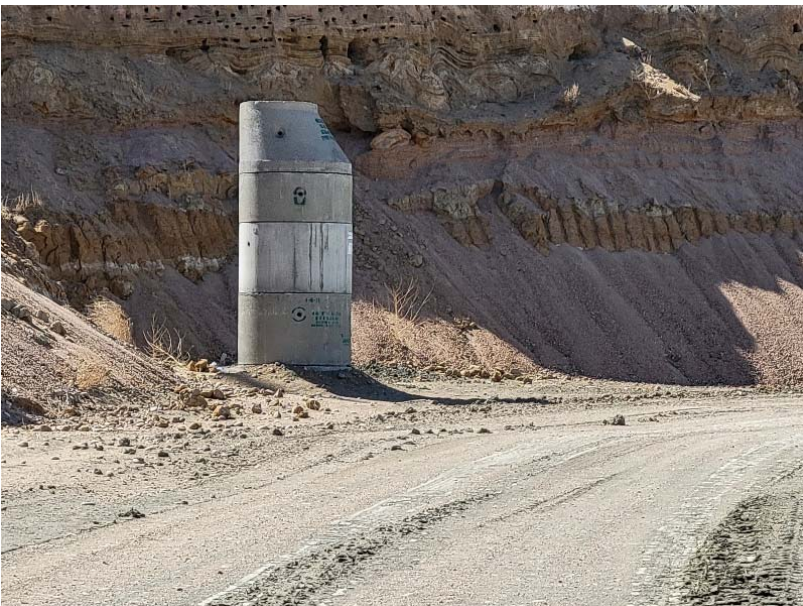
**Photo 21:** Completed manhole inside Phase 2 pit.
