**MINERALS PROGRAM INSPECTION REPORT**  
**PHONE: (303) 866-3567**

<b>MINE NAME:</b> R.B. Pit	<b>MINE/PROSPECTING ID#:</b> M-2022-002	<b>MINERAL:</b> Sand and gravel	<b>COUNTY:</b> Chaffee
<b>INSPECTION TYPE:</b> Preoperation Inspection	<b>INSPECTOR(S):</b> Dustin Czapla	<b>INSP. DATE:</b> April 7, 2022	<b>INSP. TIME:</b> 12:00
<b>OPERATOR:</b> ACA Products, Inc.	<b>OPERATOR REPRESENTATIVE:</b> Blake Bennetts	<b>TYPE OF OPERATION:</b> 112c - Construction Regular Operation	
<b>REASON FOR INSPECTION:</b> Pre-operation Inspection	<b>BOND CALCULATION TYPE:</b> Complete Bond	<b>BOND AMOUNT:</b> No Bond Held	
<b>DATE OF COMPLAINT:</b> NA	<b>POST INSP. CONTACTS:</b> None	<b>JOINT INSP. AGENCY:</b> None	
<b>WEATHER:</b> Clear	<b>INSPECTOR'S SIGNATURE:</b>

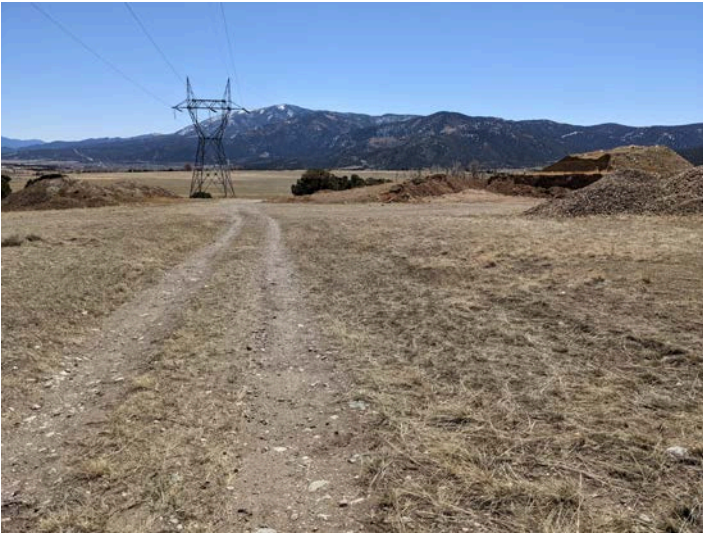
Present conditions proposed permit area

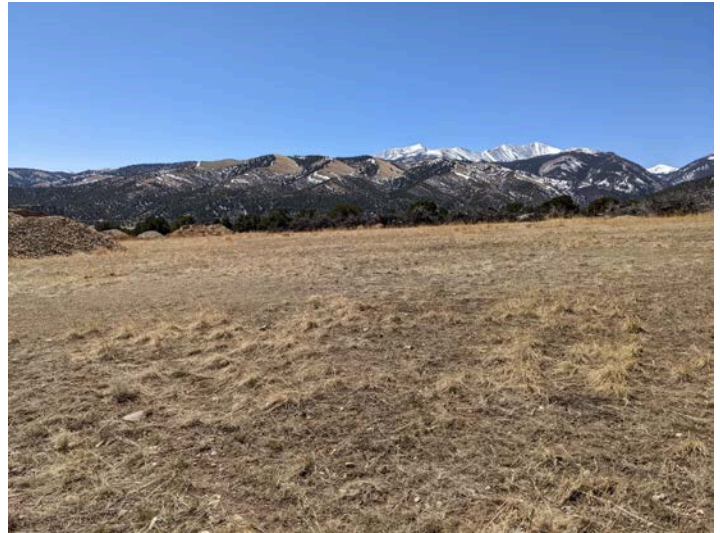
Present conditions proposed permit area

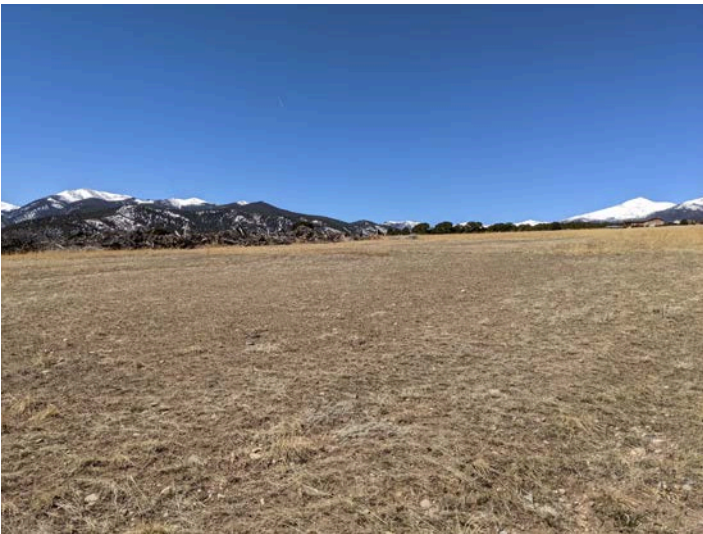
Present conditions proposed permit area

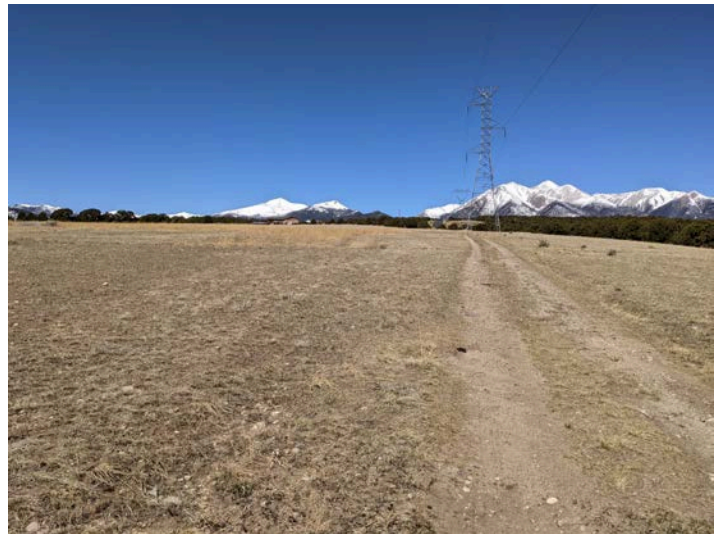
Present conditions proposed permit area

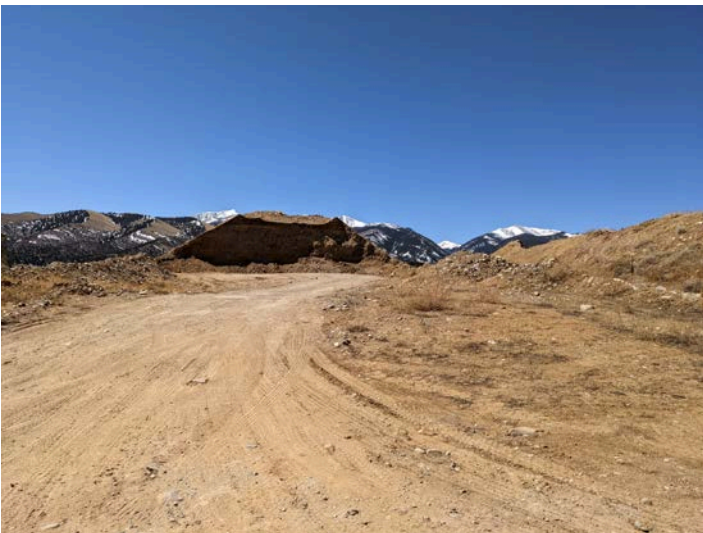
Material from road construction stockpiled in east part of proposed permit area

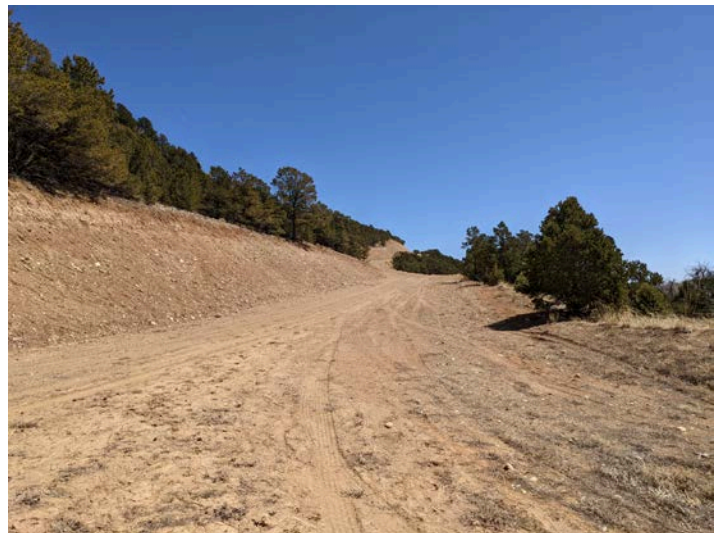
Existing access road from Hwy 50

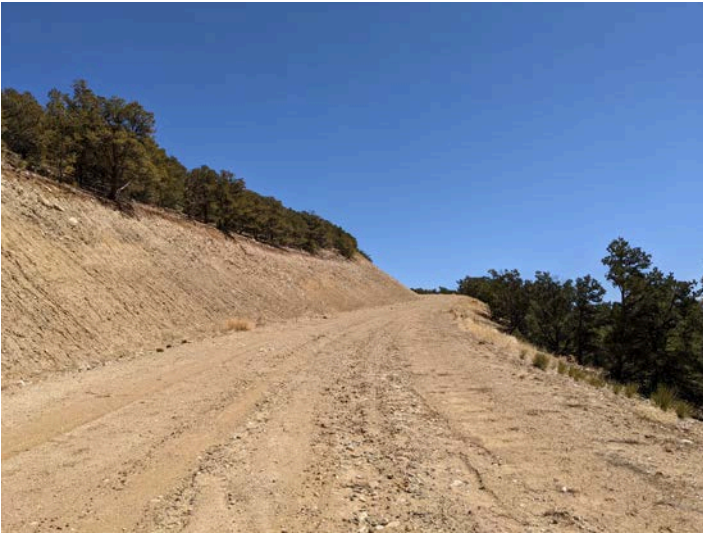
Existing access road from Hwy 50

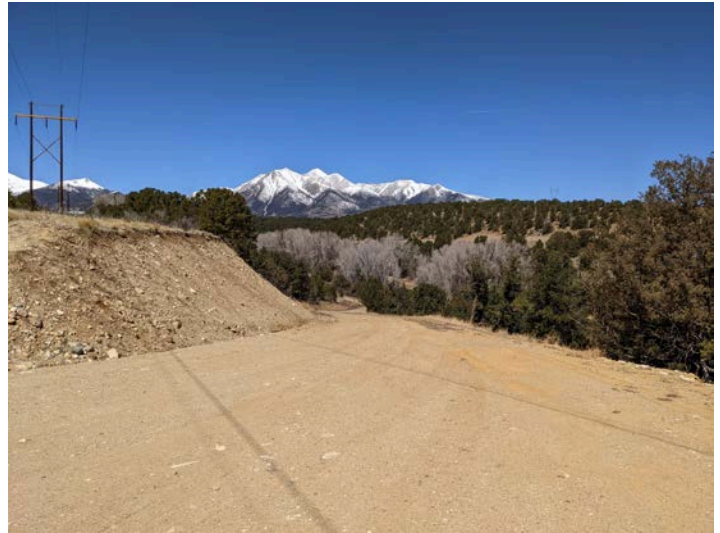
Existing access road from Hwy 50

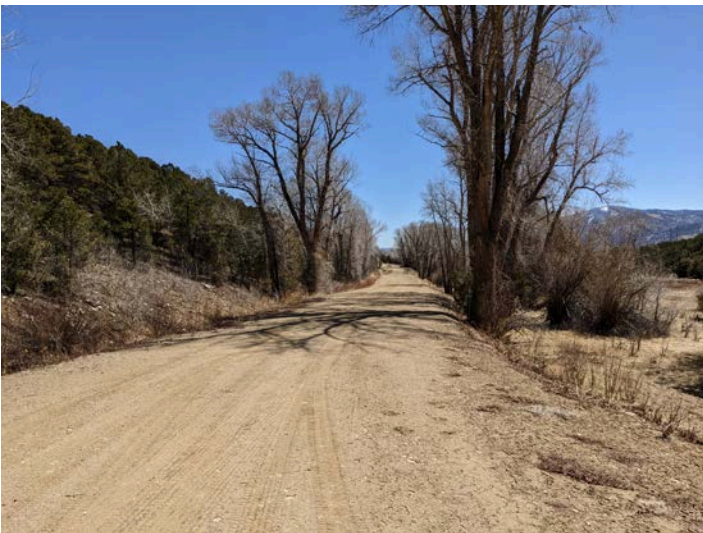
Existing access road from Hwy 50

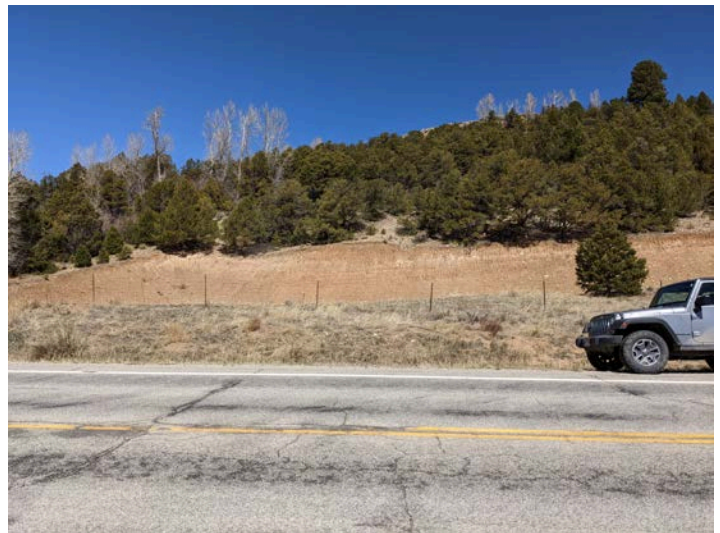
Entrance to access road from Hwy 50
