PERMIT INFORMATION

Permit Number: C-1996-083 Mine Name: Bowie No. 2 Mine Operator: Bowie Resources, LLC Operator Address: Mr. Basil Bear P.O. Box 1488 Paonia, CO 81428	County: Delta Operation Type: Underground Permit Status: Active Ownership: Private
	Operator Representative Present: Basil Bear
Operator Representative Signature: (Field Issuance Only)

Inspection Start Date: April 19, 2022 Inspection Start Time: 13:00 Inspection End Date: April 19, 2022 Inspection End Time: 16:00	Inspection Type: Coal Partial Inspection Inspection Reason: Normal I&E Program Weather: Clear
Joint Inspection Agency: None	Joint Inspection Contacts:
Post Inspection Agency: None	Post Inspection Contacts:
Inspector(s): Robert Zuber, P.E.	Inspector's Signature:

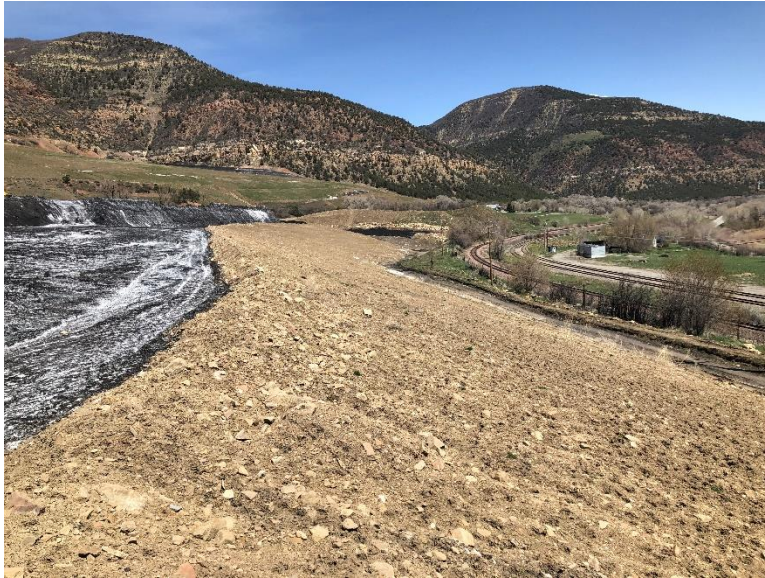
BRL continues to focus the majority of their reclamation efforts on Gob Pile #3. Coverfill has been spread along most of the southern portion of the pile.

Coverfill spread below Gob Pile #3

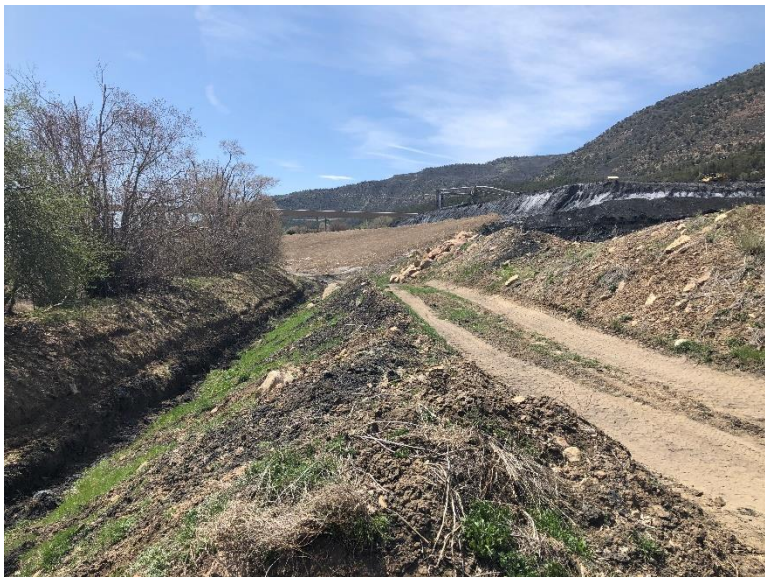
BRL has recently cleaned ditches on site, including the large ditch below Gob Pile #3, Ditch J-3. All observed ditches were stable.

Ditch below Gob Pile #3

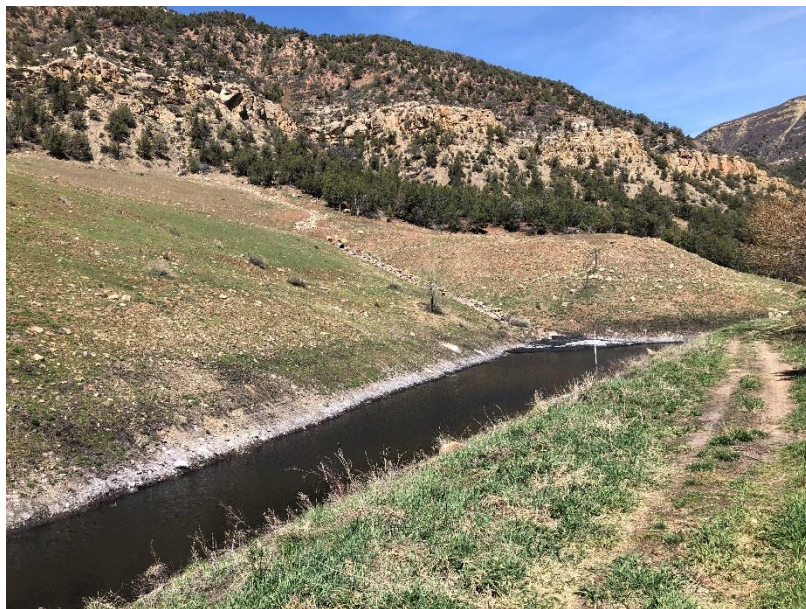
Pond F

Six sediment ponds were inspected: B, C, D, F, J, and K. None of the ponds were discharging. Five of the ponds

contained water from recent precipitation, but none of the ponds were close to full. (In Pond K, there was no standing water but the soil was muddy.) No problems were identified with embankments, spillways, inlet channels, or other features of the ponds.

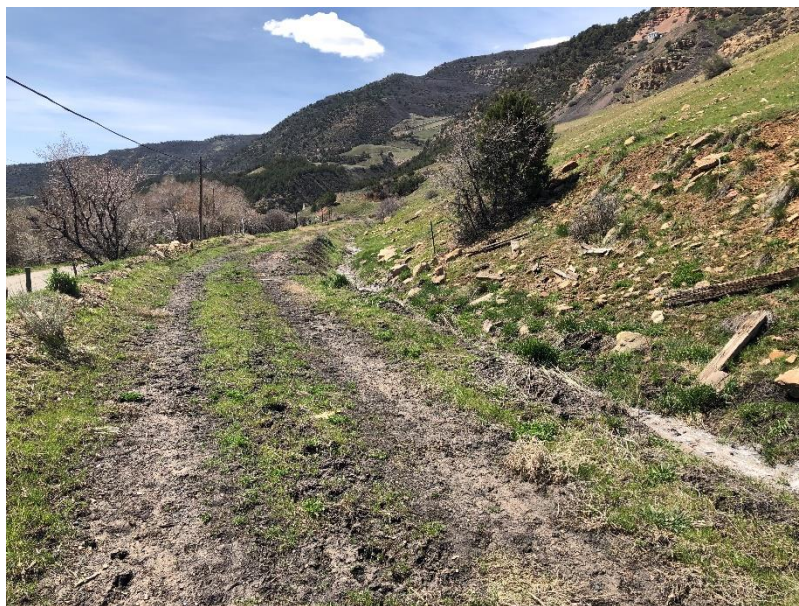
Ditch into Pond F (D-F7a)

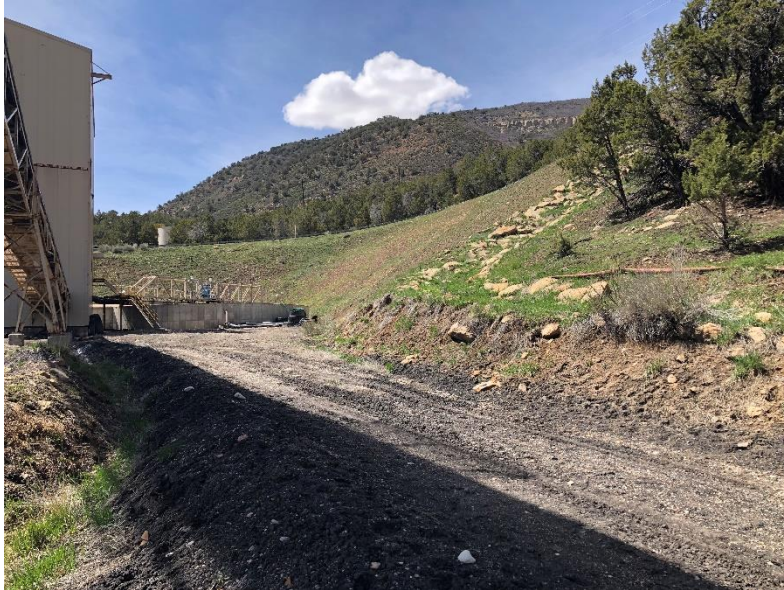
- No problems were seen in the area around the Pump House and Filter Building.
- No erosion was seen on the slopes near the Preparation Plant and nearby water tank.
- The slopes above and below the Coal Stockpile Pad are stable.
- The material storage area beside Topsoil Stockpile A is very stable.
- No erosion or other problems were seen along the conveyor corridors.
- No erosion or other problems were identified at the eastern portion of the Unit Train Loadout.

Hill above Prep Plant and Ditch B18

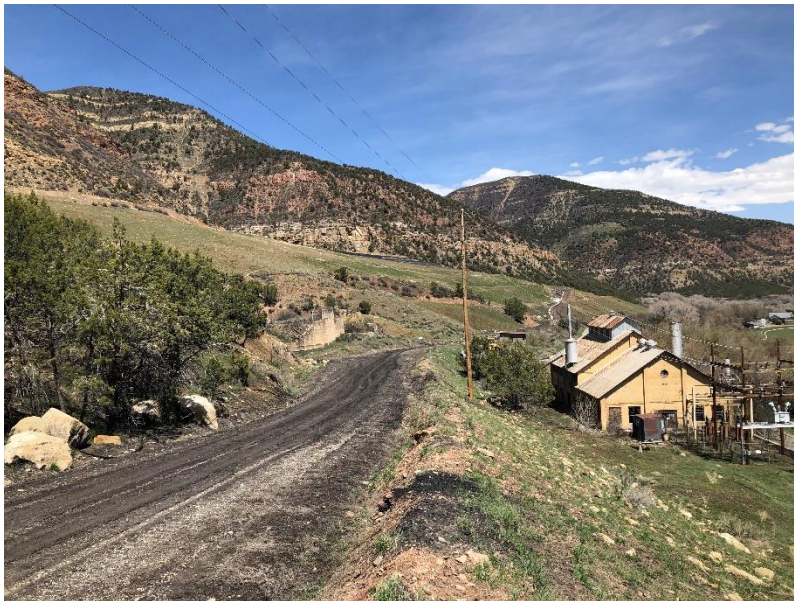
No significant problems were seen with the roads. The hillsides above and below this road were generally stable.

Road to Gob Pile #2, with old Power Plant on right

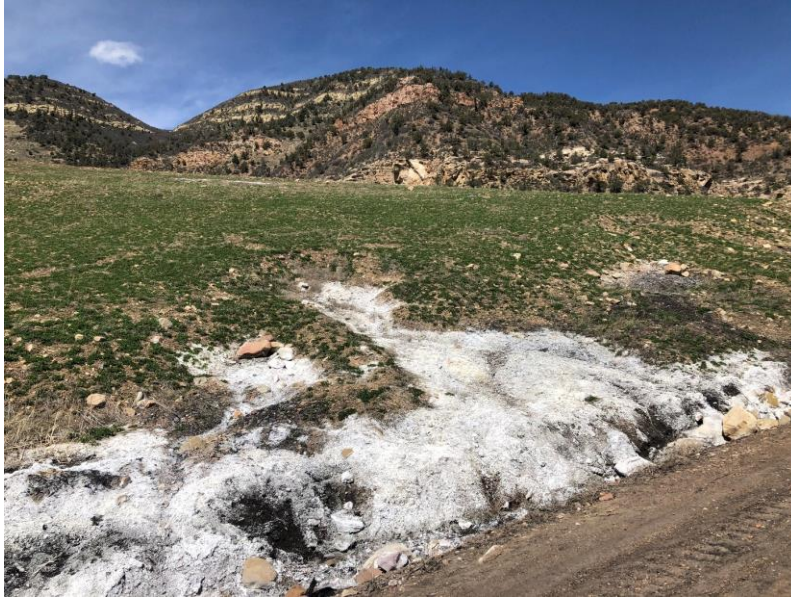
Overall the gob piles appeared stable. Parts of the piles were driven in a vehicle and appeared well compacted. Seepage from Gob Pile #2 is causing minor erosion and should be monitored closely. The BMPs on Gob Pile #2 appeared to be functioning well.

Seep on lower portion of Gob Pile #2

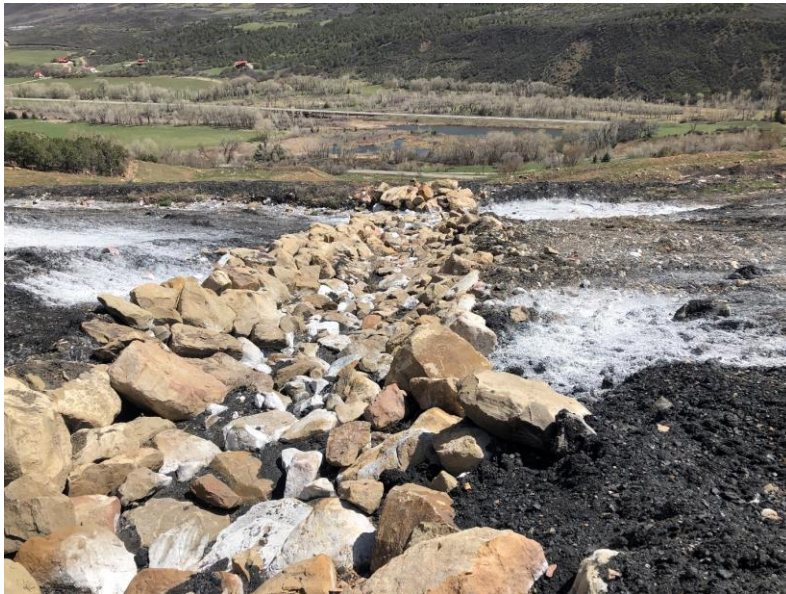
Ditch from un-reclaimed portion of Gob Pile #2

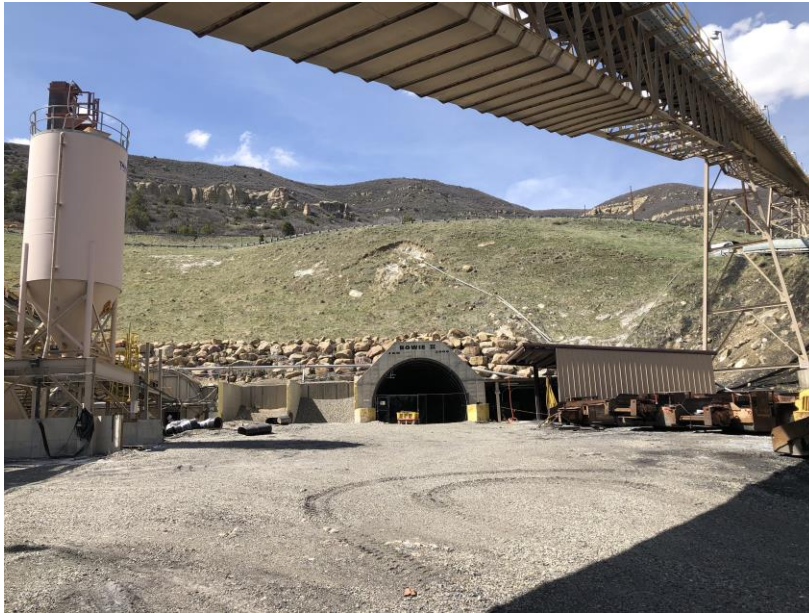
It appears that slumps have not moved significantly in the recent past. These include slumps by the B Portal and by Curve Number 11 along the Haul Road. The Division recommends that these continue to be monitored closely by BRL.

Slump above B Portal

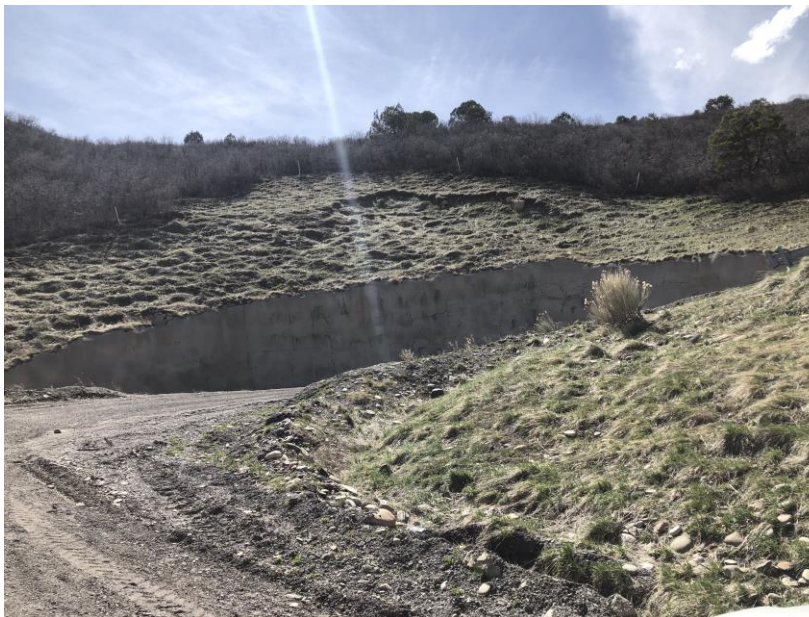
Slump at Curve 11

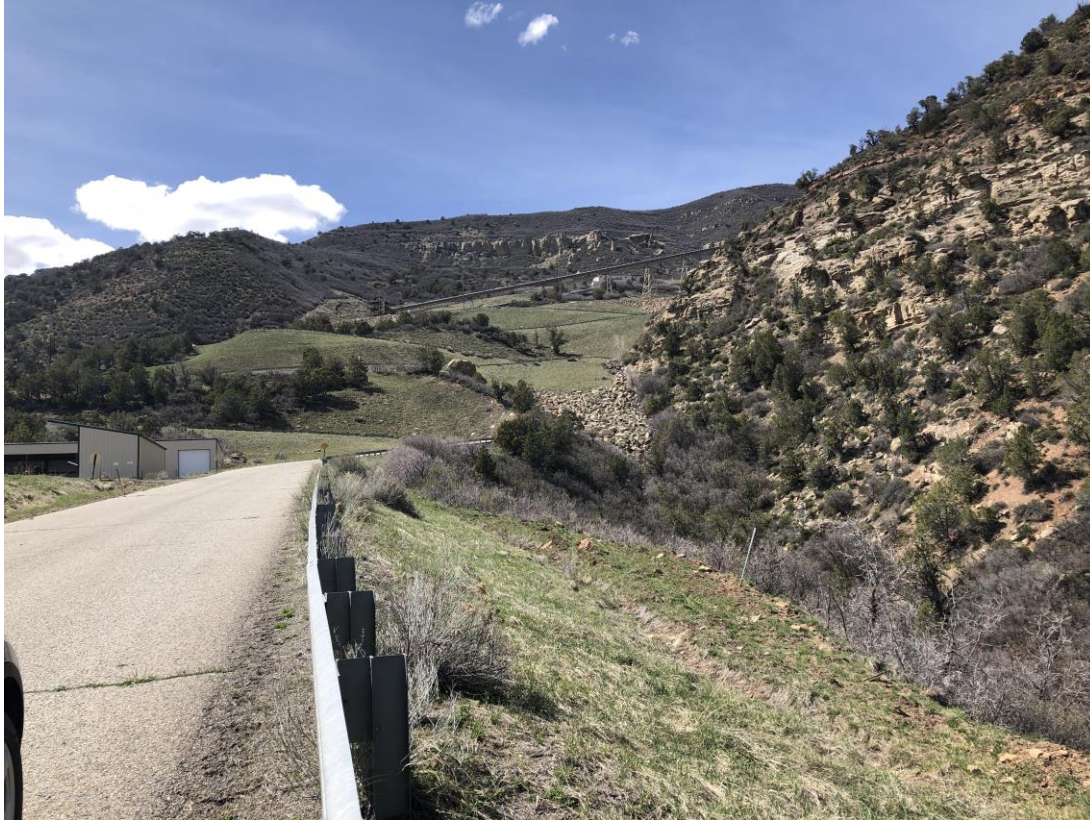
Road to portals
