April 19, 2022  
Project#01349-0001

Subject: Summary of Instrumentation Monitoring  
1<sup>st</sup> Quarter 2022  
Bowie Coal Waste Disposal Area No. 2  
Paonia, Colorado

**SUBJECT: Summary Report, 1<sup>st</sup> Quarter 2022, Inclinator and Active Vibrating Wire Piezometer Data January – March 2022, Bowie Mine #2 Coal Waste Disposal Area (CWDA) #2**

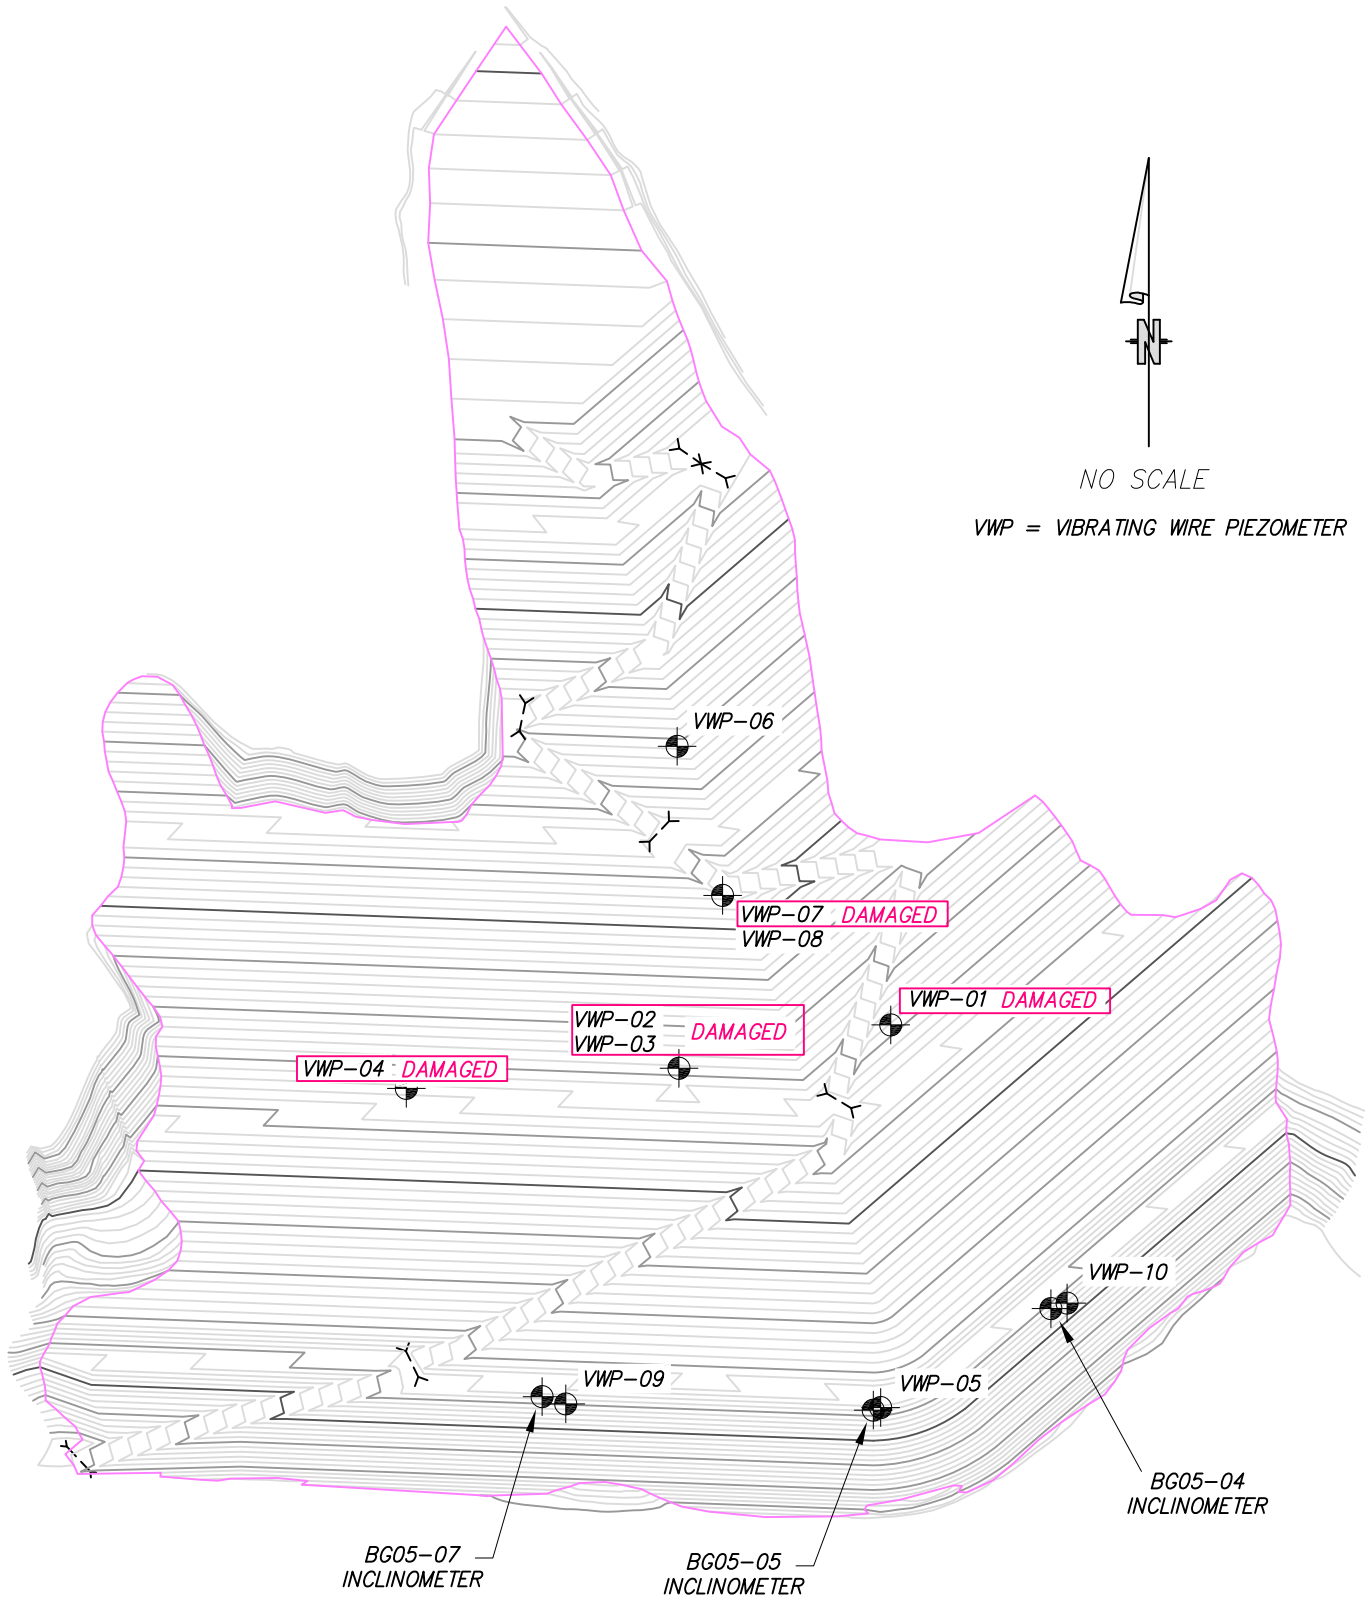
# INSTRUMENTATION SITE PLAN

The physical locations of the piezometers are shown on the attached Instrumentation Site Plan (Map 1). As seen on this map, five of the original piezometers were damaged, and some were replaced. Currently, there are five active VWP's, and three of them are adjacent to inclinometers. The graph of historical VWP data from May 16, 2005 through May 21, 2014 is presented in Figure 1. A graph of measured pore pressures of active piezometers is presented on the attached Figure 2 and is presented numerically in Table 1 below.

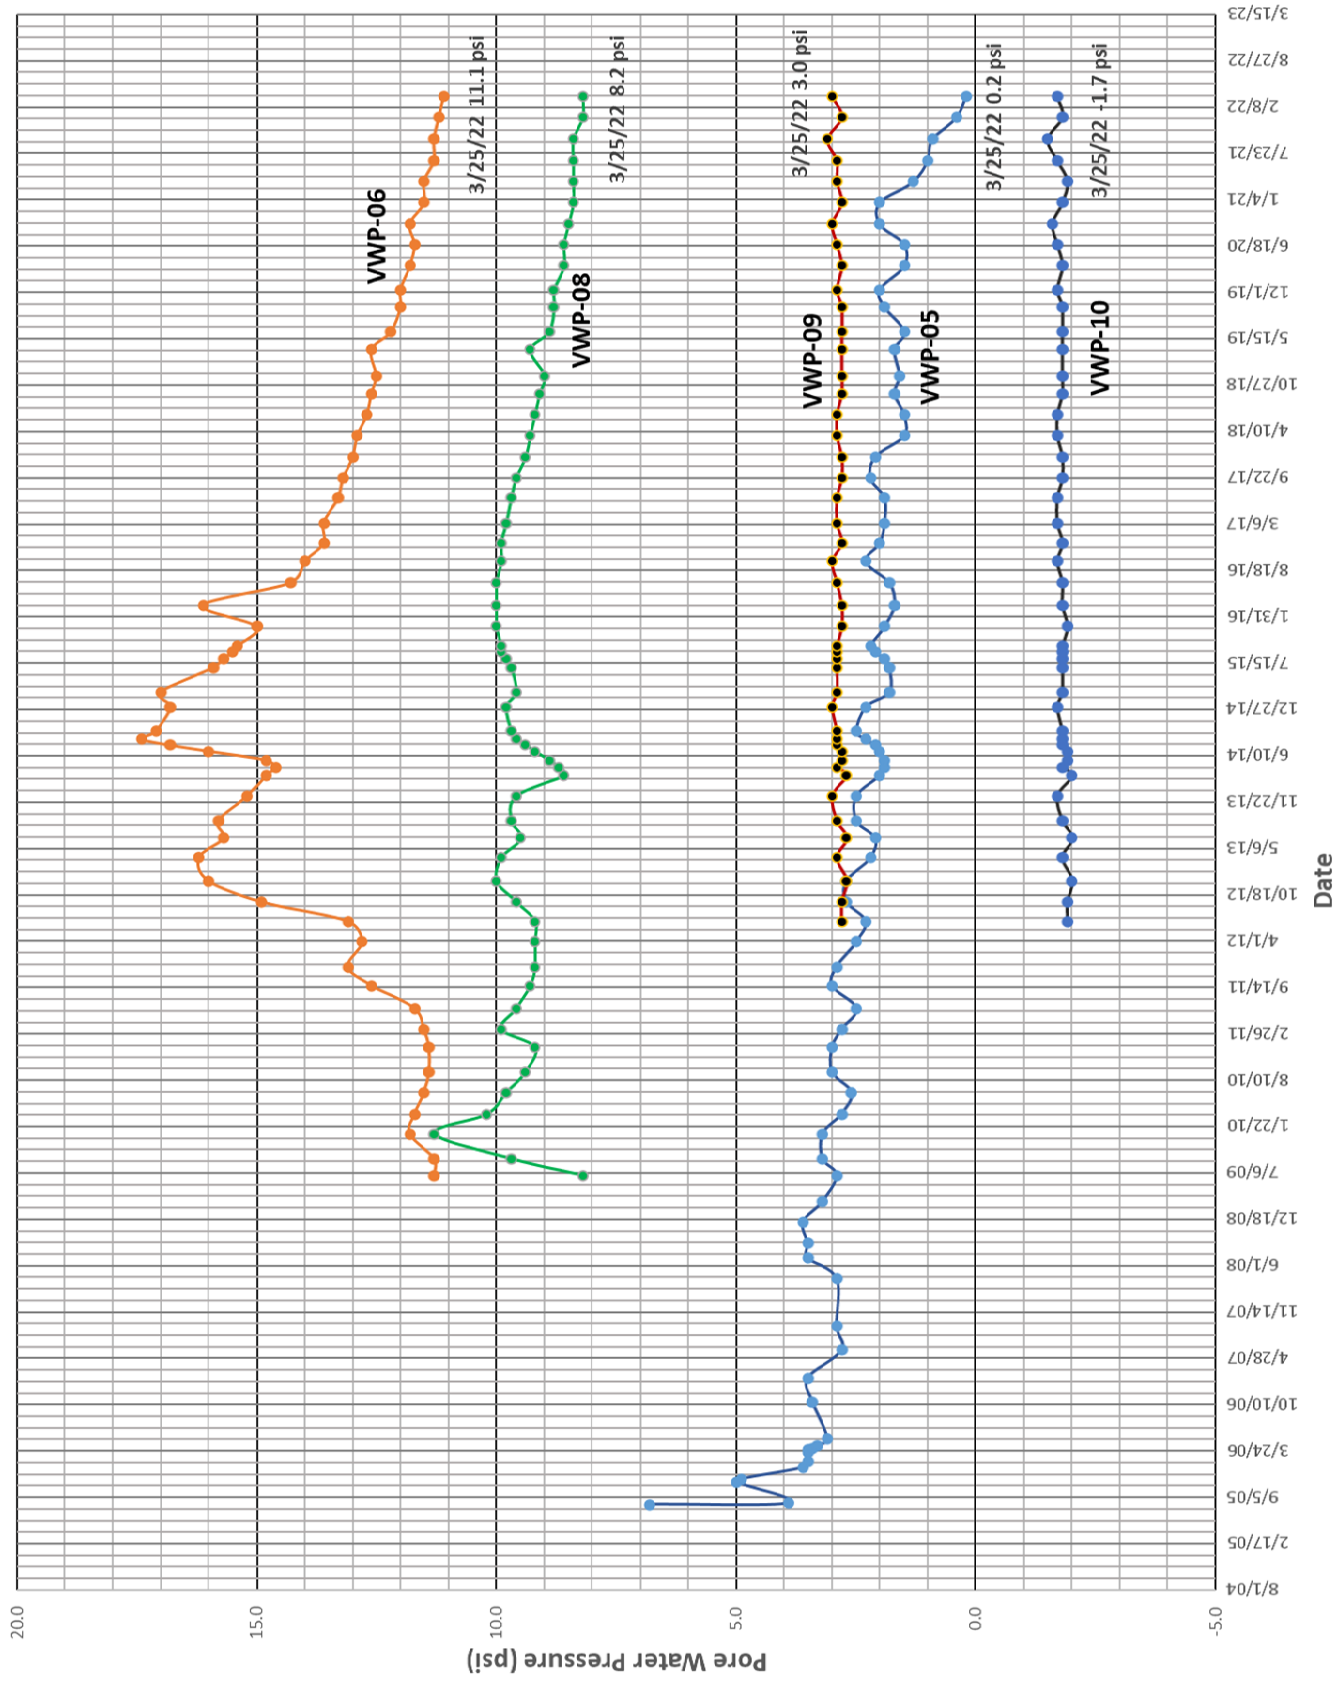
Figure 2 - Bowie Mine #2 - CWDA #2  
Active Vibrating Wire Piezometer Data

As seen on Table 1 and Figure 2, the VWP readings and trends are consistent with recent and historic readings. Pore pressure readings changed by small amounts (0.1 to -0.4 psi) for four of the five VWP's since the readings one year ago (Q1 2021), while VWP-05 had a change of -1.1 psi from a year ago. When compared with a last quarter (Q4 2021), pore pressures also changed by relatively small amounts (-0.1 to 0.2 psi) in all five VWP's. Although four of the five VWP's remain steady or have general declining trends in pore pressure over the life of the VWP's, one of the piezometers (VWP-05) has exhibited pronounced seasonal cyclical behavior for its lifespan, except for the past five quarters where there has been a steady decline in pre pressures, regardless of season. This piezometer generally (but not always) shows low pore pressures for Q1 and Q2 and higher pressures for Q3 and Q4, with a net loss of 6.6 psi over the lifetime of that VWP. The other four VWP's have experienced net changes of +/-0.2 psi or less since installation, meaning current readings are very similar to initial readings. For VWP-09 and VWP-10, pressures have been consistent throughout the lifetime of the piezometers; however, for VWP-06 and VWP-08, they experienced wild fluctuations in pore water pressure in the first half of their lifetimes, but have settled to pressures similar to the installation pressures in the past 1-2 years.

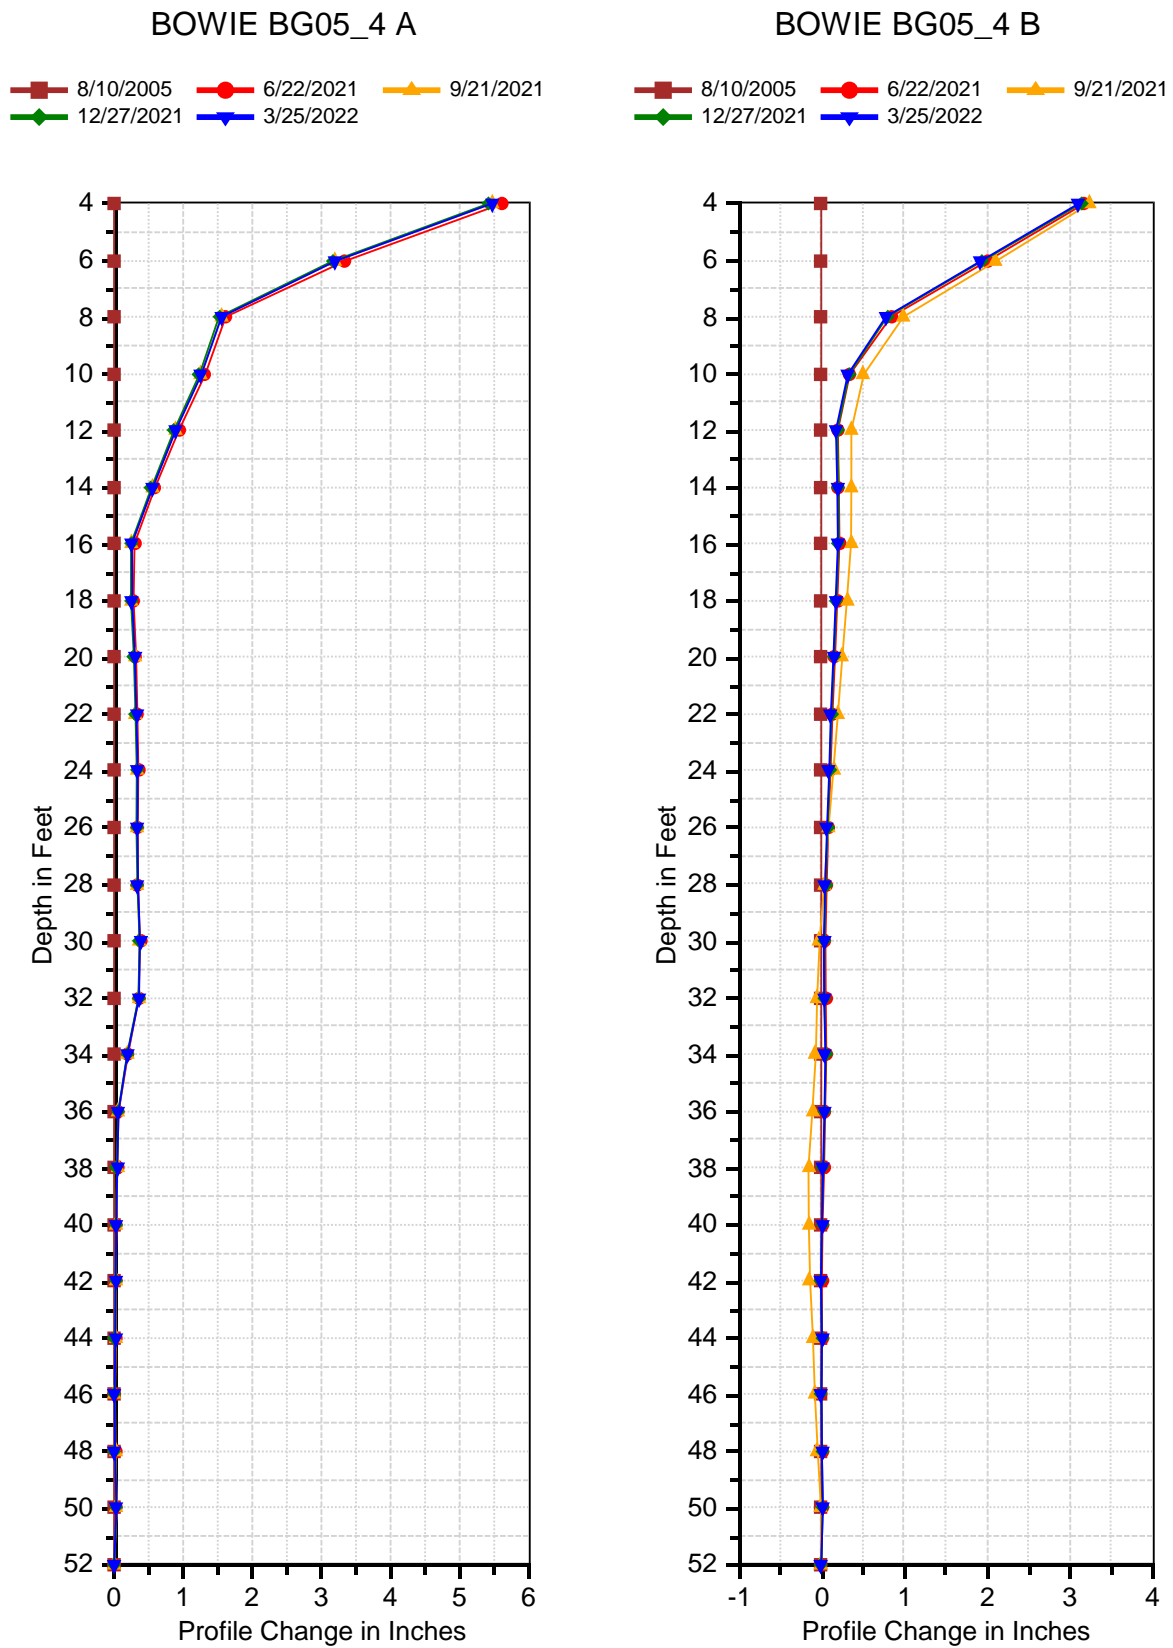
Figure 3 - Inclinator Displacement Curves

As described in previous reports, historic displacements indicated on the plots for the approximate upper 12-14 feet of the inclinometers since installation in 2005 are due to placement of cover soil on the face of the waste pile during revegetation operations in late 2006 and early 2007. This man-caused displacement is documented in a report by Buckhorn Geotech dated December 22, 2008 to Bowie Resources called *Revised Stability Evaluations for Coal Mine Waste Disposal Area No. 2, Bowie No. 2 Mine*.

Based on the current inclinometer readings, there has not been evidence of significant downslope movement (Axis A) in any of the inclinometers since 2007 and they are generally consistent with previous readings. Some "noise" which is understood to be relatively common in orthogonal direction (Axis B) readings, was observed over the past few years for all three inclinometers. This can be due to various mechanical or installation causes that are unrelated to slope movement. For example, grout voids, poor grout coverage, or soil settlement around the instrument can all contribute to vibrations and pipe movement that impacts inclinometer readings. Software bias adjustments were applied which filtered this noise. All readings were consistent with previous ones and the "displacement" error was within equipment tolerances and not deemed to be due to slope movement.

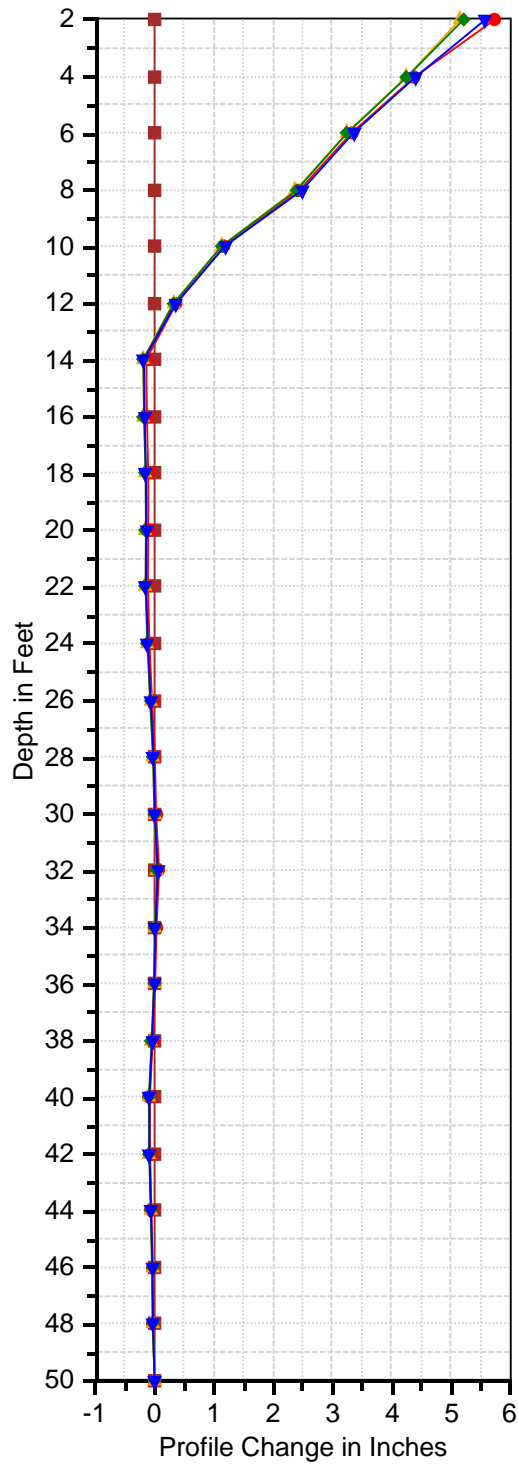
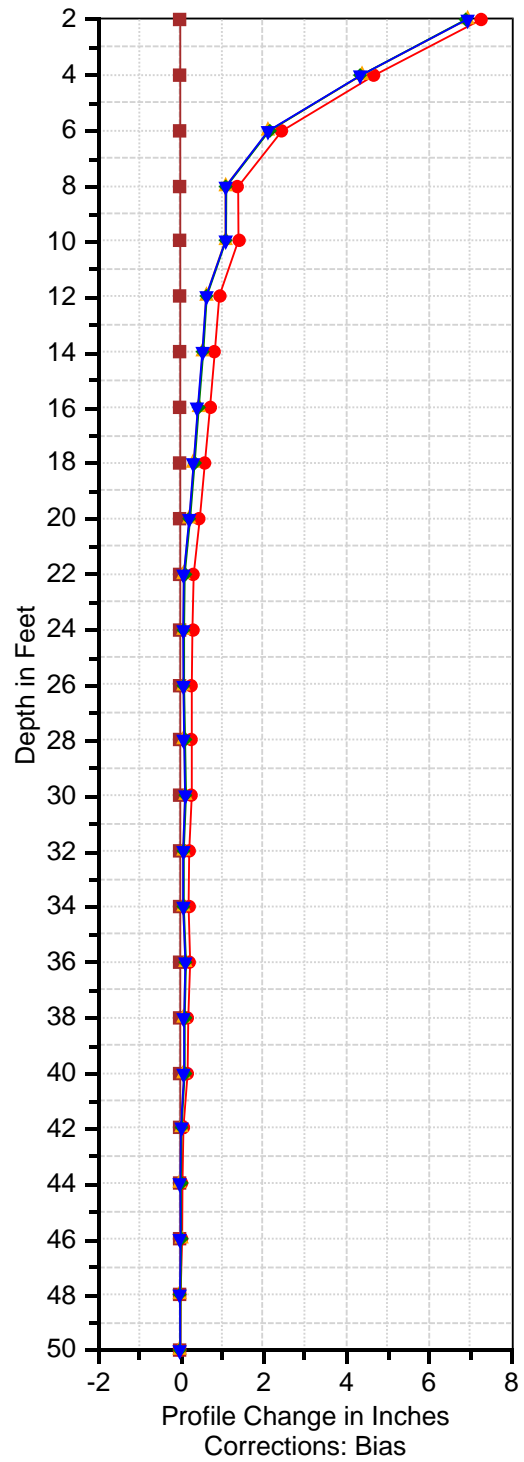
# BOWIE BG05\_7 A

Water was standing in the BG05-4 inclinometer pipe at a depth of about 6 feet below grade. Based on our observations there has always been water in this pipe. Table 2 below, shows water levels in all three inclinometers for the past five quarters. We also measured water at 10 feet in inclinometer BG05-7. There was no water in the BG05-5 pipe and this inclinometer is typically dry. Worth noting is that in order for water to be in inclinometer pipes, the seal may be broken at the seams where the pipes snap together, the grout sleeve could have voids or has deteriorated so that it no longer forms a solid sleeve around the inclinometers, or there is a crack in the pipe, either due to slope movement or other pipe damage. Although it is not known for sure, we suspect the pipes cracked in 2006-2007 when the slope revegetation occurred, in the upper 12-14 feet of the inclinometers.
