Permit Number: C-1981-041 Mine Name: Roadside Portals Operator: Snowcap Coal Company, Inc. Operator Address: MS Tonya Hammond P.O. Box 1430 Palisade, CO 81526	County: Mesa Operation Type: Underground Permit Status: Active Ownership: Private
	Operator Representative Present: Tonya Hammond
Operator Representative Signature: (Field Issuance Only)

Inspection Start Date: April 21, 2022 Inspection Start Time: 09:35 Inspection End Date: April 21, 2022 Inspection End Time: 10:15		Inspection Type: Coal Partial Inspection Inspection Reason: Normal I&E Program Weather: Clear	
Joint Inspection Agency: None		Joint Inspection Contacts: None	
Post Inspection Agency: None		Post Inspection Contacts: None	
Inspector(s): Clayton Wein	Inspector's Signature: <i>Clayton Wein</i>		Signature Date: 4/21/2022

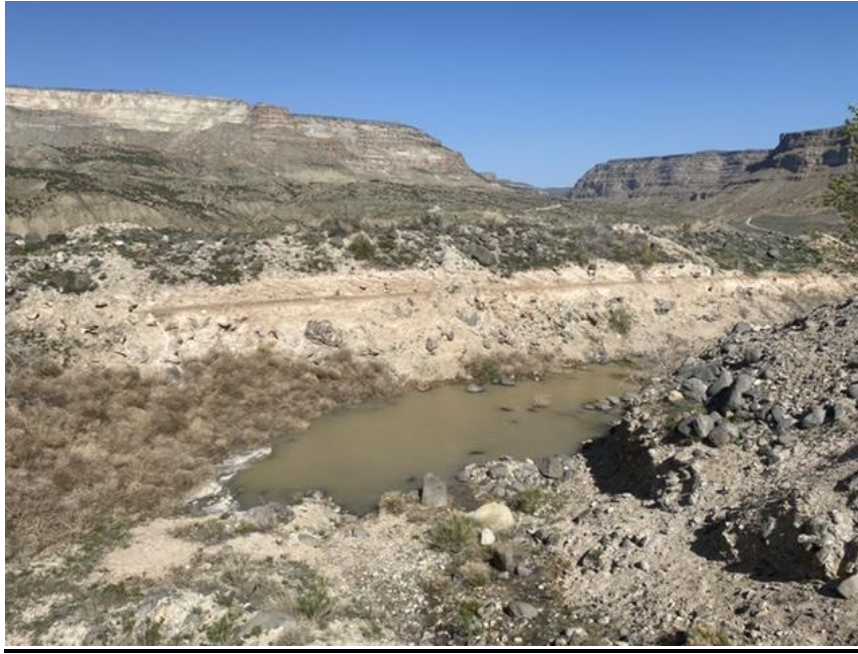
During the inspection, the Division noticed the landowner was applying water from the pipeline on tract 71 to the inlet of the Carey Pit. There was a small amount of water impounded in the pit and no discharge was observed from the pit (Photo 1).

Photo 1: The water impounded in the Carey Pit.

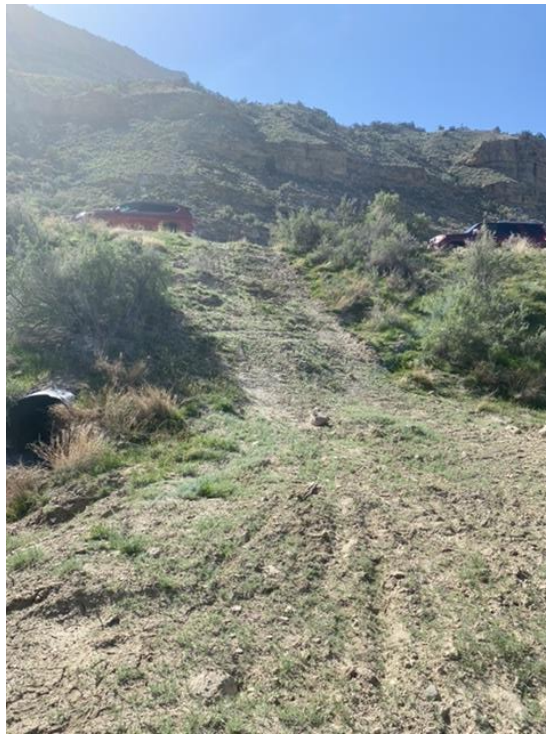
The 016 Outlet was visited during the inspection. The gauge on the outlet gave a reading of 106.2 gpm. This reading is within the range of historical data collected from the outlet. The embankment leading down from the access road was stable with no erosional features (Photo 2). The vegetation seeded on the slope from last fall was beginning to grow for the spring season.

Photo 2: The Embankment leading from the access road to the 016 Outlet.

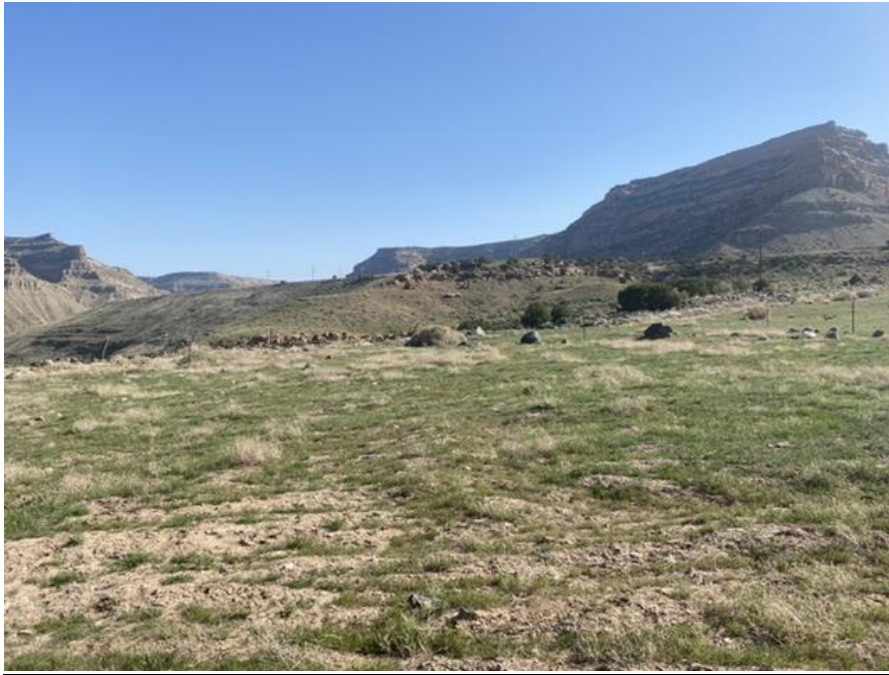
The remaining permitted disturbance at the mine site is located on Tract 71 and is approximately 0.4 acres in size (TR-69 Repair Area). The site was stable with vegetative cover (Photo 3 and 4). Plants were growing for the spring season. Additionally, plant species such as Shadscale (Photo 5), Fourwing Saltbrush and Rabbit Brush were identified. The operator sprayed for Whitetop on Tuesday April 19th. There were no erosional features identified at the site. The sediment logs were in good condition and located at the down gradient portions of the disturbance. The disturbance boundary markers were in places and could be seen from all portions of the disturbance. There was a mine identification sign displayed on a t-post at the entrance to the disturbance from the access road. The sign was placed in a clearly marked location and was easy to read.

Photo 3: The northeastern portion of the TR-69 Repair Area.

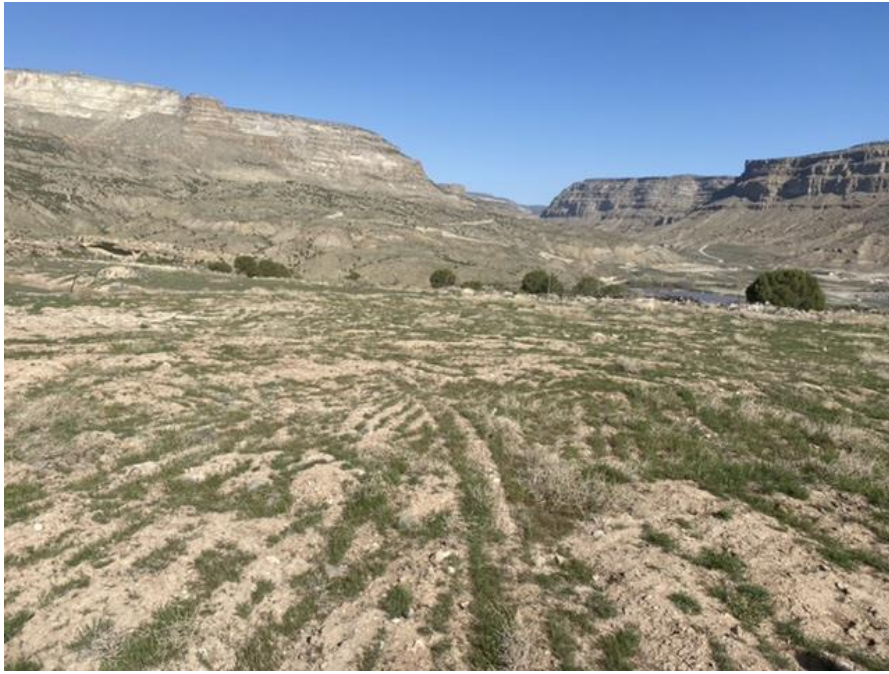
Photo 4: The western portion of the TR-69 Repair Area.

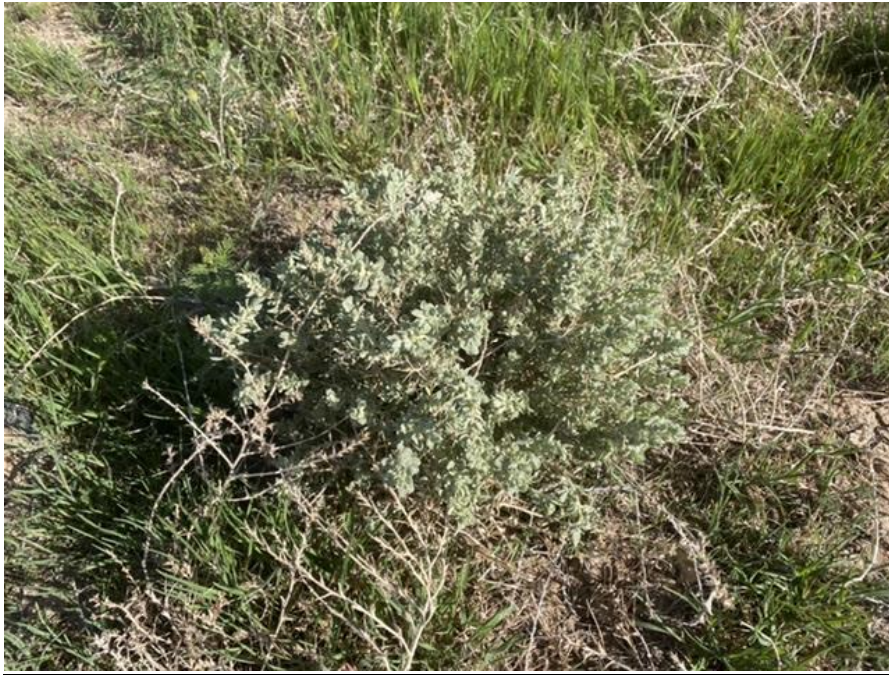
Photo 5: One of the Shadscale plants growing in the TR-69 Repair Area.
