## Bowie #1 inspection report

**PERMIT INFORMATION**

<b>Permit Number:</b> C-1981-038 <b>Mine Name:</b> Bowie No. 1 Mine <b>Operator:</b> Bowie Resources, LLC <b>Operator Address:</b> Mr. Basil R Bear P.O. Box 1488 Paonia, CO 81428	<b>County:</b> Delta <b>Operation Type:</b> Underground <b>Permit Status:</b> Active <b>Ownership:</b> Private
	<b>Operator Representative Present:</b>  Basil Bear
<b>Operator Representative Signature: (Field Issuance Only)</b>

<b>Inspection Start Date:</b> April 20, 2022 <b>Inspection Start Time:</b> 09:15 <b>Inspection End Date:</b> April 20, 2022 <b>Inspection End Time:</b> 11:45		<b>Inspection Type:</b> Coal Partial Inspection <b>Inspection Reason:</b> Normal I&E Program <b>Weather:</b> Clear	
<b>Joint Inspection Agency:</b>  None		<b>Joint Inspection Contacts:</b>  	
<b>Post Inspection Agency:</b>  None		<b>Post Inspection Contacts:</b>  	
<b>Inspector(s):</b>  Robert Zuber, P.E.		<b>Inspector's Signature and Date:</b>

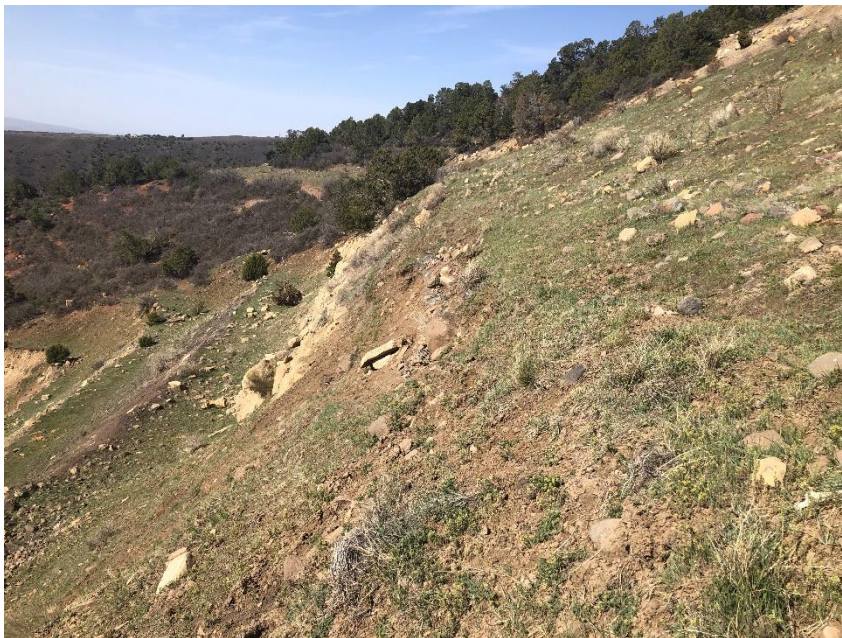
Mr. Bear indicated that he is still considering options related to the fallen fence at the upper part of the East Mine. After a closer inspection, it is apparent that working on that area could be a safety concern and it could result in a significant disturbance because soil and rocks would very likely be disturbed while performing the work.

The slope around the fallen fence at the upper part of the East Mine was stable.

**East Mine, area of concern due to remaining fencing material**

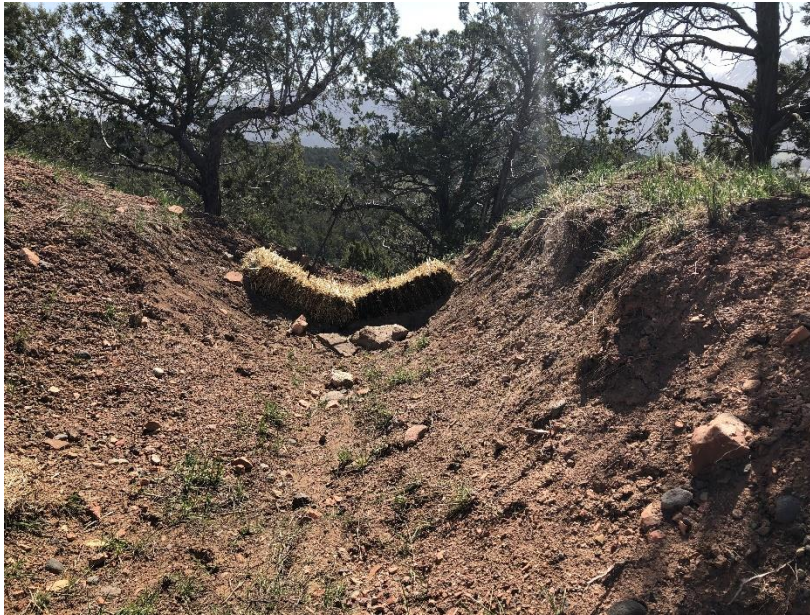
Straw bales southeast of the reclaimed RDA pond are functioning. At the first bend in the haul road west of the RDA, a bare spot exists near the edge of the disturbed area. BRL should use silt fence, erosion logs, or other practices to prevent erosion at this location.

**Straw bales near RDA**

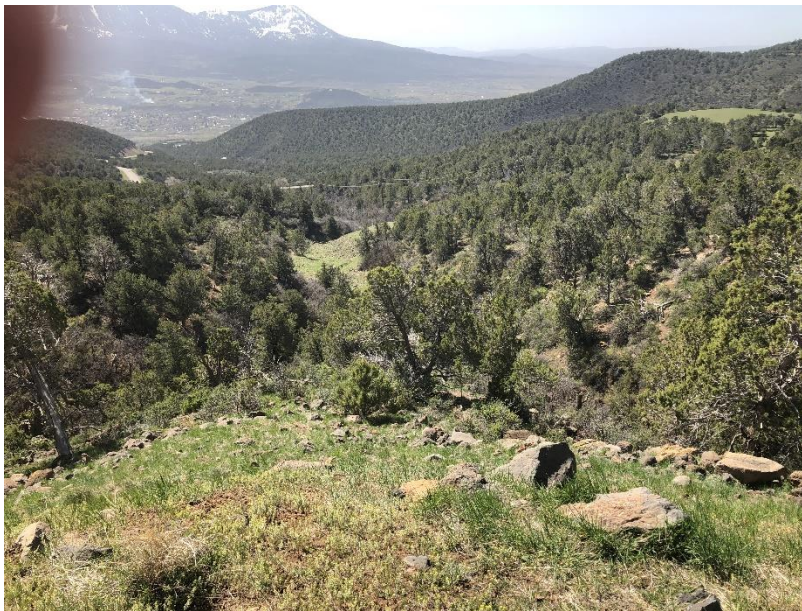
No erosion was seen at the reclaimed areas of the East Mine, including:

- The main area along the haul road and around the old portals
- The RDA
- The Old Waste Disposal Area
- The drainage where the reclaimed ponds (Ponds 1 – 4) are located.

**Drainage below Old Waste Disposal Area**

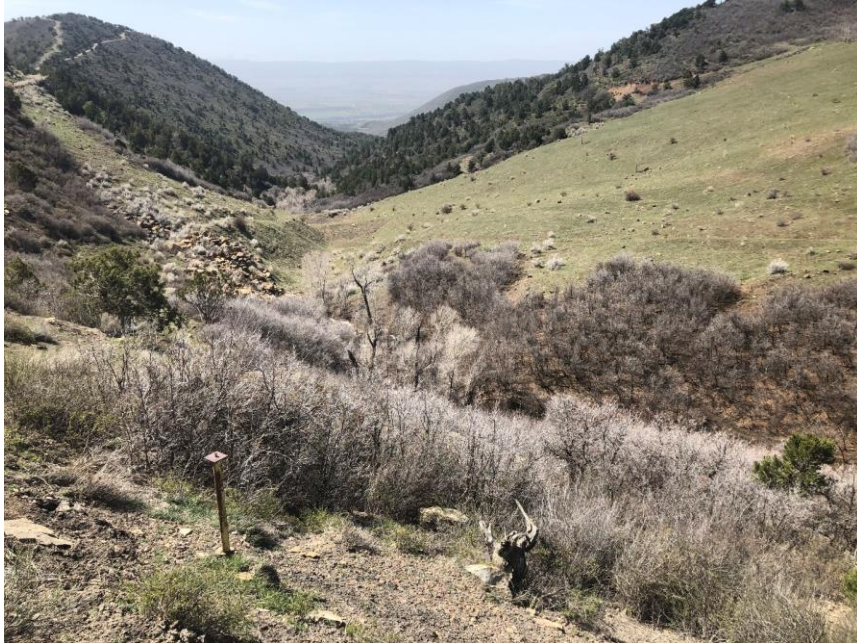
The ponds at the loadout, the Coal Storage Area (near Black Bridge Road), and the West Mine were dry, and no problems were identified with these ponds.

Reclamation at the West Mine was in good shape.

**West Mine, lower portion with ponds**

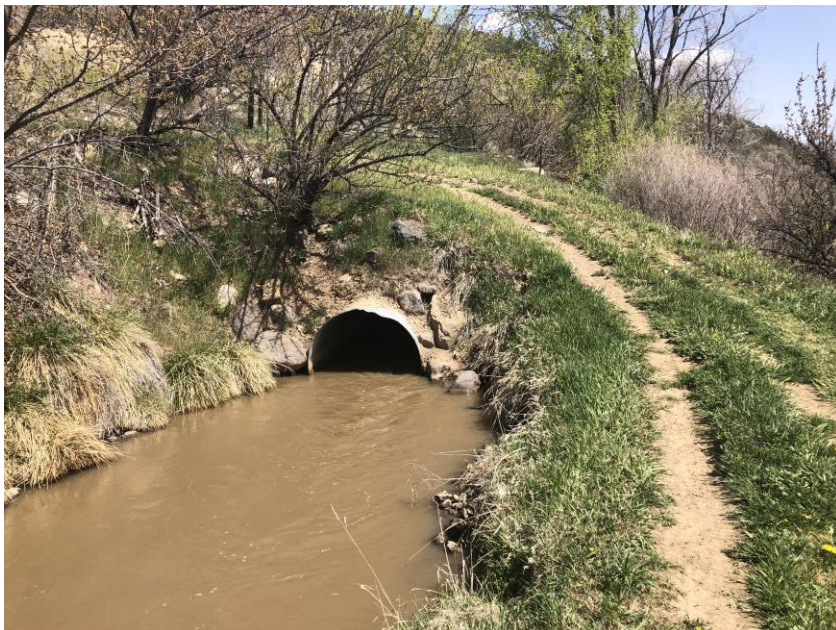
Flow in the Farmers Ditch was high. This ditch flows through a long culvert at the loadout, and the ends of the culvert were found to be in good shape.

**Farmers Ditch below the loadout**
