MINERALS PROGRAM INSPECTION REPORT
PHONE: (303) 866-3567

MINE NAME: Kirtright Pit	MINE/PROSPECTING ID#: M-1986-123	MINERAL: Sand and gravel	COUNTY: Larimer
INSPECTION TYPE: Monitoring	INSPECTOR(S): Brock Bowles	INSP. DATE: March 29, 2022	INSP. TIME: 08:30
OPERATOR: Coulson Excavating Company, Inc.	OPERATOR REPRESENTATIVE: None	TYPE OF OPERATION: 112c - Construction Regular Operation	
REASON FOR INSPECTION: Normal I&E Program	BOND CALCULATION TYPE: None	BOND AMOUNT: \$58,400.00	
DATE OF COMPLAINT: NA	POST INSP. CONTACTS: None	JOINT INSP. AGENCY: None	
WEATHER: Cloudy	INSPECTOR'S SIGNATURE:

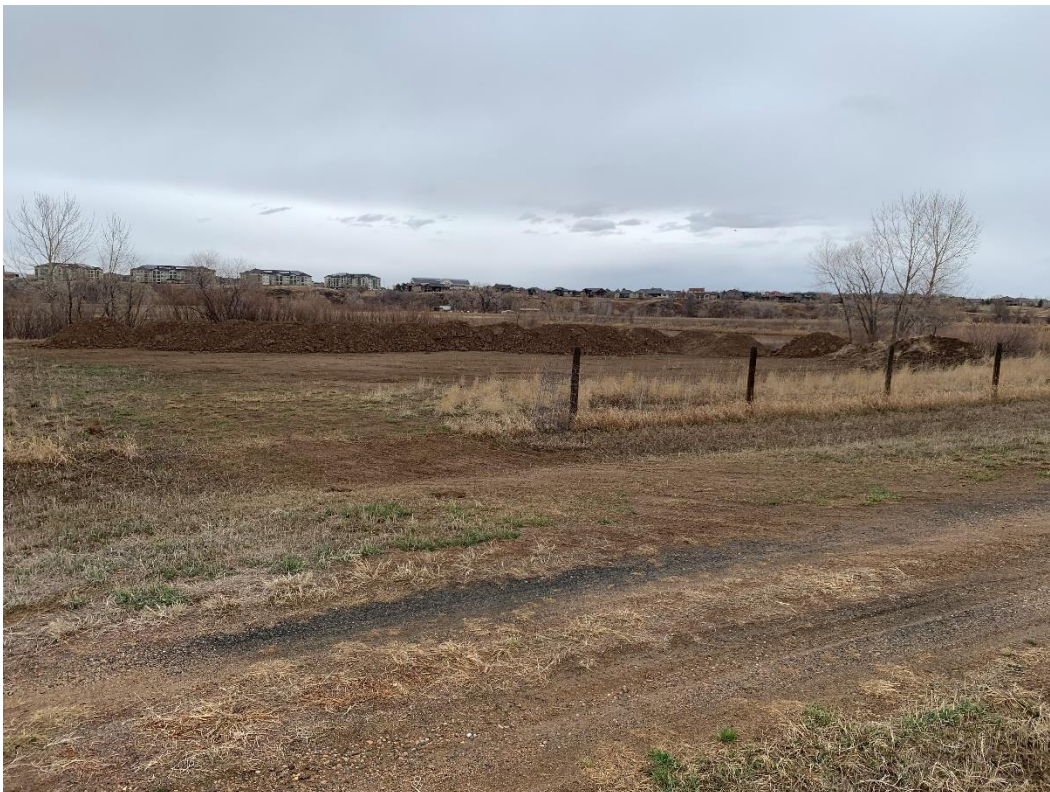
It was explained by Ms. O'Brien and Mr. Giroux that the source of the soil piles (photo 1) located on the southwest corner of the east pond was an old berm on the north side of the east pond. The berm was installed on the north side of the pond (photo 2) to protect the pond from any future potential flooding of the Big Thompson River. It was later discovered the berm maybe directing water towards Ms. O'Brien's home located within the permit boundary. So the berm was removed and the soil was deposited in its current location. The former location of the berm was snow covered during the February 15, 2022 inspection. The mine operator will be responsible for grading and seeding the piles or removing the piles altogether.

Photo 1 – Soil piles on the southwest corner of the east pond

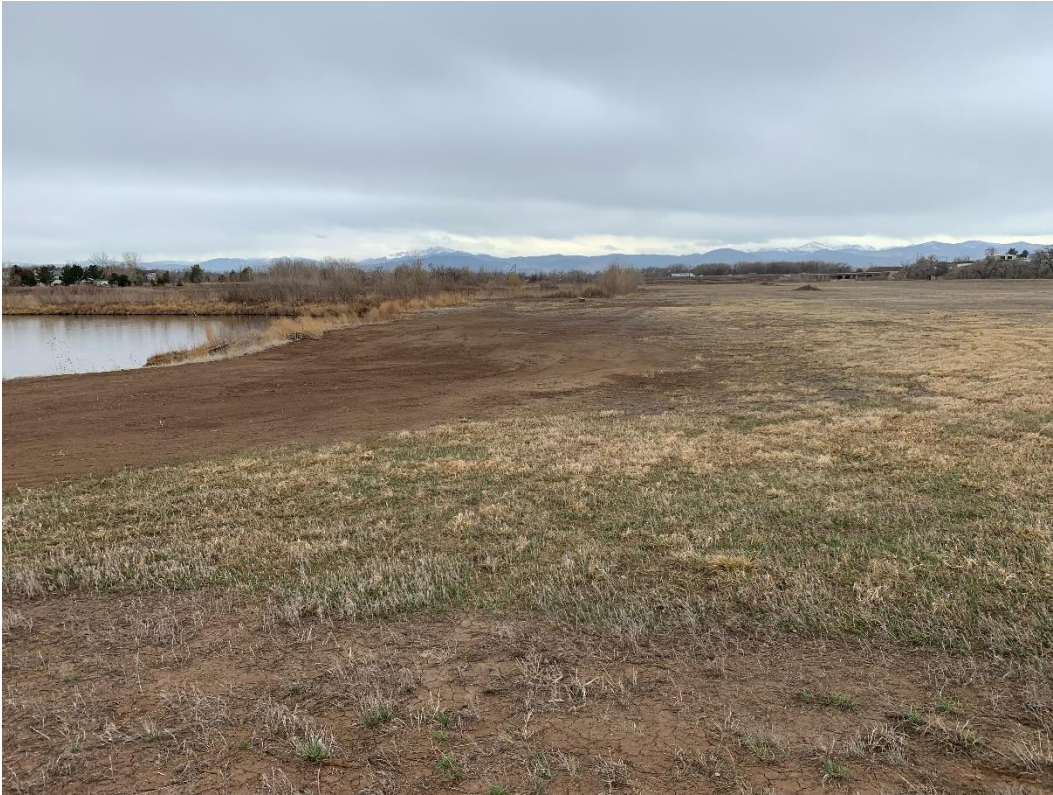
Photo 2 – Location north of the east pond where the berm was located.
