New Elk Mine, C-1981-012, April 14 2022 Inspection Report

PERMIT INFORMATION

Permit Number: C-1981-012 Mine Name: New Elk Mine Operator: New Elk Coal Company, LLC Operator Address: Mr. Mark Gray 12250 Highway 12 Weston, CO 81091 County: Las Animas Operation Type: Underground Permit Status: Active Ownership: Private

INSPECTION INFORMATION

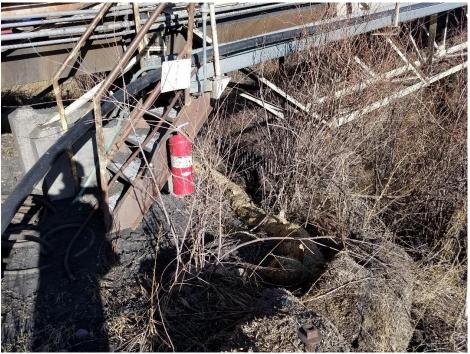
The maintenance item from the March 15, 2022 previous inspection regarding improper drainage in the small area north of the wash plant just under and adjacent to where the conveyor exits the plant has been addressed. Straw waddles for sediment control have been installed.

Figure 1. Area under and adjacent to where the conveyor exists the plant. Straw waddles for sediment control were observed.

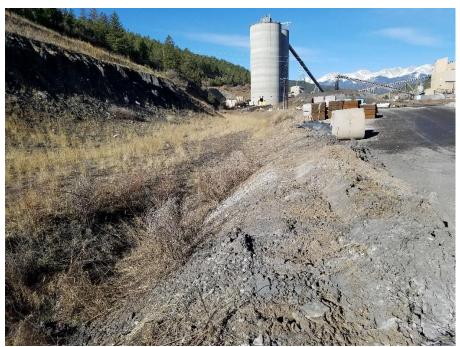
The Small Area Exemption (SAE) south of Pond 007A has maintained a stable berm to direct water towards Pond 007A.

Figure 2. SAE south of Pond 007A looking west.

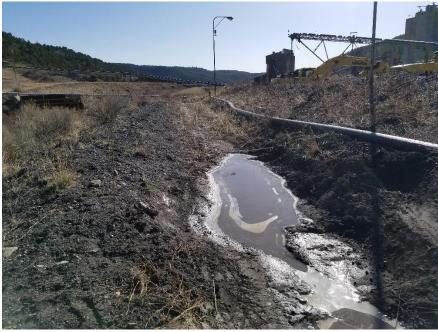
The maintenance item from the March 15, 2022 previous inspection regarding ditch D15 just west of culvert C13 where sediment build up and some of the embankment of the ditch appears to be slightly eroding on the north side remains to be addressed. Mr. Massarotti indicated it will be addressed before the next inspection. NECC should repair this area to ensure mine water does not over-top the ditch and discharge into the river without treatment.

Figure 3. Ditch D15 west of culvert C13 looking east.

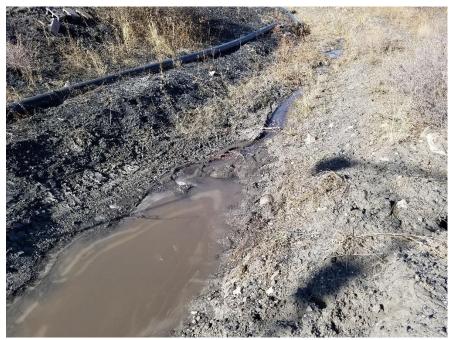
Figure 4. Ditch D15 west of culvert C13 looking west.

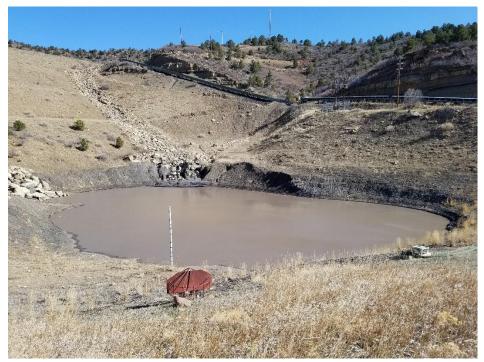
Ponds 004A, 006A, 007A, and 008 were observed stable and not discharging. Primary and emergency spillways appeared clear and functional.

Figure 5. Pond 08.

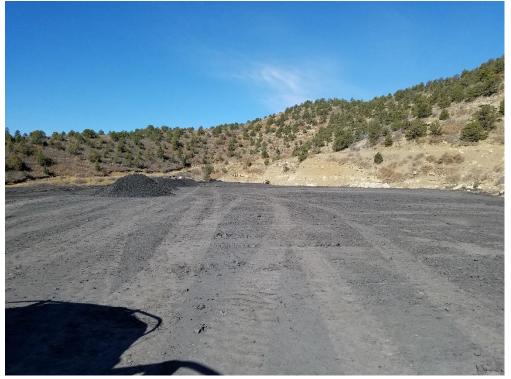
The Refuse Disposal Area (RDA) was observed with no issues noted. Waste was actively being placed on the pile with a truck and dozer crew. A compactor was present onsite but was not active at the time of the inspection.

Figure 6. RDA looking west.

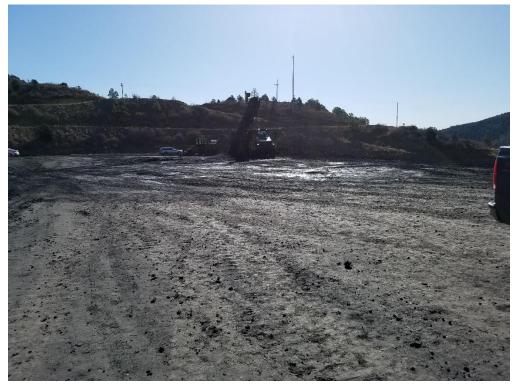
Figure 7. RDA looking east.

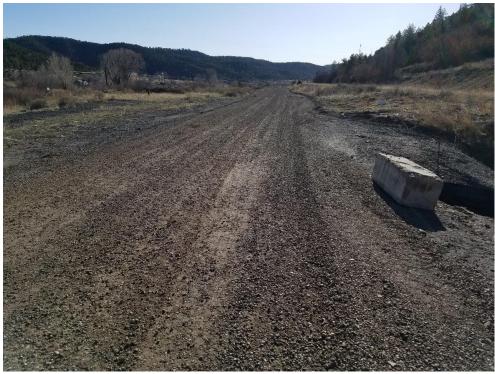
The road that runs east from New Elk Mine along the southern side of the Middle Fork of the Purgatoire River was observed and appears to remain not in use to comply until TR76 is approved.

Figure 8. TR76 road.
