## MINERALS PROGRAM INSPECTION REPORT

<b>MINE NAME:</b> Climax Mine	<b>MINE/PROSPECTING ID#:</b> M-1977-493	<b>MINERAL:</b> Molybdenum	<b>COUNTY:</b> Lake, Summit
<b>INSPECTION TYPE:</b> Monitoring	<b>INSPECTOR(S):</b> Dustin Czaplá	<b>INSP. DATE:</b> April 6, 2022	<b>INSP. TIME:</b> 13:00
<b>OPERATOR:</b> Climax Molybdenum Company	<b>OPERATOR REPRESENTATIVE:</b> Diana Kelts	<b>TYPE OF OPERATION:</b> 112d-3 - Designated Mining Operation

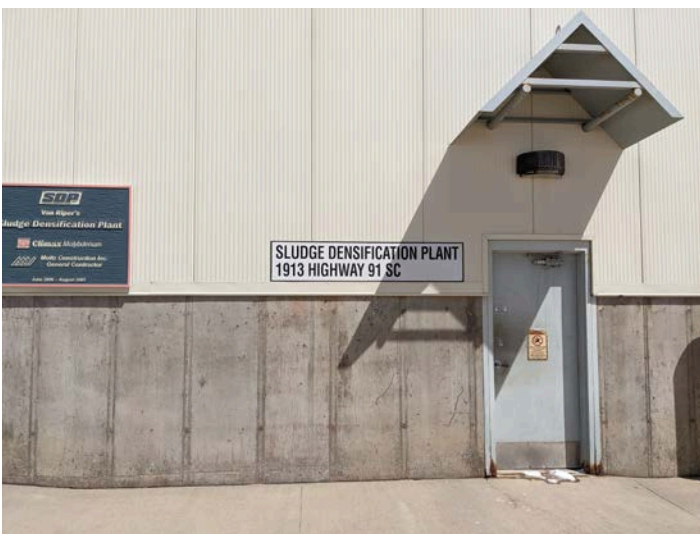
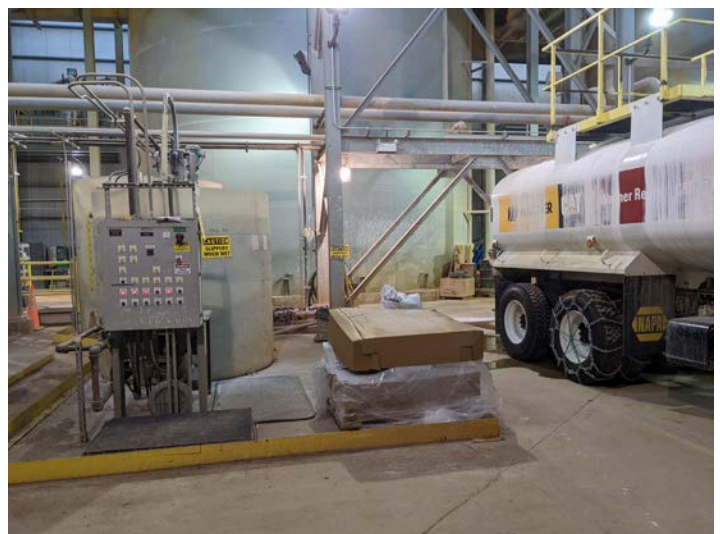
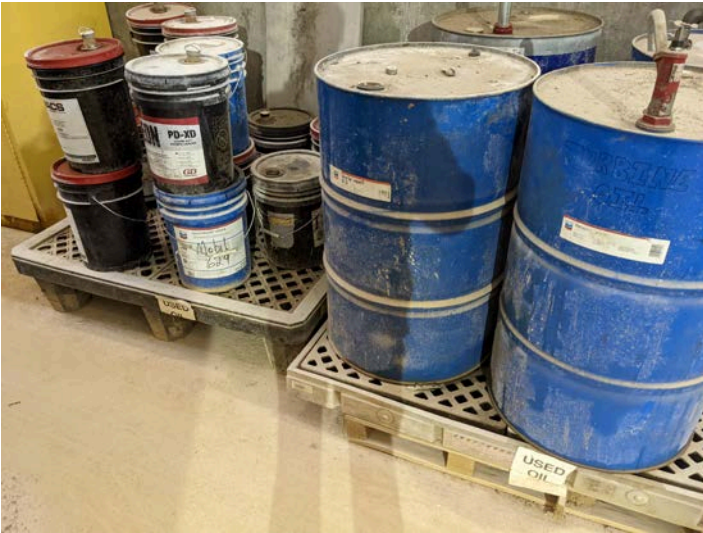
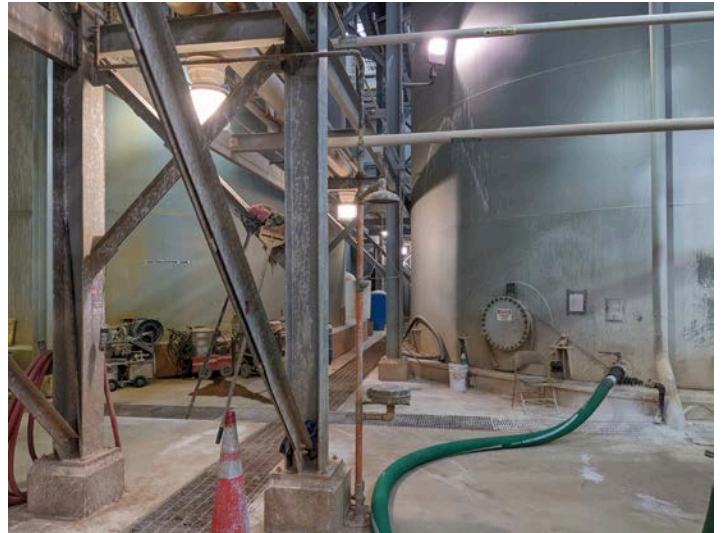
The SDP facility appeared to be well maintained and functioning as designed. No problems were noted.

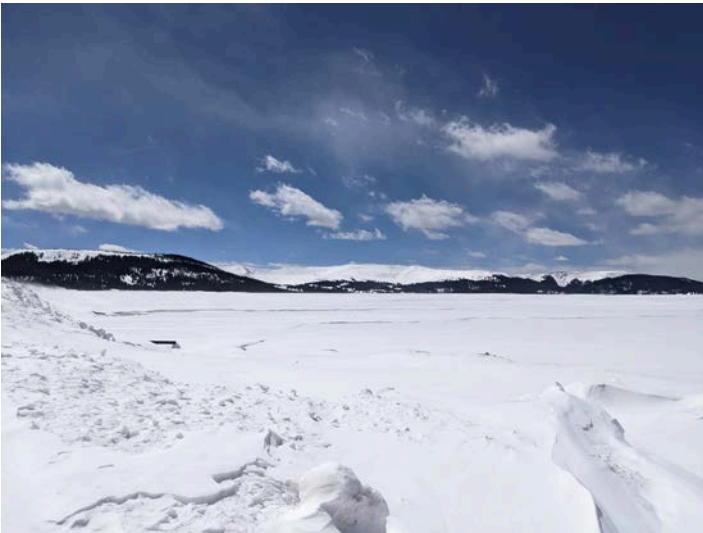
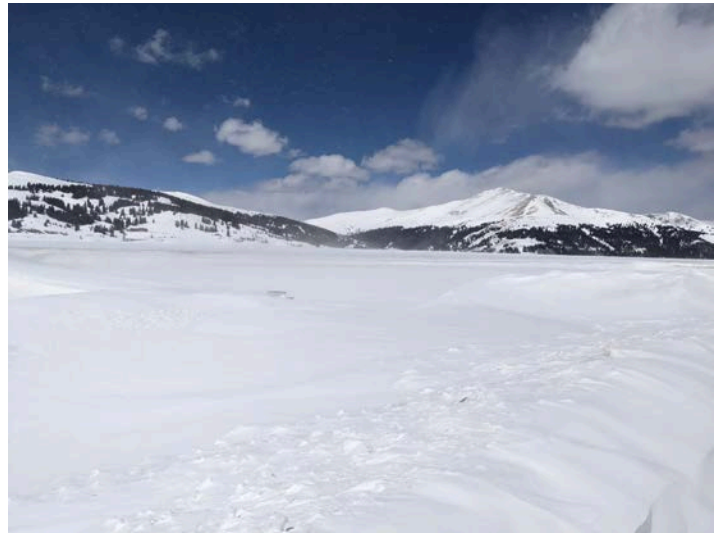
Tenmile Pond and 3 Dam, Mayflower TSF and 5 Dam were observed. The dams were under snow cover. No staining or discoloration was noted. No abnormal conditions were noted.

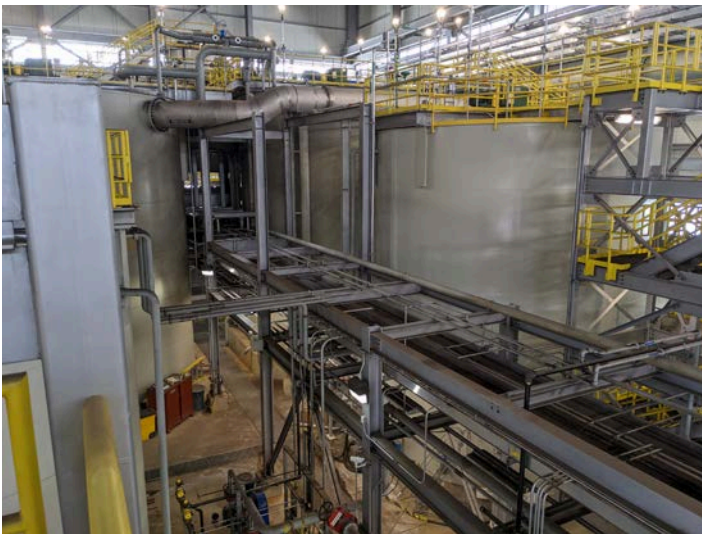
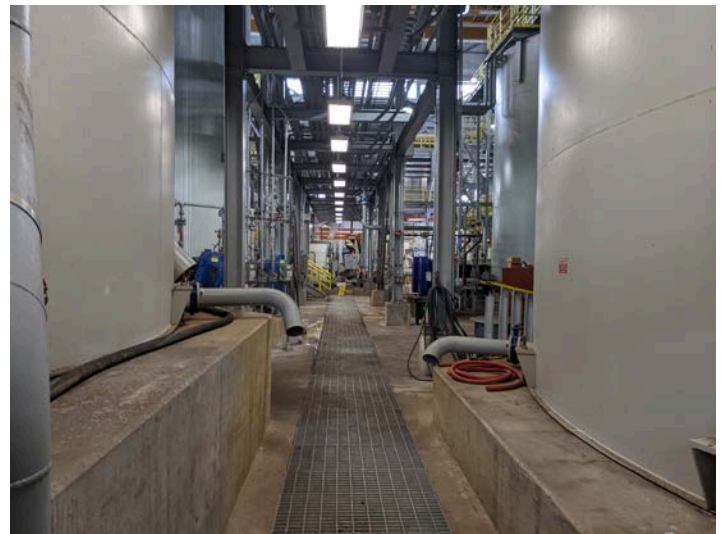
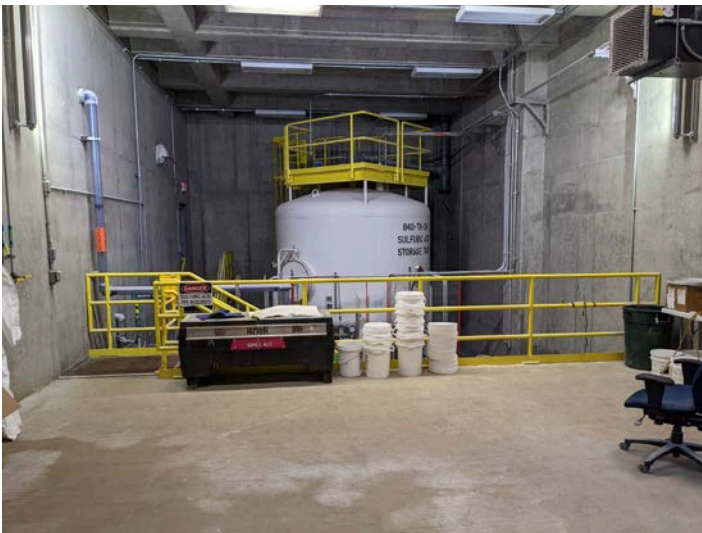
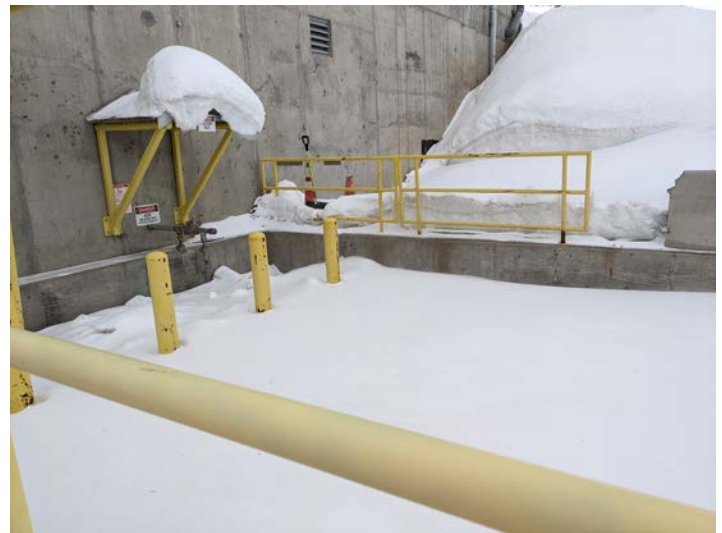
The PDWTP is located below 5 Dam and is intended to remove second stage metals, such as manganese, iron, copper and zinc, prior to discharging excess water into Tenmile Creek. It provides final treatment before affected water leaves the property. The plant has been constructed with adequate secondary containment, in the form of concrete sumps, to contain spills that could occur within the plant. Spills were not noted within the PDWTP during this inspection. Operation of the PDWTP is automated, but also manned around the clock. Emergency generators are in place in case of power outages. Reagents utilized in the PDWTP include lime, flocculant and sulfuric acid. All chemicals and reagents observed in the PDWTP area were properly stored with adequate secondary containment protections. Containers were clearly labeled. The sulfuric acid is stored in an isolated room in a phenolic lined carbon steel tank, located within an epoxy coated concrete containment area, which is isolated from the rest of the plants containment area. The sulfuric acid truck unloading area has adequate secondary containment in the form of a concrete sump. The PDWTP facility appeared to be well maintained and functioning as designed. No problems were noted with the PDWTP.
