MINERALS PROGRAM INSPECTION REPORT

MINE NAME: Union Hill Gravel Pit	MINE/PROSPECTING ID#: M-2000-056	MINERAL: Gravel	COUNTY: Fremont
INSPECTION TYPE: Surety Release Inspection	INSPECTOR(S): Timothy Cazier, P.E.	INSP. DATE: April 20, 2022	INSP. TIME: 07:35
OPERATOR: Fremont County	OPERATOR REPRESENTATIVE: Sterling Rife	TYPE OF OPERATION: 112c - Construction Regular Operation	
REASON FOR INSPECTION: Surety Release Requested	BOND CALCULATION TYPE: None	BOND AMOUNT: \$0.00	
DATE OF COMPLAINT: NA	POST INSP. CONTACTS: None	JOINT INSP. AGENCY: None	
WEATHER: Clear	INSPECTOR'S SIGNATURE:

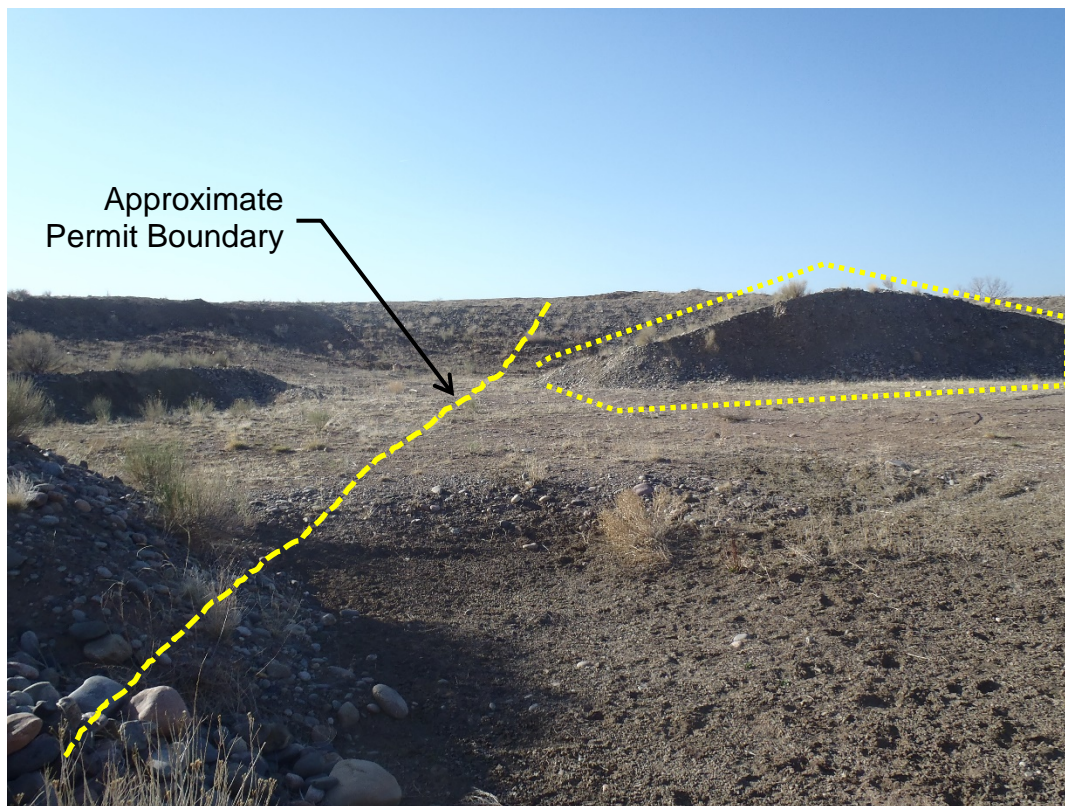
Backfilling and Grading: No further highwall backfill is required. There is a stockpile of material on the pit floor (see **Photo 1**), but it was determined to be on the adjacent Dist. No. 2 Gravel Pit permit area (M-1979-215).

Photo 1. Product stockpile on Dist. No. 2 Gravel Pit (looking south).

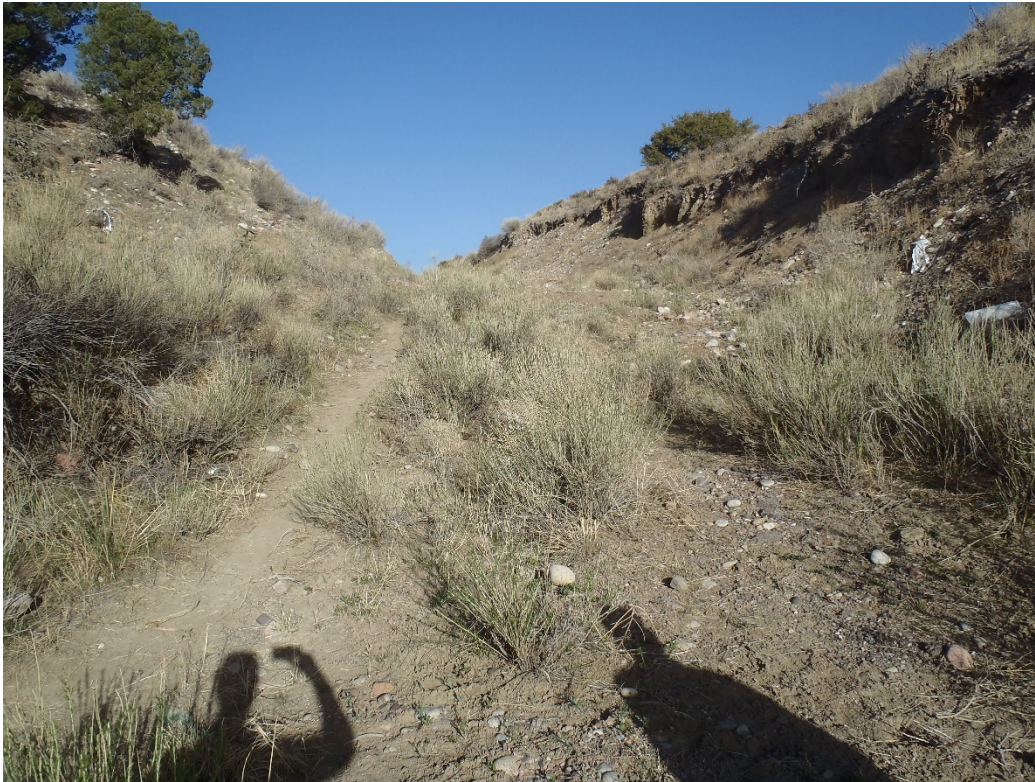
Roads: As stated in the previous inspection report, the purpose of the road cut (see **Photo 2**) appears to continue to be used by cattle to access the adjacent areas.

Photo 2. Revegetated road cut (cattle trail on left, looking west).

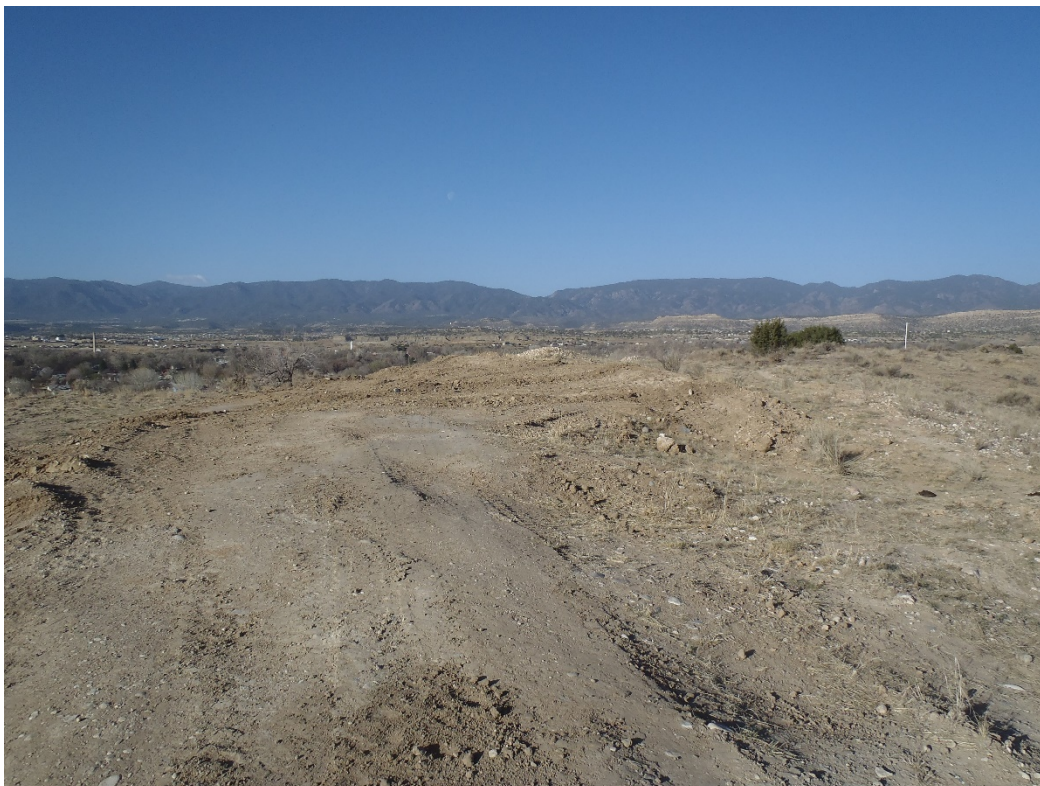
Reclamation Success: All major necessary grading is sloped to 3H:1V or flatter. However, in the southwest corner of the site, a topsoil stockpile was removed (see **Photo 3**) and placed on the adjacent slope, without being graded into place (see **Photo 4**). The DRMS cannot approve release from reclamation liability until this material is graded, seeded and vegetation is becoming established, typically after two growing seasons.

Photo 3. Topsoil stockpile removal area on ridge in SW corner (looking SW).

Closeout Meeting: Mr. Rife and I discussed the need to grade the topsoil moved to the slope and disk the compacted area from which the topsoil was removed, then seed both areas. The DRMS cannot release sites where significant areas are not stabilized with establishing vegetation as required by the approved permit. This site will not be recommended for release until these conditions are corrected.

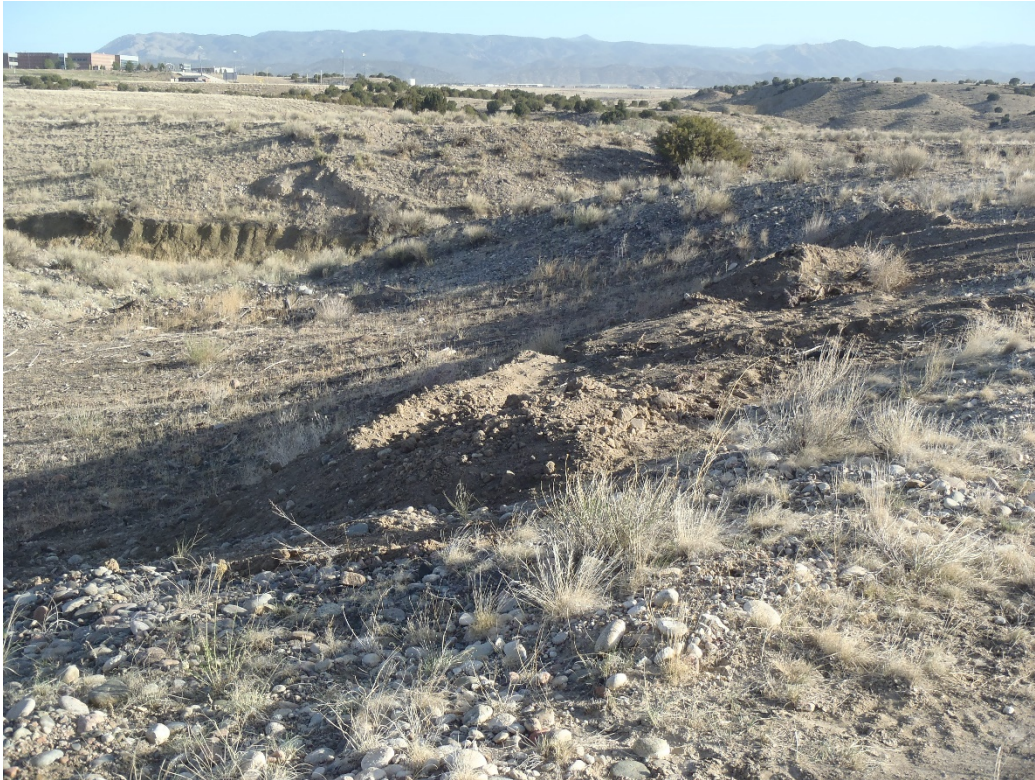
Topsoil: The relocated topsoil (see **Photo 4**) needs to be spread evenly on the slope and revegetated in order to prevent its erosion.

Photo 4. Ungraded topsoil placed on graded slope (SW corner, looking NE).

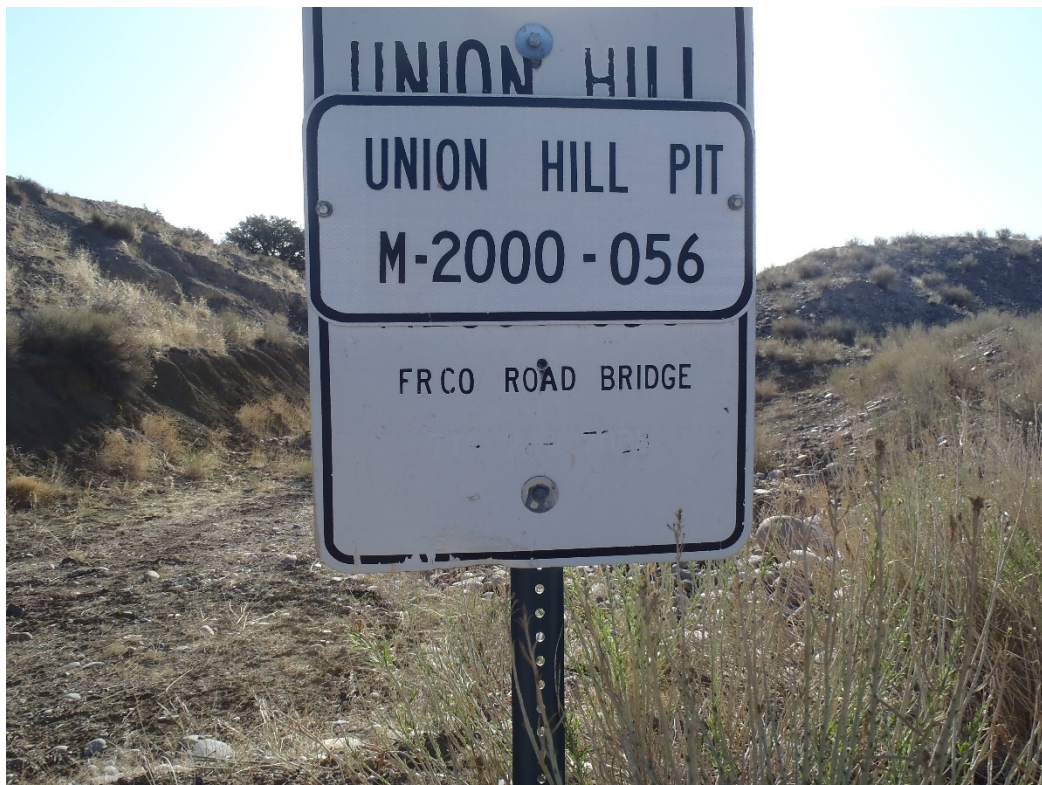
Signs and Markers: The permit sign was properly posted (see **Photo 5**) and boundary markers were observed

Photo 5. Permit sign at road cut entrance (looking east).

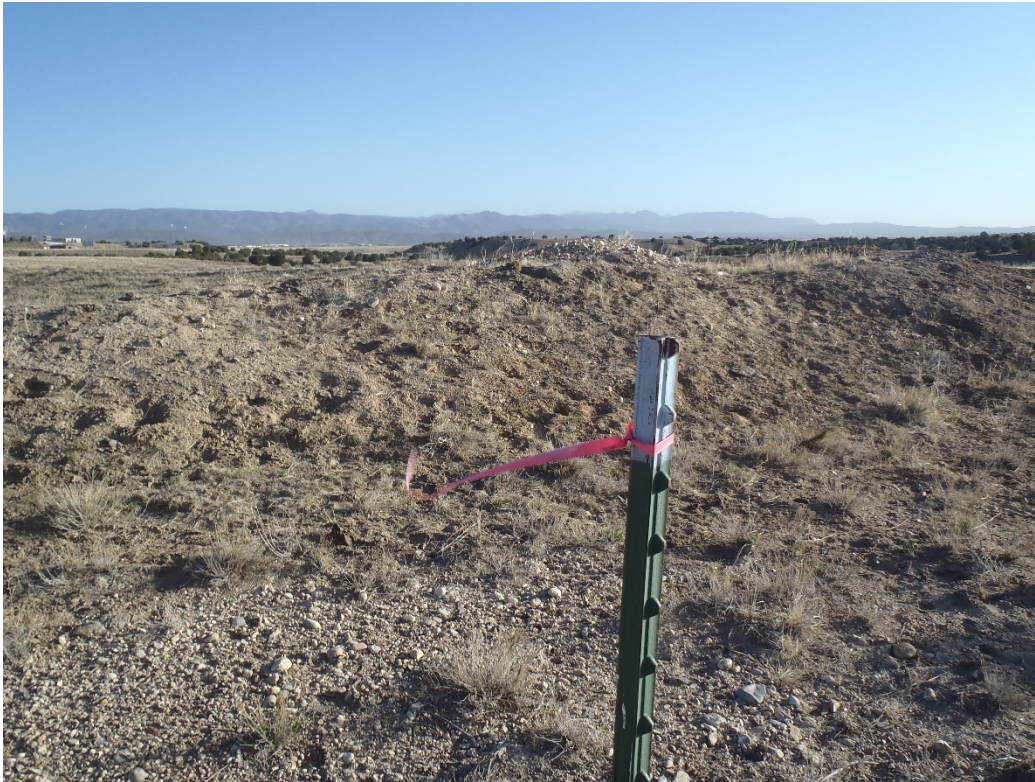
to delineate the permit boundary (see **Photo 6**).

Photo 6. Typical boundary marker (SW corner, looking north).
