Pikeview monitoring report

Reference: March 2022 Geotechnical Monitoring Summary Pikeview Quarry

CONTINENTAL MATERIALS
CORP.
PIKEVIEW QUARRY SLOPE
MONITORING

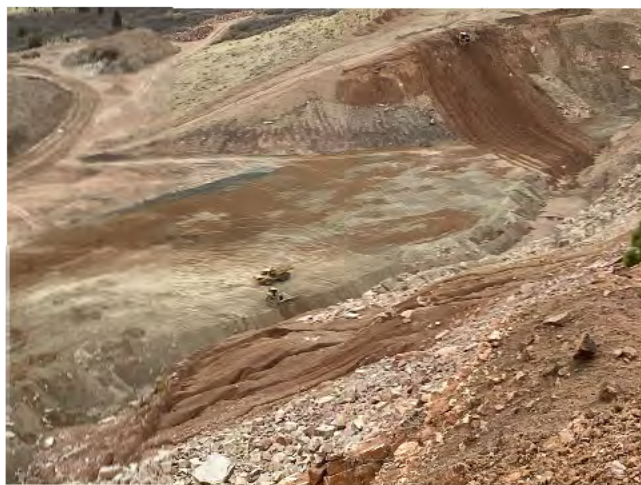
- A dozer is pushing material down the slope of the south borrow area and into the pit near the reclamation benches on the south-end of the site. The fill is placed in one-foot compacted lifts. (Photo 6)

6. Dozer pushing material at south borrow area.

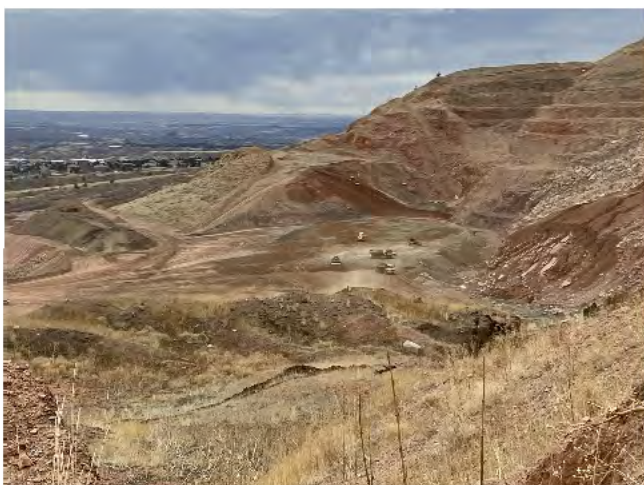
- Fill material continues to be delivered to the central location on the production floor where it was temporarily placed. Future fill material will not be stockpiled; it will be directly placed, spread, and compacted. (Photo 5)

5. View to the south: Pit floor and south borrow.

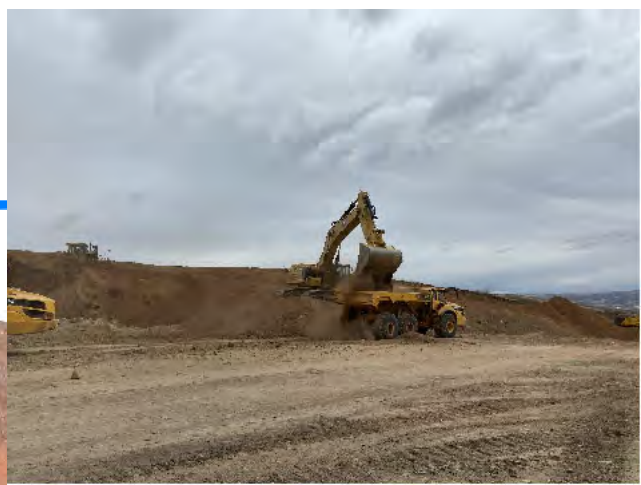
- Three excavators, five dozers and eight haul trucks are operating in a loop on the pit floor to move material from the North Borrow Area to the pit floor for compaction in one-foot lifts. Note that the North Borrow Area is a separate project associated with the City's future plans for the property; this grading was permitted by El Paso County. (Photos 3 and 4)

4. Excavator, dozer and haul trucks at borrow area

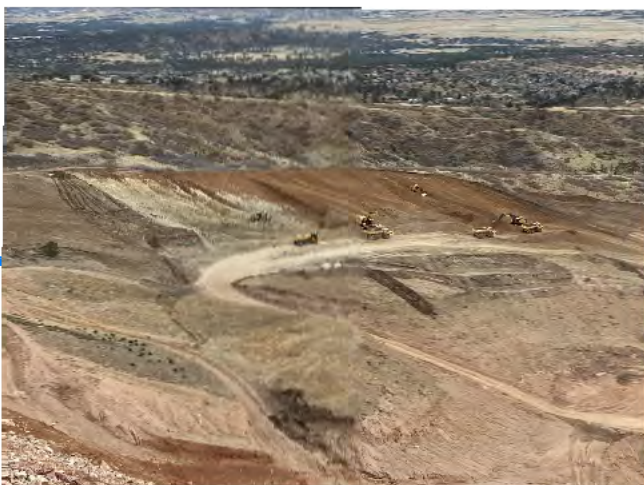
3. View of the north borrow area to the northeast.

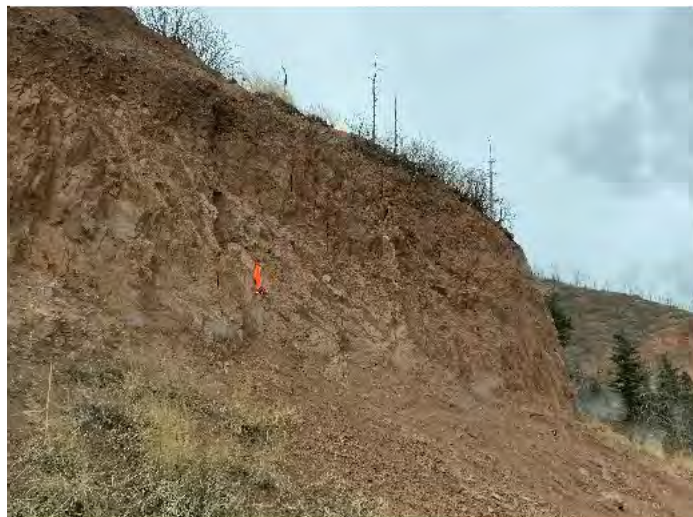
- Several prisms are being removed and new prisms are coming online as grading progresses, and the line of sight is cut-off between some of the prisms and the station. (Photo 7)

| 03/28/2022 | TOE3 not found | Blocked by fill placement. Prism removed. | 03/28/2022 |

7. TOE-3 Prism removed as pit floor rises.

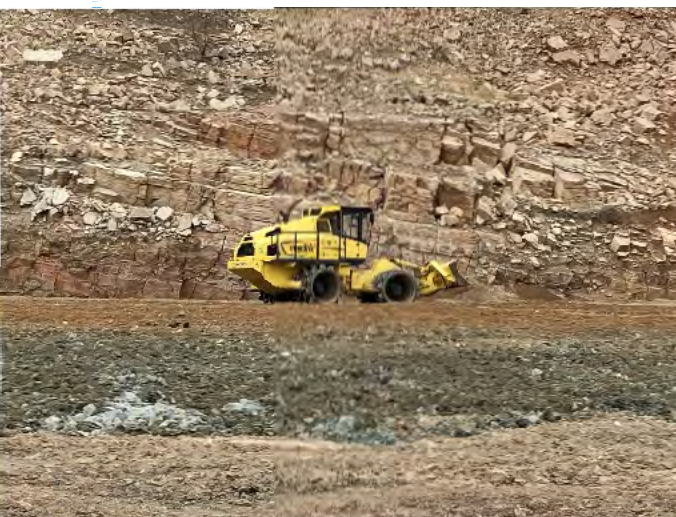
- The temporary fill stockpile has been removed and placed as compacted fill. The material was spread by dozers and compacted in one-foot lifts in accordance with the project specifications. (Photo 2)

2. Sheep's foot compactor in the pit area.

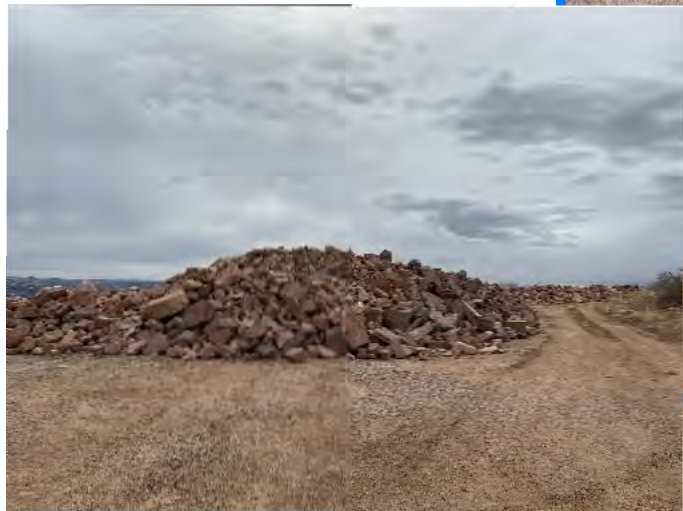
- Riprap has been produced and stockpiled at several locations on site. (Photo 8)
- No cracking was observed on the native granite slopes above the extents of the disturbed area.

8. Riprap stockpiled at the south-end near top of ramp.

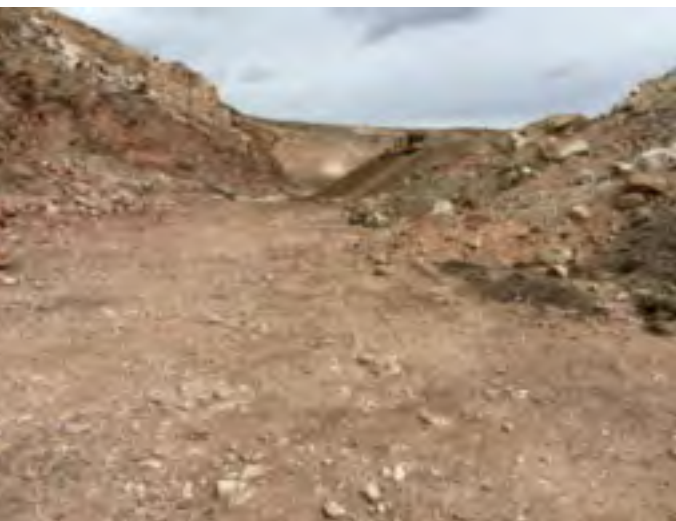
- Reclamation grading began in February 2022 and continued throughout March.
- A buffer zone is being kept between the active work areas and the toe of the slide to safely stop any loose rocks that might come loose and roll down the slope during grading operations. Compacted fill is placed in the buffer zone as the buttress fill is placed, and this area is maintained approximately 5 feet lower than the working bench. (Photo 1)

1. Safety buffer between toe of slope and work area.

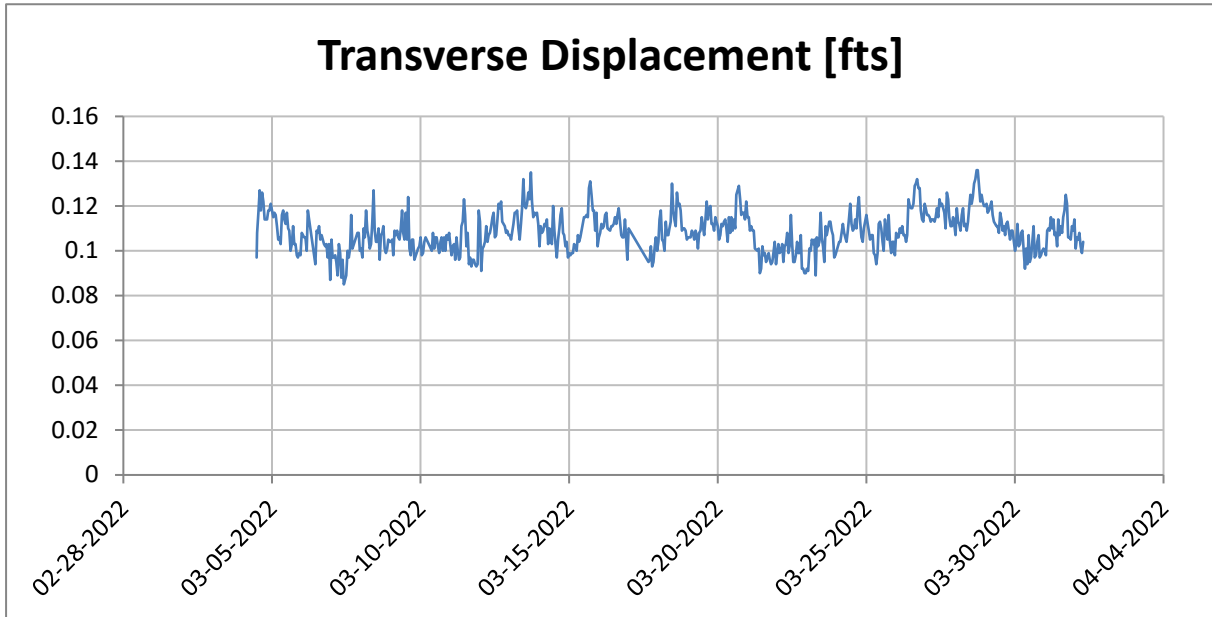
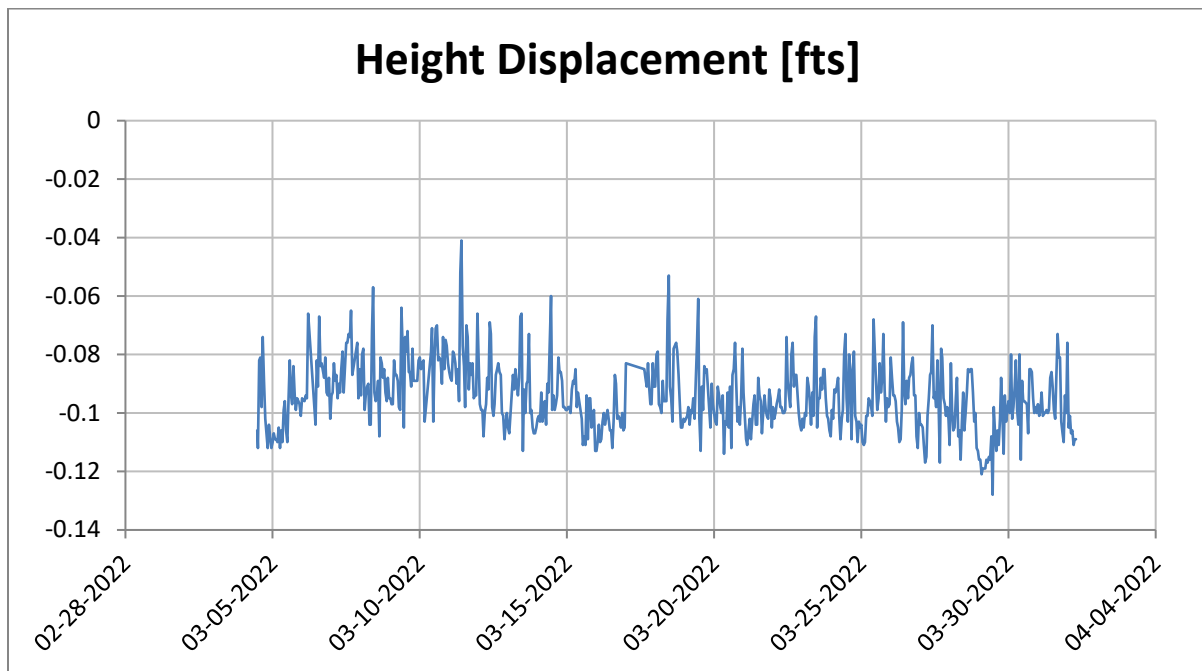
Prism NP2

| 03/11/2022 | Regression limit exceeded NP2 | No sign of movements after inspection. | 03/11/2022 |

1. Survey accuracy is ± 0.016 feet.
2. Alarm threshold is ± 0.35 feet.
3. Transverse displacement is in the horizontal direction. Positive direction means closer to the robotic station.
4. Height displacement is in the vertical direction. Positive direction means higher in elevation.
5. A regression limit alarm was received on March 11.

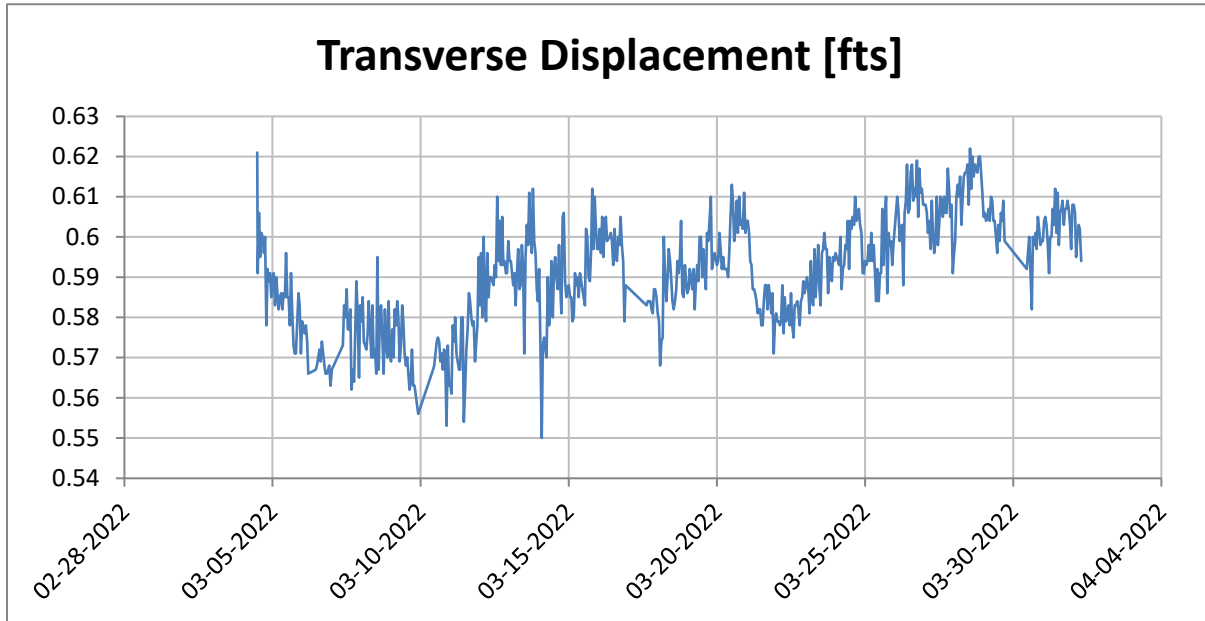
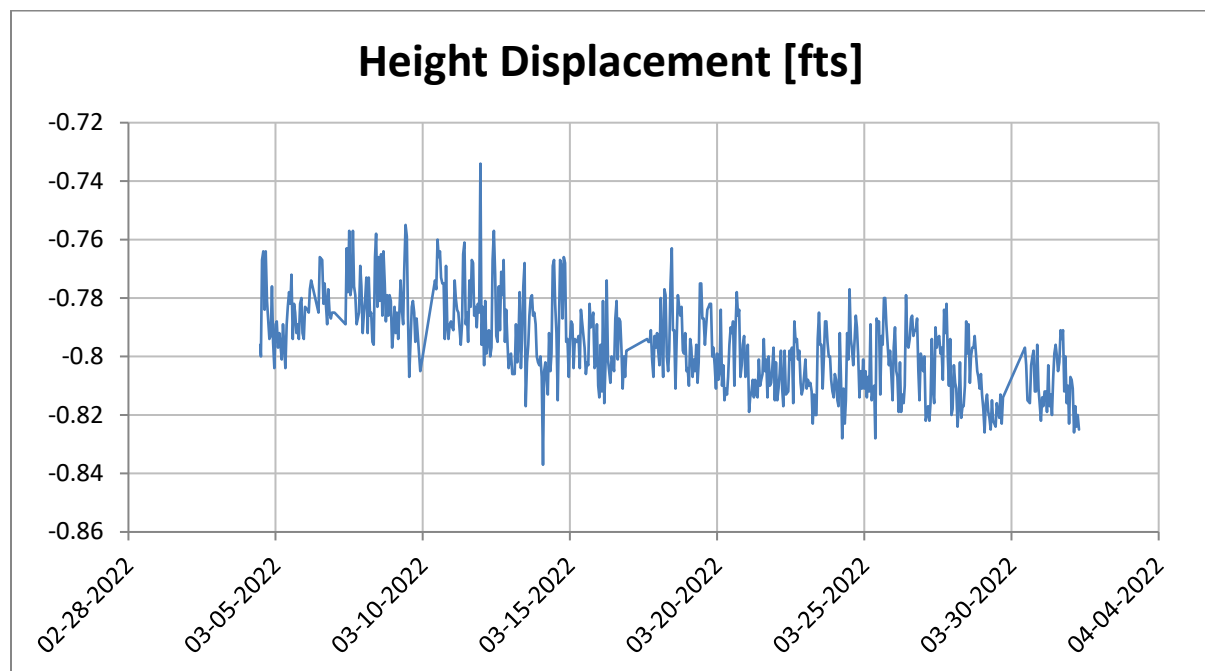
Prism NP66

1. Survey accuracy is ± 0.016 feet.
2. Alarm threshold is ± 0.35 feet.
3. Transverse displacement is in the horizontal direction. Positive direction means closer to the robotic station.
4. Height displacement is in the vertical direction. Positive direction means higher in elevation.
5. Prism records slope creep movements with slow velocity.

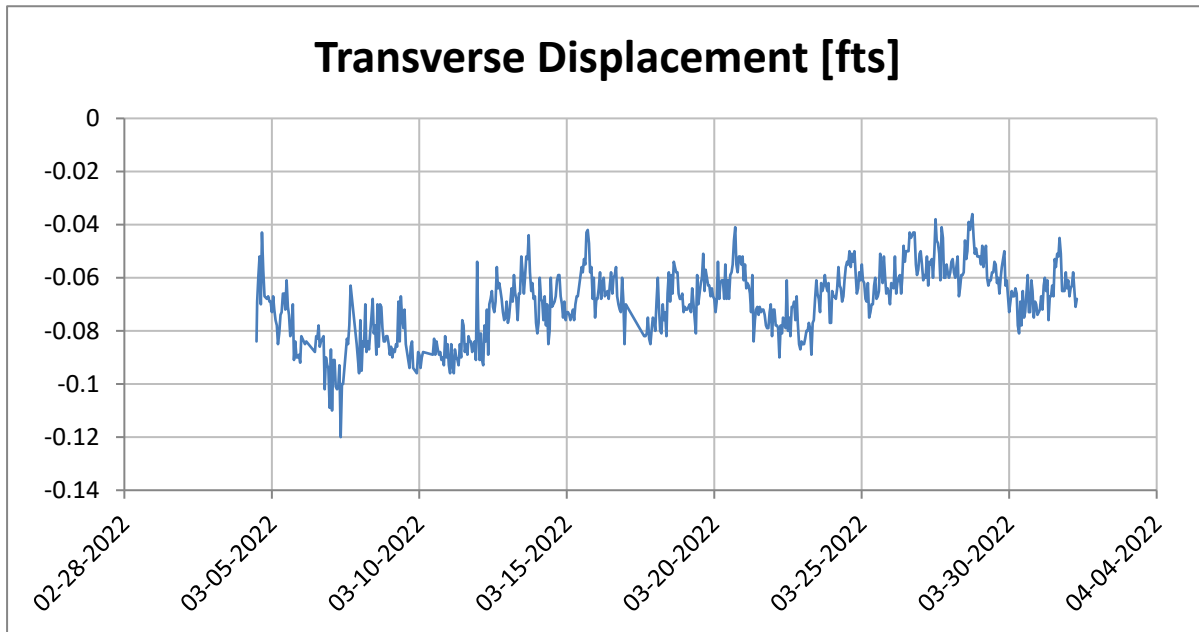
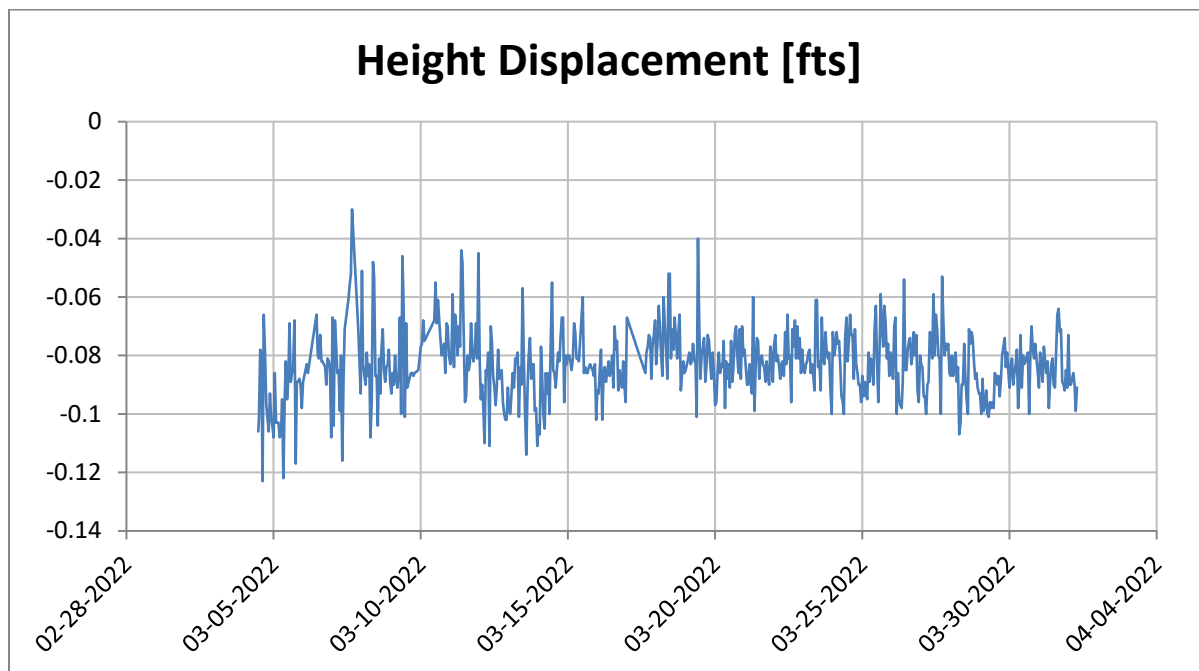
Prism P32

| 03/11/2022 | Regression limit exceeded P32 | Data error. No sign of movements after inspection. One reading was -0.391' followed by a reading of +0.382'. | 03/11/2022 |

1. Survey accuracy is ± 0.016 feet.
2. Alarm threshold is ± 0.35 feet.
3. Transverse displacement is in the horizontal direction. Positive direction means closer to the robotic station.
4. Height displacement is in the vertical direction. Positive direction means higher in elevation.
5. Alarm recorded on February 10, 2022. Assumed to be data error from inclement weather.
6. Regression limit alarms were received on March 9, 11, and 17.

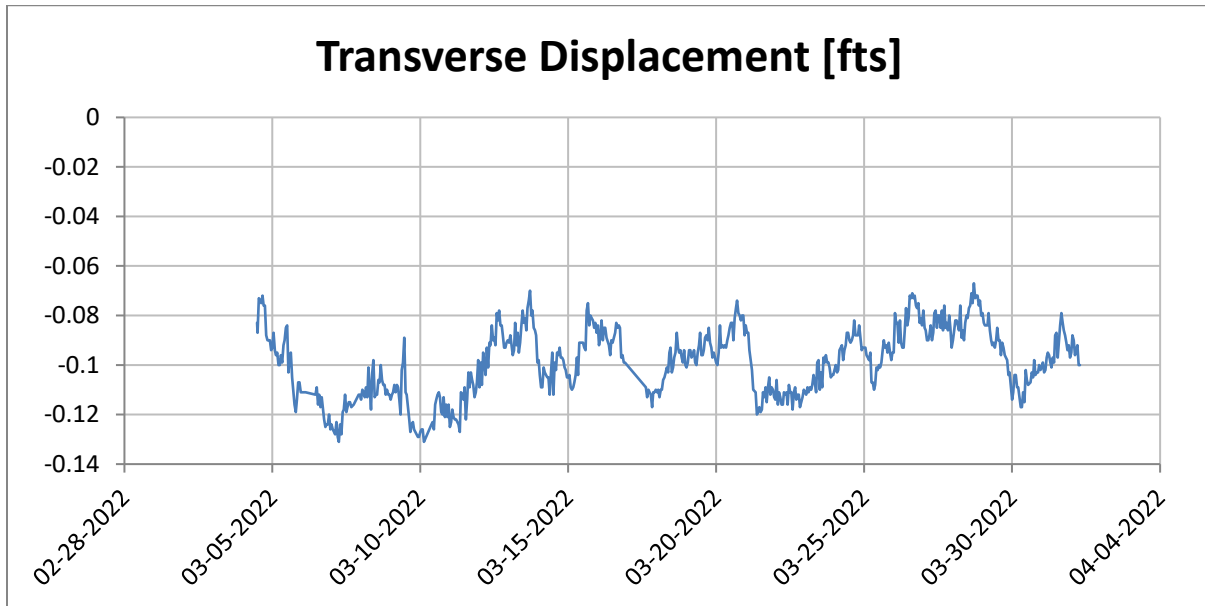
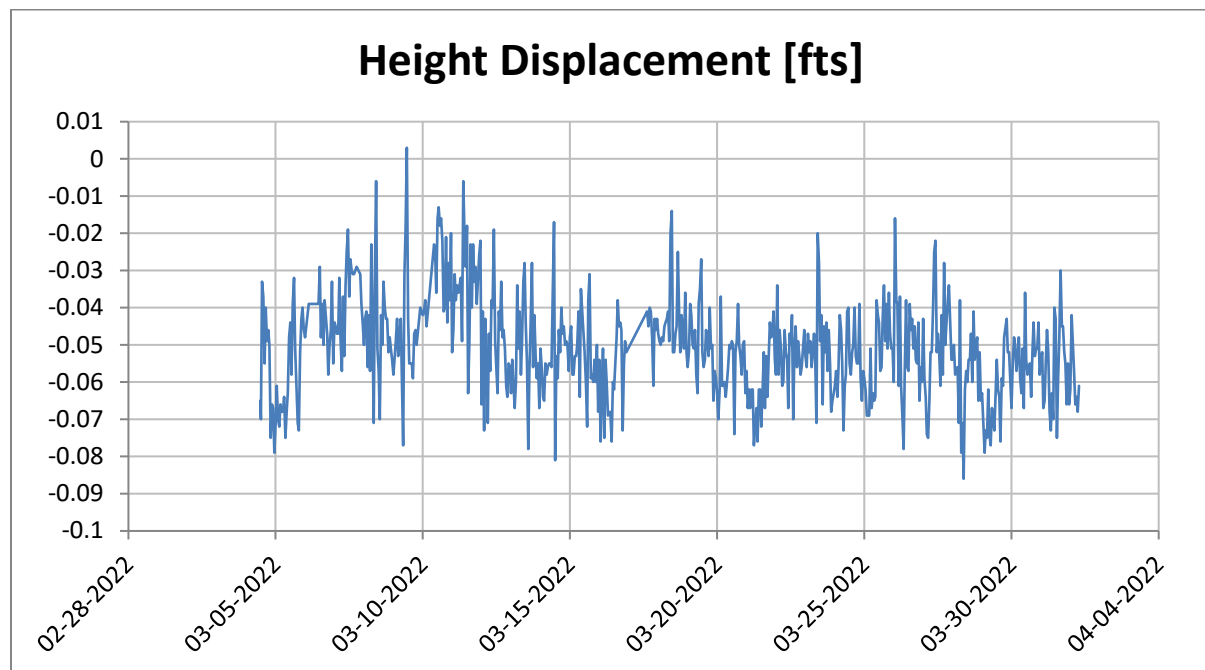
Prism P33

| 03/15/2022-03/16/2022 | Regression limit exceeded P33 | Data error. No sign of movements after inspection. One reading was -0.466 followed by a reading of +0.371 | 03/16/2022 |
| 03/27/2022 | Regression limit exceeded P33 | Data error. No sign of movements after inspection. One reading was +0.371 followed by a reading of -0.372 | 03/27/2022 |

1. Survey accuracy is ± 0.016 feet.
2. Alarm threshold is ± 0.35 feet.
3. Transverse displacement is in the horizontal direction. Positive direction means closer to the robotic station.
4. Height displacement is in the vertical direction. Positive direction means higher in elevation.
5. Regression limit alarms were received on March 16 and 27.

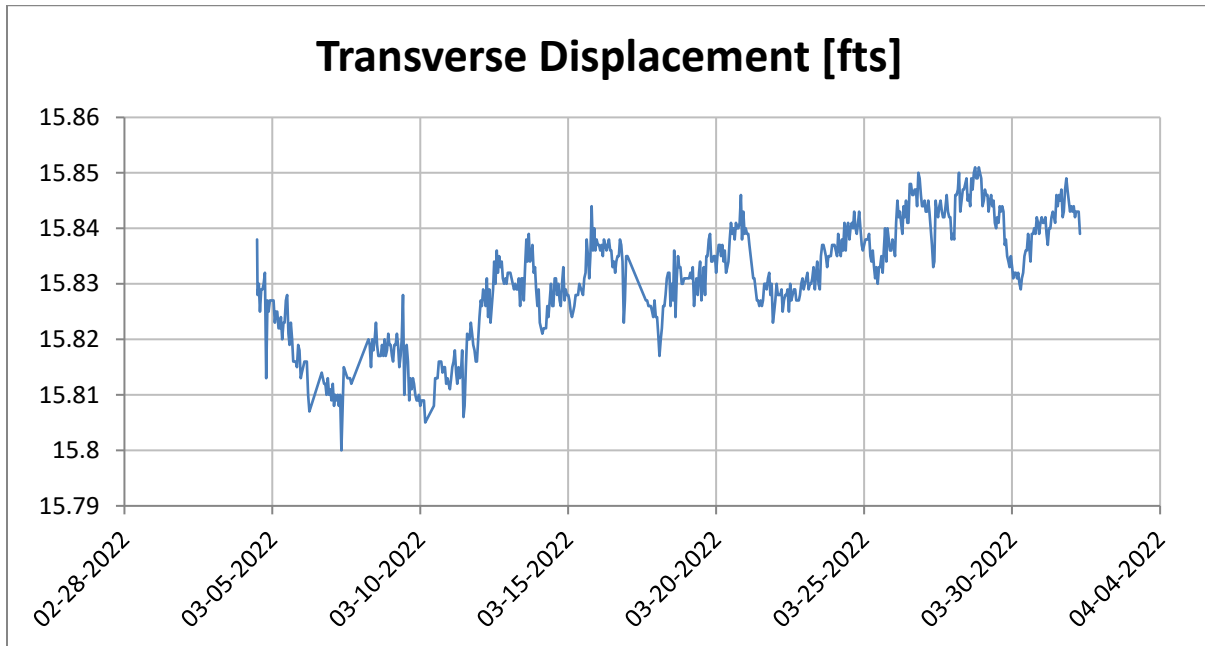
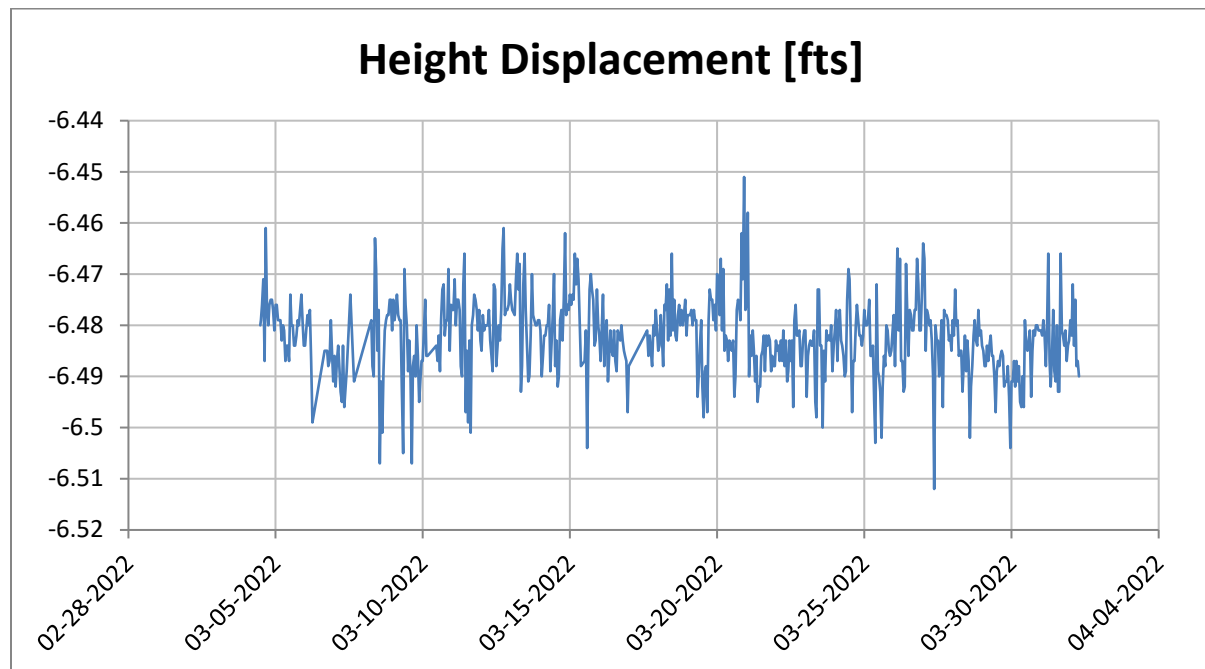
Prism P63

The data show stable conditions with no movement for 20 of 23 prisms with recorded displacements limited to data scatter and not actual movements. Prisms P63 and TOE3 are located at the toe of the landslide, and these locations showed slope creep movements at slow velocities. Prism NP66 is located above the landslide, and this prism also recorded slope creep movements at slow velocity. This settlement is likely

1. Survey accuracy is ± 0.016 feet.
2. Alarm threshold is ± 0.35 feet.
3. Transverse displacement is in the horizontal direction. Positive direction means closer to the robotic station.
4. Height displacement is in the vertical direction. Positive direction means higher in elevation.
5. Prism records slope creep movements with slow velocity.

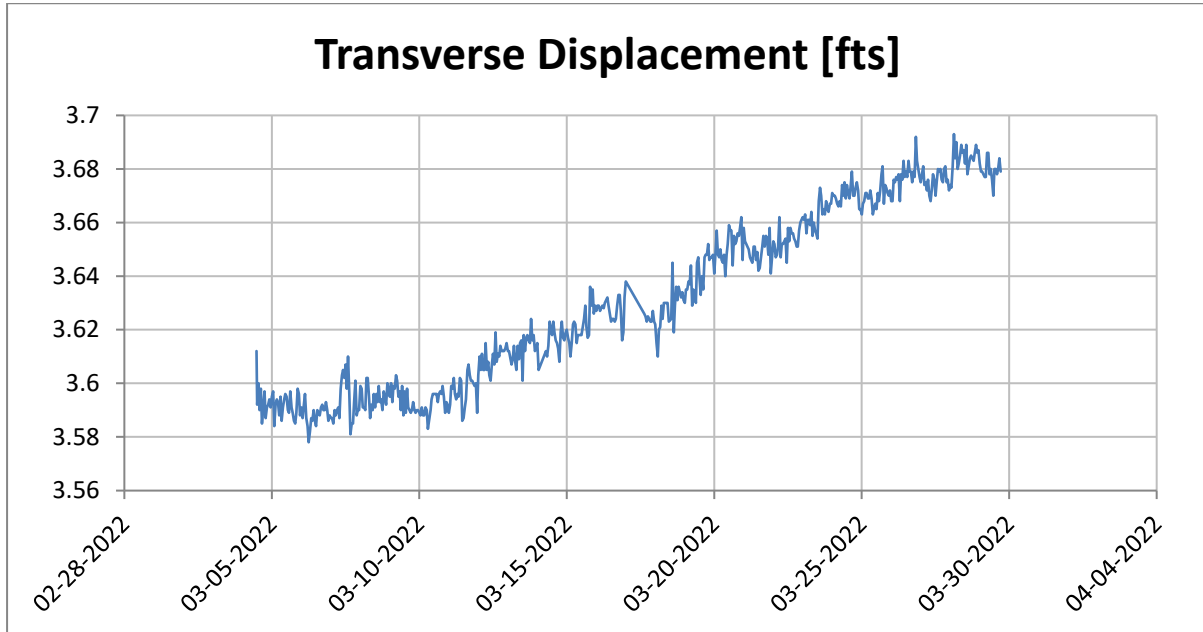
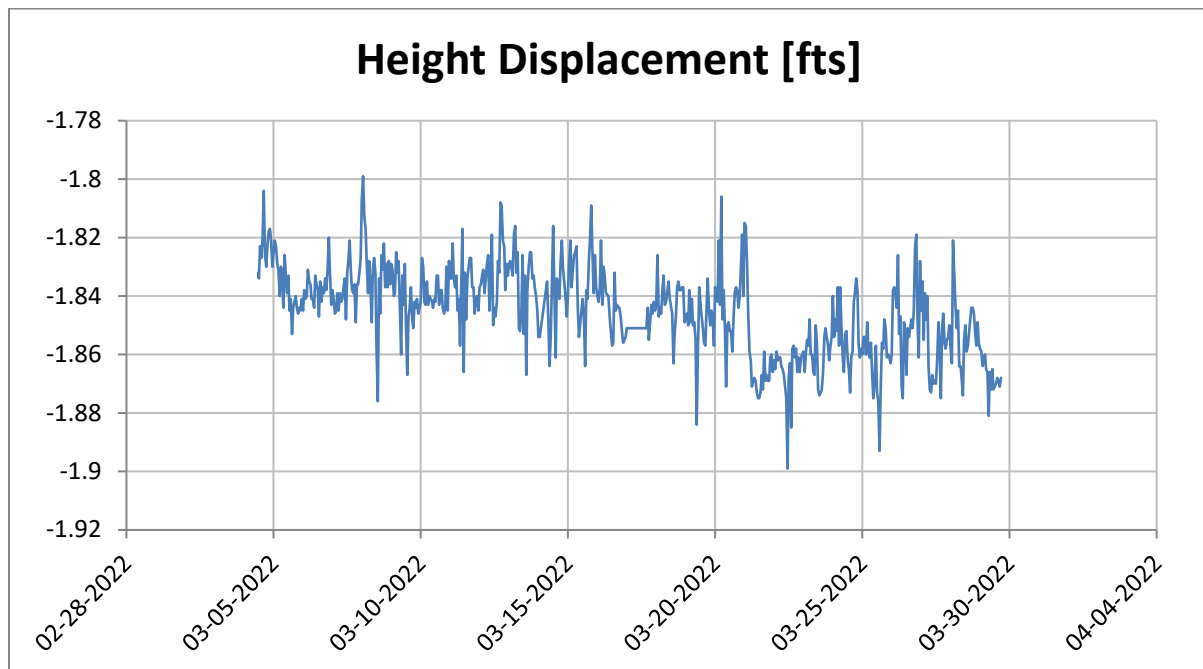
Prism TOE3

1. Survey accuracy is ± 0.016 feet.
2. Alarm threshold is ± 0.35 feet.
3. Transverse displacement is in the horizontal direction. Positive direction means closer to the robotic station.
4. Height displacement is in the vertical direction. Positive direction means higher in elevation.
5. Prism located at toe of slide where ongoing slope creep movements at slow velocity are expected.
6. Prism removed March 30.
