PERMIT INFORMATION

Permit Number: C-1981-028 Mine Name: Keenesburg Strip Mine Operator: Coors Energy Company Operator Address: Mr. Ben Moline PO Box 4030 Golden, CO 80402	County: Weld Operation Type: Surface Permit Status: Permanent Cessation Ownership: Private
	Operator Representative Present: None
Operator Representative Signature: (Field Issuance Only)

Inspection Start Date: April 27, 2022 Inspection Start Time: 09:15 Inspection End Date: April 27, 2022 Inspection End Time: 10:45		Inspection Type: Coal Partial Inspection Inspection Reason: Normal I&E Program Weather: Cloudy	
Joint Inspection Agency: None		Joint Inspection Contacts: 	
Post Inspection Agency: None		Post Inspection Contacts: 	
Inspector(s): Robert Zuber, P.E.	Inspector's Signature: <i>Robert D. Zuber</i>		Signature Date: 4/28/2022

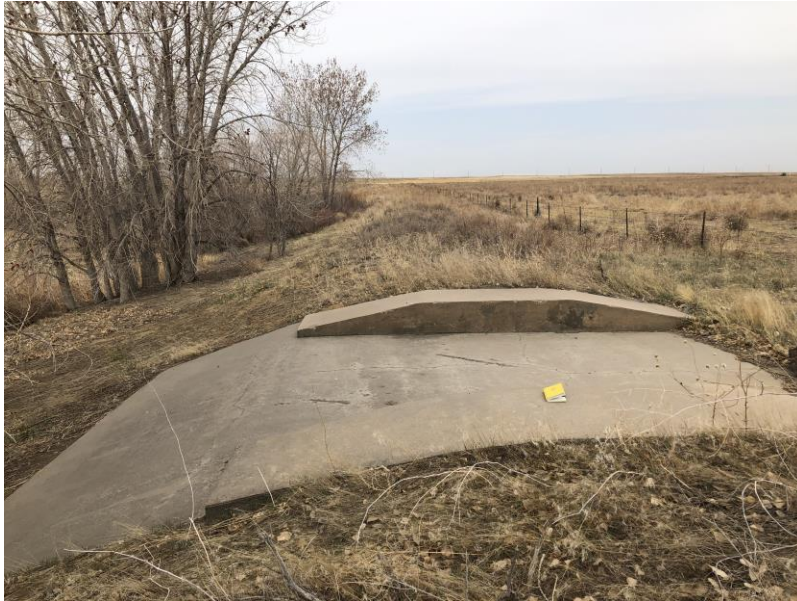
Sediment Pond 2 and the Dugout Pond contained little to no water (thick vegetation obscures the bottoms). They were not discharging during the inspection. There were no signs that either pond had discharged recently. No problems were observed.

Sediment Pond 2 spillway

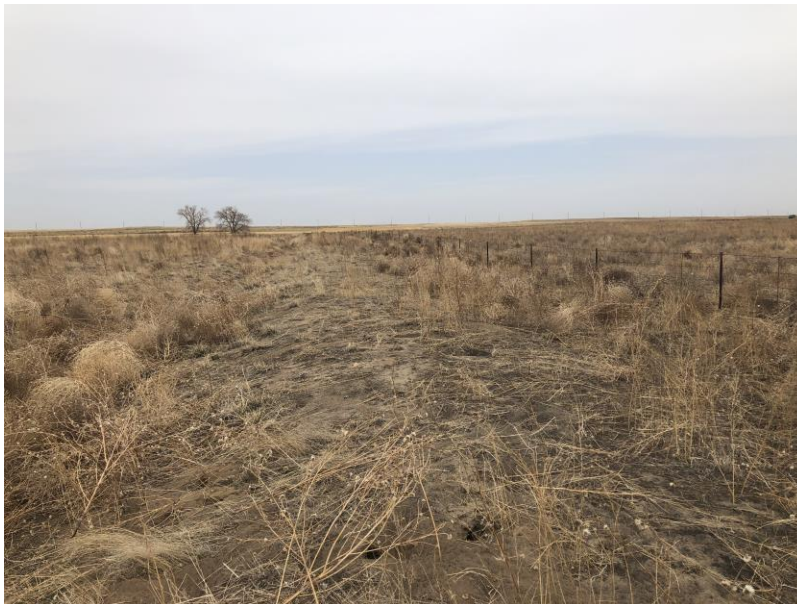
The ditch west of Sediment Pond 2 appeared to be functioning well.

Boundary west of Sediment Pond 2

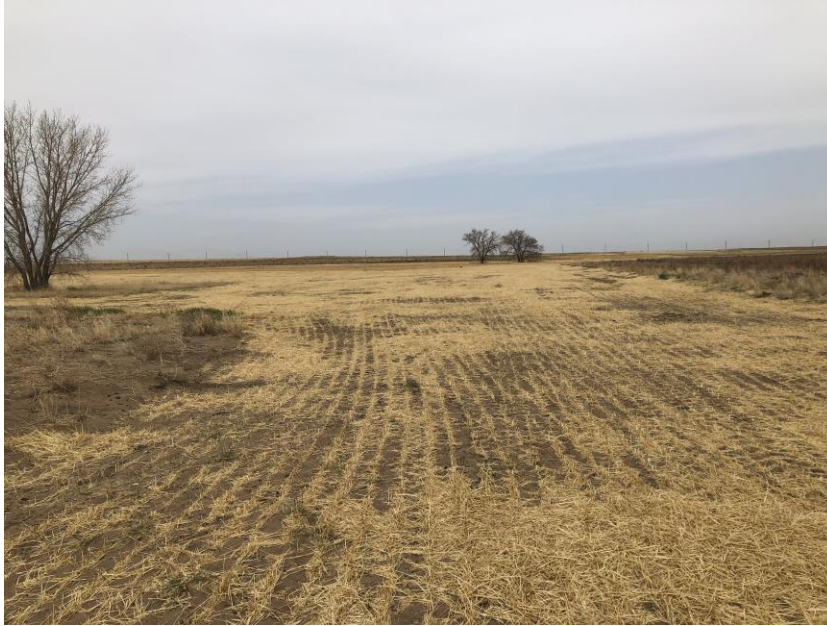
Green grass was seen emerging at several locations, including (but not limited to) Areas 25, 31, 32, and 42. Older reclamation around the site, especially in the southwest part, was generally in good condition with thick, desirable vegetation. On some parts of the older reclamation (e.g., the Long Term Spoil Area) winds have deposited significant sand, and observed vegetation was sparse.

Recent reclamation at Area 42

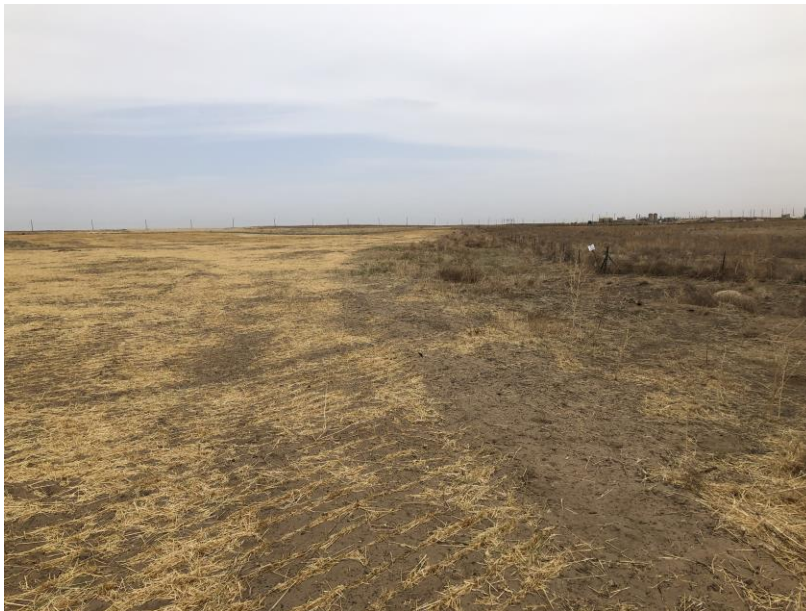
Recent reclamation at Area 37 (left) and Area 42 (right)

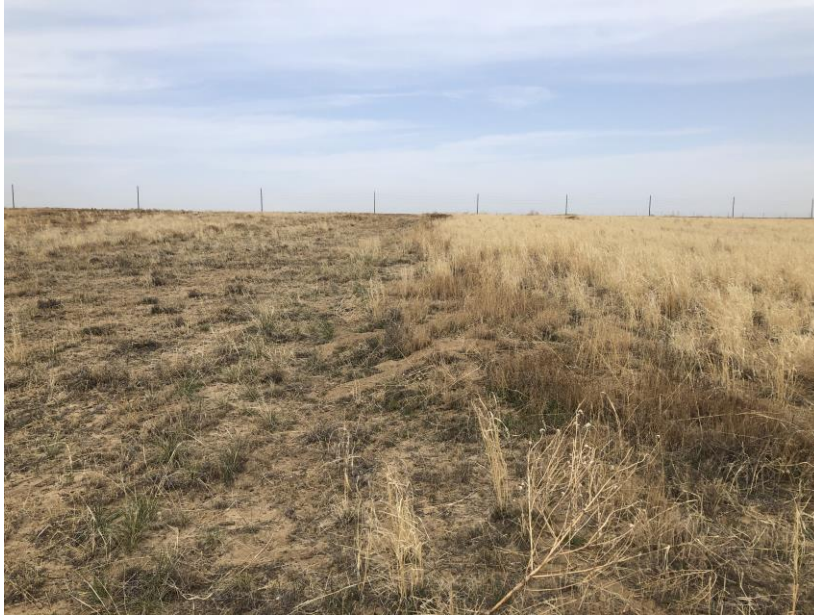
Northern portion of B Pit

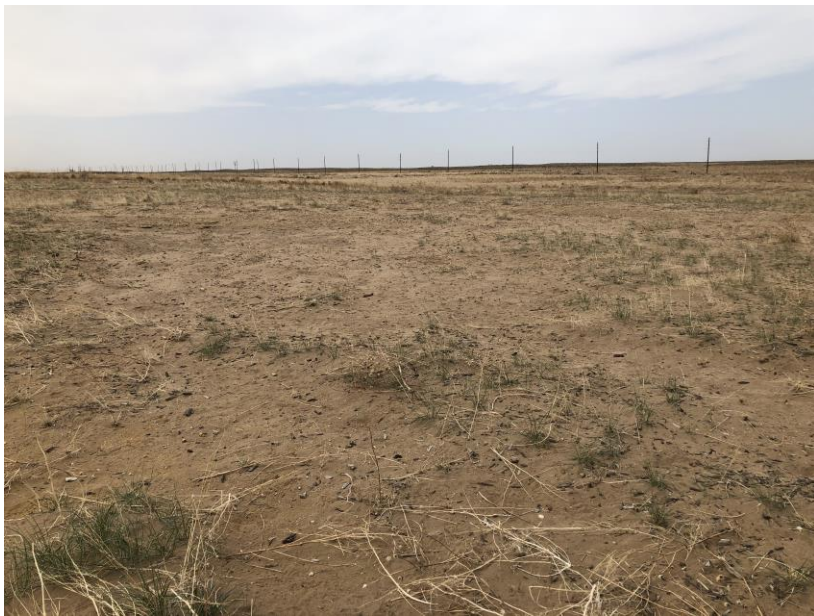
Bare ground at southern portion of B Pit

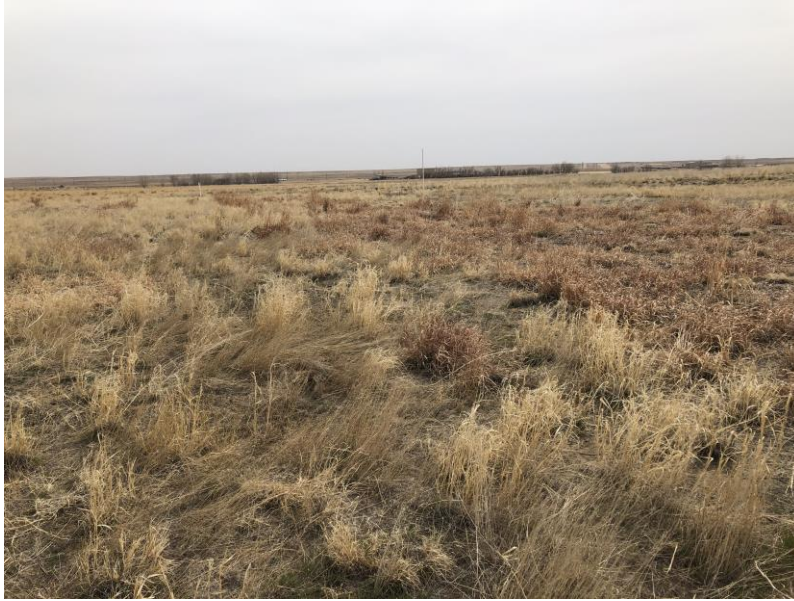
The entrance sign contained all necessary information. Boundary markers were seen in many locations.

Area 23 with boundary markers

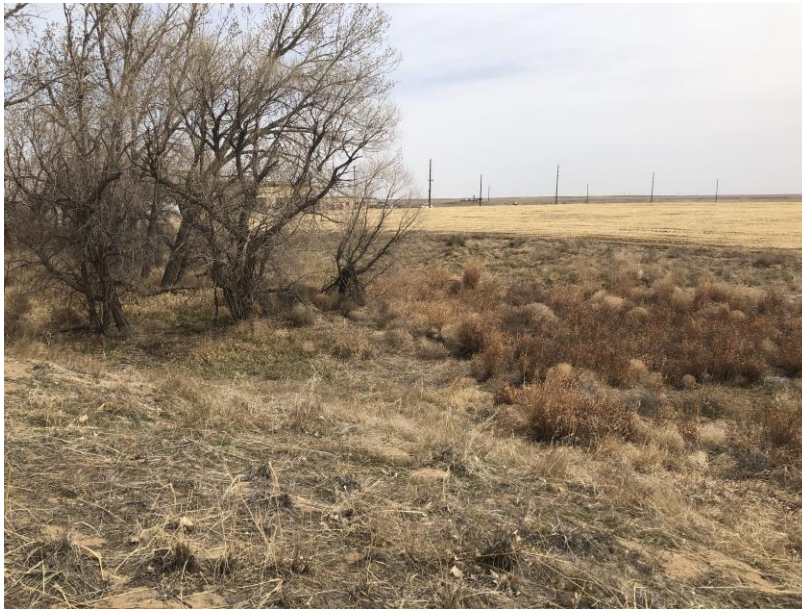
Near the southeast corner of the Dugout Pond, the relatively steep hill (where a topsand pile existed in past years) was stable, with no erosion.

Upper end of Dugout Pond and recently reclaimed topsand storage area
