MINERALS PROGRAM INSPECTION REPORT

| MINE NAME: Howard Creek Pit #1 & #2 | MINE/PROSPECTING ID#: M-1999-033 | MINERAL: Gravel | COUNTY: Fremont |
| INSPECTION TYPE: Surety-Related Inspection | INSPECTOR(S): Timothy Cazier, P.E. | INSP. DATE: April 20, 2022 | INSP. TIME: 09:30 |
| REASON FOR INSPECTION: Surety Release Requested | BOND CALCULATION TYPE: None | BOND AMOUNT: \$0.00 | |

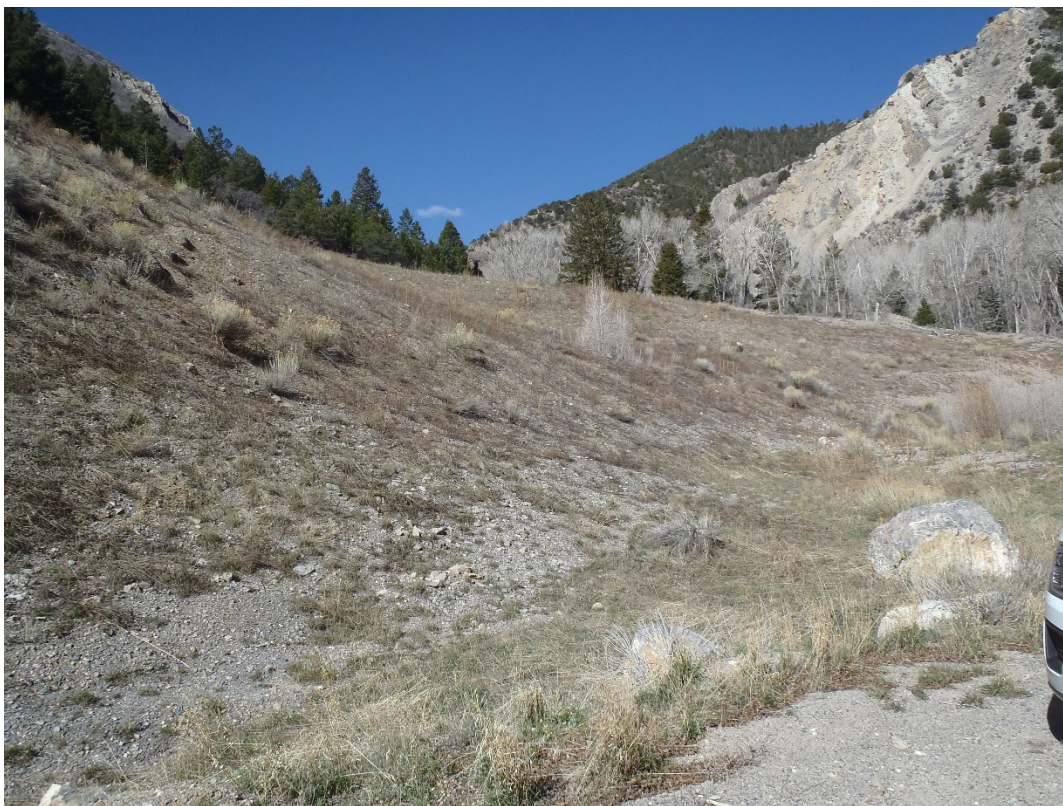
Backfilling and Grading: Both the west side (see **Photo 1**) and the east side (see **Photo 2**) were inspected. All backfilling and grading appeared to meet the required 3H:1V reclamation slopes.

Reclamation Success: As can be seen in **Photos 1, 2, 3** and **4** the slope reclamation appeared adequate. The east pit floor (see **Photo 5**) has been ripped and seeded, with minimal growth.

Photo 1. Reclaimed west side (looking WSW).

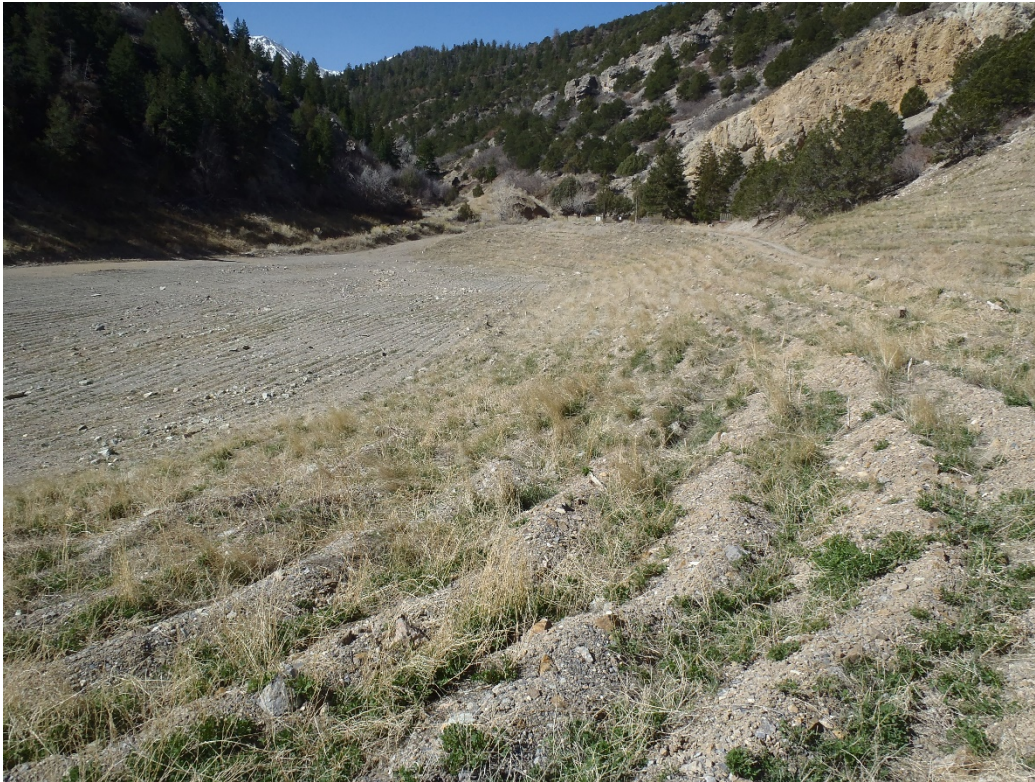
Photo 2. Reclaimed east side (looking south).

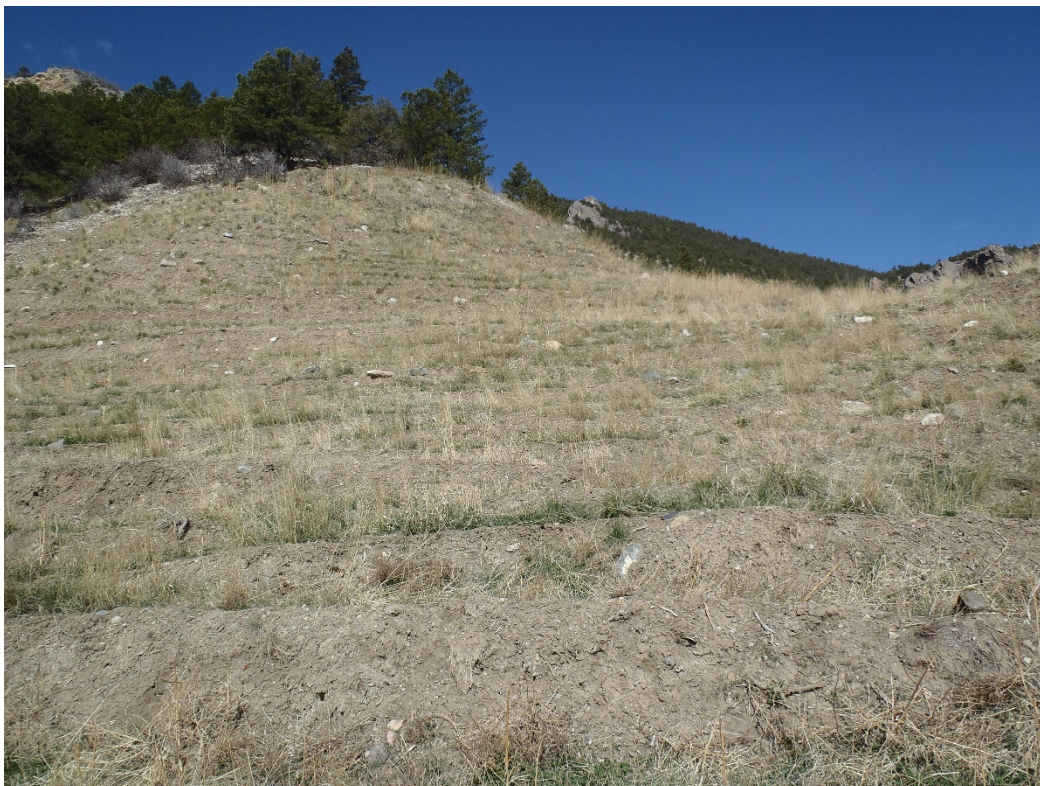
Photo 3. Reclaimed east side of mined area added through AM-1 (looking NW).

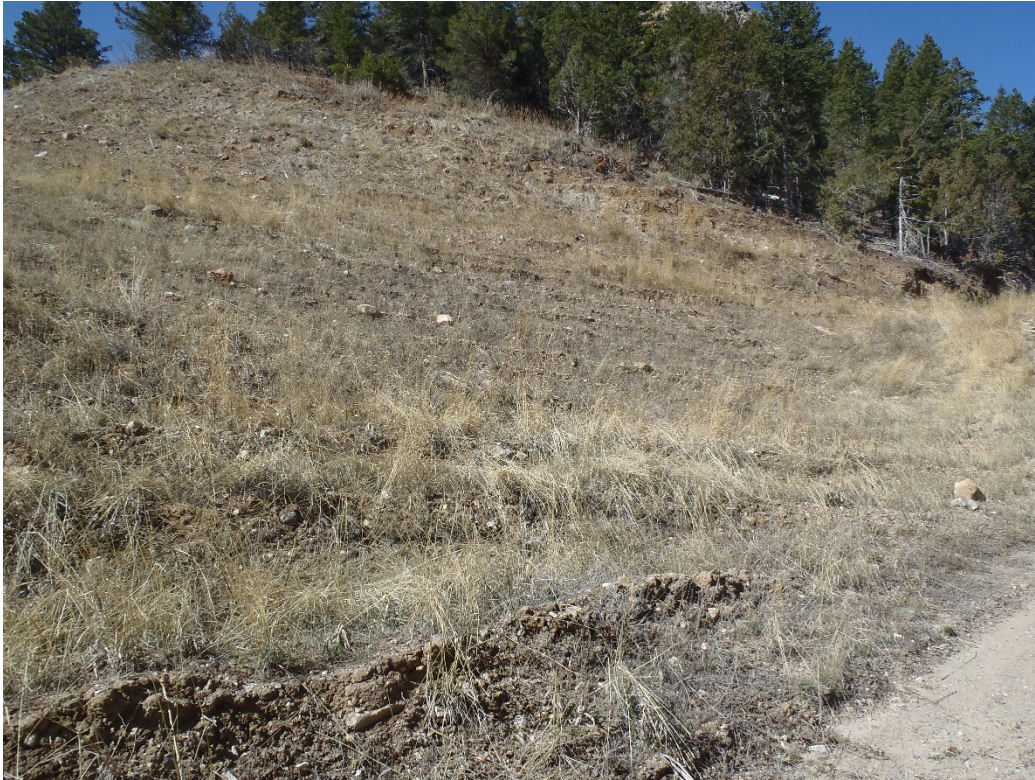
Photo 4. Reclaimed west side of mined area added through AM-1 (looking SW).

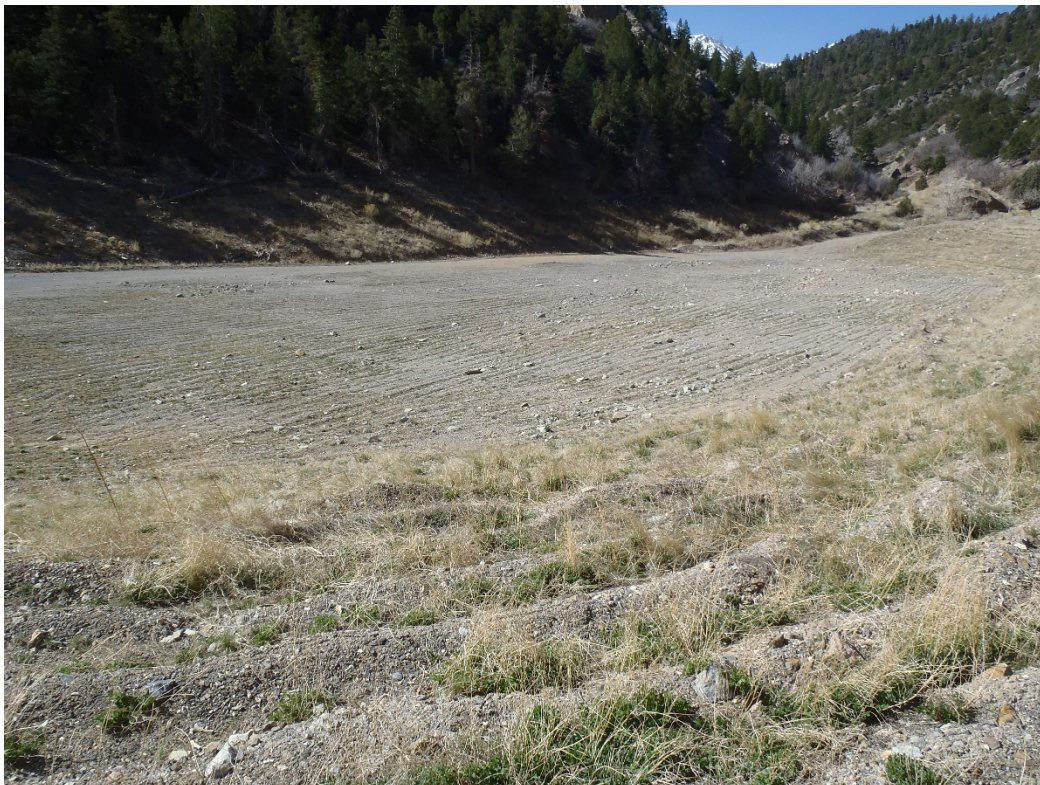
Revegetation: As indicated above, all areas, save the east pit floor were observed to support adequate vegetation. Mr. Canterbury explained he runs cattle through the area and that he transports the herd on the adjacent County Road (FC4/Howard Creek Rd) using semi-trucks. He intends to use the east pit floor for cattle corals and a place for the cattle trucks to turn around. He also stated the ripped floor would be a good base for the cattle to be staged and that he was satisfied with the reclamation status. As cattle truck turnaround and staging are necessary activity for rangeland, the DRMS accepts the east pit floor as observed to be releasable. Representatives from the FCD stated they were satisfied with the revegetation status as well.

Photo 5. Ripped and seeded east pit floor to be used for cattle loading (looking south).

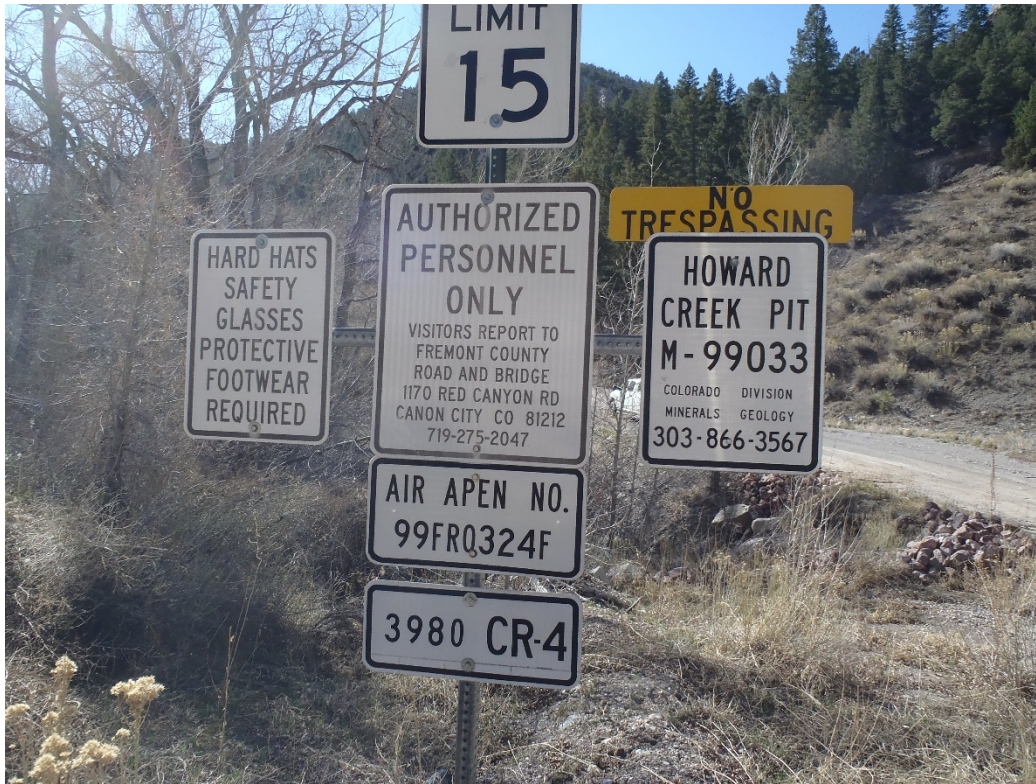
Signs and Markers: The permit sign was properly posted (see **Photo 6**).

Photo 6. Permit sign.
