**MINERALS PROGRAM INSPECTION REPORT**  
**PHONE: (303) 866-3567**

<b>MINE NAME:</b> Sprague Red Lyons	<b>MINE/PROSPECTING ID#:</b> M-1981-057	<b>MINERAL:</b> Sandstone	<b>COUNTY:</b> Boulder
<b>INSPECTION TYPE:</b> Monitoring	<b>INSPECTOR(S):</b> Patrick Lennberg	<b>INSP. DATE:</b> April 27, 2022	<b>INSP. TIME:</b> 08:00
<b>OPERATOR:</b> Arkins Park Stone Corporation	<b>OPERATOR REPRESENTATIVE:</b> David Sprague Melissa Medrano	<b>TYPE OF OPERATION:</b> 112c - Construction Regular Operation

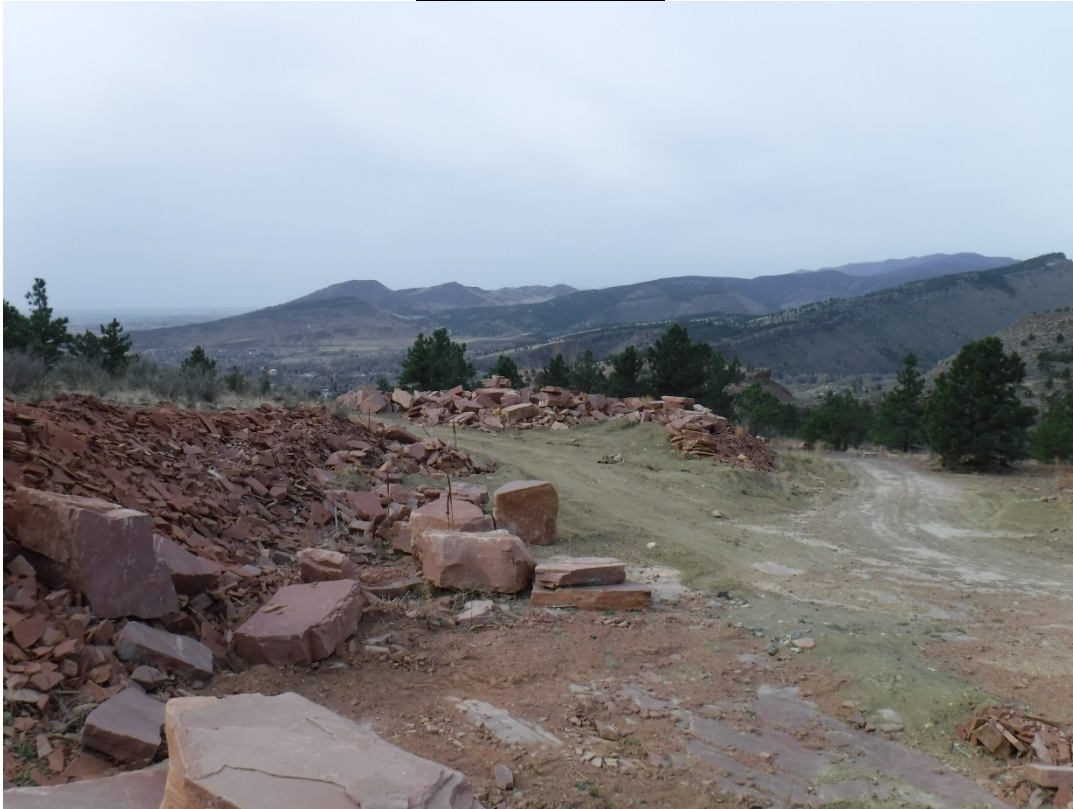
**Photo 1:** Main mine road as it enters into Quarry 2, looking south

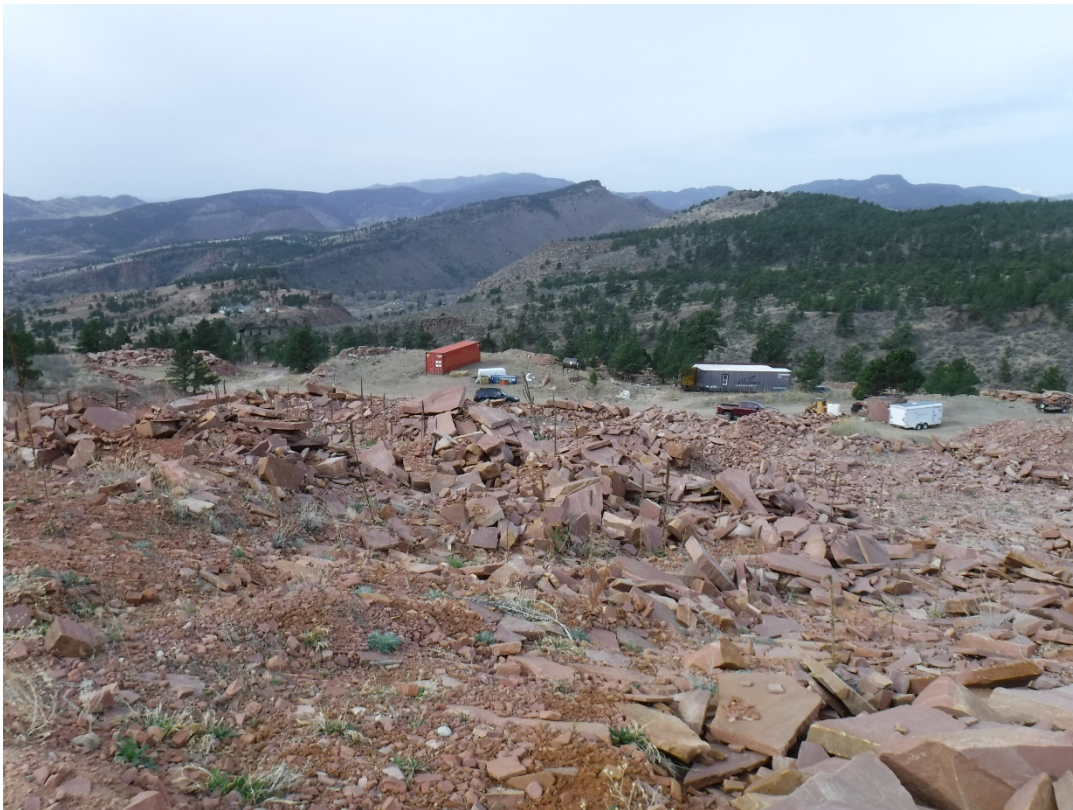
The permit was not active at the time of inspection. The permittee indicated they were probably going to begin final reclamation activities later this year in an effort to get the permit reclaimed as quickly as possible. They did state they wanted to discuss final reclamation with the property owner to reclaim the site to the land owners satisfaction. Once they have reconciled how the site should look it was recommended the permittee let the Division know so any revisions to the permit could be completed before reclamation efforts were complete. It was noted the land owner has built an accessory dwelling unit within the permit boundary. A review of the Boulder County Assessor website indicates this dwelling may be unpermitted and appeared onsite soon after sale of the land in 2017.

**Photo 2:** Looking across Quarry2 from Quarry1, ADU right of center of picture

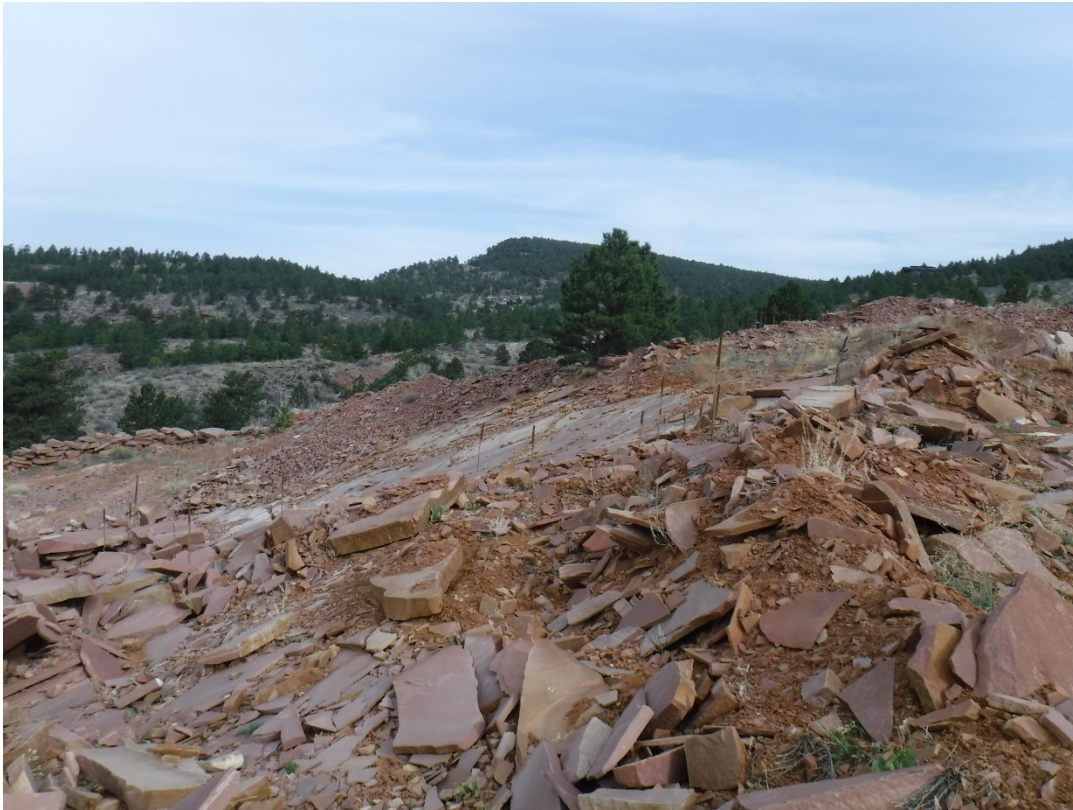
**Photo 3:** Quarry 2 pit area looking north

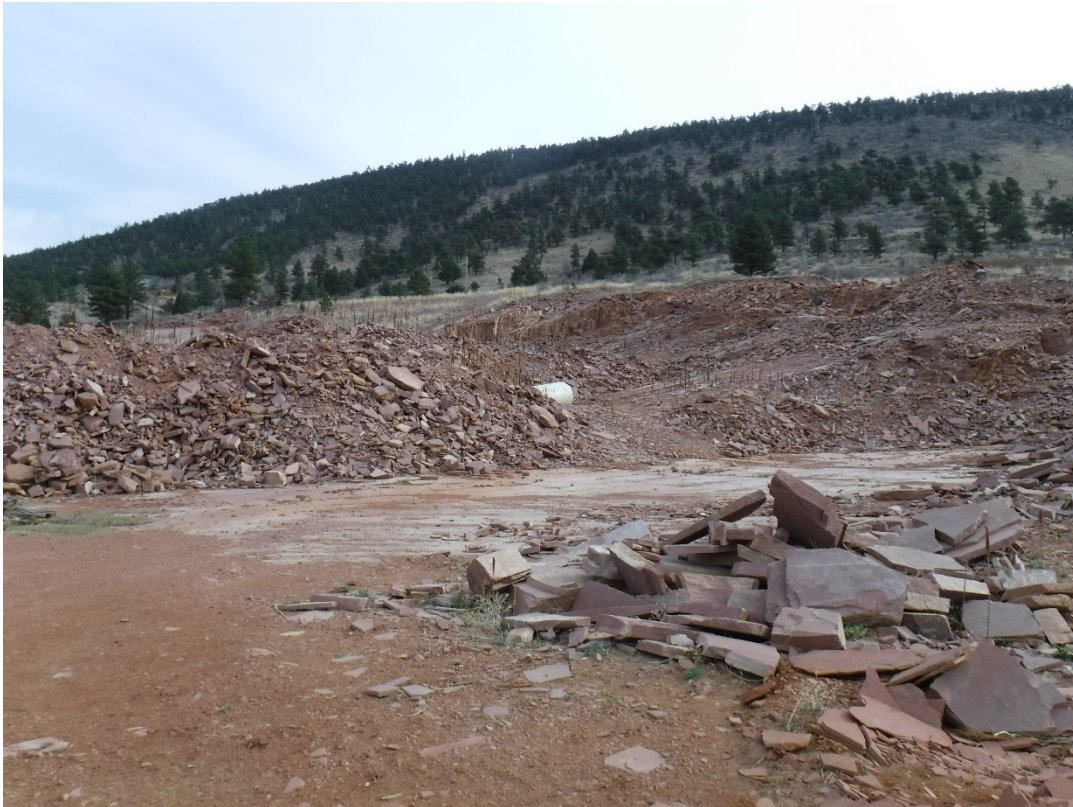
**Photo 4:** Looking from Quarry 2 towards Quarry 1 area, looking northeast

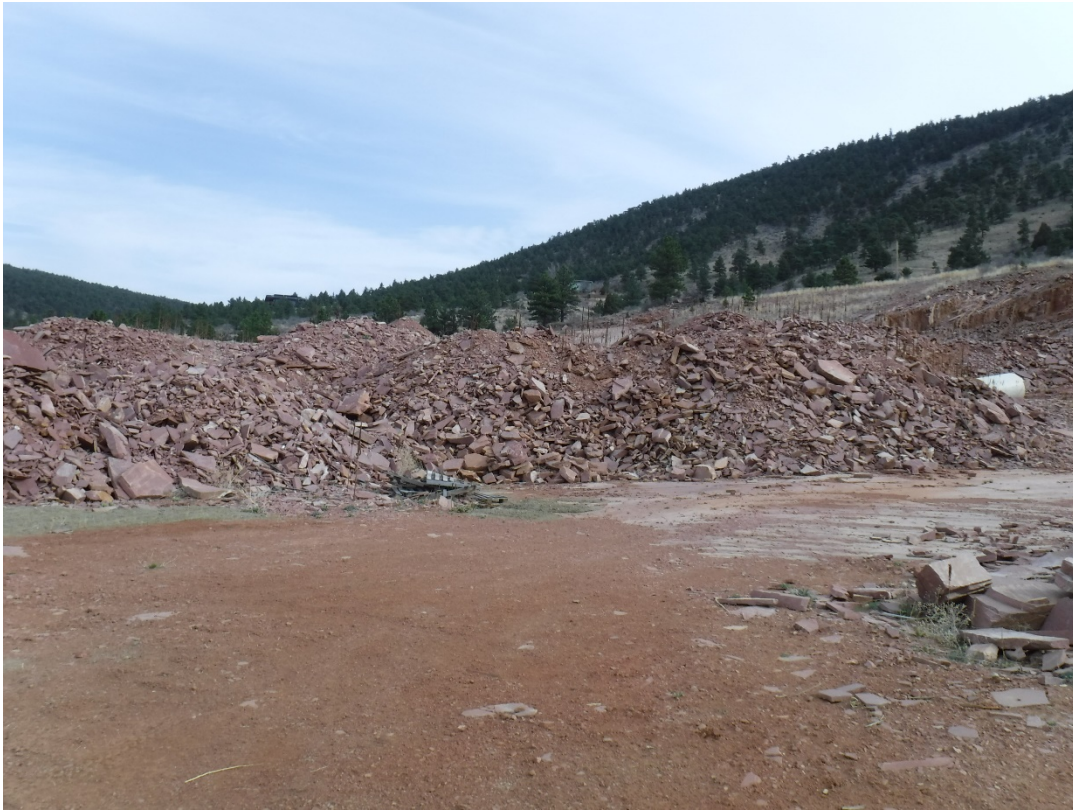
**Photo 5:** Typical stockpiles of material at the site

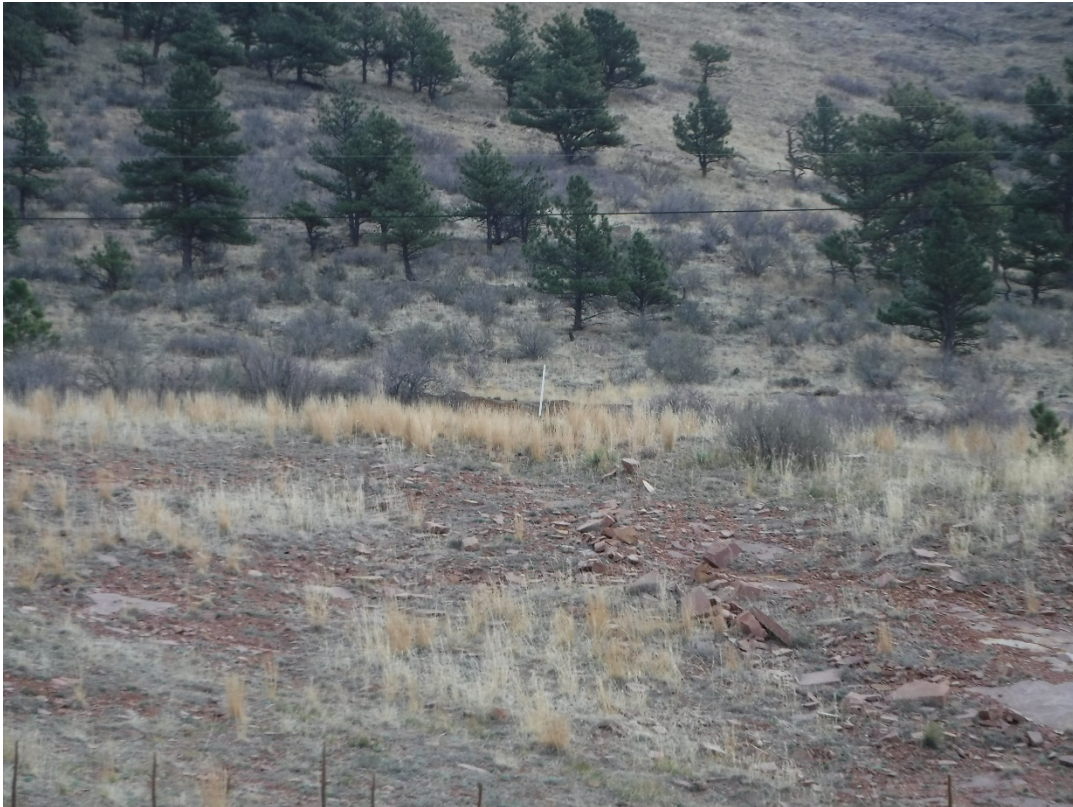
**Photo 6:** Typical permit boundary marker at the site

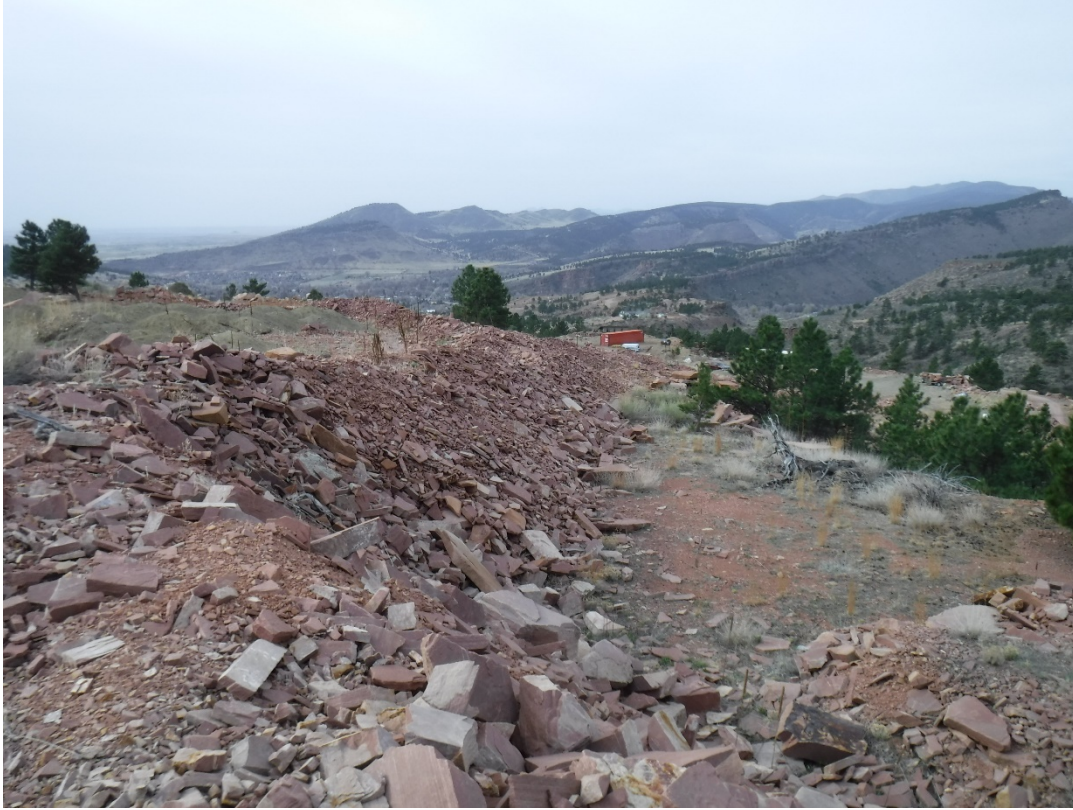
**Photo 7:** Material available for reclamation

The approved post-mining land use for the site is a combination of rangeland and residential. For reclamation, quarry areas will be backfilled with 6 inches of overburden/waste rock and graded to 3H:1V or flatter to blend with existing topography. Pre-existing steep rock ledges in the quarries may be reclaimed by placing large stones on portions of the slopes to form steps which can be retopsoiled and revegetated. Disturbed land will receive 6-8 inches of topsoil and be revegetated with a native grass seed mixture. Additionally, the operator will plant six Ponderosa pine trees and six Rocky Mountain juniper trees per acre. Existing roads will remain after reclamation for use by the landowner. The Division recommends beginning reclamation activities as soon as possible to avoid future financial warranty increases.

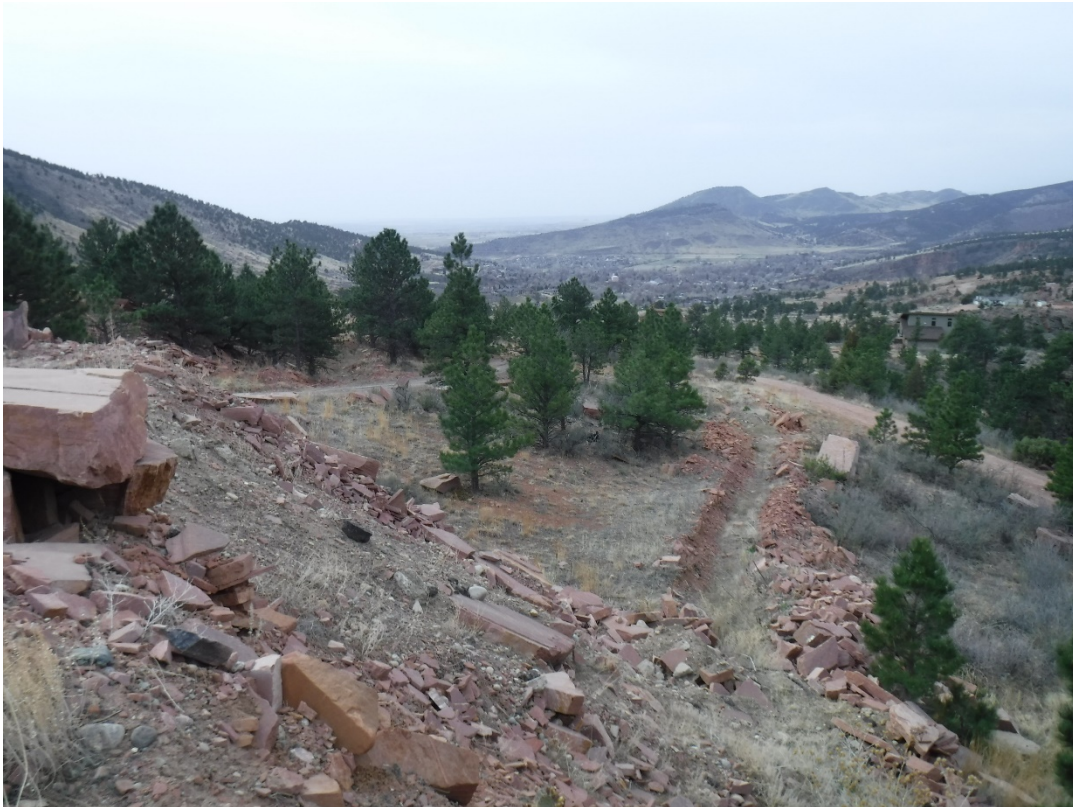
**Photo 8:** Looking down to Steamboat Valley Road that bisects permit area.
