**MINERALS PROGRAM INSPECTION REPORT**  
**PHONE: (303) 866-3567**

<b>MINE NAME:</b> Segelke Gravel Pit	<b>MINE/PROSPECTING ID#:</b> M-1986-048	<b>MINERAL:</b> Sand and gravel	<b>COUNTY:</b> Morgan
<b>INSPECTION TYPE:</b> Surety-Related Inspection	<b>INSPECTOR(S):</b> Brock Bowles	<b>INSP. DATE:</b> April 27, 2022	<b>INSP. TIME:</b> 09:00
<b>OPERATOR:</b> Beaver Ranch Gravel L.L.C.	<b>OPERATOR REPRESENTATIVE:</b> Rebecca Curtis	<b>TYPE OF OPERATION:</b> 112c - Construction Regular Operation	
<b>REASON FOR INSPECTION:</b> Surety Related	<b>BOND CALCULATION TYPE:</b> Complete Bond	<b>BOND AMOUNT:</b> \$43,357.00	
<b>DATE OF COMPLAINT:</b> NA	<b>POST INSP. CONTACTS:</b> None	<b>JOINT INSP. AGENCY:</b> None	
<b>WEATHER:</b> Cloudy	<b>INSPECTOR'S SIGNATURE:</b>

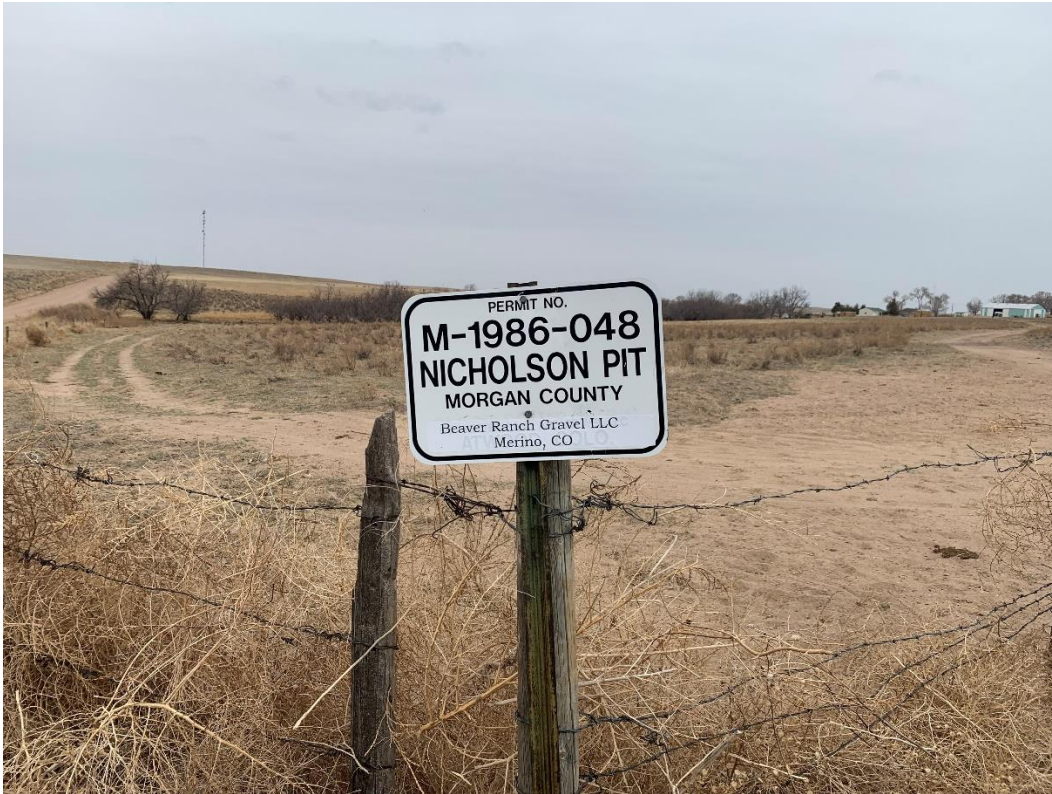
The mine entrance sign was in place facing CR GG (photo 1). The sign has a sticker applied to show the new operator. The permit boundary corner posts were in place (photo 2). Cattle and calves were gathered in the pit area. Bale feeders were located just south of the pit area keeping the cattle in the area (photo 3).

Photo 1 – Mine entrance sign facing CR GG

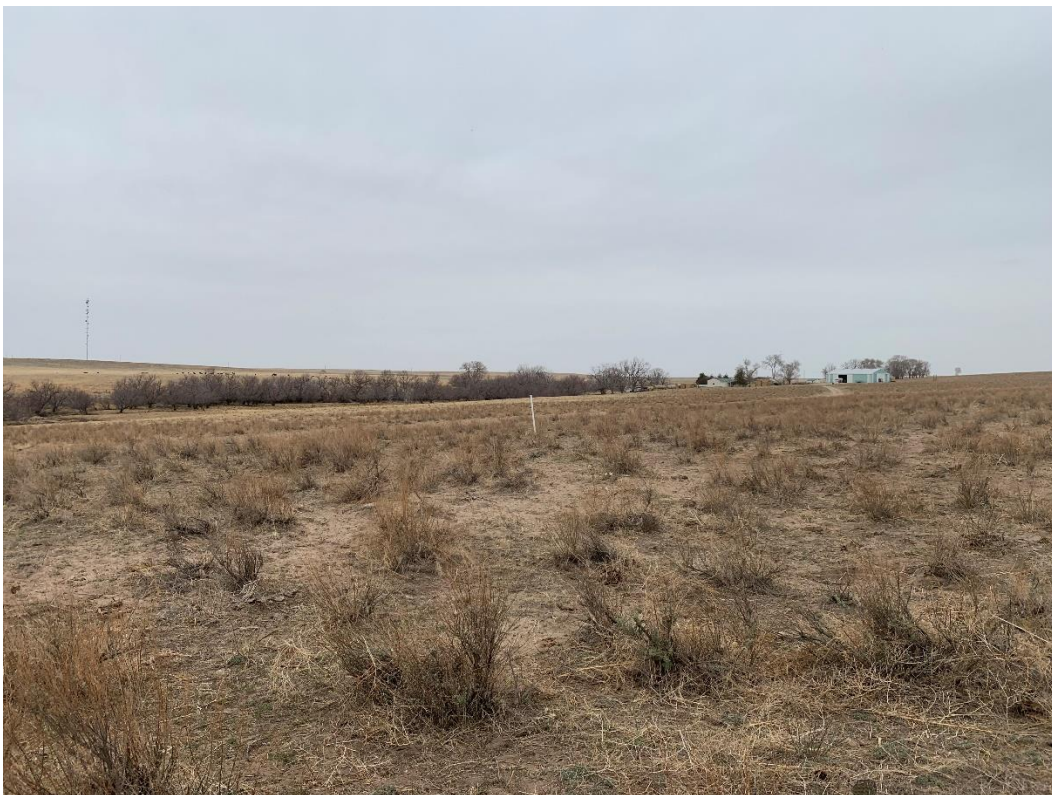
Photo 2 – The southwest corner marker

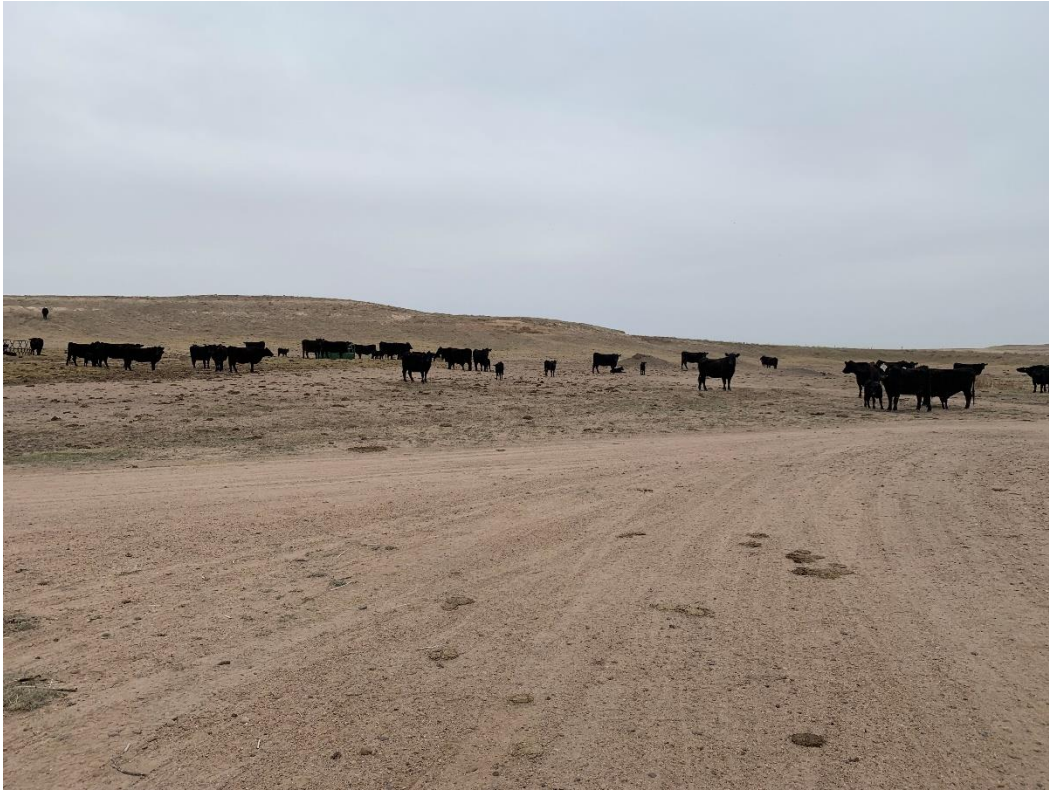
Photo 3 – Cattle and calves in the pit area
