**MINERALS PROGRAM INSPECTION REPORT**  
**PHONE: (303) 866-3567**

<b>MINE NAME:</b> Tamarcaz Pit	<b>MINE/PROSPECTING ID#:</b> M-2022-022	<b>MINERAL:</b> Aggregate	<b>COUNTY:</b> Gunnison
<b>INSPECTION TYPE:</b> Illegal(Unpermitted Operation)	<b>INSPECTOR(S):</b> Dustin Czapla	<b>INSP. DATE:</b> April 7, 2022	<b>INSP. TIME:</b> 14:00
<b>OPERATOR:</b> Cornerstone Materials LLC	<b>OPERATOR REPRESENTATIVE:</b>	<b>TYPE OF OPERATION:</b> NP - Needs Permit

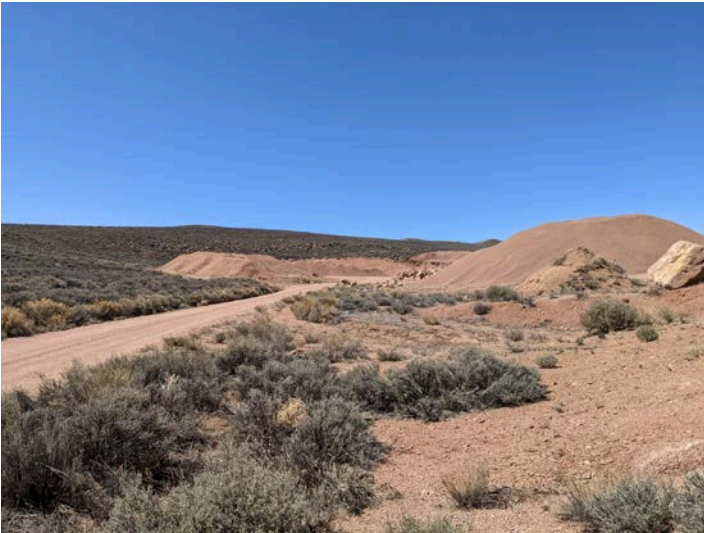
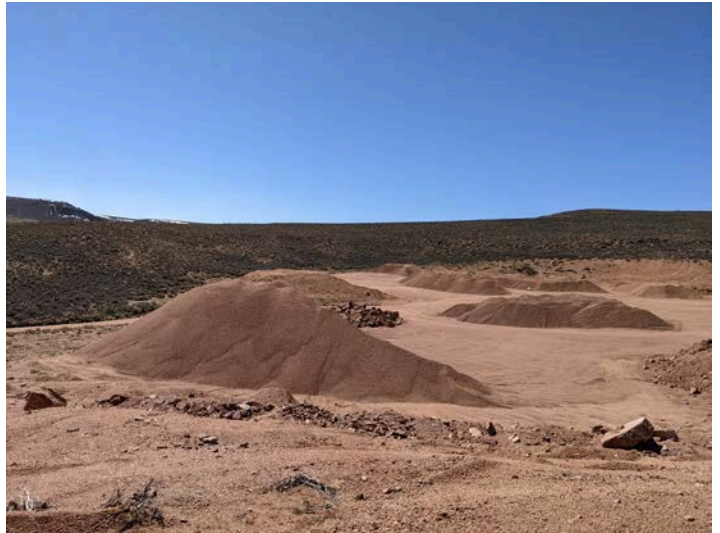
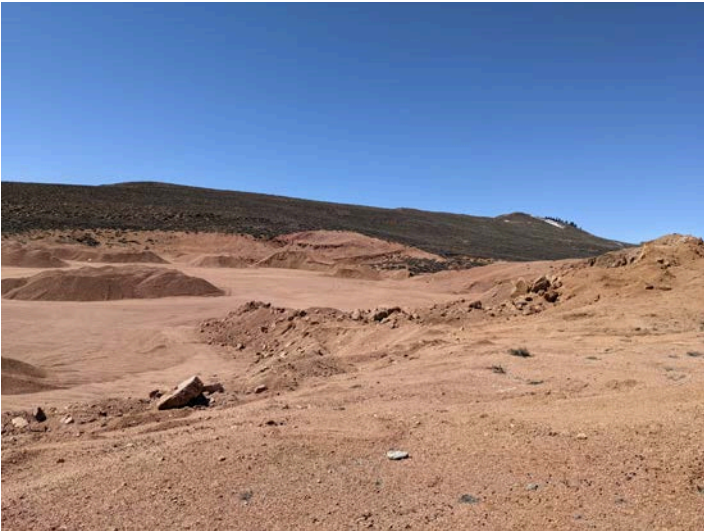
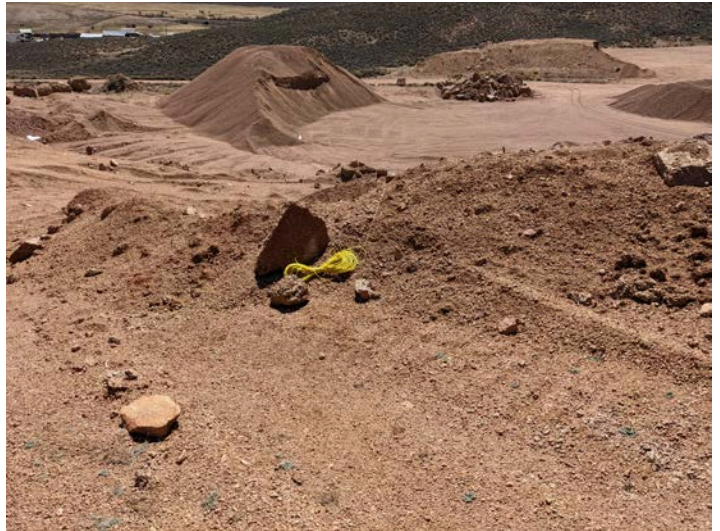
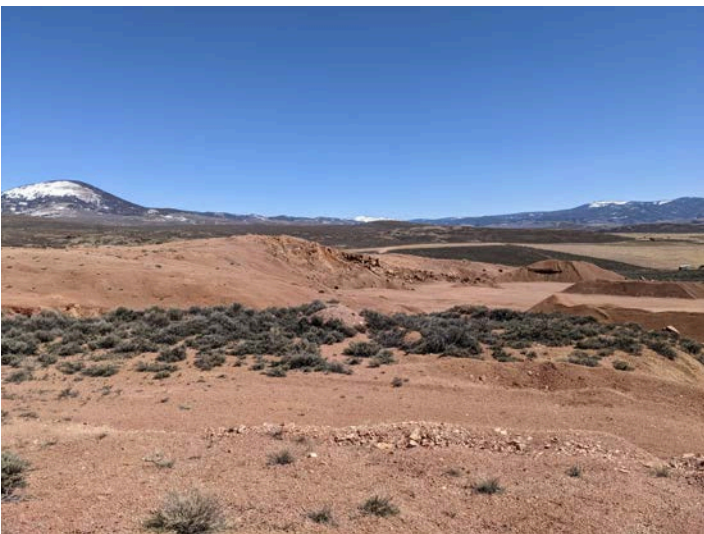
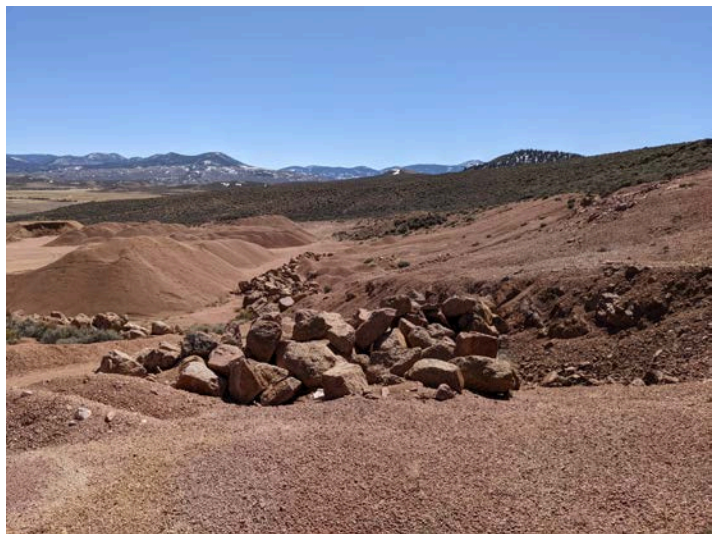
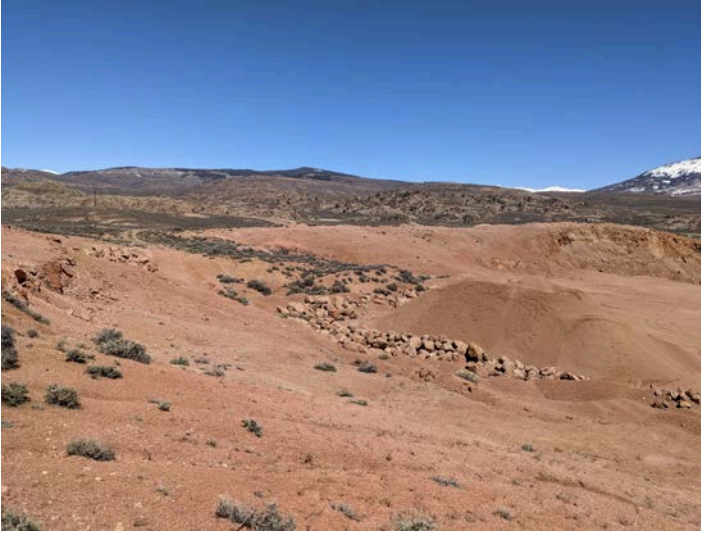
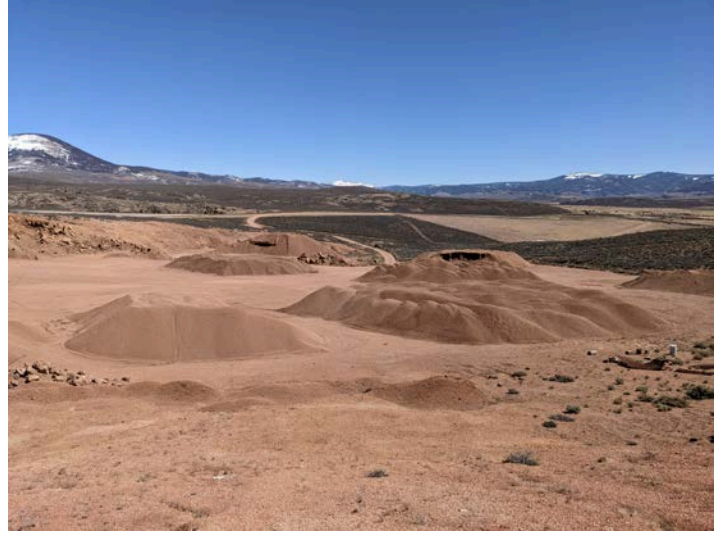
The Taramarcaz Pit is located on BLM managed lands at 38.478302°, -106.654418°, approximately sixteen miles east of Gunnison. Site access is from CR 44. The disturbed pit area includes approximately nine acres. The commodity mined at the site is granite. Stockpiles of processed material and riprap boulders are located throughout the pit floor. Mining is active on the east highwall of the pit.

The following photographs illustrate conditions observed at the site during this inspection.
