### MINERALS PROGRAM INSPECTION REPORT

| <b>MINE NAME:</b><br>Cresson Project | <b>MINE/PROSPECTING ID#:</b><br>M-1980-244 | <b>MINERAL:</b><br>Gold | <b>COUNTY:</b><br>Teller |
| <b>INSPECTION TYPE:</b><br>Monitoring | <b>INSPECTOR(S):</b><br>Timothy Cazier, P.E. | <b>INSP. DATE:</b><br>April 19, 2022 | <b>INSP. TIME:</b><br>09:50 |

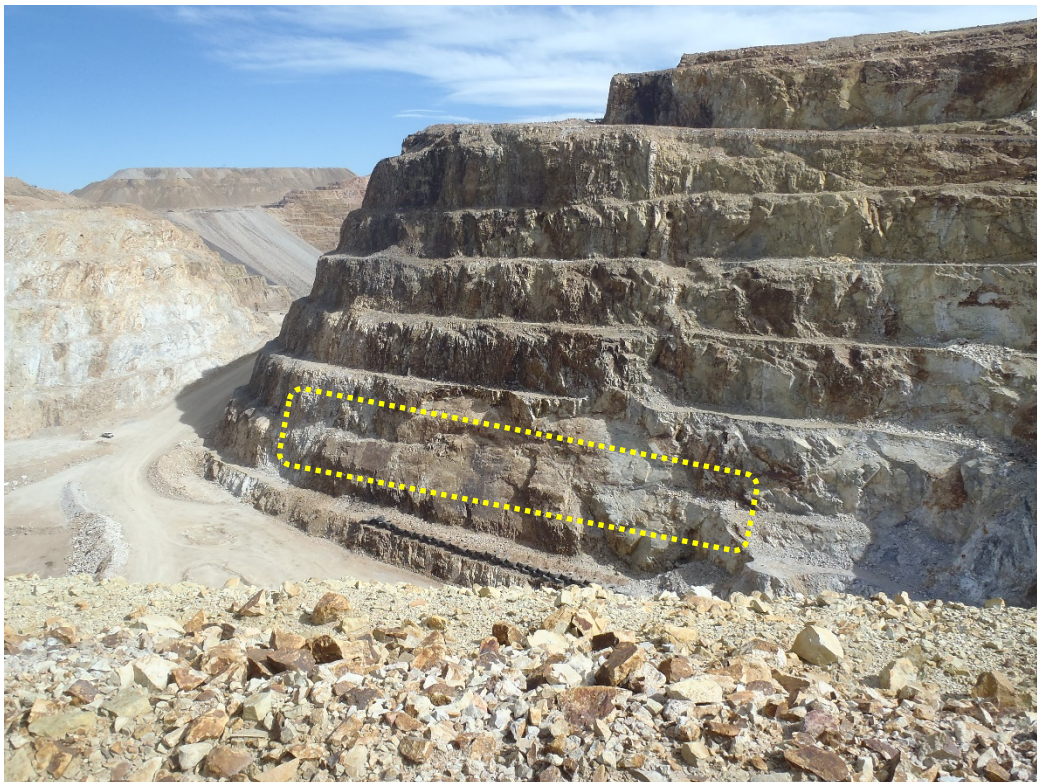
South Cresson Bench Failure: The Cresson bench failure (see **Photo 1**) was discussed in the DRMS' March 30, 2022 inspection report. A follow-up visit was performed during this inspection to observe the mitigation under much better visibility conditions. The DRMS had concerns related to the effectiveness of the haul truck tire build up mitigation on the bench below the failed bench to have sufficient capacity to capture sloughed rock above it during the post-reclamation period. Discussions with site representatives revealed this section of the highwall will be laid back during the phase 2 of the South Cresson pit mine plan. As such, the DRMS is no longer concerned with this issue.

Photo 1. South Cresson bench failure (looking NE)

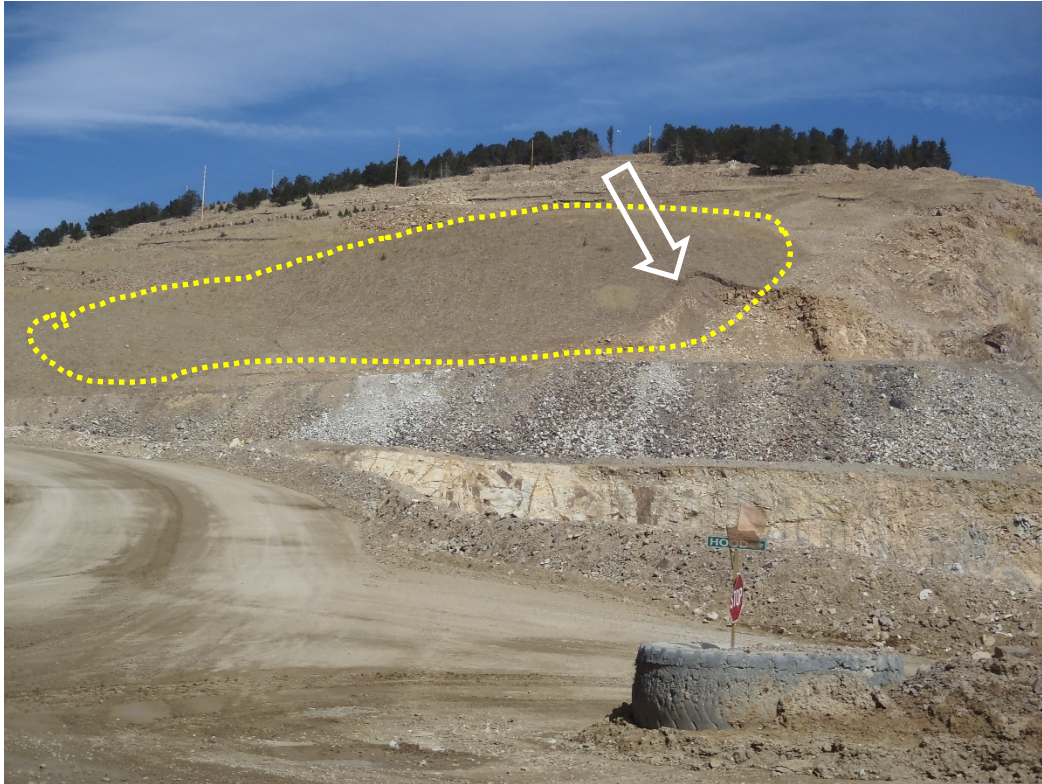
Growth Media Stockpile #32: The stability of Growth Media Stockpile #32 (GM-32) was discussed in the DRMS' March 30, 2022 inspection report. This was a follow-up visit to observe the stockpile under much better visibility conditions (see **Photo 2**). There was not a safe place to stop and inspect the stockpile up close due to its proximity to a major haul road. Photographs taken while driving past the stockpile were reviewed subsequent to the inspection. Review of these photos, suggests a small amount of growth media was lost either when the adjacent haul road was re-aligned, or shortly thereafter. Darker soil (typically indicating the presence of organic matter) can be seen in **Photo 2** on the east side of GM-32 below a scarp in the same area. The scarp is estimated to be on the order of two feet in thickness. The DRMS believes there is potential for the scarp to migrate to the north, resulting in the loss of additional growth media. However, given the thin nature of the scarp and that it's on the edge of the stockpile, additional growth media loss may not be significant. Nevertheless, [the GM-32 stockpile should be monitored to ensure significant growth media is not lost](#). Maria Bujenovic stated the annual report submitted to the DRMS reflected a reduction in the volume of growth media stockpiled in GM-32 (and the adjacent GM-33 across the haul road). The DRMS checked these records subsequent to the inspection and notes last year's annual report listed a combined GM-32/33 volume of 136,181 CY, which was reduced to 92,181 CY in this year's annual report. A reduction of 44,000 CY. Ms. Bujenovic indicated this material was placed as

Photo 2. Growth media stockpile #32 (circled), sloughing (arrow) (looking NW).

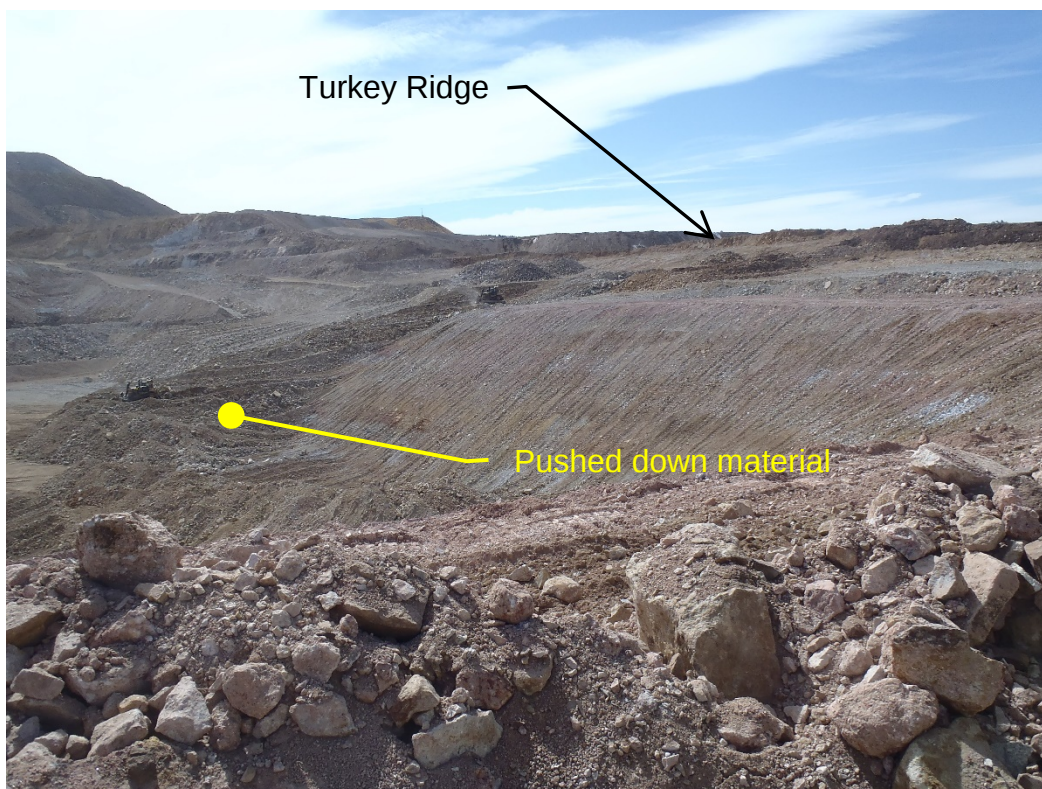
Schist Island backfill: The high compaction zone backfill has ceased for the time being. Site representatives indicated the current effort is focused on shaping the compacted fill and reducing the height of Turkey Ridge (the term used to describe the ridge between the Schist Island pit and the north side of VLF2 - see **Photo 3**). A significant amount of oversized material (see **Photo 4**) was being pushed down by the dozers. I raised concerns about how this oversized material would not meet the specifications. A Newfields representative named Tyler stated all the Turkey Ridge material being pushed down would be wasted, most likely on the ECOSA. Furthermore, additional high compaction backfill placement was expected to resume one to two weeks after this inspection. He also stated underground opening remediation was being performed and would be documented the forthcoming CQA reports.

Photo 3. Dozers shaping (push down) Schist Island pit/Turkey Ridge.

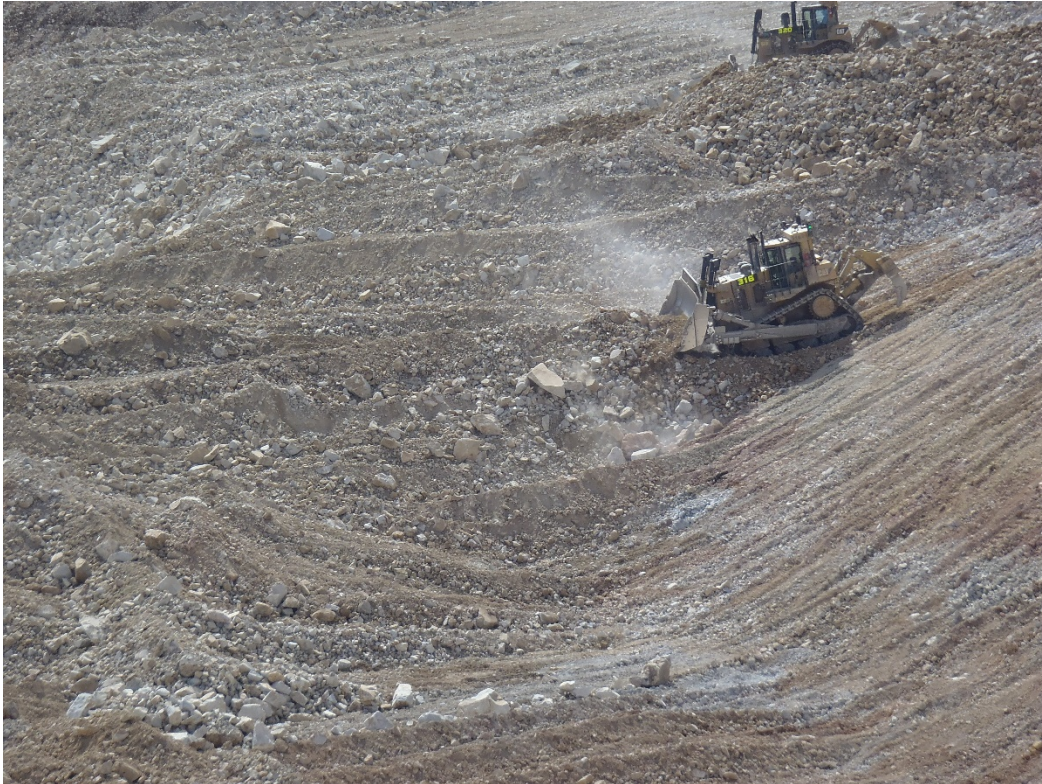
Photo 4. Oversize rock in Turkey Ridge material – to be wasted on ECOSA

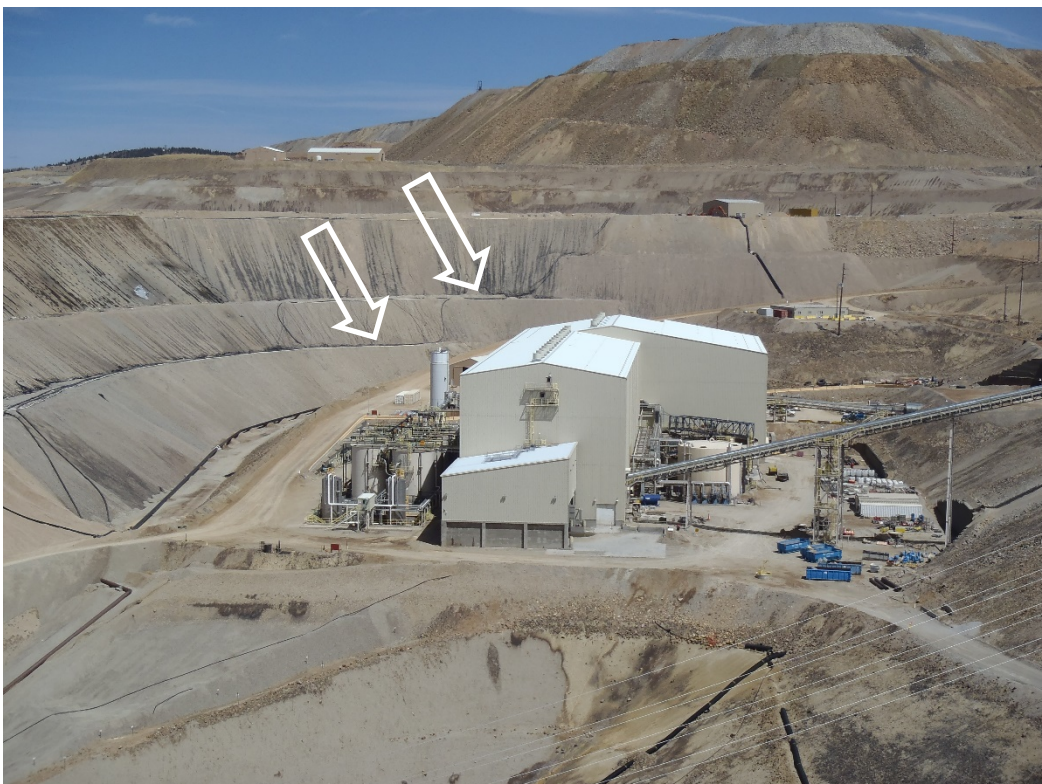
**PROBLEM/POSSIBLE VIOLATION No. 2:** Problem: The current mine plan related to ore stacking as approved with TR-103 appears not to have been followed above the HGM.

VLF 2 Ore Stacking: Photographs from the DRMS March 2022 aerial inspection indicated ore stacking on the southeast portion of VLF2, west of the High Grade Mill and north of the nearby projects office (see **Photo 5**) may not conform to the standards approved in TR-103. The ore stacking criteria for "Ore slopes above the Mill Platform were designed to be 2.0(H):1(V), a bench with a minimum width of 60' is required between the crest of the lower lift and the toe of the new lift." The TR further explains the 60-foot bench is required for the standard or typical 100-foot lift height. The area most concerning to the DRMS is that northwest of the projects building (see **Photo 6**). Site representatives concurred the bench observed in **Photo 6** was about 10 feet in width and the lift height was likely 50 feet. Pursuant to TR-103, the bench width for a 50-foot lift height would only need to be 30 feet, 20 feet wider than what was observed. **The inadequate bench width is cited as Problem 2 on page 1 of this report.** The prescribed bench width and lift height is intended to create an overall ore stack slope of 2H:1V in areas above the HGM. It is difficult to access a vantage point where additional bench widths and lift heights can be assessed. The DRMS requires as part of the corrective action, CC&V provide a contoured survey map/drawing of VLF2. The resulting map should have the following:

Photo 5. VLF2 benches in question (looking NNE from VLF1 overlook).

**CORRECTIVE ACTIONS:** The operator must provide sufficient topographic information (i.e., a contoured survey

map of the entire VLF2) to the DRMS by the corrective action due date, in order for the DRMS to fully evaluate the VLF2 ore stacking with respect to the TR-103 stacking plan addendum approved on May 22, 2020. The resulting map should have the following:

- 10-foot, labeled contours;
- Distinctive line types delineating the crest and toe of each bench/intermediate slope to facilitate bench width measurements; and
- Labeled bench elevations to easily determine lift heights.

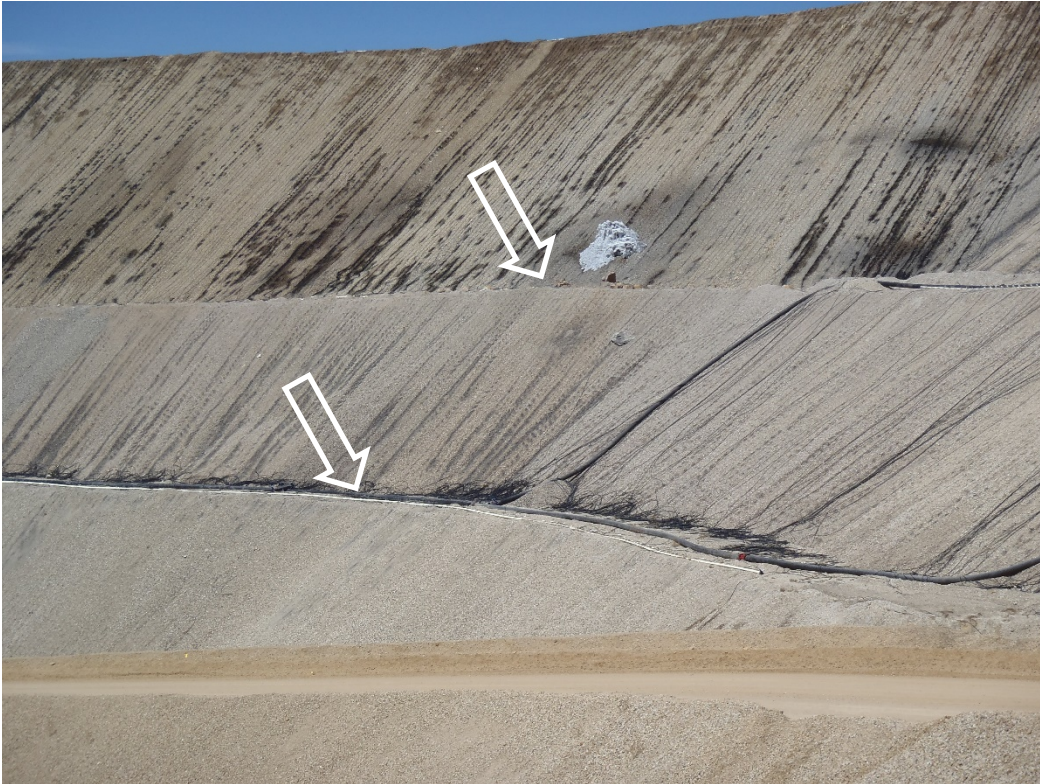
Photo 6. 10-foot benches/50-foot lifts on VLF2 above the HGM (looking NW from projects office).

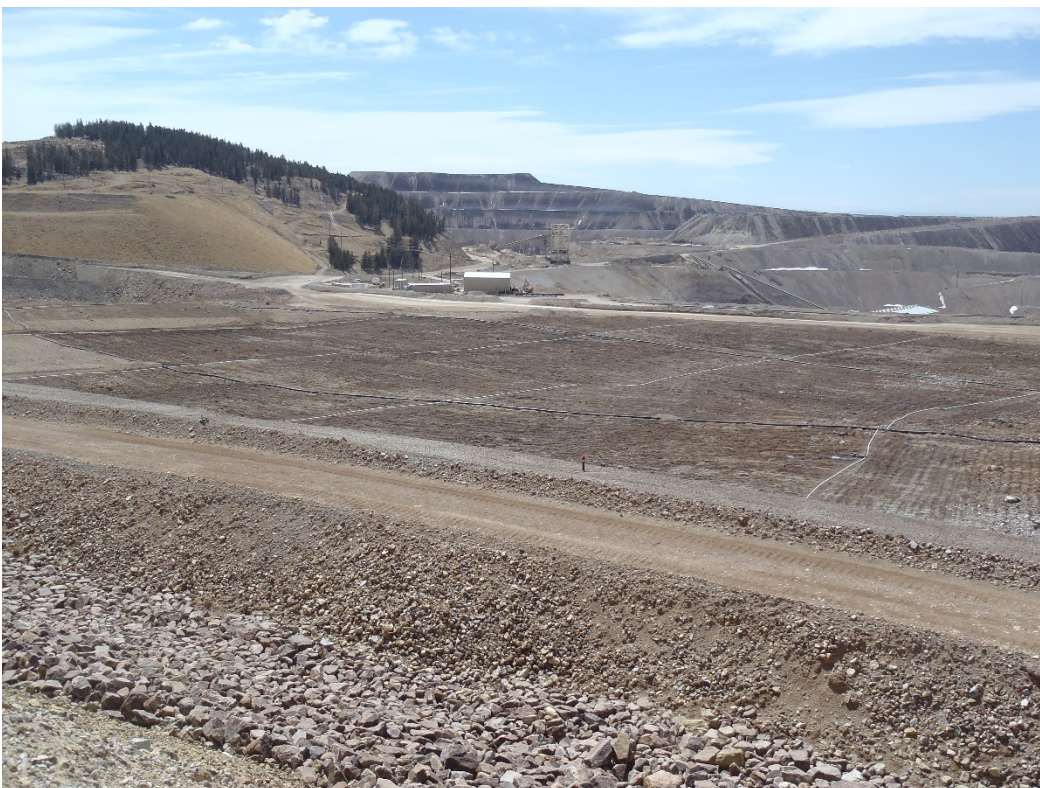
The surface of VLF2 was observed from the contractor buildings on the northeast side of VLF2 for ponded process solution (see **Photos 7 and 8**). No ponding was observed.

Photo 7. VLF2 leaching – no observed ponding (looking south from contractor buildings).

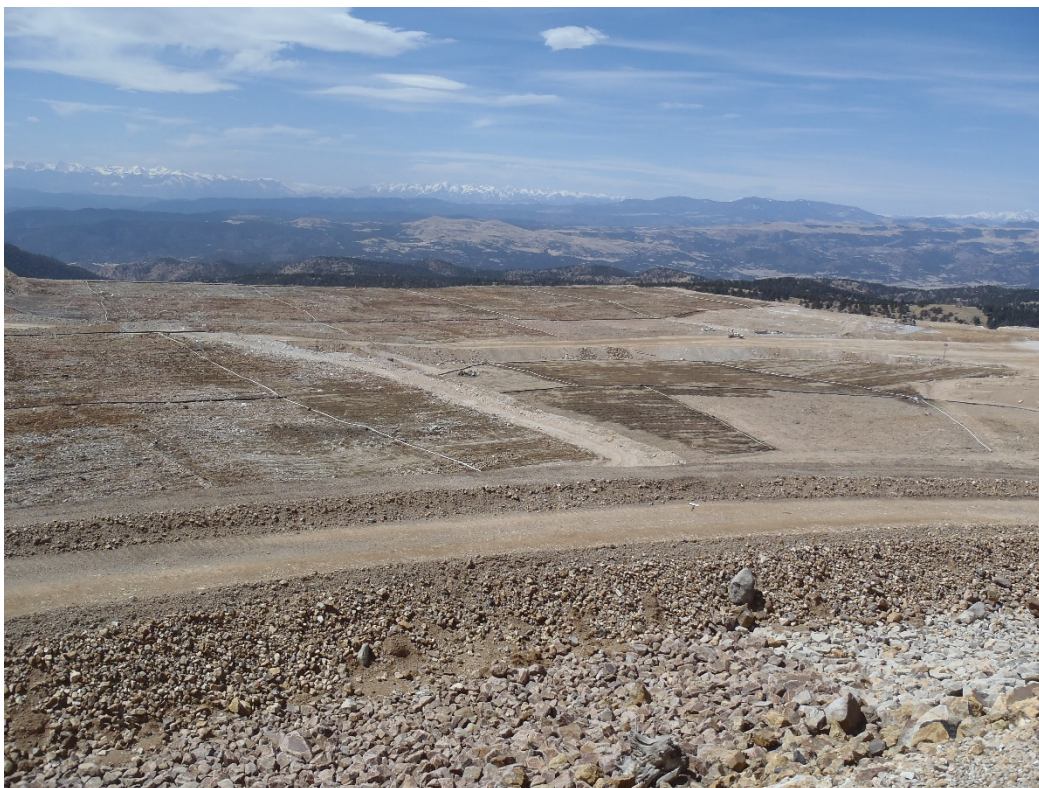
Photo 8. VLF2 leaching – no observed ponding (looking west from contractor buildings).
