MINERALS PROGRAM INSPECTION REPORT
PHONE: (303) 866-3567

MINE NAME: Riverside Pit	MINE/PROSPECTING ID#: M-1976-056	MINERAL: Sand and gravel	COUNTY: Logan
INSPECTION TYPE: Preoperation Inspection	INSPECTOR(S): Brock Bowles	INSP. DATE: April 27, 2022	INSP. TIME: 12:00
OPERATOR: McAtee Construction Company	OPERATOR REPRESENTATIVE: Jeff Harms	TYPE OF OPERATION: 112c - Construction Regular Operation	
REASON FOR INSPECTION: Preoperation Inspection	BOND CALCULATION TYPE: None	BOND AMOUNT: \$175,000.00	
DATE OF COMPLAINT: NA	POST INSP. CONTACTS: None	JOINT INSP. AGENCY: None	
WEATHER: Cloudy	INSPECTOR'S SIGNATURE:

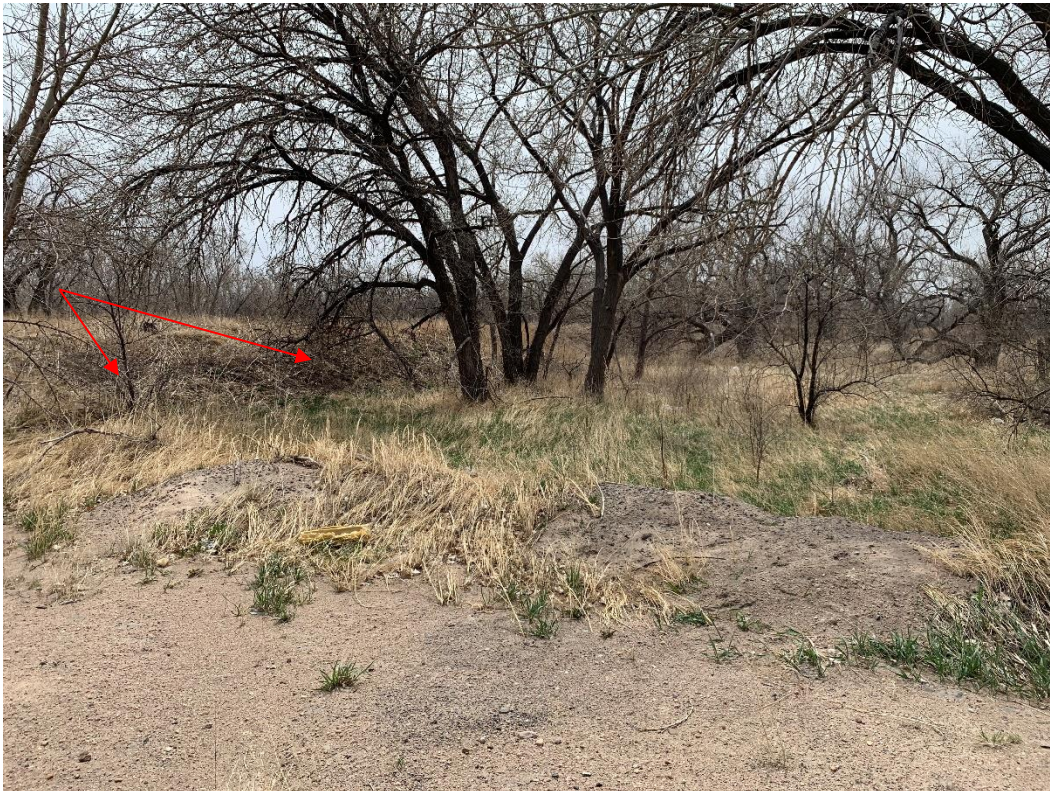
Photo 1 – Amendment area facing southeast. Lowline Ditch Berm in background

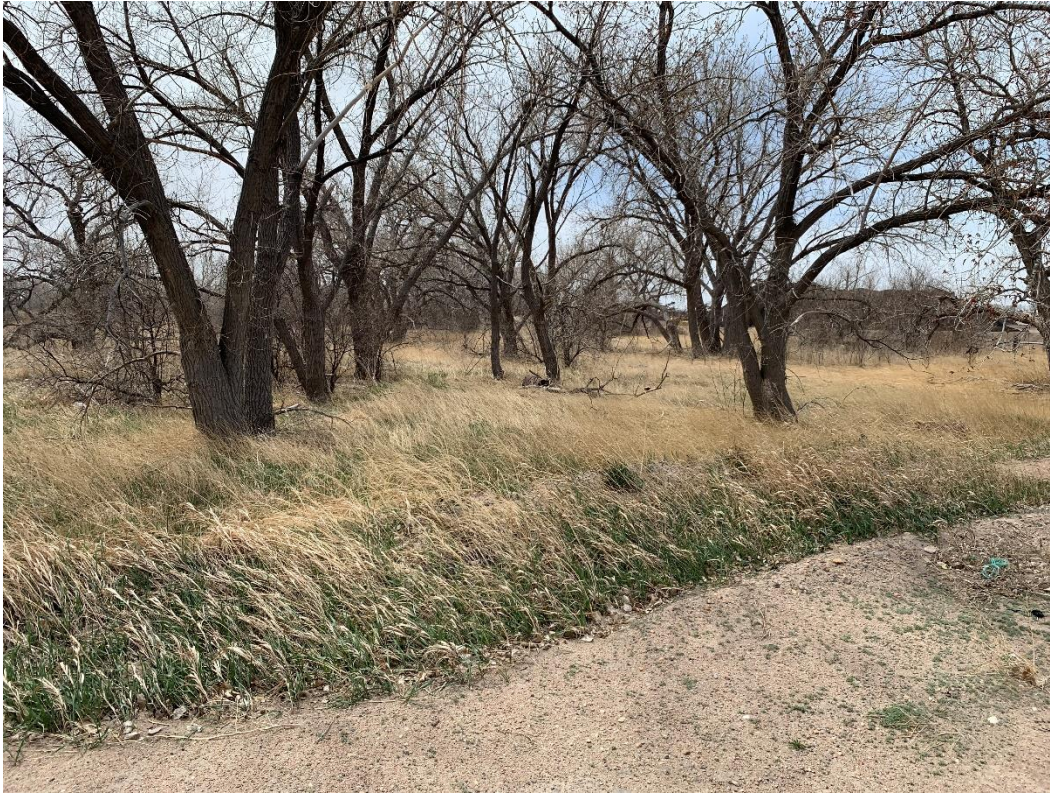
Photo 2 – Amended area facing southwest
