Response to Citizen Complaint M-2022-017

Re: Response to Citizen Complaint, M-2022-017

MINERALS PROGRAM INSPECTION REPORT

MINE NAME: Clayton Homes Pit	MINE/PROSPECTING ID#: M-2022-017	MINERAL: Sand and gravel	COUNTY: Adams
INSPECTION TYPE: Illegal (Unpermitted Operation)	INSPECTOR(S): Nikie Gagnon	INSP. DATE: April 25, 2022	INSP. TIME: 10:00
OPERATOR: Clayton Homes	OPERATOR REPRESENTATIVE: Mike Jansen	TYPE OF OPERATION: ILL - Illegal

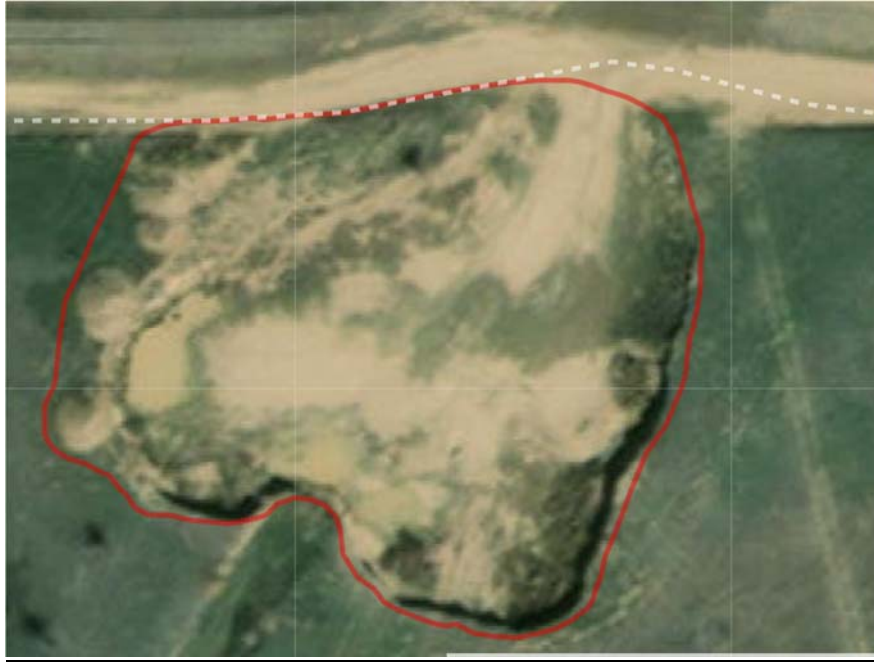
The Division reviewed Google Earth imagery which shows a borrow pit at this location since the early 2000s. The borrow pit has expanded over the years and the disturbance area is currently 1.21 acres (Photo 1). The Division contacted Richard Huwa of Turnpike LLC, who is listed as the property owner on the Adams County Assessor website. Mr. Huwa stated that he sold the property to Clayton Homes in November 2021. When asked about the borrow pit, Mr. Huwa stated that he routinely excavated material from the pit to fill sprinkler tracks on the property. According to Mr. Huwa, the Division was called out to investigate this practice in the past and determined that he was not mining because excavated material did not leave the property. No records were found in the DRMS permit system to confirm a previous inspection, however, Todd Denning, the adjacent landowner and complainant, acknowledged that the pit has been there for years and previous owners used material from the pit for agriculture practices. Mr. Denning's current concern with the activity is that the material removed from the pit was trucked off-site by the new owner, Clayton Homes, and groundwater could be impacted if Clayton Homes excavated any deeper into the pit. Although Mr. Denning stated in the complaint that the illegal mining of sand and soil is occurring in the West Sand Creek waterway, the Division determined West Sand Creek is approximately 400 feet east of the pit (Photo 2). Imagery of the area shows a ditch that intersects the south highwall of the pit (Photo 2 & 3). During the inspection, there was no evidence of exposed groundwater or stormwater in the pit.

Google imagery from April 20, 2021 and GPS points taken during the inspection shows the boundary of the pit wall has not expanded since Clayton Homes purchased the property in November, 2021 (Photo 1). During the inspection, Justin Markwardt confirmed that Clayton Homes removed ten truckloads of material on one day during the previous week and drove it to a home site approximately 5 miles north of the borrow pit. The fill material was removed from the northwestern side of the pit (Photos 5 & 6). Justin Markwardt estimated that the amount of material was 250 cubic yards (25 cubic yards per truck). Justin Markwardt stated that Clayton Homes was not aware of the requirement for a permit to move material between properties and now that they are informed of the process, the company has no plans to submit a permit application to mine the borrow pit.

Photo 1: Google earth imagery photo from April 20, 2021. Red boundary shows the current disturbance surveyed on 4/25/2022. For safety reasons, GPS points were taken approximately 5 feet away from the high wall.

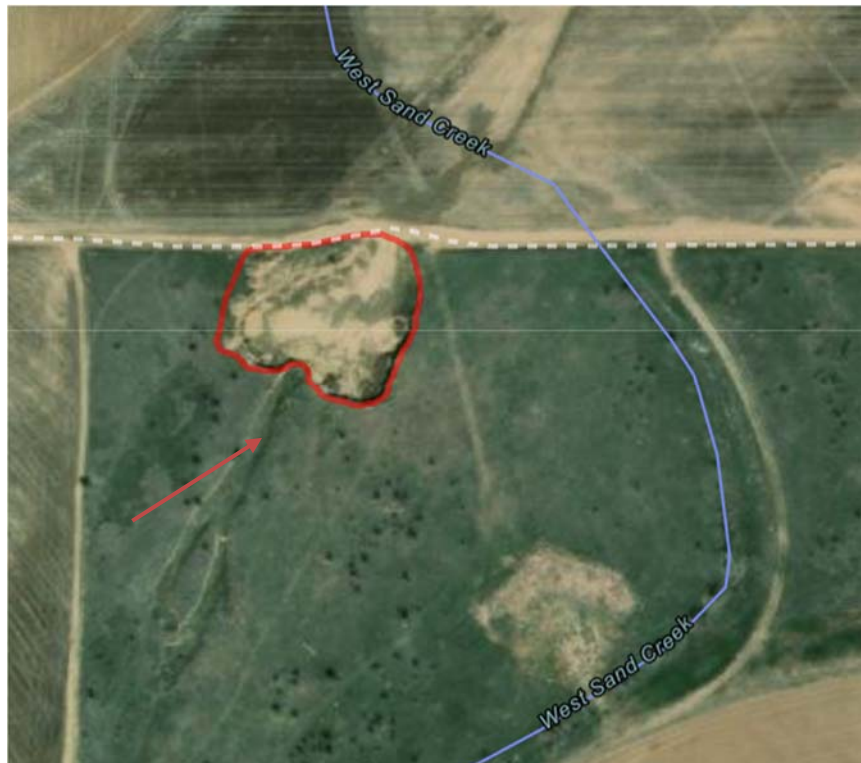
Photo 2: Google earth imagery photo from April 20, 2021 showing location of West Sand Creek, east of the pit. Arrow points to ditch.

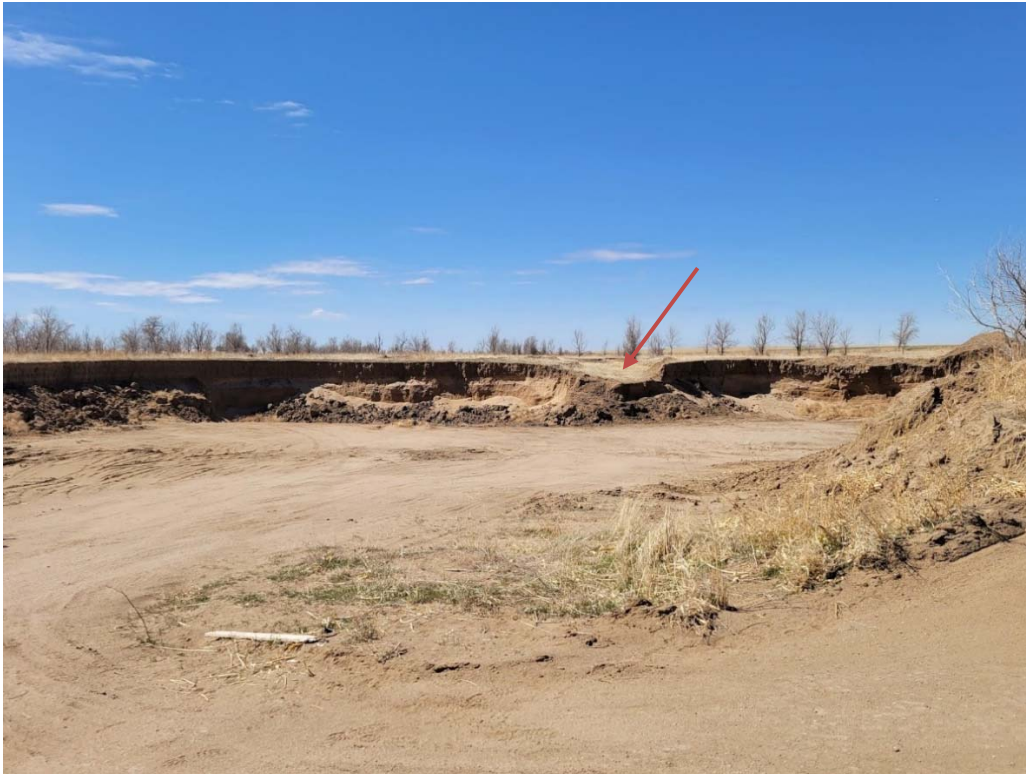
Photo 3: Entrance to borrow pit looking south. Photo taken from Weld County Road 2. Red arrow indicates where the ditch enters the pit.

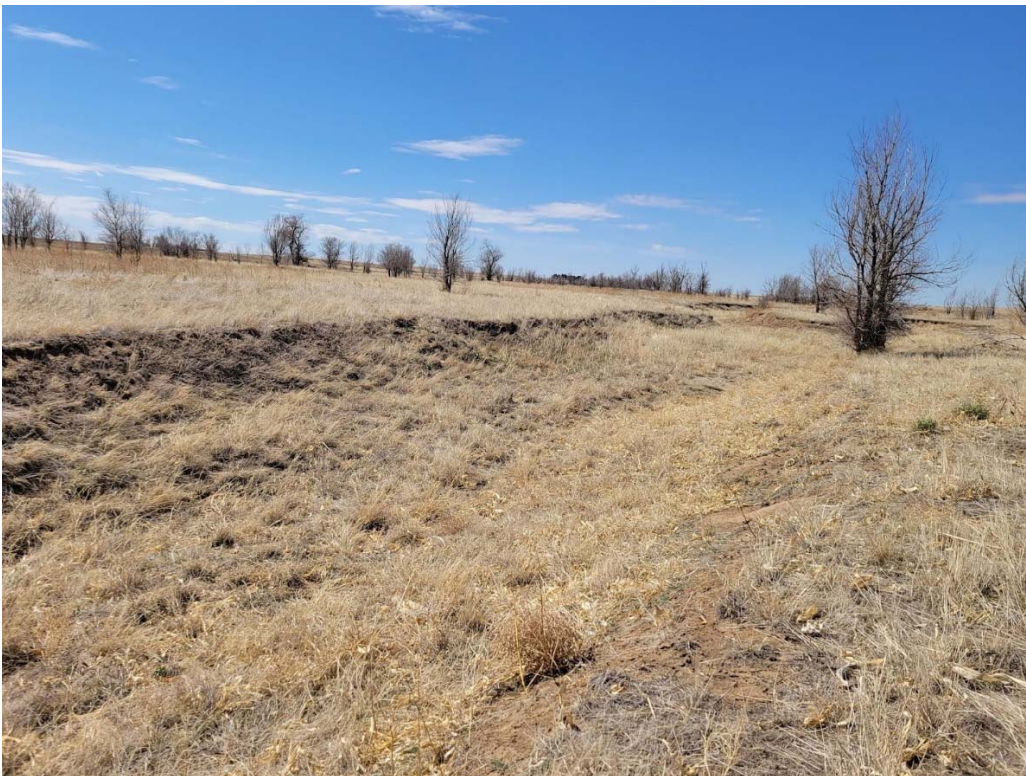
Photo 4: Looking south at ditch located on the south side of the pit. Water flows north into borrow pit.

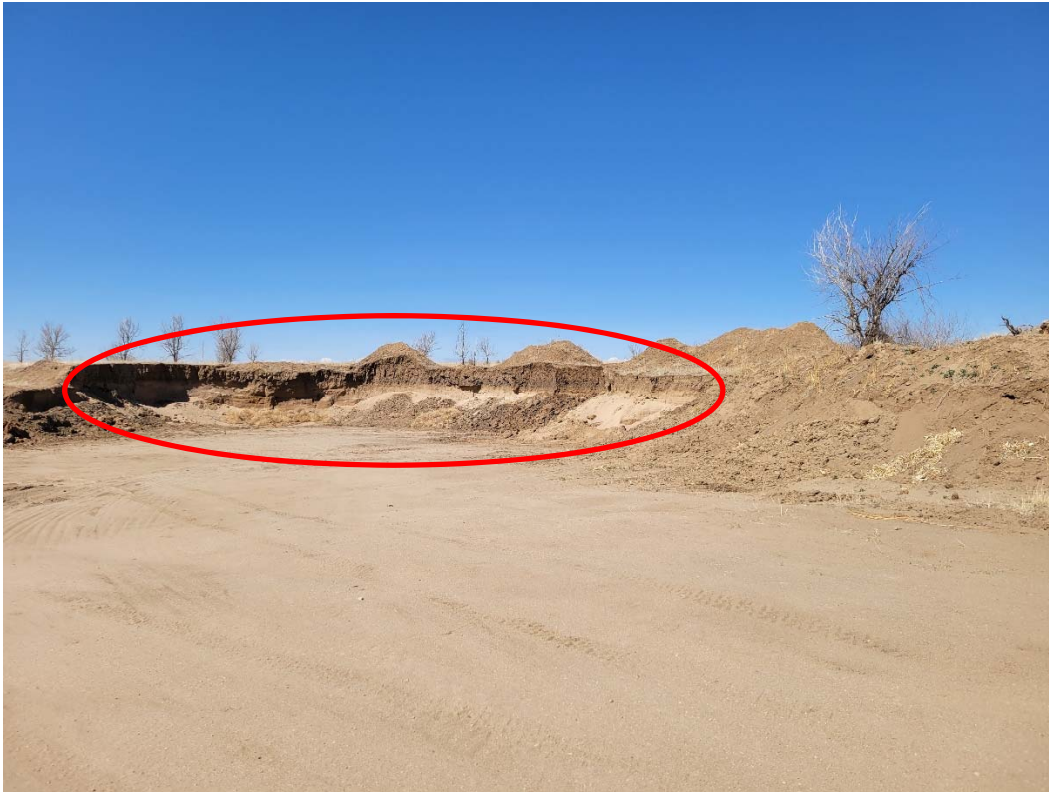
Photo 5: Looking southwest from inside the pit. Red circle indicates area where material was excavated and removed from the site.

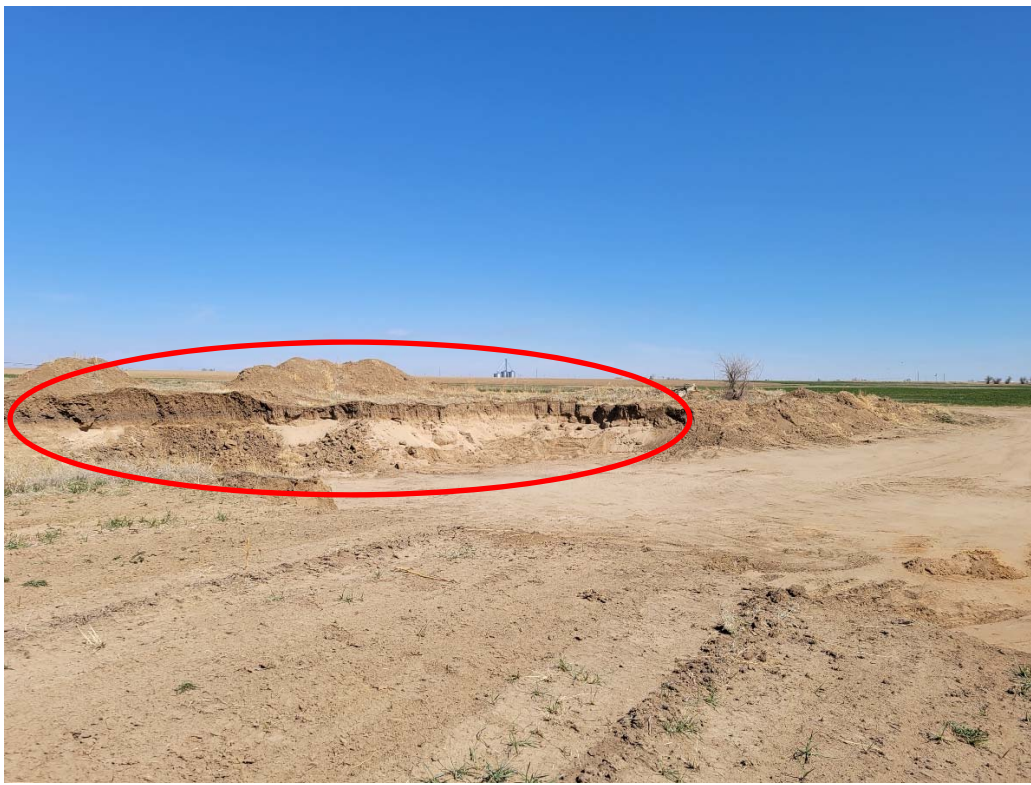
Photo 6: Looking northwest from southern edge of pit. Red circle indicates area where material was excavated and removed from the site.

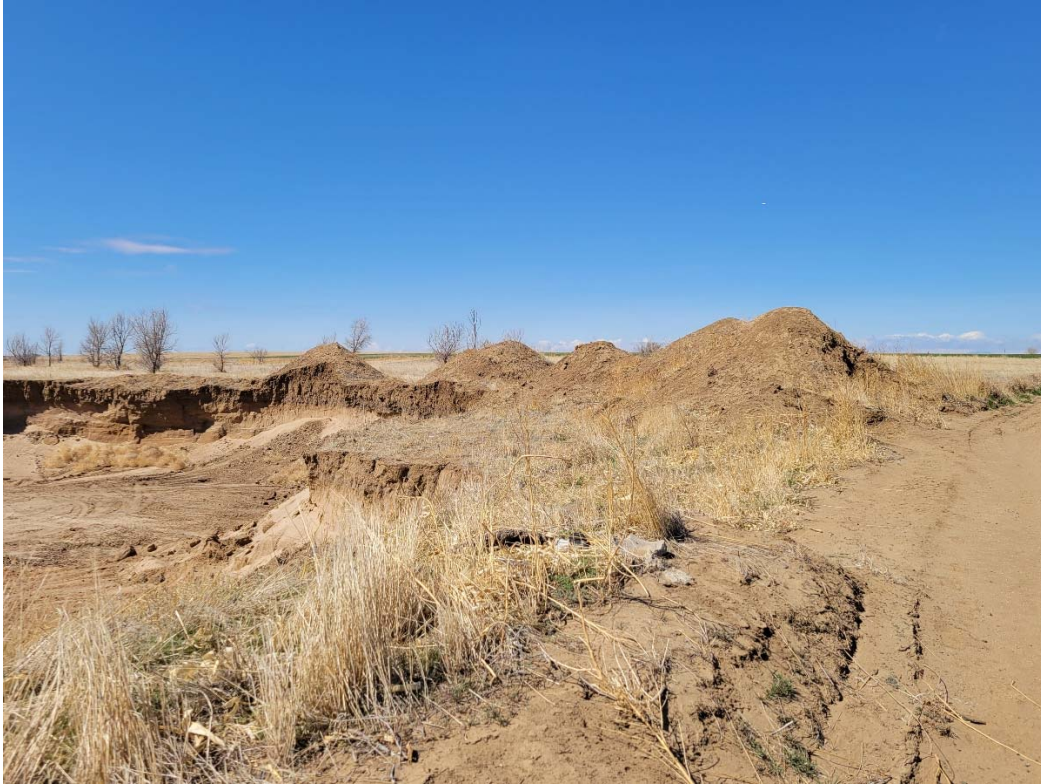
Photo 7: Looking southwest from the road. Stockpiled material along western edge of the pit.

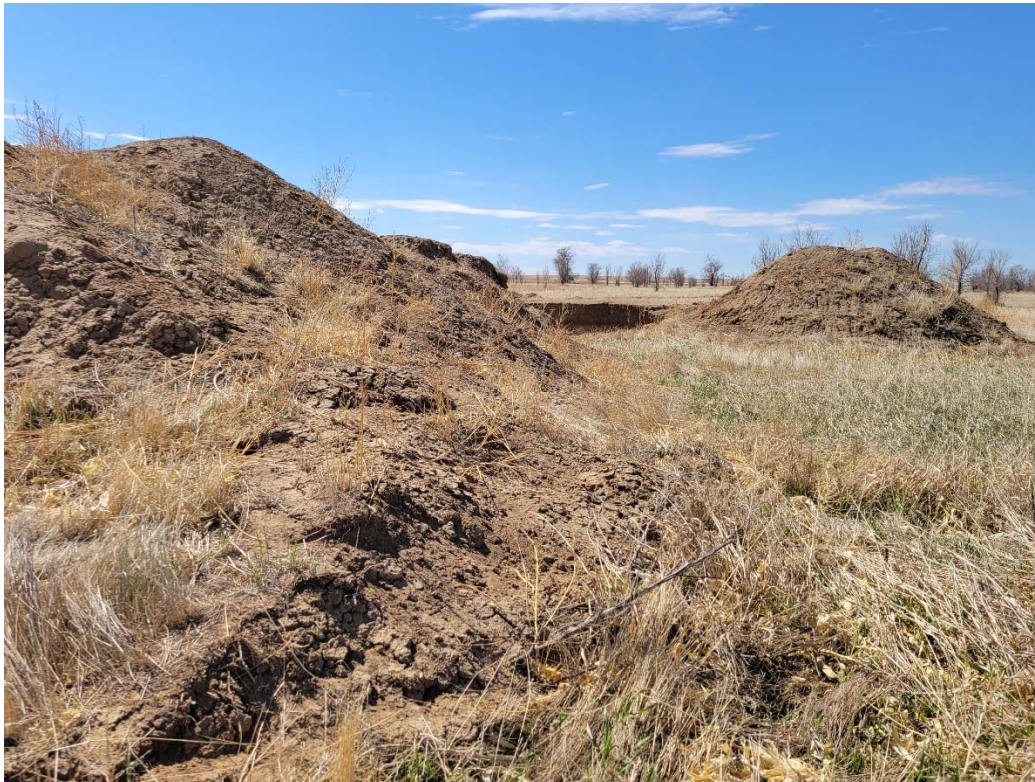
Photo 8: Closer view of stockpiled material along western edge of the pit.

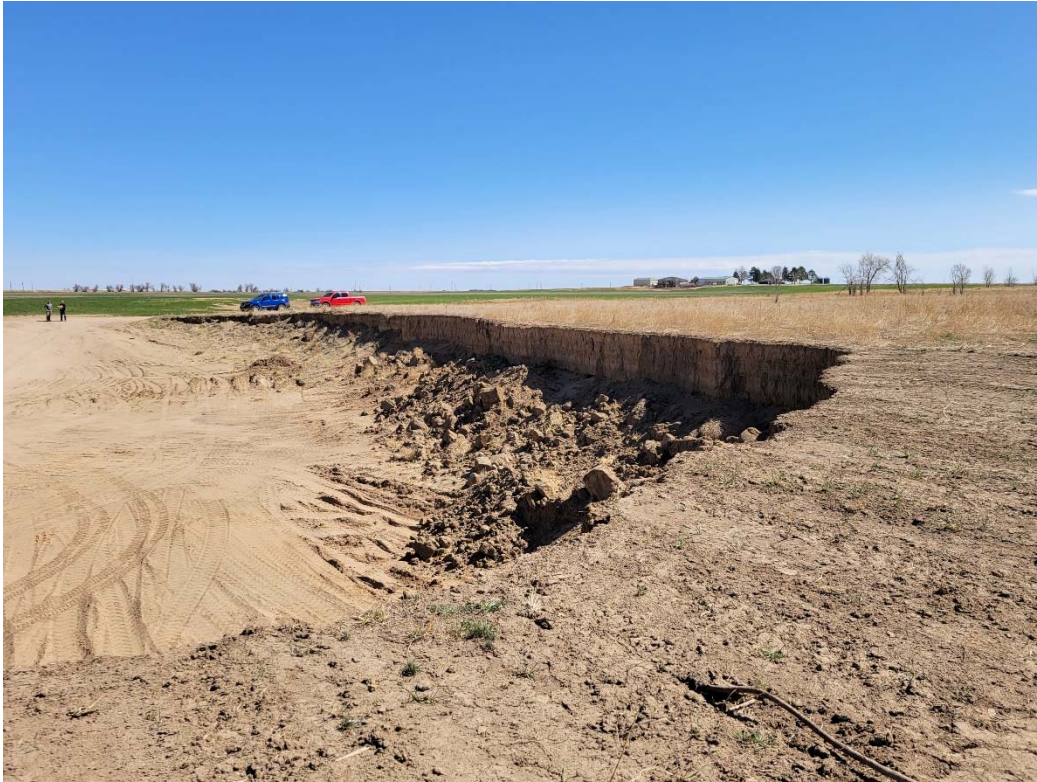
Photo 9: Looking north at the eastern edge of the pit.

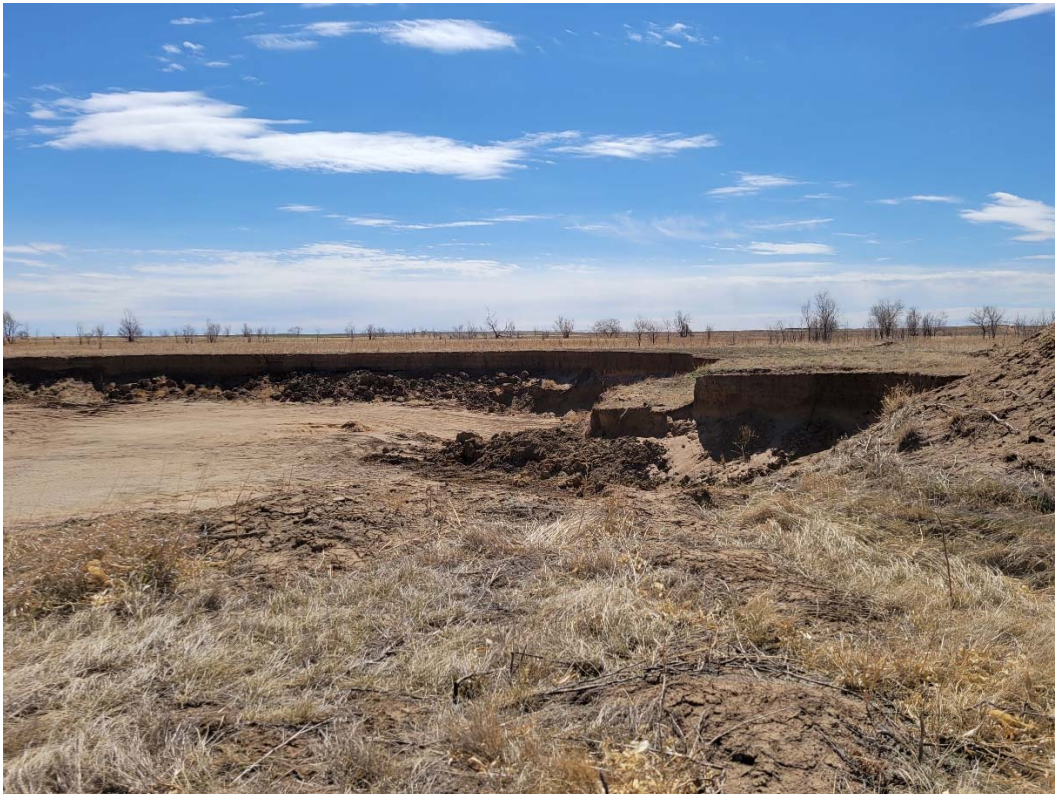
Photo 10: Looking east at the southern wall of the pit.

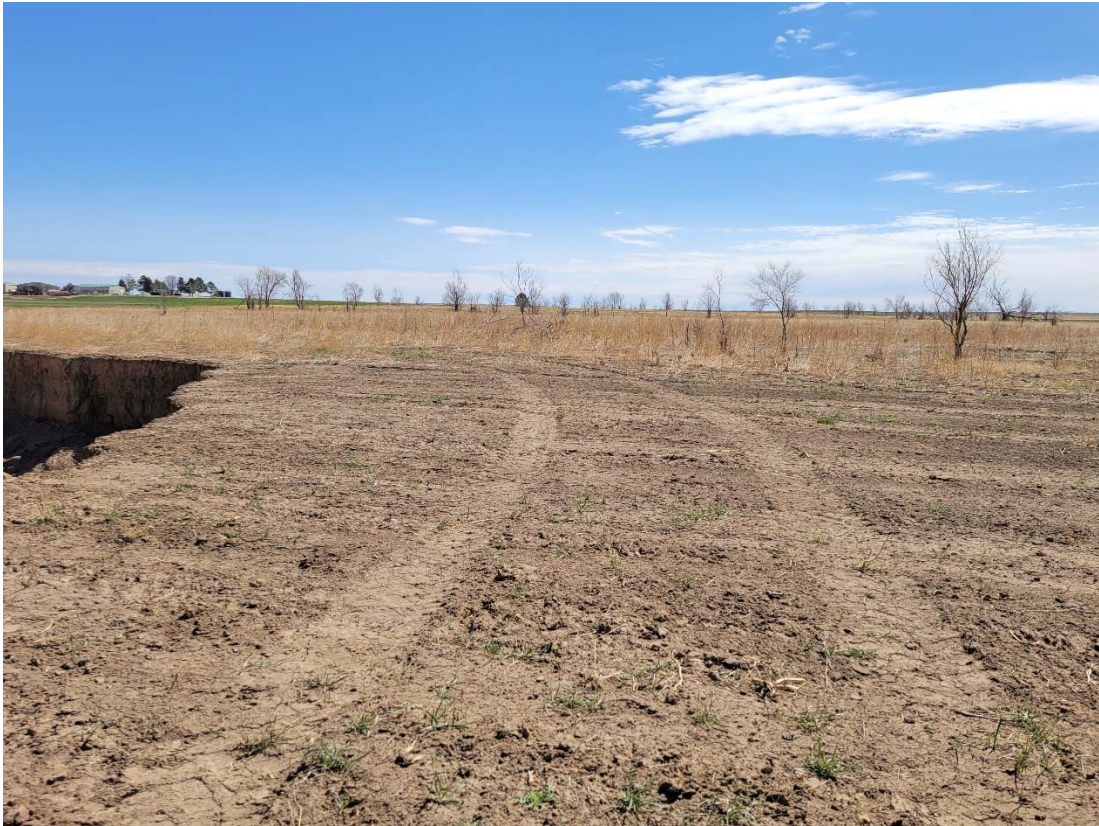
Photo 11: Looking east, previous disturbance above southern highwall of the pit.
