**Response to Citizen Complaint, M-2022-017**

## MINERALS PROGRAM INSPECTION REPORT

<b>MINE NAME:</b> Clayton Homes Pit	<b>MINE/PROSPECTING ID#:</b> M-2022-017	<b>MINERAL:</b> Sand and gravel	<b>COUNTY:</b> Adams
<b>INSPECTION TYPE:</b> Illegal (Unpermitted Operation)	<b>INSPECTOR(S):</b> Nikie Gagnon	<b>INSP. DATE:</b> April 25, 2022	<b>INSP. TIME:</b> 10:00
<b>OPERATOR:</b> Clayton Homes	<b>OPERATOR REPRESENTATIVE:</b> Mike Jansen	<b>TYPE OF OPERATION:</b> ILL - Illegal

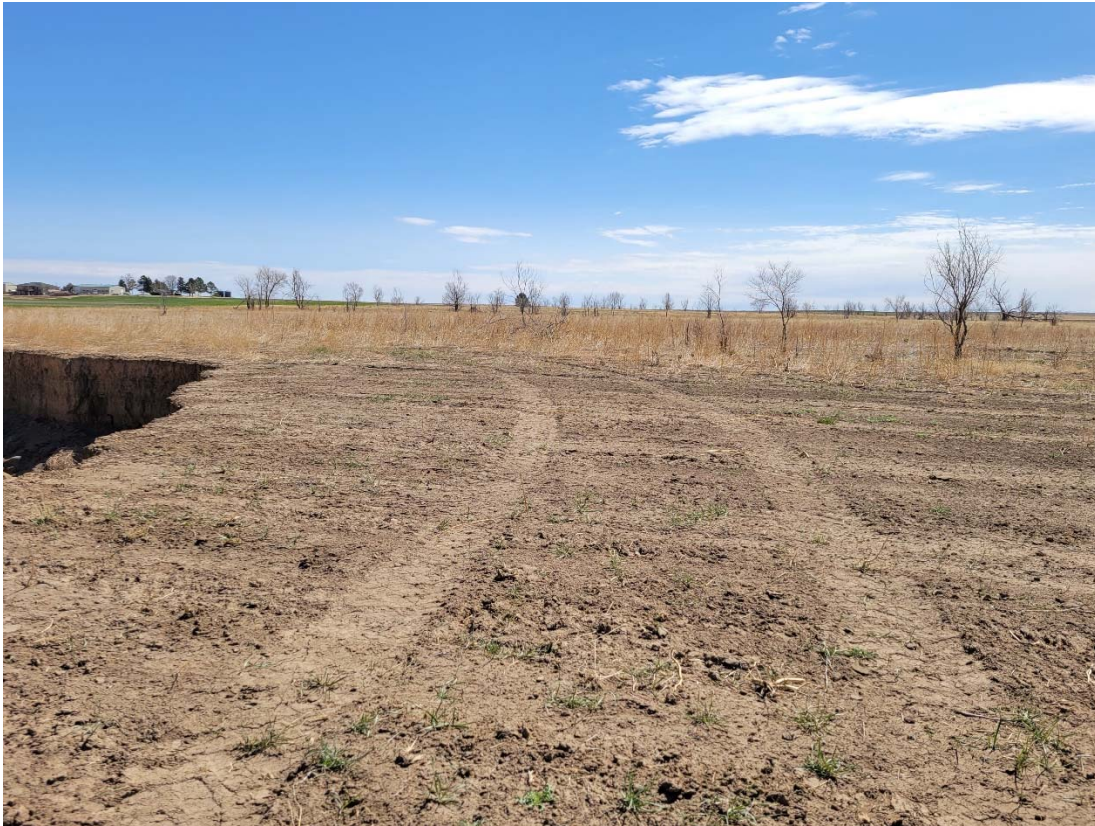
**Photo 11:** Looking east, previous disturbance above southern highwall of the pit.
