PERMIT INFORMATION

Permit Number: C-1981-018 Mine Name: Deserado Mine Operator: Blue Mountain Energy, Inc. Operator Address: Mr. Kurtis Blunt 3607 County Road 65 Rangely, CO, 81648	County: Moffat, Rio Blanco Operation Type: Underground Permit Status: Active Ownership: Private
	Operator Representative Present: Kurt Blunt
Operator Representative Signature: (Field Issuance Only)

Inspection Start Date: April 28, 2022 Inspection Start Time: 10:51 Inspection End Date: April 28, 2022 Inspection End Time: 13:00		Inspection Type: Coal Partial Inspection Inspection Reason: Normal I&E Program Weather: Clear	
Joint Inspection Agency: None		Joint Inspection Contacts: None	
Post Inspection Agency: None		Post Inspection Contacts: None	
Inspector(s): Clayton Wein	Inspector's Signature: <i>Clayton Wein</i>		Signature Date: 5/5/2022

This was a partial inspection of the Deserado Mine conducted on April 28, 2022. The inspection was completed by Clayton Wein of the Division. Kurt Blunt of Blue Mountain Energy (BME) accompanied the inspection. The weather was clear with a temperature of 65 degrees F. The ground conditions were dry.

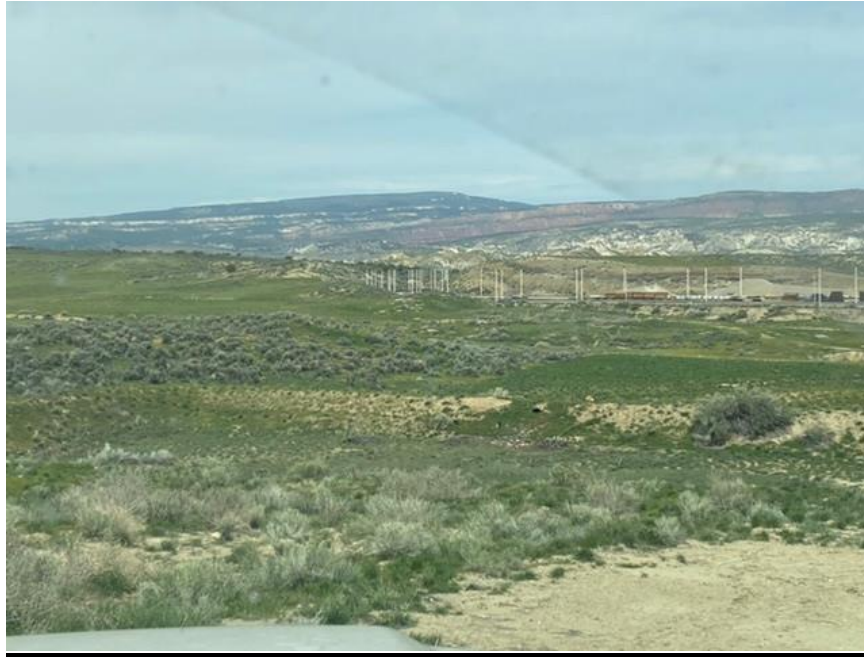
The SS-1 pond and SS-2 pond (Photo 1) are located to the Northeast and northwest of the Slot Storage facility. The SS-1 pond was impounding a small amount of water. There was no discharge from the pond. The embankments were stable with vegetative cover. No erosional features were seen. The SS-2 pond was dry at the

time of the inspection. The outlet of the pond was clear of debris. The embankment was vegetated and stable. There were no indications of erosion.

Photo 1: The SS-2 pond north of the Slot Storage.

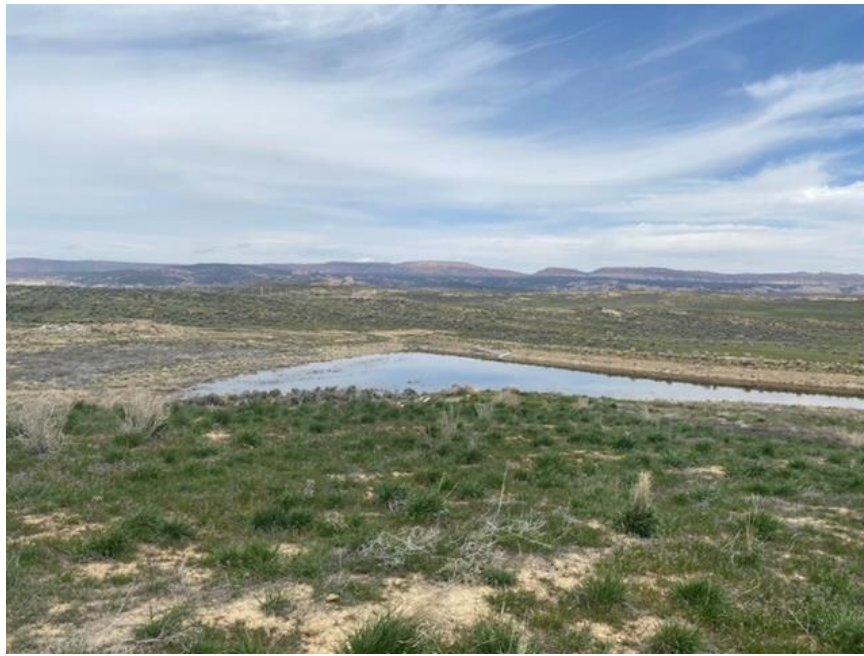
The B Seam Dewatering System #2 was inactive during the inspection. Both the upper and middle cells were holding a small amount of water (Photo 2). There was no discharge from either cell observed. The embankments of the cells were stable with vegetation. The outlets for the cells were clear of debris. No erosional concerns were noted.

Photo 2: The second cell of the B Seam Dewatering System #2.

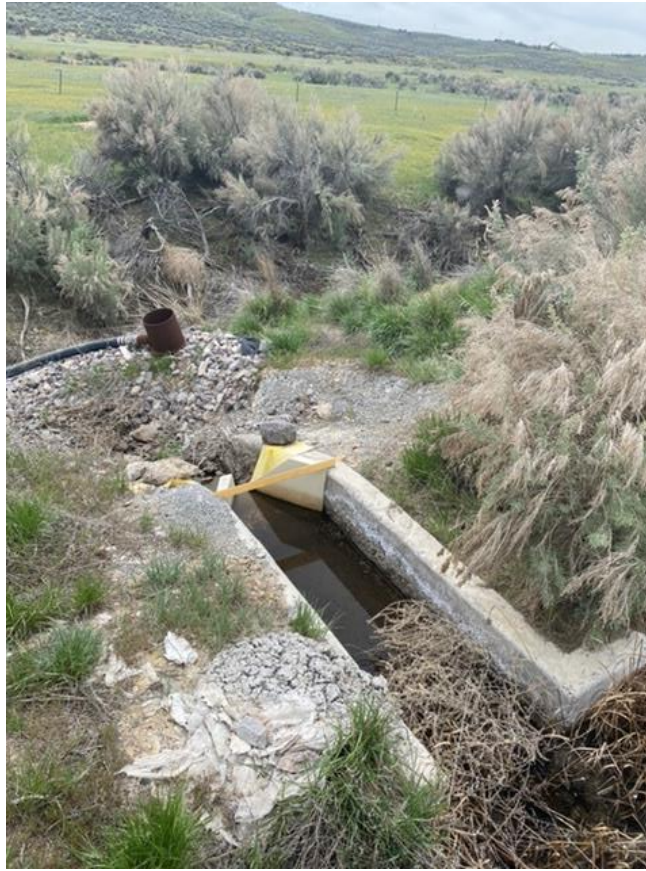
The B Seam Dewatering System #1 was active during the inspection. All cells in the system were impounding water. There was discharge from the Last Chance Pond observed (Photo 3). The concrete outlet and riprap lined channel were in good repair. No blockages were observed. The embankments for the cells were stable with vegetative cover. No erosional features were identified.

Photo 3: The discharge outlet of the Last Chance Pond.

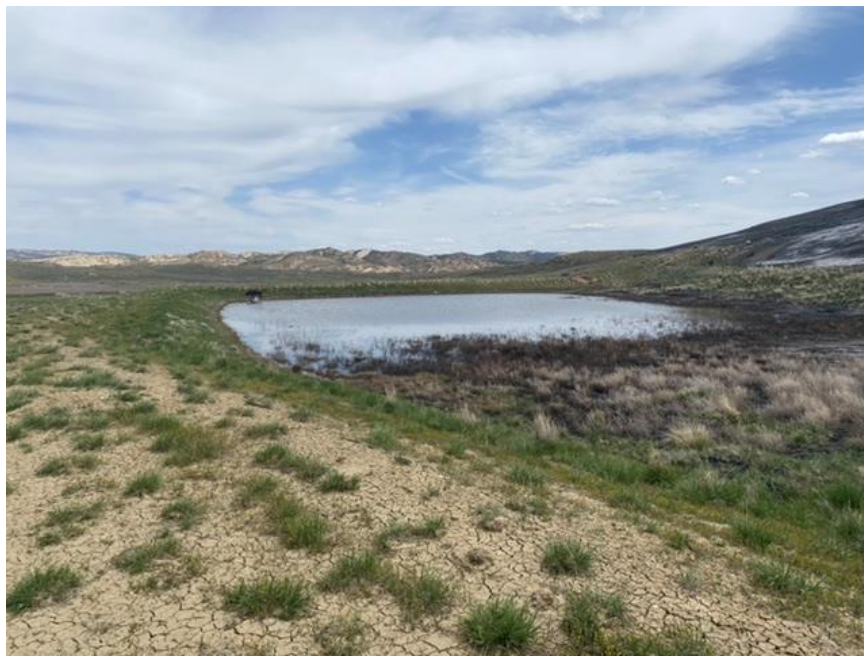
The RP-4 pond is located at the northwestern base of the RP-2/3/4 refuse pile. The pond was holding water, but had not reached the level of the primary spillway (Photo 4). The trash rack on the spillway was clear of debris. The pond's embankment was stable with vegetative cover. There were no indications of erosion.

Photo 4: The RP-4 Pond.

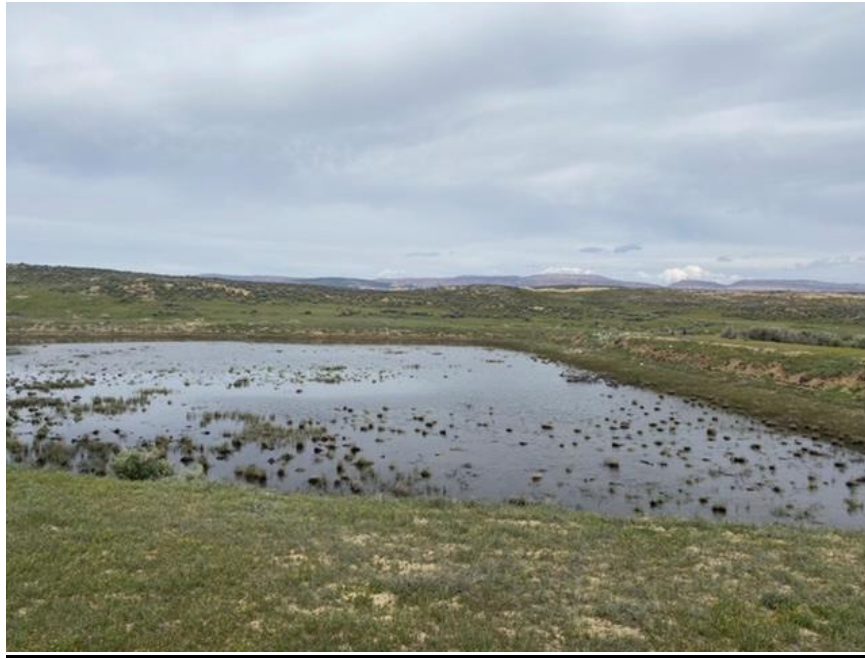
The RP-5 pond is located at the northern base of the RP-5a refuse pile. The pond was also holding water (Photo 5). The level of water impounded in the pond had not reached the primary spillway. The trash rack covering the spillway was clear of debris. The embankment was vegetated and stable. No erosional features were seen.

Photo 5: The RP-5 pond.

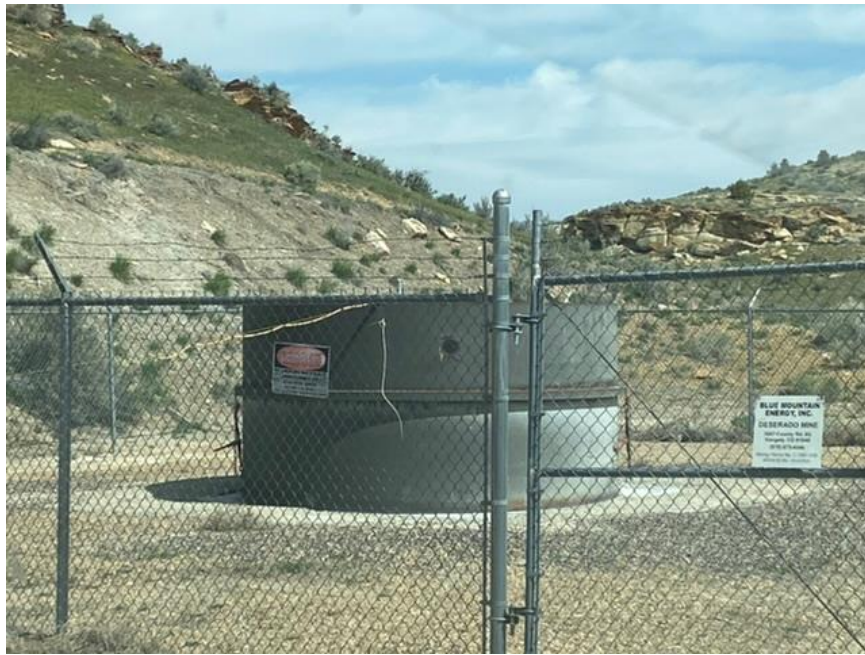
Support Facilities inspected included; the B Vent Shaft No. 1 (Photo 6), RDH-2, the Halandras Landfill, The Slot Storage, the Nitrogen Plant #2, and the conveyor corridor w/ transfer buildings. Pads for the support facilities were in good condition. Only minor ruts were observed at the RDH-2 pad. The berms inspected were stable with vegetative cover. No off-site impacts were observed.

Photo 6: The B Vent Shaft No. 1.
