**MINERALS PROGRAM INSPECTION REPORT**  
**PHONE: (303) 866-3567**

<b>MINE NAME:</b> Bulldog Mine Operation	<b>MINE/PROSPECTING ID#:</b> M-1977-215	<b>MINERAL:</b> Lead and silver	<b>COUNTY:</b> Mineral
<b>INSPECTION TYPE:</b> Monitoring	<b>INSPECTOR(S):</b> Lucas West	<b>INSP. DATE:</b> May 4, 2022	<b>INSP. TIME:</b> 10:15
<b>OPERATOR:</b> Rio Grande Silver, Inc.	<b>OPERATOR REPRESENTATIVE:</b> Randy McClure	<b>TYPE OF OPERATION:</b> 112d-2 - Designated Mining Operation	
<b>REASON FOR INSPECTION:</b> Normal I&E Program	<b>BOND CALCULATION TYPE:</b> None	<b>BOND AMOUNT:</b> \$163,228.13	
<b>DATE OF COMPLAINT:</b> NA	<b>POST INSP. CONTACTS:</b> None	<b>JOINT INSP. AGENCY:</b> None	
<b>WEATHER:</b> Clear	<b>INSPECTOR'S SIGNATURE:</b>

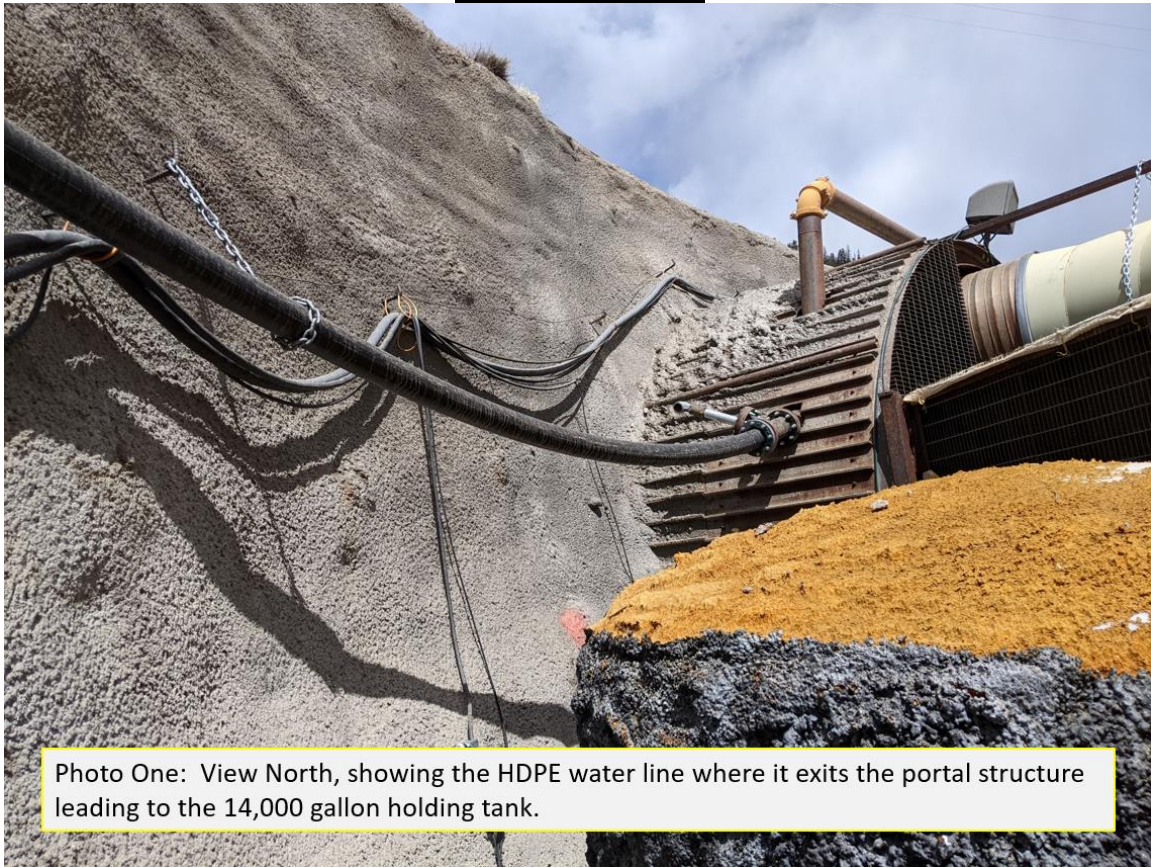
Water will be transferred to the holding tank using pumps located underground. The water will be conveyed through approximately 970 Linear Feet of above ground HDPE piping leading from the 9400 portal, shown in Photo One to the above ground 14,000 gallon red holding tank at the 9360 area. The line crosses the access road to the 9400 level portal underground, the crossing point can be seen in Photo Two. The tank, inlet and outlet piping were observed to be in good condition and can be seen in Photos Three and Four. The tank will be allowed to fill, and is allowed to gravity flow from a pipe located at the top of the tank into the approximately 740 Linear Feet of HDPE pipe leading to the holding pond. The pipes leading from the portal to the 14,000 gallon tank, and from the tank to the pond are in excellent condition and can be seen in Photos Five through Seven. The inlet to the HDPE lined holding pond was observed to be free from obstructions and in good condition. The holding pond has approximately 150,000 gallons of capacity and contained a small amount of water from recent precipitation events. An 8 foot exclusion fence surrounds the pond with an access gate when needed. The pond, and its inlet can be seen in Photo Eight and Nine. From the holding pond, the water will be transferred to water hauling trucks via pump and suction line, and transferred to the HDPE lined holding pond located at TP-2. Once arriving at the unloading location the trucks will hook to the above ground transfer line, unloading into the pond. The pond was observed, having minimal water from snowmelt and recent precipitation events. The liner is in good condition and no evidence of compromise was noted. The unloading area, line and pond can be seen in Photo Ten. All elements of the upcoming dewatering operation were observed to be in excellent condition. Pending the submittal of the Technical Revision the operation appears to be able to function as designed.

Photo One: View North, showing the HDPE water line where it exits the portal structure leading to the 14,000 gallon holding tank.

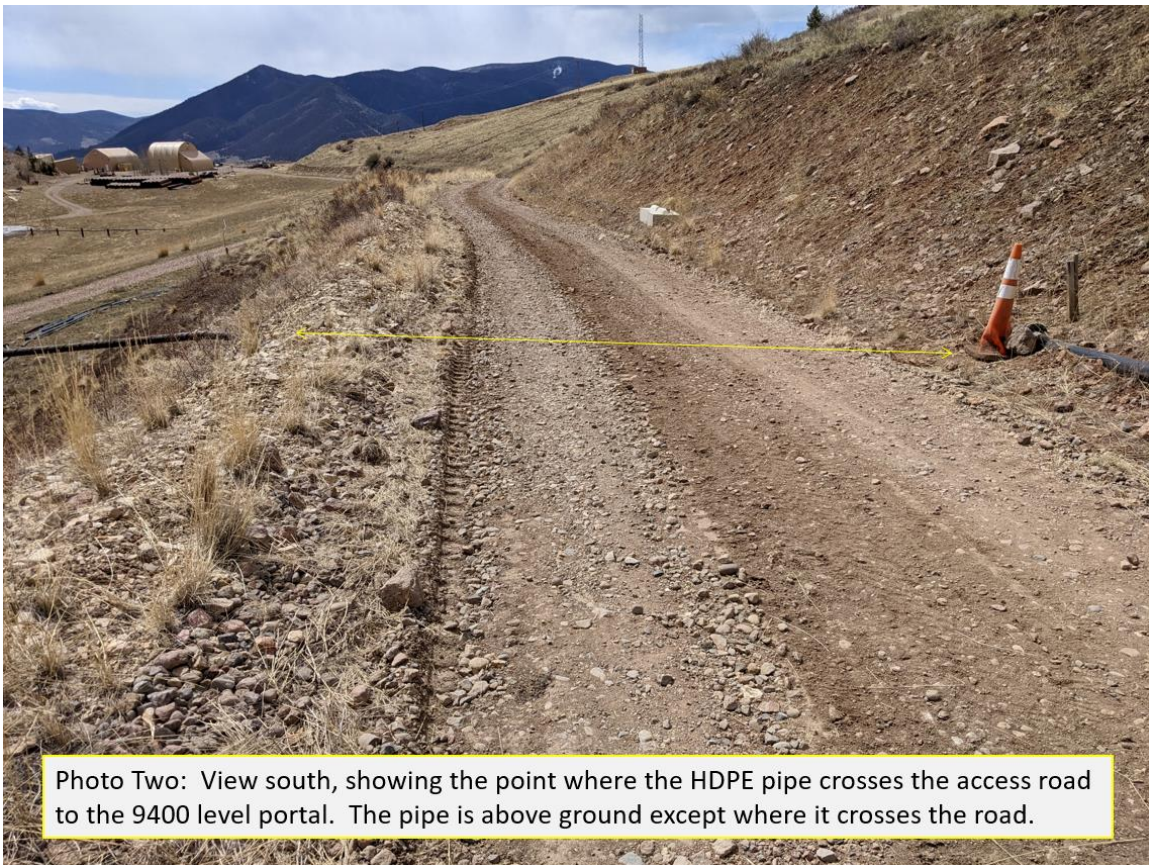
Photo Two: View south, showing the point where the HDPE pipe crosses the access road to the 9400 level portal. The pipe is above ground except where it crosses the road.

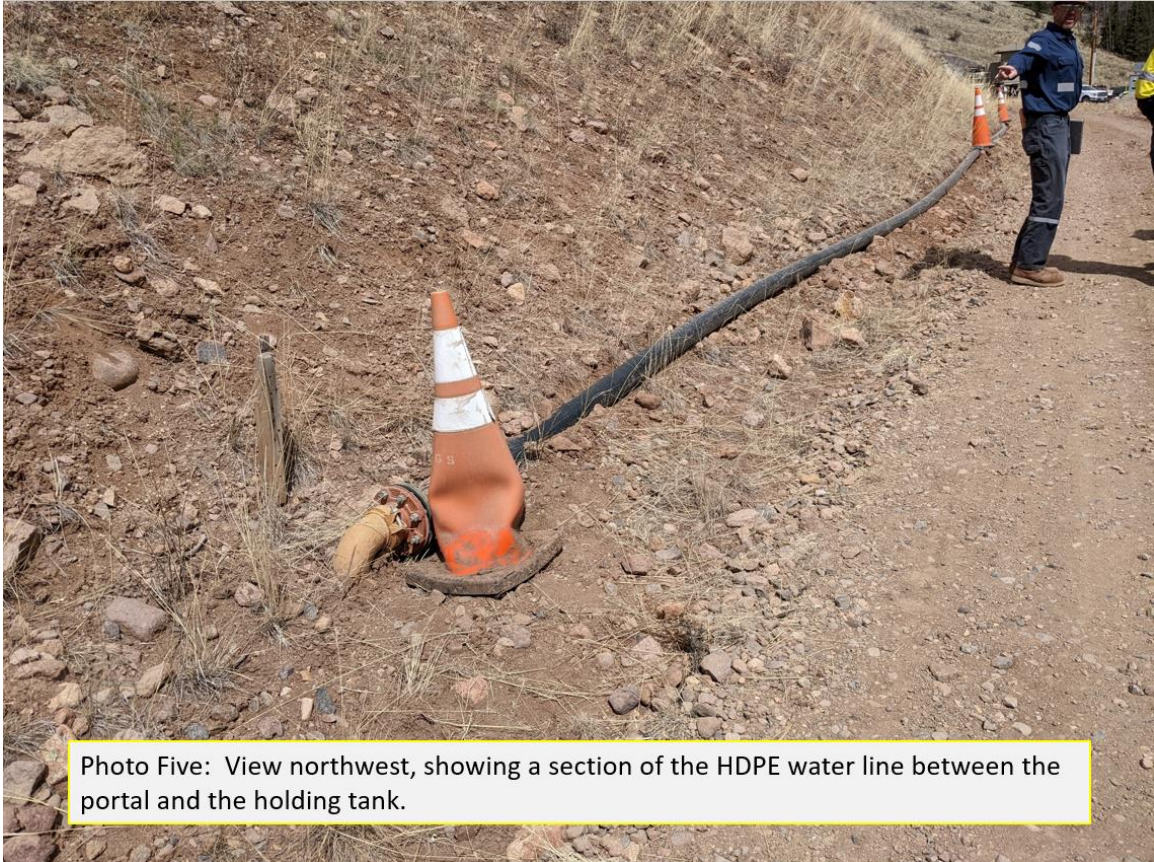
Photo Five: View northwest, showing a section of the HDPE water line between the portal and the holding tank.

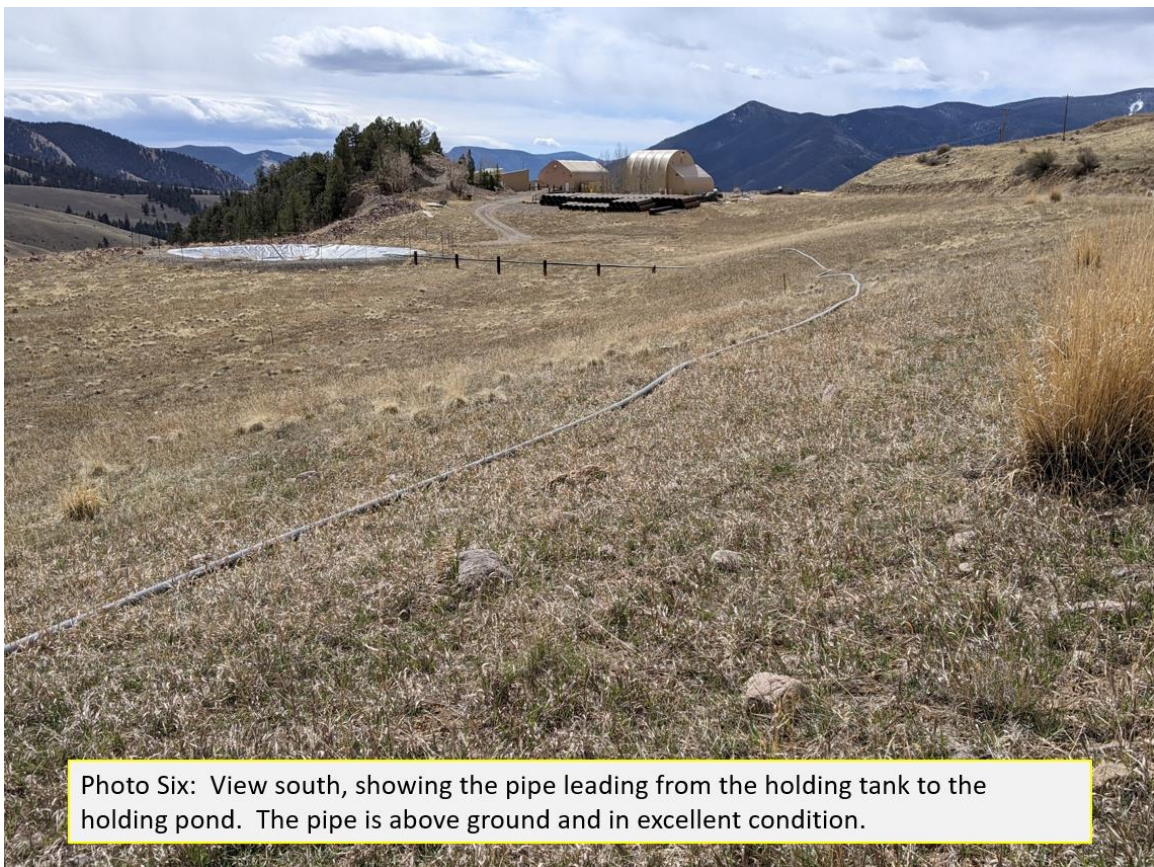
Photo Six: View south, showing the pipe leading from the holding tank to the holding pond. The pipe is above ground and in excellent condition.

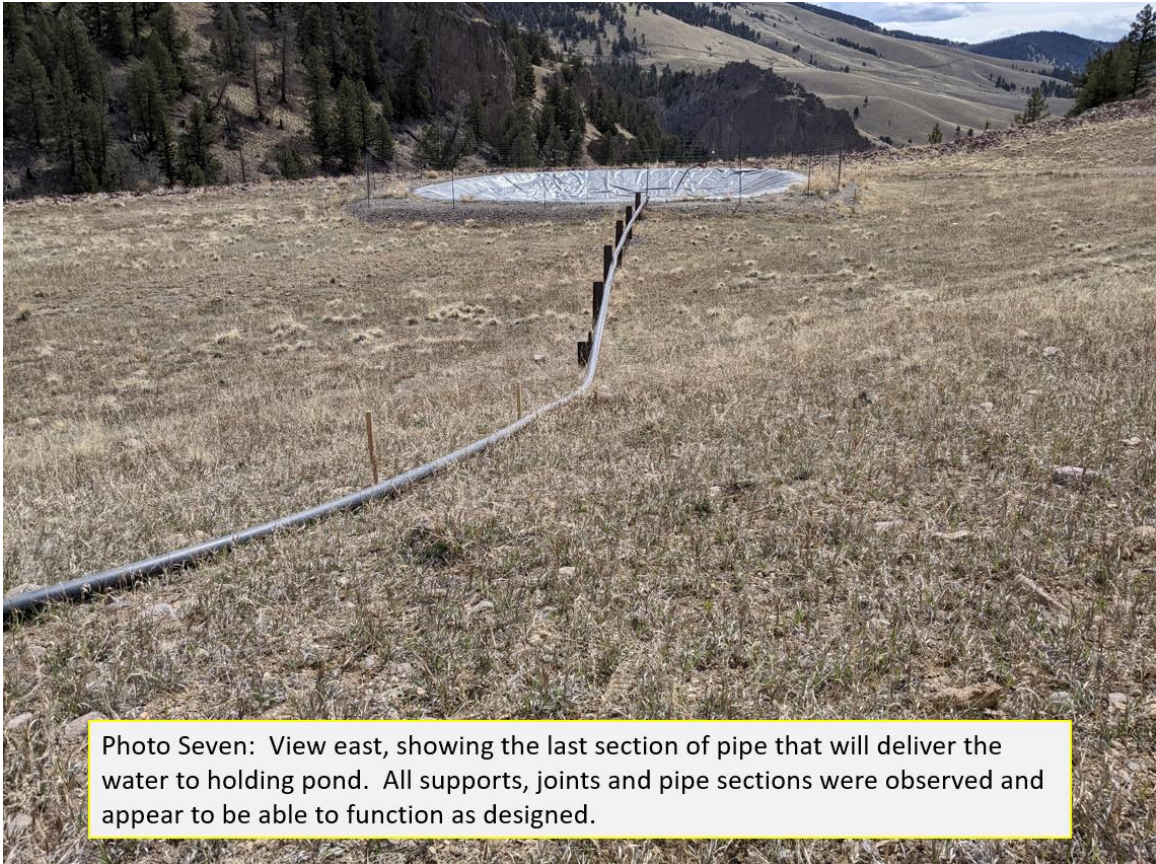
Photo Seven: View east, showing the last section of pipe that will deliver the water to holding pond. All supports, joints and pipe sections were observed and appear to be able to function as designed.

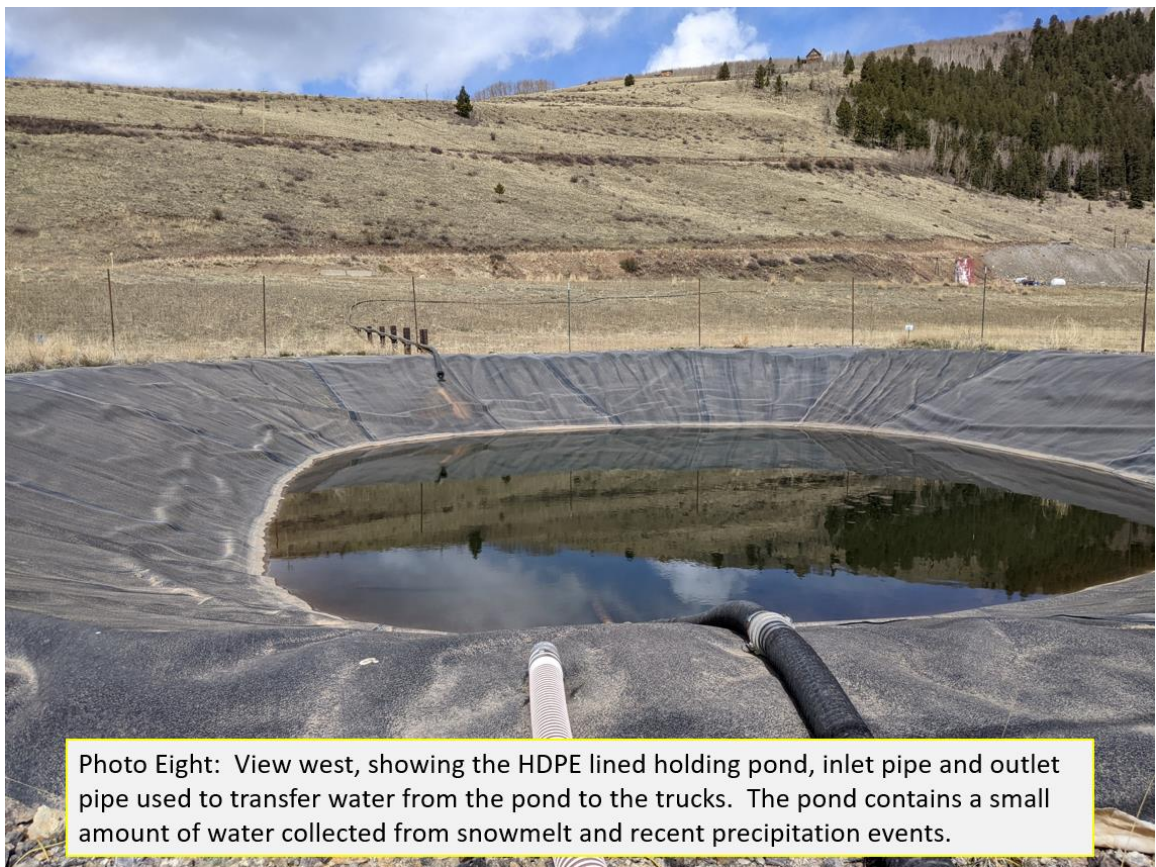
Photo Eight: View west, showing the HDPE lined holding pond, inlet pipe and outlet pipe used to transfer water from the pond to the trucks. The pond contains a small amount of water collected from snowmelt and recent precipitation events.
