MINERALS PROGRAM INSPECTION REPORT

MINE NAME: Miller Midwest	MINE/PROSPECTING ID#: P-2021-004	MINERAL: Unknown commodity	COUNTY: Mineral
INSPECTION TYPE: Monitoring	INSPECTOR(S): Lucas West	INSP. DATE: May 4, 2022	INSP. TIME: 13:15
OPERATOR: GRE, Inc.	OPERATOR REPRESENTATIVE: None	TYPE OF OPERATION: MP - Mineral Prospecting

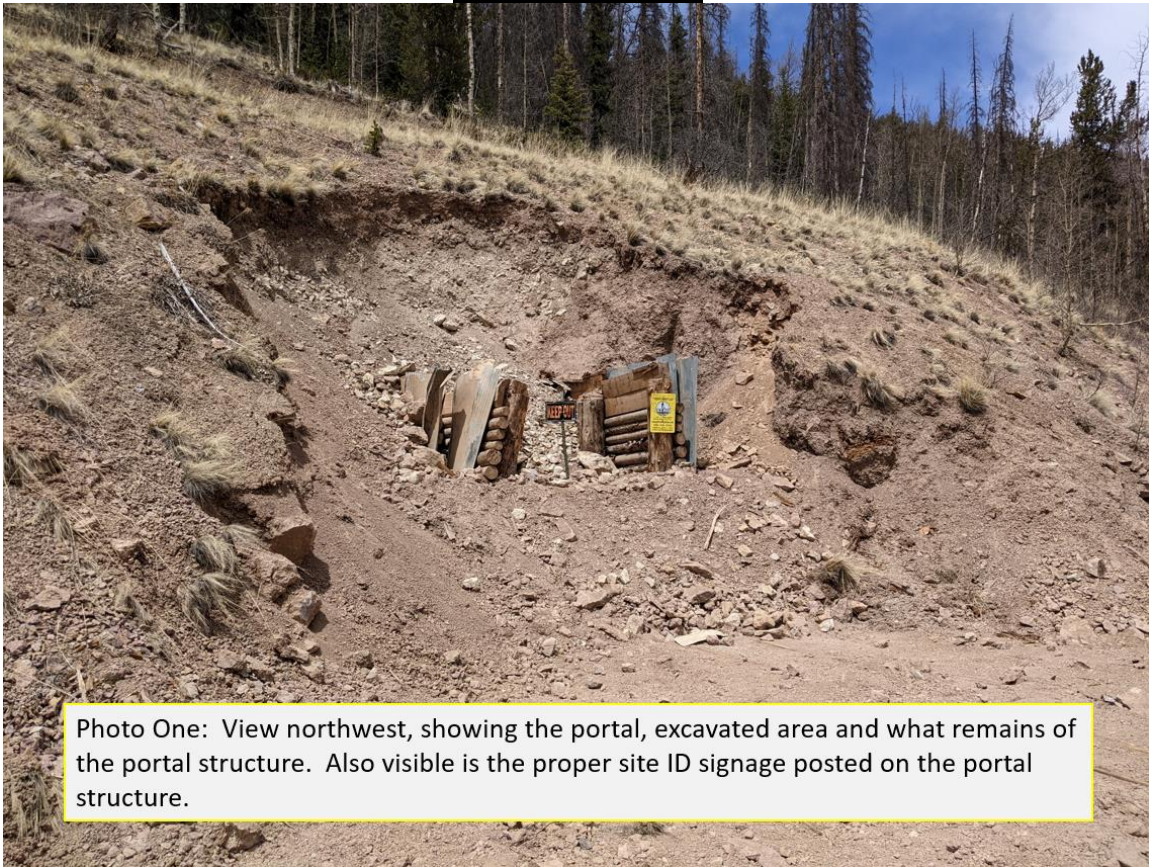
Photo One: View northwest, showing the portal, excavated area and what remains of the portal structure. Also visible is the proper site ID signage posted on the portal structure.

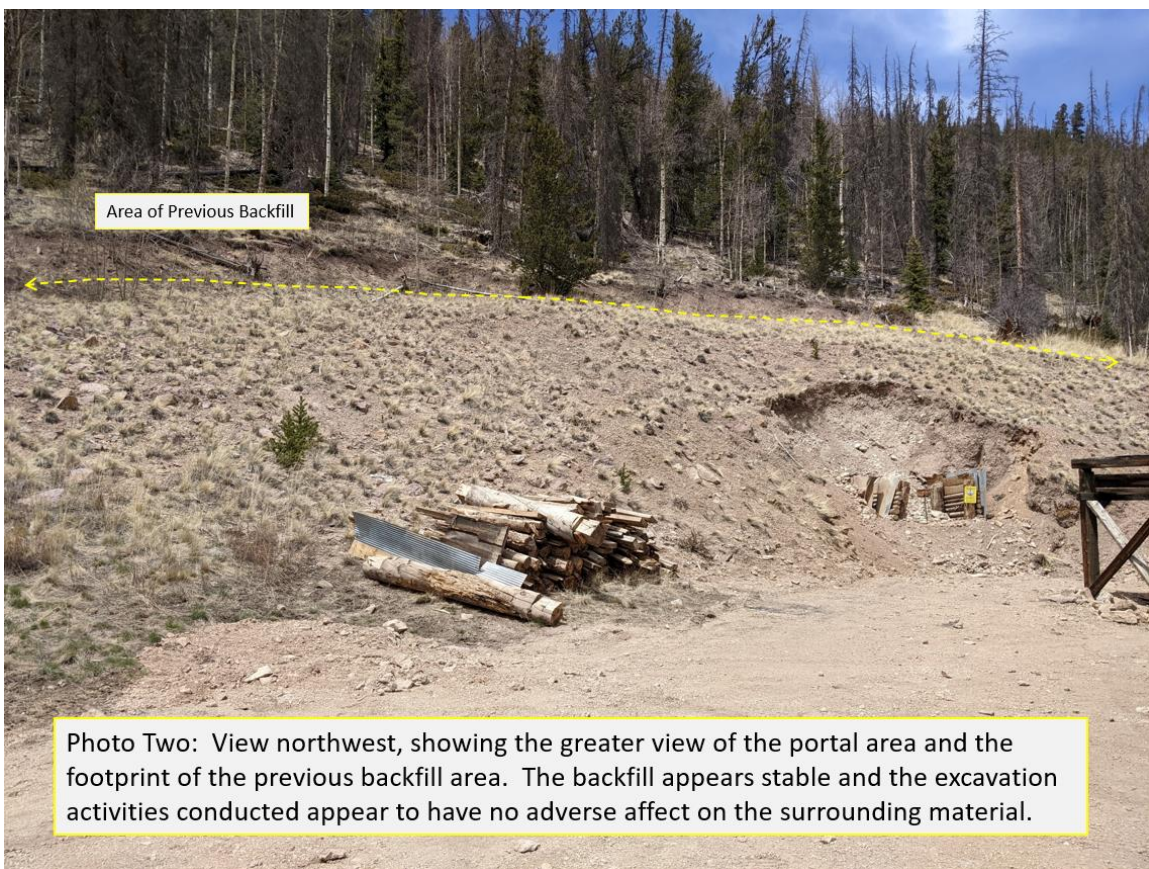
Photo Two: View northwest, showing the greater view of the portal area and the footprint of the previous backfill area. The backfill appears stable and the excavation activities conducted appear to have no adverse effect on the surrounding material.

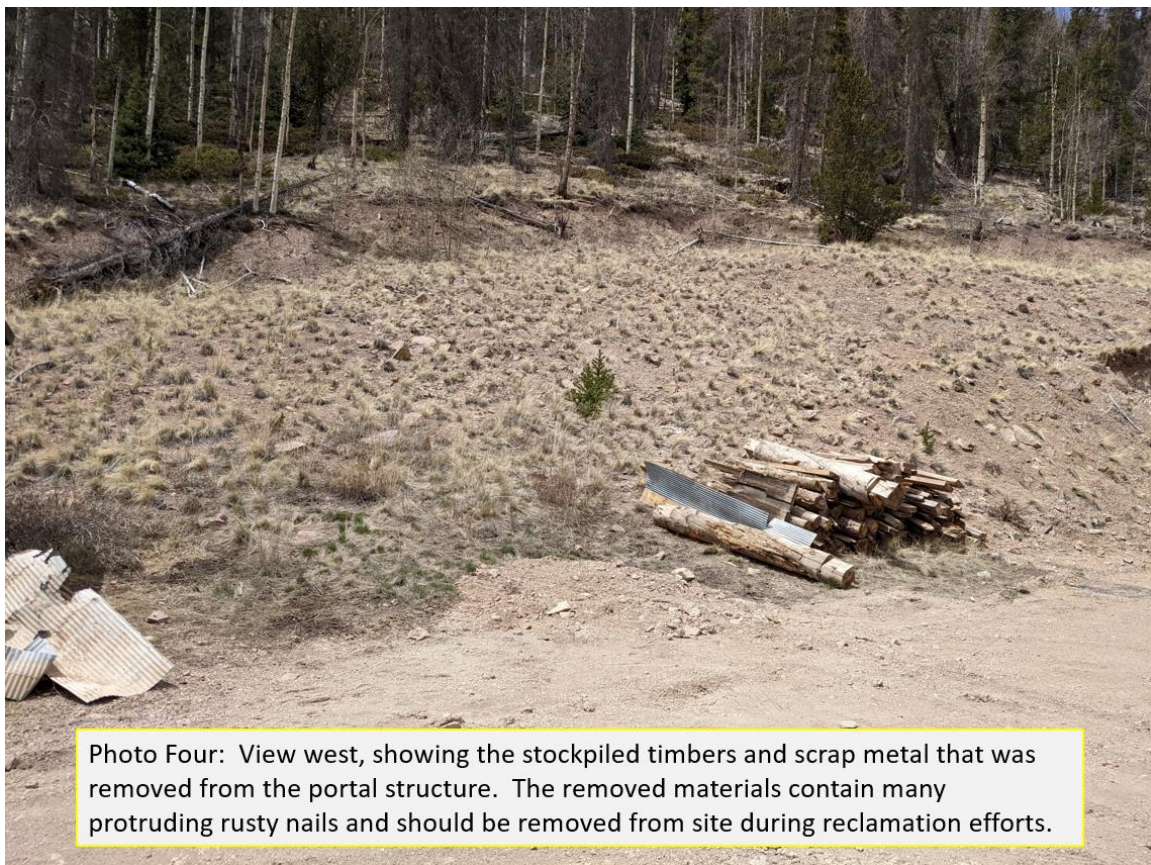
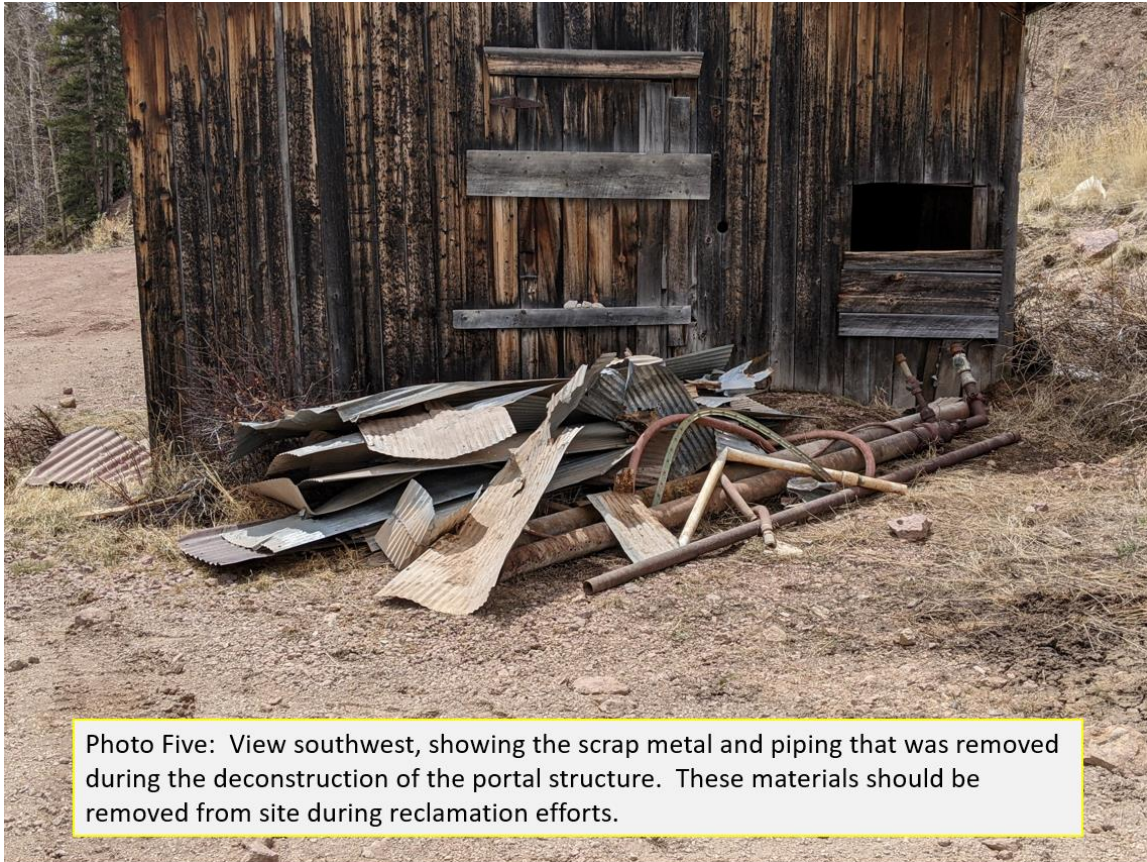
Surrounding the portal are several historic mining structures. The structures were not addressed to have any impact under the approved plan, and remain unaffected. Material removed from the portal structure was stockpiled adjacent to the portal and historic structure and can be seen in Photos Four and Five. The overall footprint of the site is in good condition and free from excessive trash and debris associated with the prospecting operation. No evidence of settling, slumping or erosion was noted throughout the site.
