MINERALS PROGRAM INSPECTION REPORT
PHONE: (303) 866-3567

MINE NAME: Achieve More Agricultural Complex Site	MINE/PROSPECTING ID#: M-2021-024	MINERAL: Borrow material for	COUNTY: Weld
INSPECTION TYPE: Monitoring	INSPECTOR(S): Peter Hays	INSP. DATE: April 7, 2022	INSP. TIME: 10:00
OPERATOR: New Vision Investments, LLC	OPERATOR REPRESENTATIVE: Dan LaCoe	TYPE OF OPERATION: 111(1)(b) - Special One-Time Incidental

REASON FOR INSPECTION: Citizen Complaint	BOND CALCULATION TYPE: None	BOND AMOUNT: \$75,000.00
DATE OF COMPLAINT: NA	POST INSP. CONTACTS: None	JOINT INSP. AGENCY: None
WEATHER: Windy	INSPECTOR'S SIGNATURE:

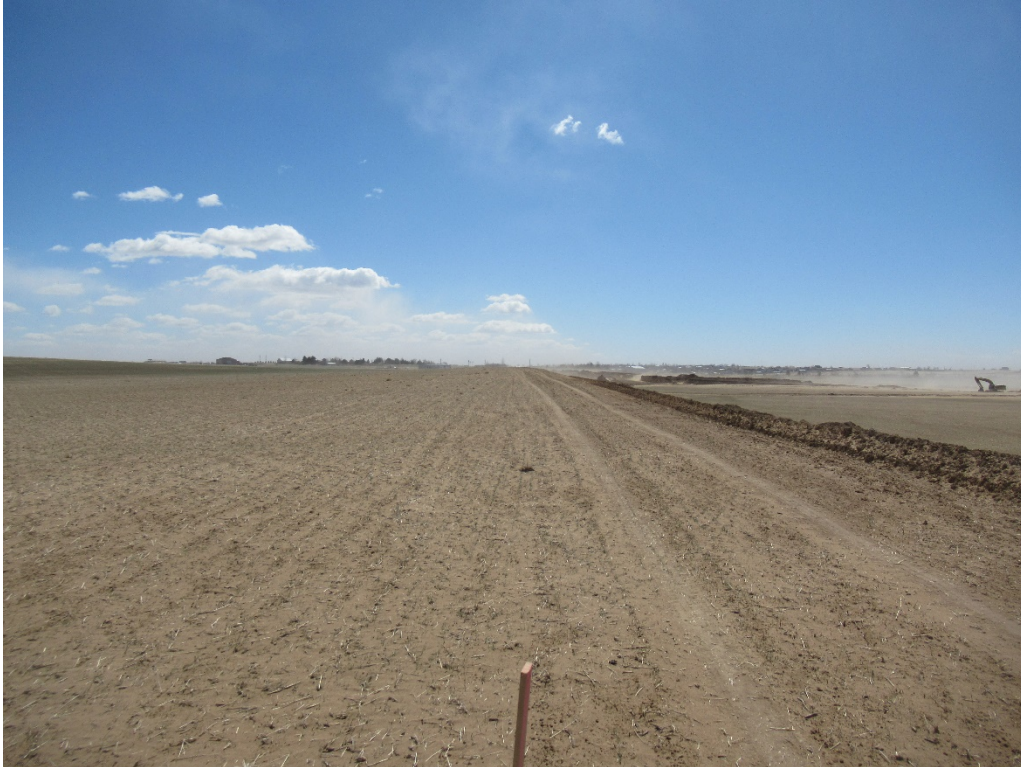
View of Mining Area "B" from the west side looking southeast

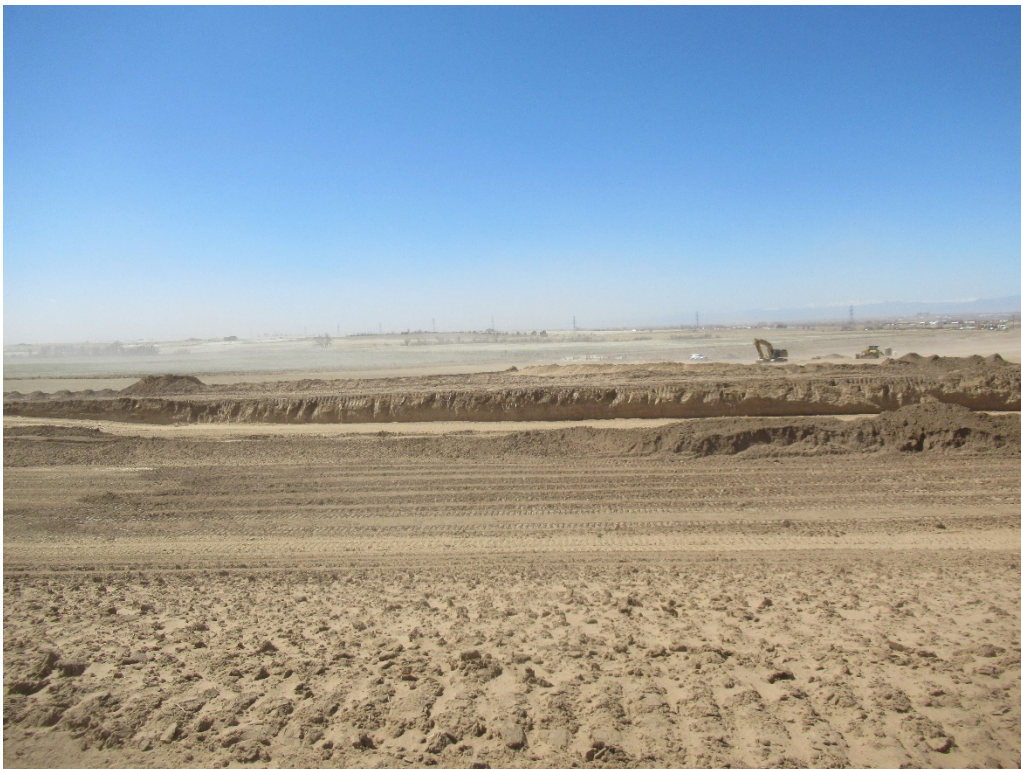
View of the excavation activity in the southeast corner of Mining Area "B" from the north side looking southwest

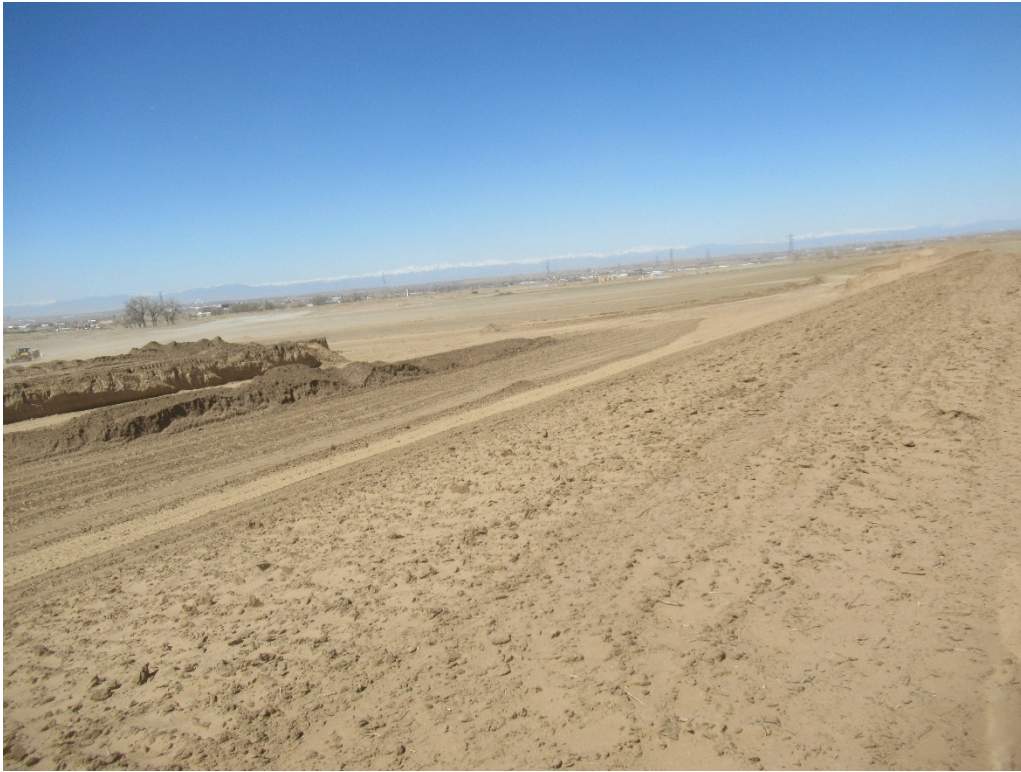
View of Mining Area "B" from the northeast side looking southwest

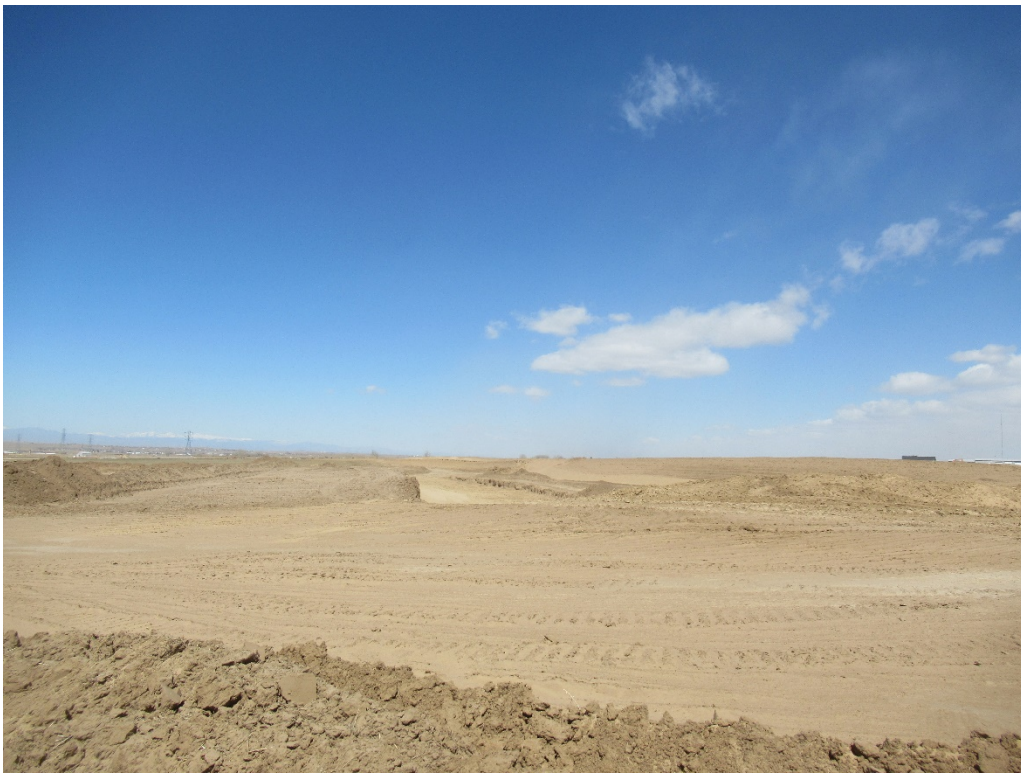
View of the excavation activity in the southeast corner of Mining Area "B" from the south side looking north

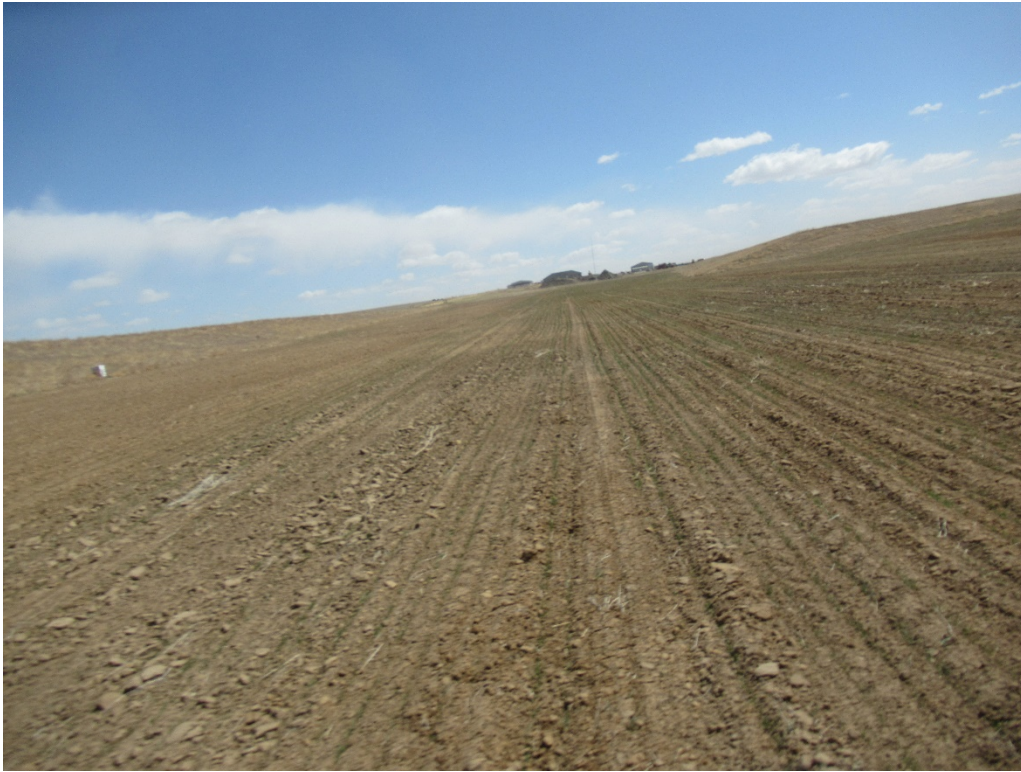
View of Mining Area "A" from the west side looking east

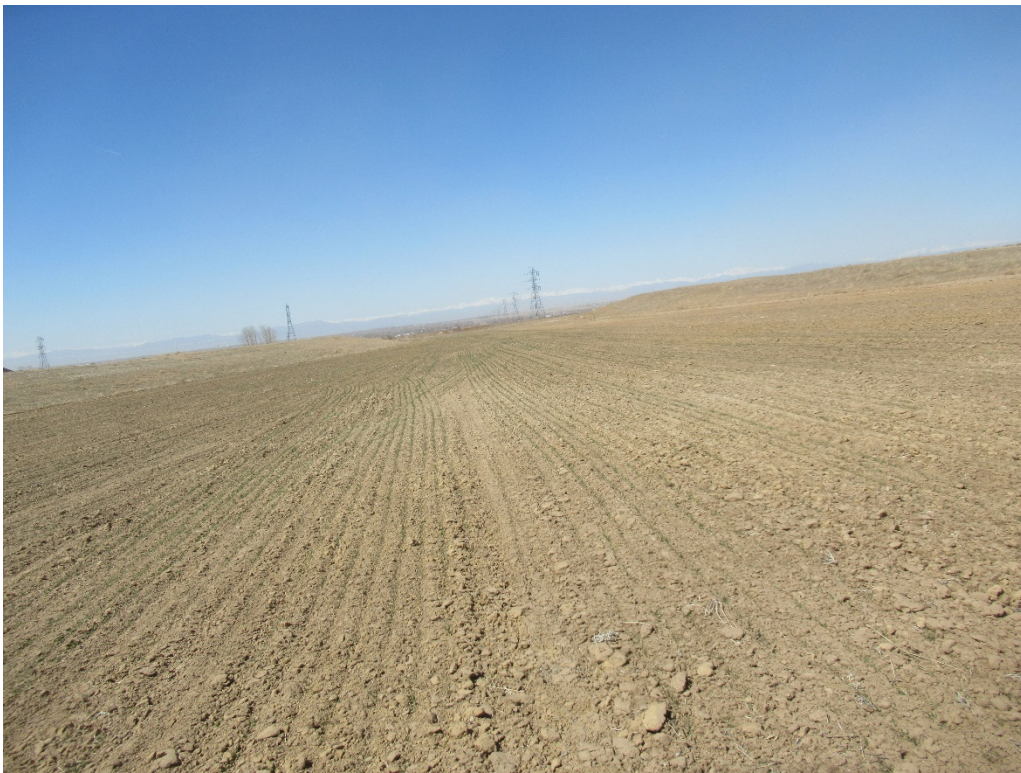
View of Mining Area "A" from the east side looking west
