MINERALS PROGRAM INSPECTION REPORT PHONE: (303) 866-3567

MINE NAME:		MINE/PROSPECTING ID#:	MINERAL:	COUNTY:
Barnard Quarry		M-1996-079	Sandstone	Boulder
INSPECTION TYPE:		INSPECTOR(S):	INSP. DATE:	INSP. TIME:
Monitoring		Patrick Lennberg	April 27, 2022	09:30
OPERATOR:		OPERATOR REPRESENTATIVE:	TYPE OF OPERATION:	
Barnard Quarry, LLC		Sherri Gerhardt	110c - Construction Limited Impact	
	Ī		1	
REASON FOR INSPECTION:		BOND CALCULATION TYPE:	BOND AMOUNT:	
Normal I&E Program		Complete Bond	\$22,000.00	
DATE OF COMPLAINT:		POST INSP. CONTACTS:	JOINT INSP. AGENCY:	
NA		None	None	
WEATHER:	INSPECTOR'S SIGNATURE:		SIGNATURE DATE:	
Clear	Patrick So		May 9, 2022

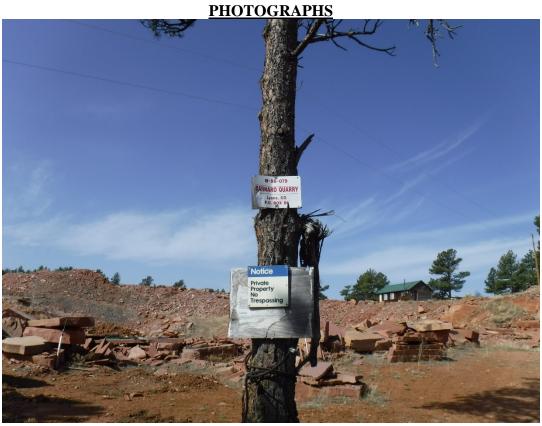
This is a 110c operation permitted for 9.9 acres. The permit is to mine sandstone for building materials and decorative use. The mine is located on property owned by Barnard Quarry, LLC. The mine is located in Boulder County. The site entrance is located 2.5 miles north of Lyons, CO. The approved post-mining land use wildlife habitat. A mine sign was posted at the mine entrance pursuant to Rule 3.1.12.

Photo 1: Mine sign at the primary mine entrance

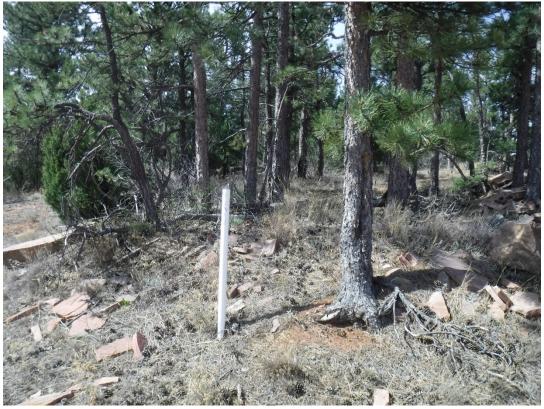
Photo 2: Typical mine permit boundary marker

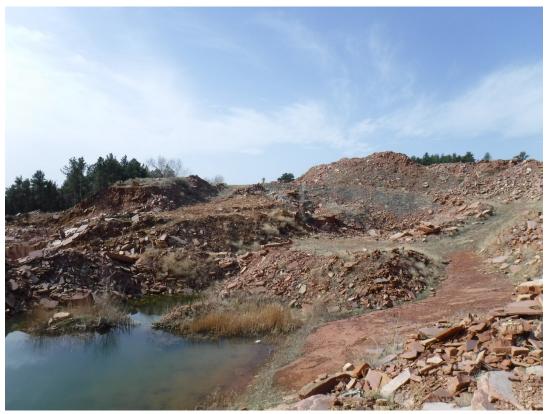
It does not appear the site has been active for number of years. There are two pits, a main pit located in the northeastern corner of the permit area and another small depression towards the center of the permit area along the western boundary. The main pit has standing water that pre-dates the permit and is sampled twice a month with sample results submitted to the state. It appears the permit to the east, Beech Hills Quarries M1981-277, has mined into Barnard Quarry permit area. Beech Hills is operated by Loukonen Brothers Stone Company and would need to demonstrate legal right of entry to mine on the Barnard Quarry site.

Photo 3: Northeastern quarry area

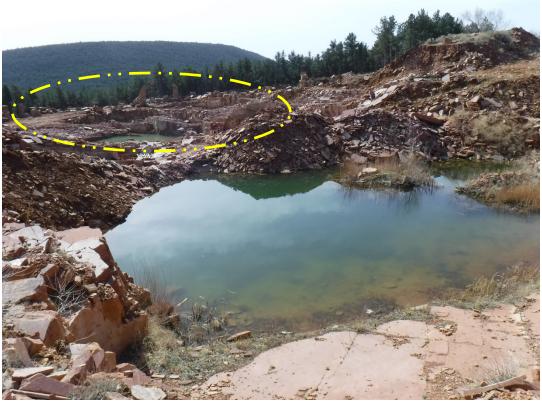
Photo 4: Northeastern quarry area looking east, Beech Hills Quarry area marked in yellow

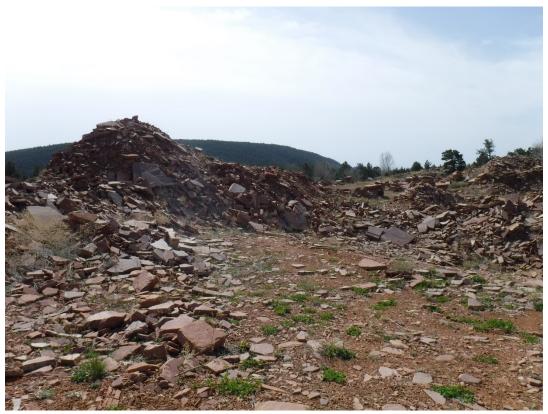
Photo 5: Typical overburden pile located between the two quarry areas

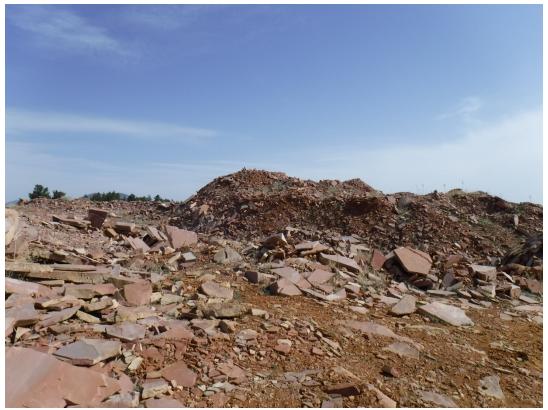
Photo 6: Typical overburden pile located between the two quarry areas

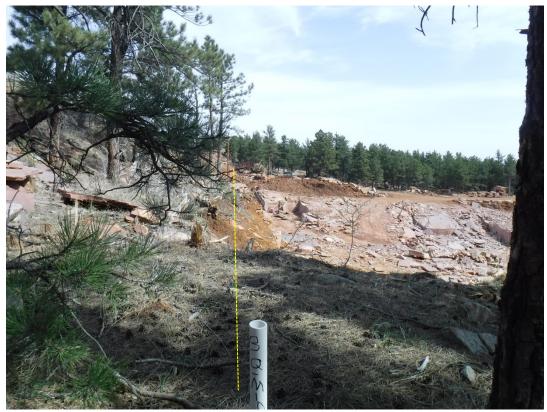
Photo 7: Looking north from near the mid-point of eastern permit boundary, Beech Hills Quarry to the right of picture, approximate property boundary marked in yellow

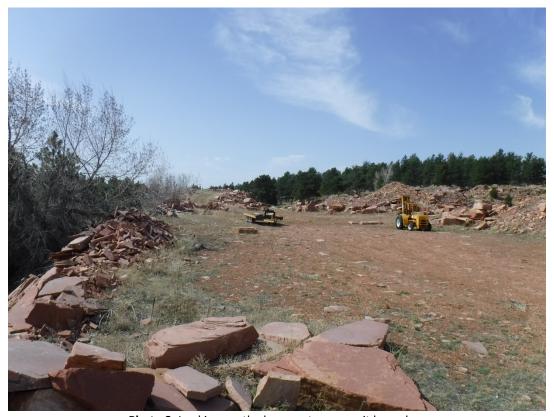
Photo 8: Looking south along eastern permit boundary

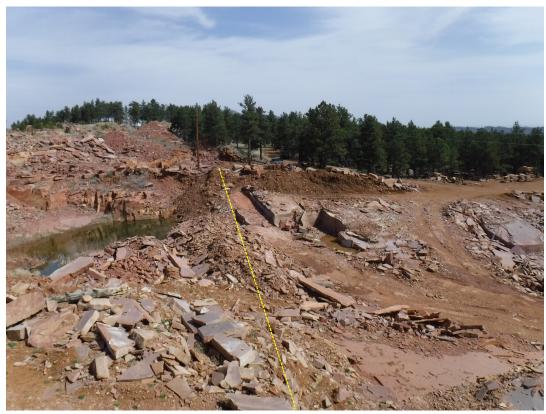
Photo 9: Looking north from near the mid-point of eastern permit boundary, Beech Hills Quarry to the right of picture, approximate property boundary marked in yellow

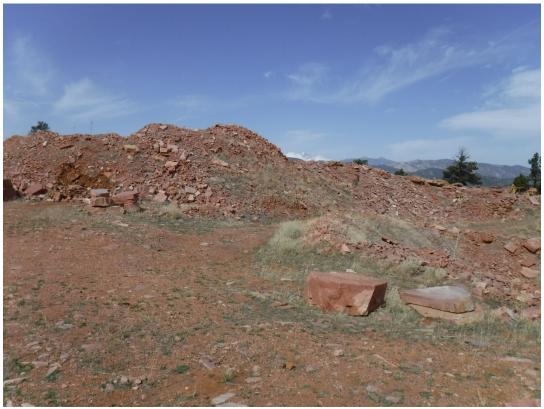
Photo 10: Overburden stockpile south of main pit area
