MINERALS PROGRAM INSPECTION REPORT

MINE NAME: Quagmire Creek	MINE/PROSPECTING ID#: M-1990-047	MINERAL: Gravel	COUNTY: Fremont
INSPECTION TYPE: Surety Release Inspection	INSPECTOR(S): Timothy Cazier, P.E.	INSP. DATE: April 20, 2022	INSP. TIME: 11:10
OPERATOR: Fremont County	OPERATOR REPRESENTATIVE: Sterling Rife	TYPE OF OPERATION: 110c - Construction Limited Impact	
REASON FOR INSPECTION: Surety Release Requested	BOND CALCULATION TYPE: None	BOND AMOUNT: \$0.00	
DATE OF COMPLAINT: NA	POST INSP. CONTACTS: U.S.BLM	JOINT INSP. AGENCY: U.S.BLM	
WEATHER: Clear	INSPECTOR'S SIGNATURE:

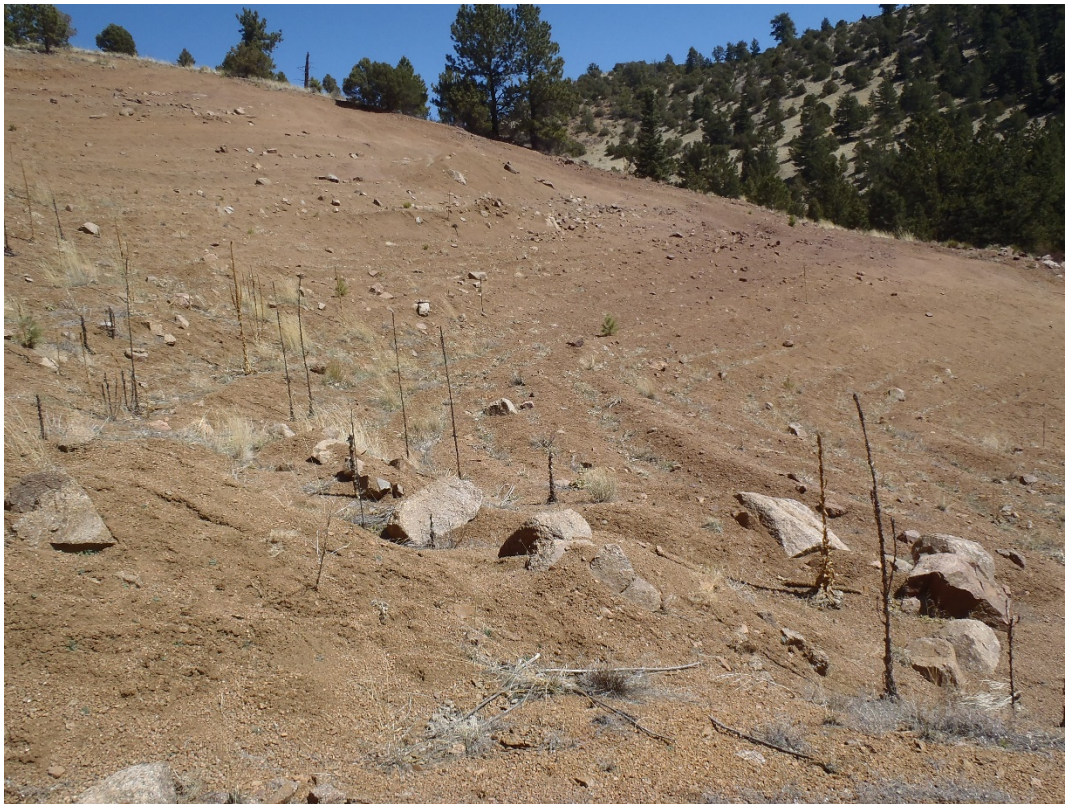
As this site was inspected on November 18th of 2021, the focus of this inspection was a collaboration with the BLM regarding whether the northern portion of the pit (see **Photo 1**) where re-establishing vegetation has been relatively unsuccessful could be deemed adequate for release. As stated in the previous inspection report, no erosion was observed on the regraded highwall. The area was contour furrowed (see **Photo 2**) where a small amount of grasses are slowly getting established (see **Photo 3**). The southwest corner of the highwall appears to have had the most success with the growth of volunteer ponderosa pines (see **Photo 4**). The east side of the highwall is essentially void of any vegetation (see **Photo 5**). Knapweed is also a problem at the site as noted in the aforementioned 2021 inspection report. New knapweed plants were observed to be emerging in the upper contour furrows (see **Photo 6**).

The approved post mine land use is wildlife habitat/rangeland. Despite the highwall appearing to be erosionally stable (due primarily to the coarse fraction of weathered bedrock), the lack of grasses does not meet the approved post mine land use. Therefore the DRMS cannot recommend approval of the release of this site.

It would appear the lack of organic matter in the highwall area is the primary impediment to establishing grasses. The DRMS is aware limited topsoil was available prior to mining and all that was salvaged has been used for reclamation on the pit floor and a small sloped area on the southwest.

Photo 1. Northern portion of pit (looking NE – minimal grasses [and mullein] in foreground/west side; no vegetation in background/east side).

- 1) For grasses: Import and place topsoil on the highwall, or import soil amendments (such as biosol, or compost or biosolids) to blend into the coarse material to help retain moisture and provide nutrients for the establishment of grasses.

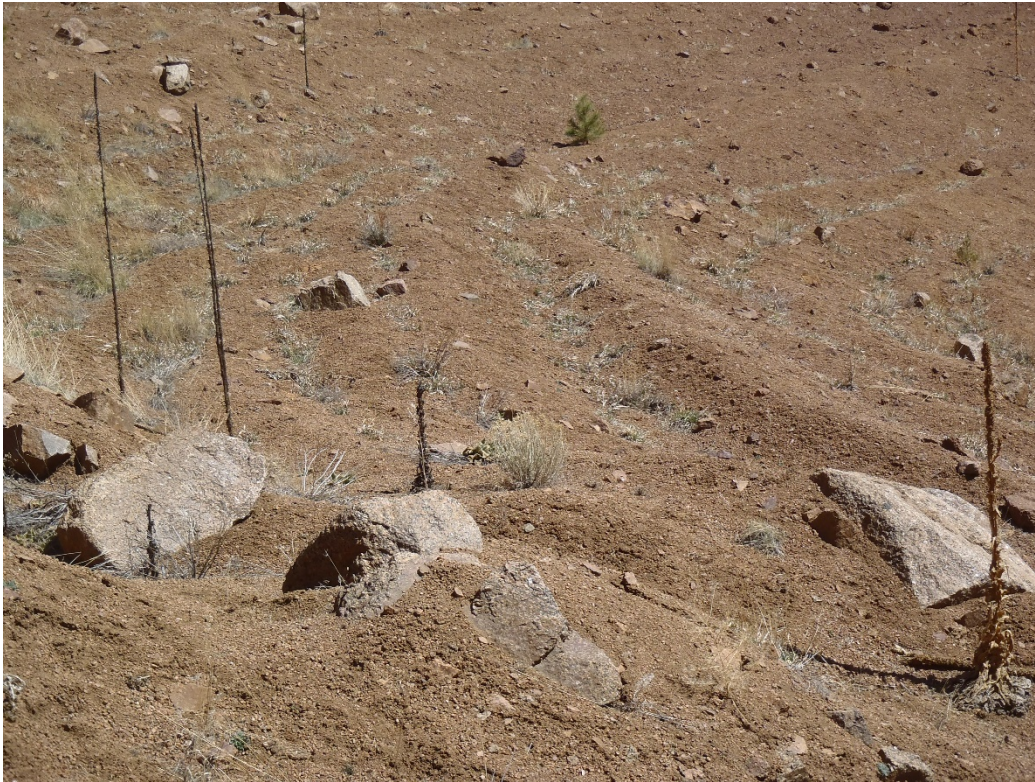
Photo 2. Contour furrows on regraded highwall – west side (foreground) includes some grasses (looking NE).

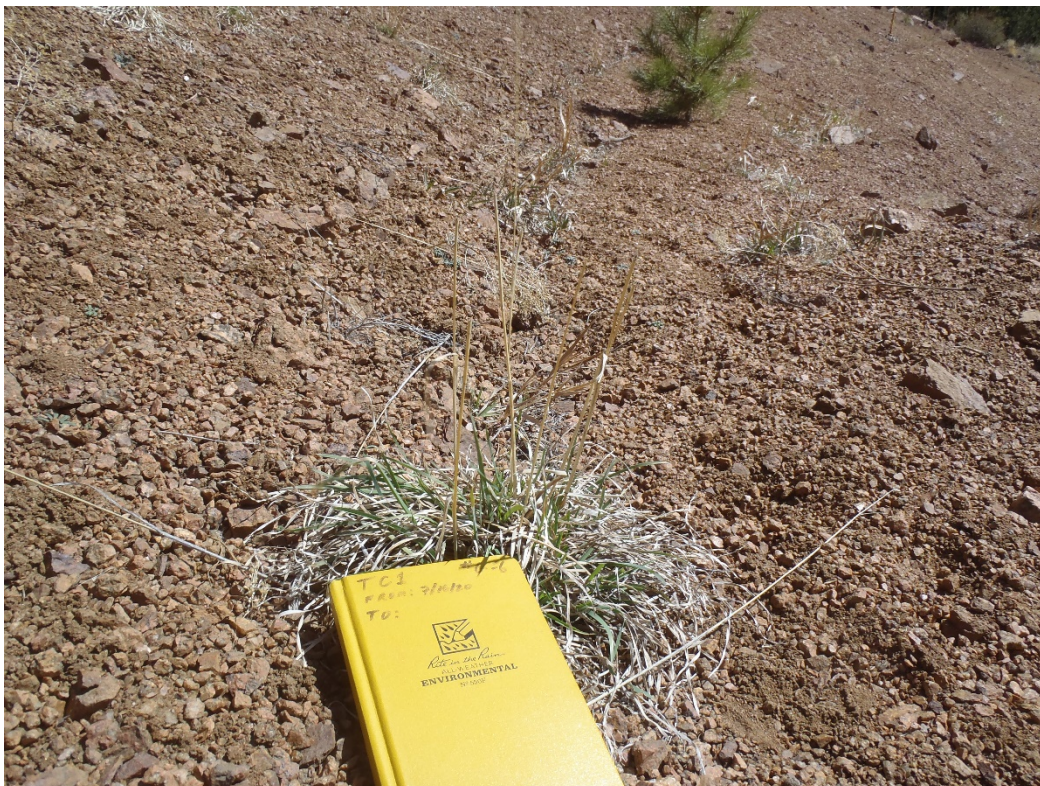
Photo 3. Typical bunch grass in furrow.

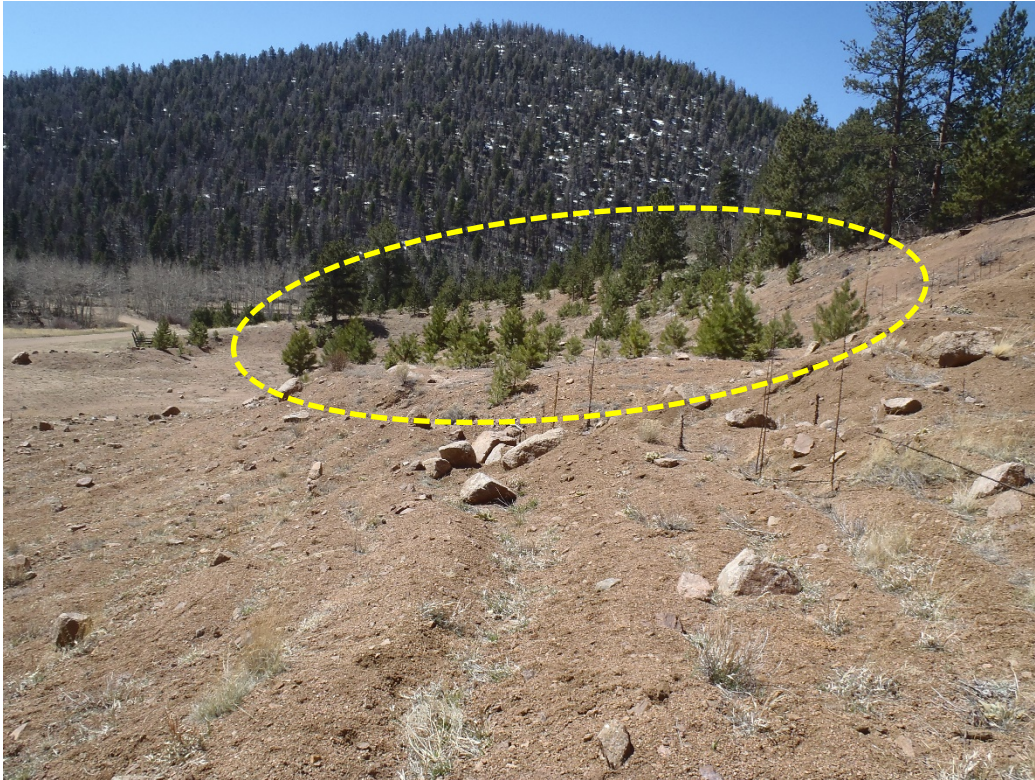
Photo 4. Volunteer ponderosa pines on west side of highwall (looking SW).

- 2) For trees: Given the success of the aforementioned volunteer ponderosa pines and that much of the undisturbed surrounding area is a mixed ponderosa pine/grass community (see **Photo 7**), trying to establish ponderosa pines may be more successful. Ideas proposed by our IMRP group include:

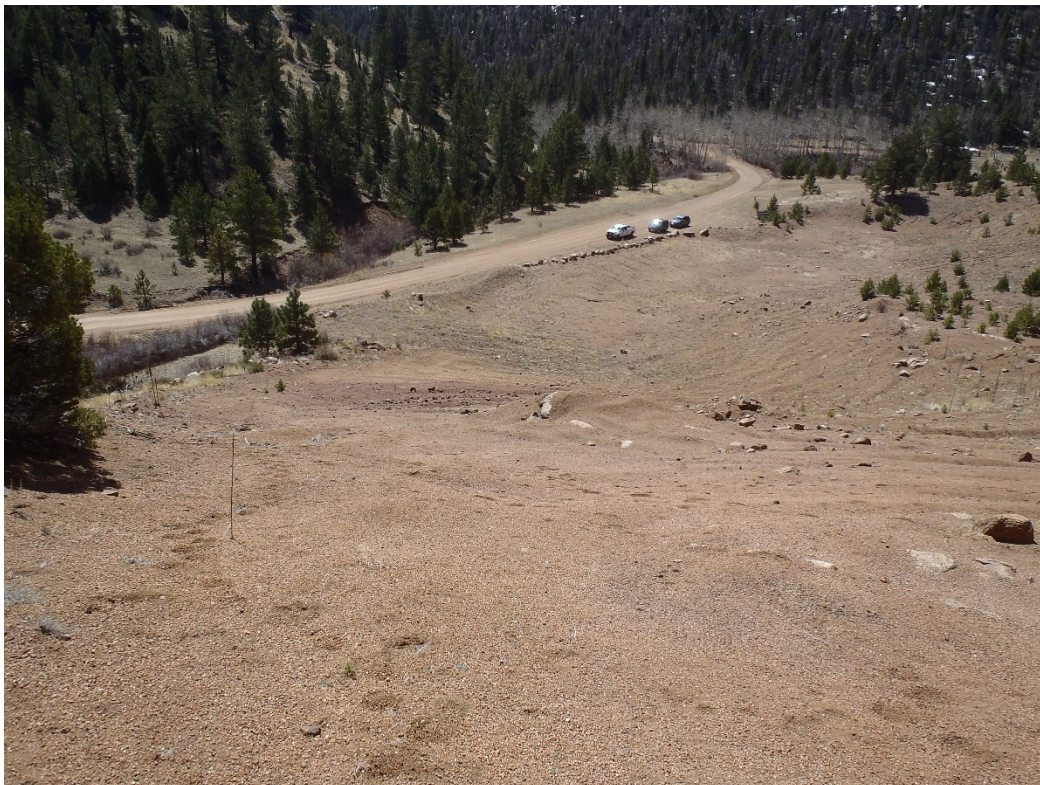
Photo 5. Bare east side of regarded highwall (looking downhill to the south).

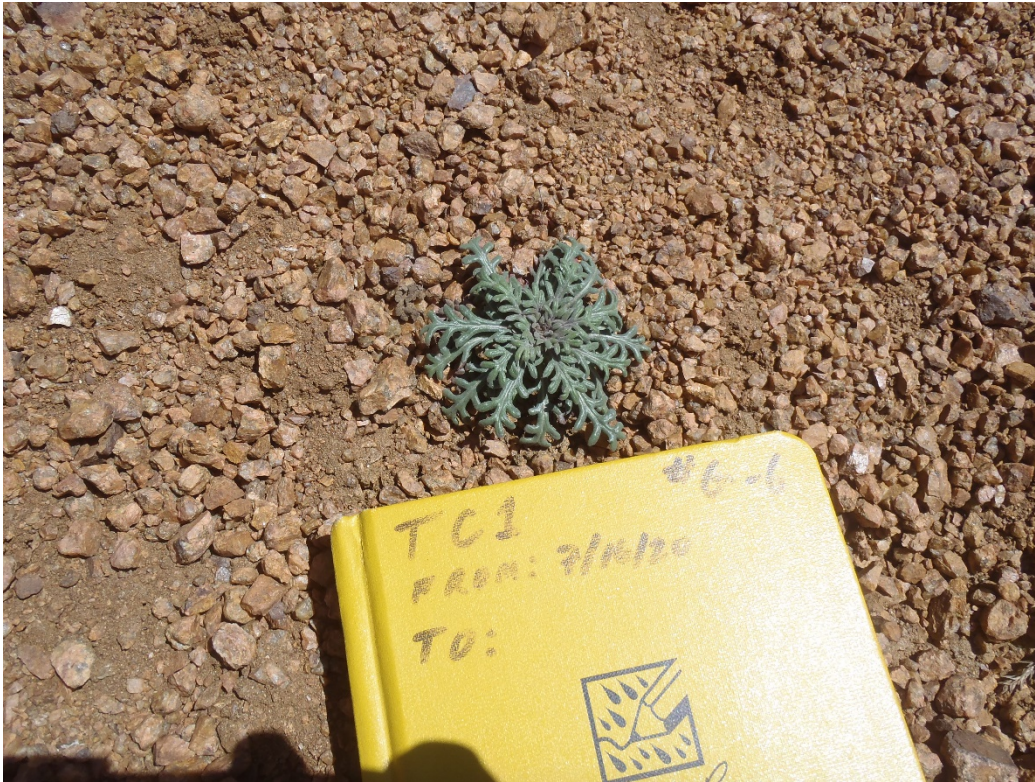
Photo 6. Typical new knapweed growth.

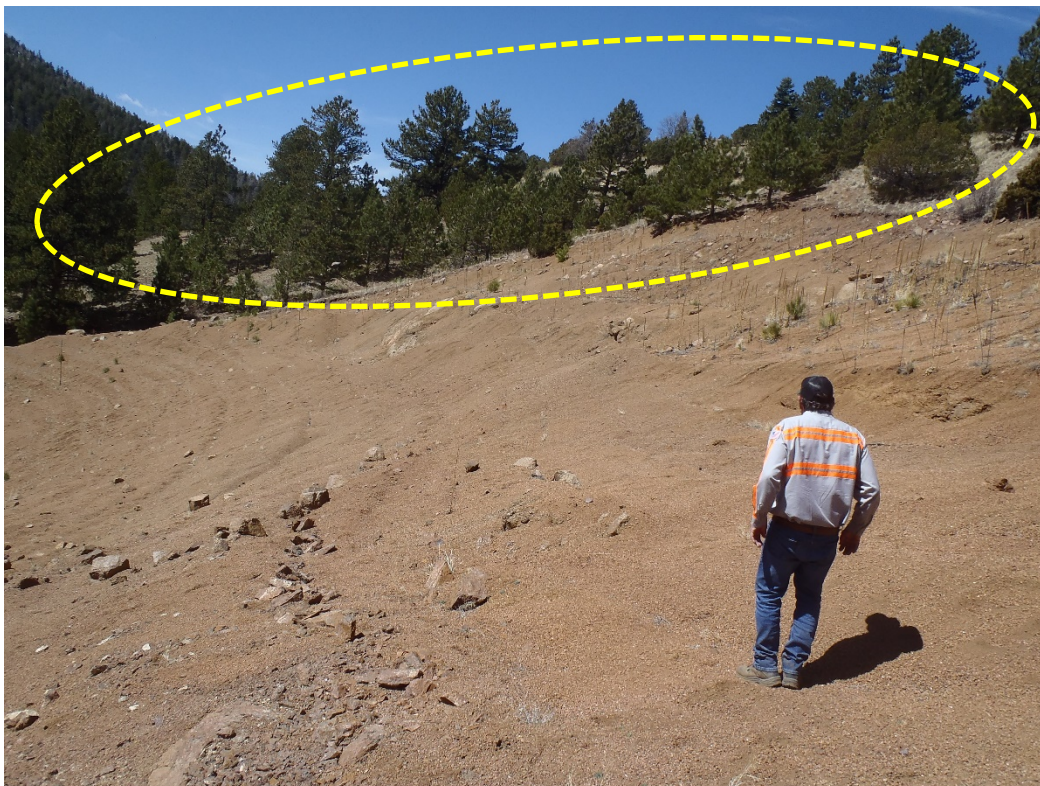
Photo 7. Typical ponderosa pine/grass community in undisturbed area (looking west).

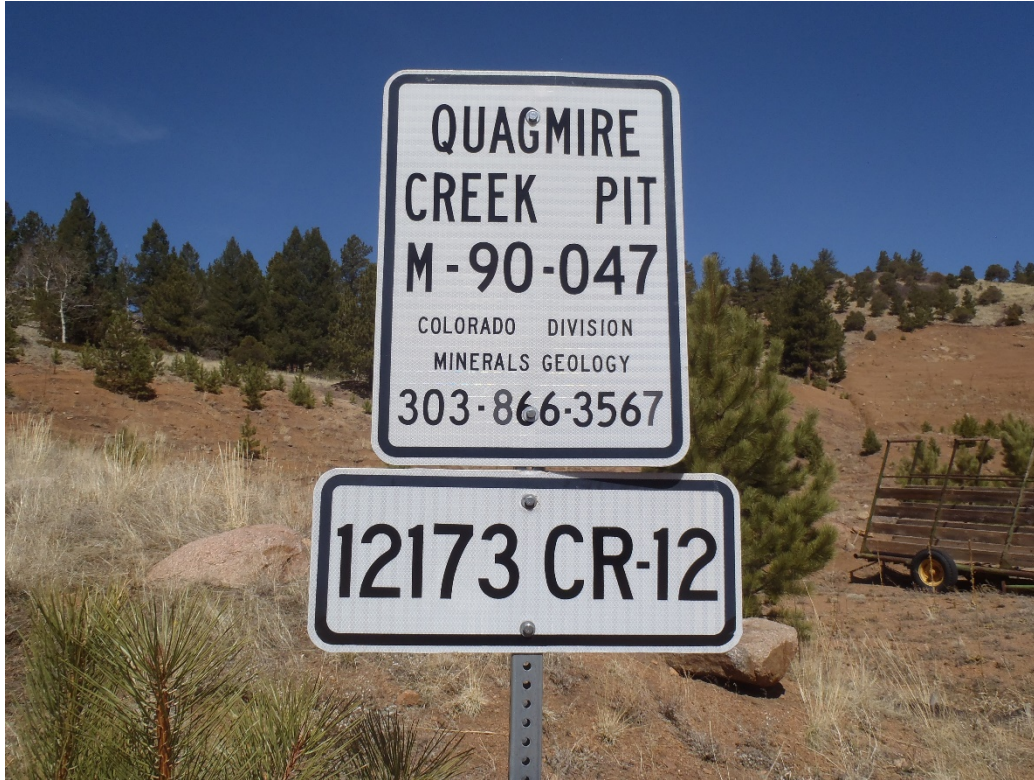
The permit sign was posted at the site entrance (see **Photo 8**) and must remain there until the site is released from final reclamation liability.

Photo 8. Permit sign off CR12 (looking north).
