MINERALS PROGRAM INSPECTION REPORT
PHONE: (303) 866-3567

MINE NAME: Bad Boy Stone	MINE/PROSPECTING ID#: M-1992-108	MINERAL: Dimension stone	COUNTY: Boulder
INSPECTION TYPE: Monitoring	INSPECTOR(S): Patrick Lennberg	INSP. DATE: April 27, 2022	INSP. TIME: 09:00
OPERATOR: Bad Boy Stone	OPERATOR REPRESENTATIVE: Raul Vasquez and Buda Vasquez	TYPE OF OPERATION: 110c - Construction Limited Impact	
REASON FOR INSPECTION: Normal I&E Program	BOND CALCULATION TYPE: Partial Bond	BOND AMOUNT: \$5,300.00	
DATE OF COMPLAINT: NA	POST INSP. CONTACTS: None	JOINT INSP. AGENCY: None	
WEATHER: Clear	INSPECTOR'S SIGNATURE:

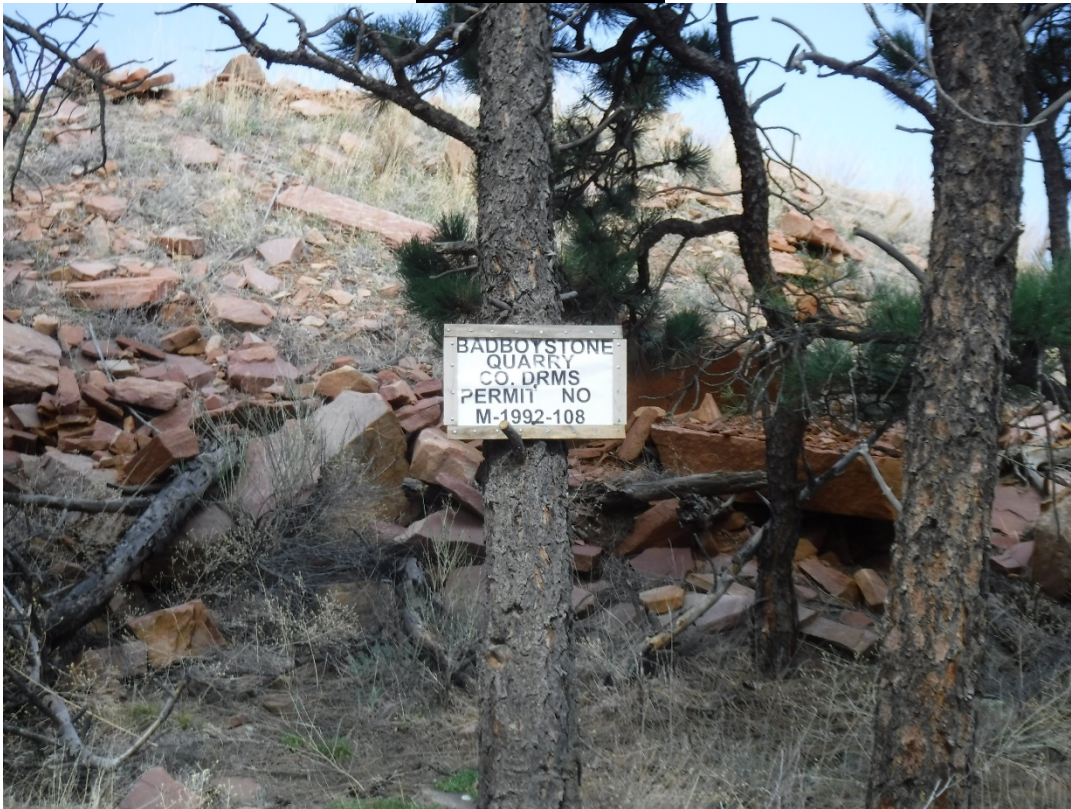
This is a 110c operation permitted for 6.58 acres. The permit is to mine sandstone for building materials and decorative use. The mine is located on property owned by Raul Vasquez. The mine is located in Boulder County. The site entrance is located 2.5 miles north of Lyons, CO. The approved post-mining land use is a combination of residential and wildlife habitat. A mine sign was posted at the mine entrance pursuant to Rule 3.1.12.

Photo 1: Mine sign at the primary mine entrance

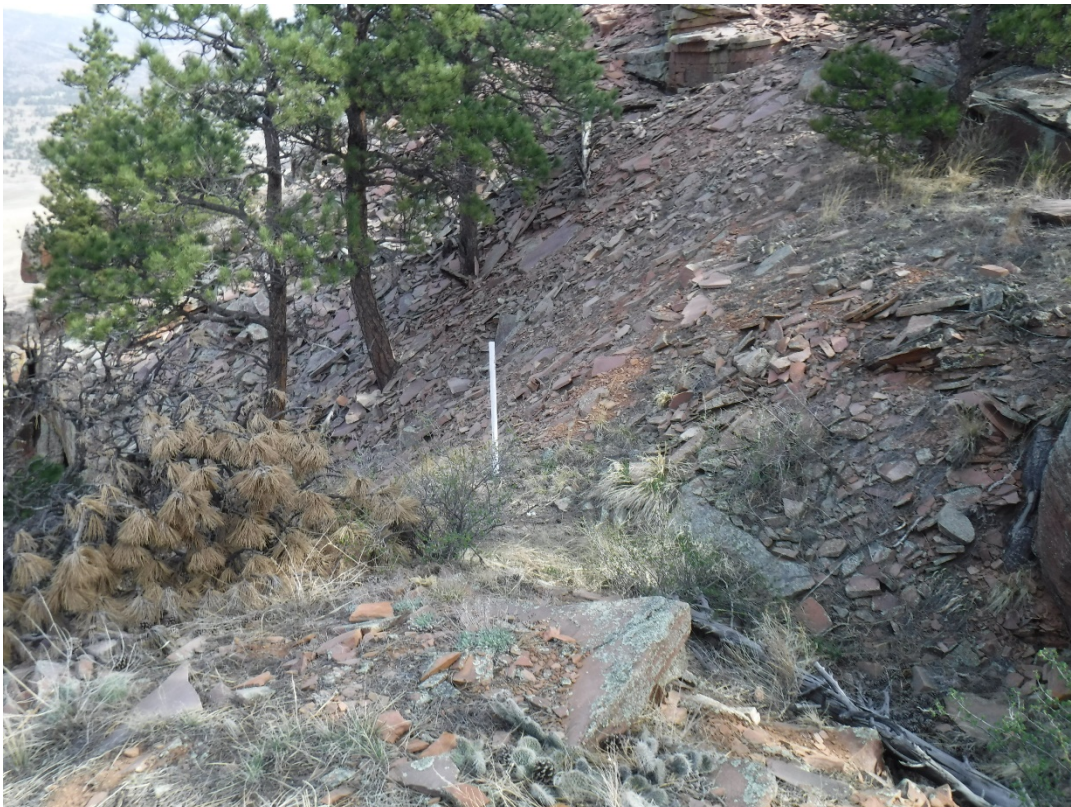
Photo 2: Typical permit boundary marker, northwestern corner

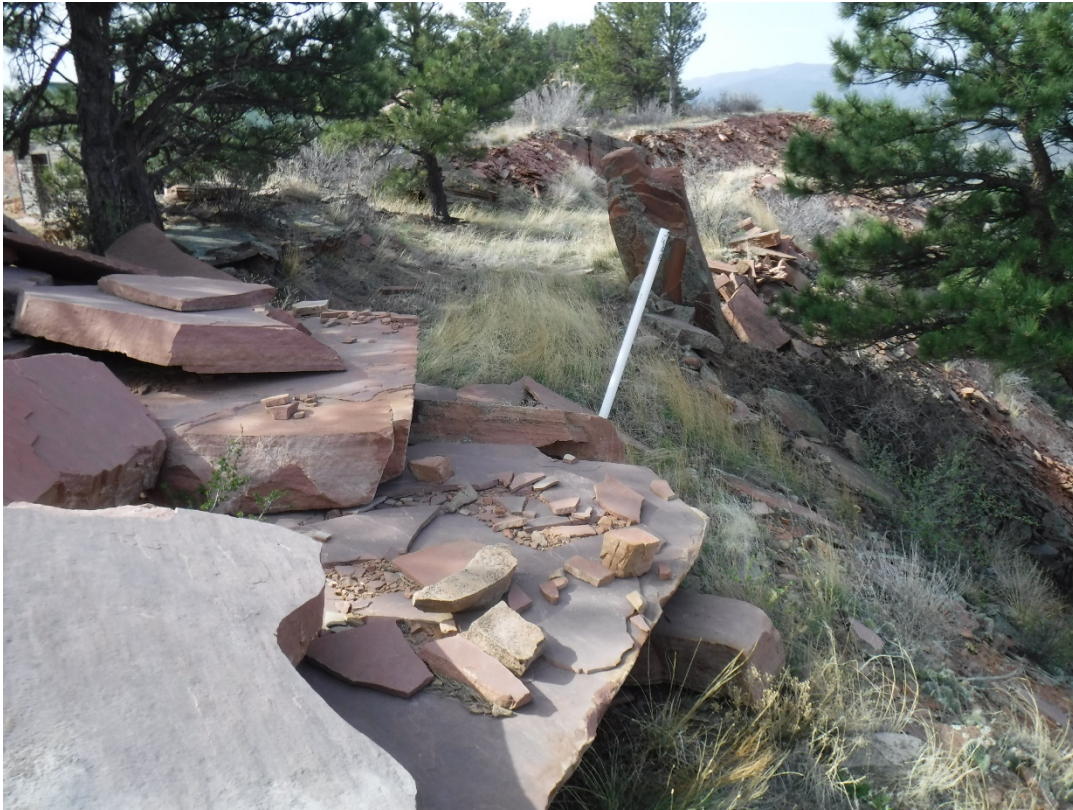
Photo 3: Typical permit boundary marker, southwestern corner

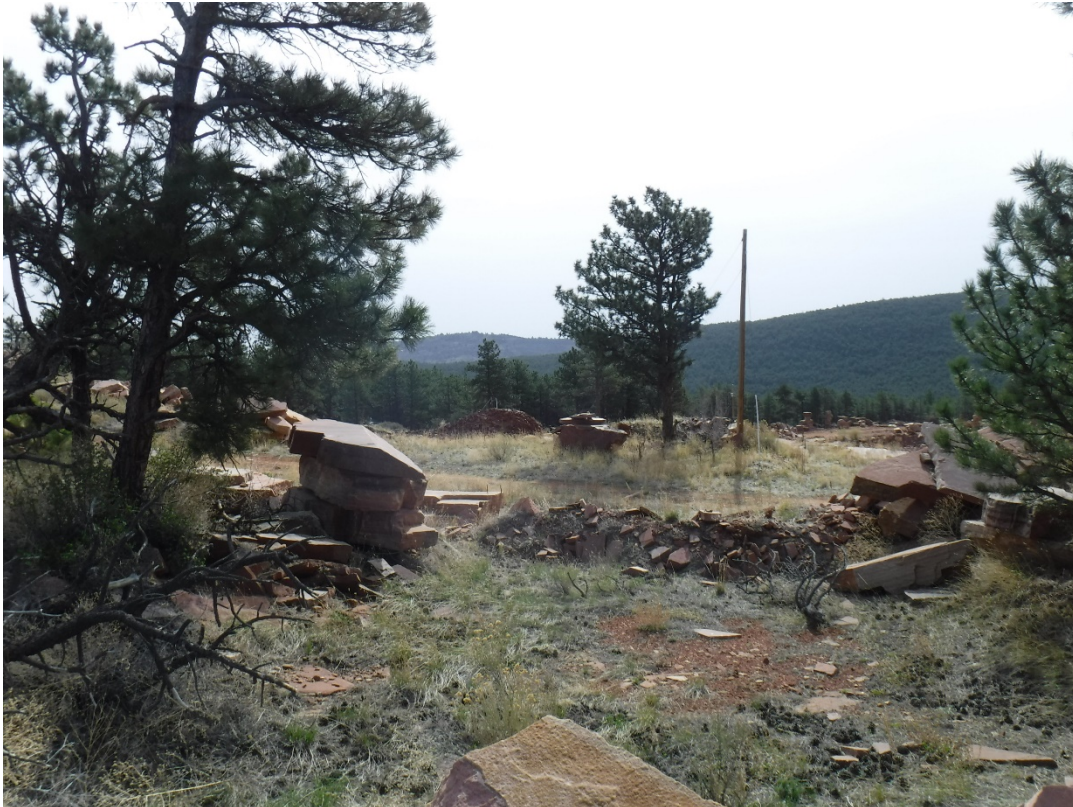
Photo 4: Looking east from the southwestern permit corner towards the southeastern corner

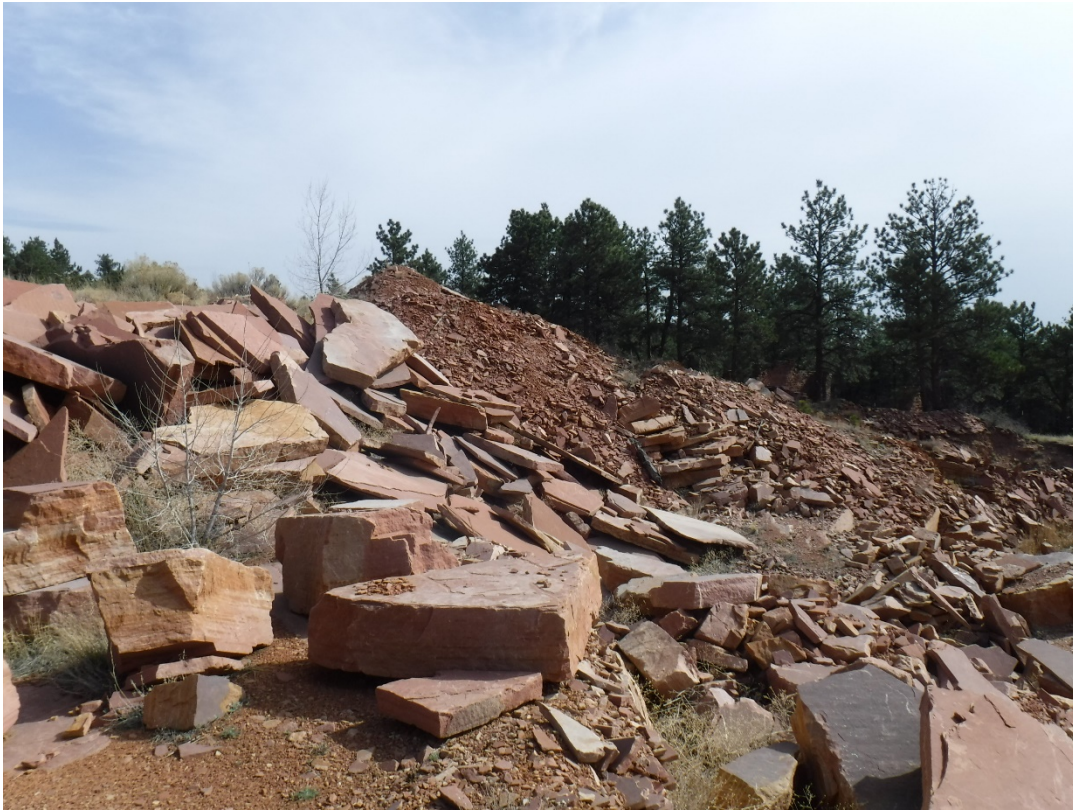
Photo 5: Material adjacent to pit area

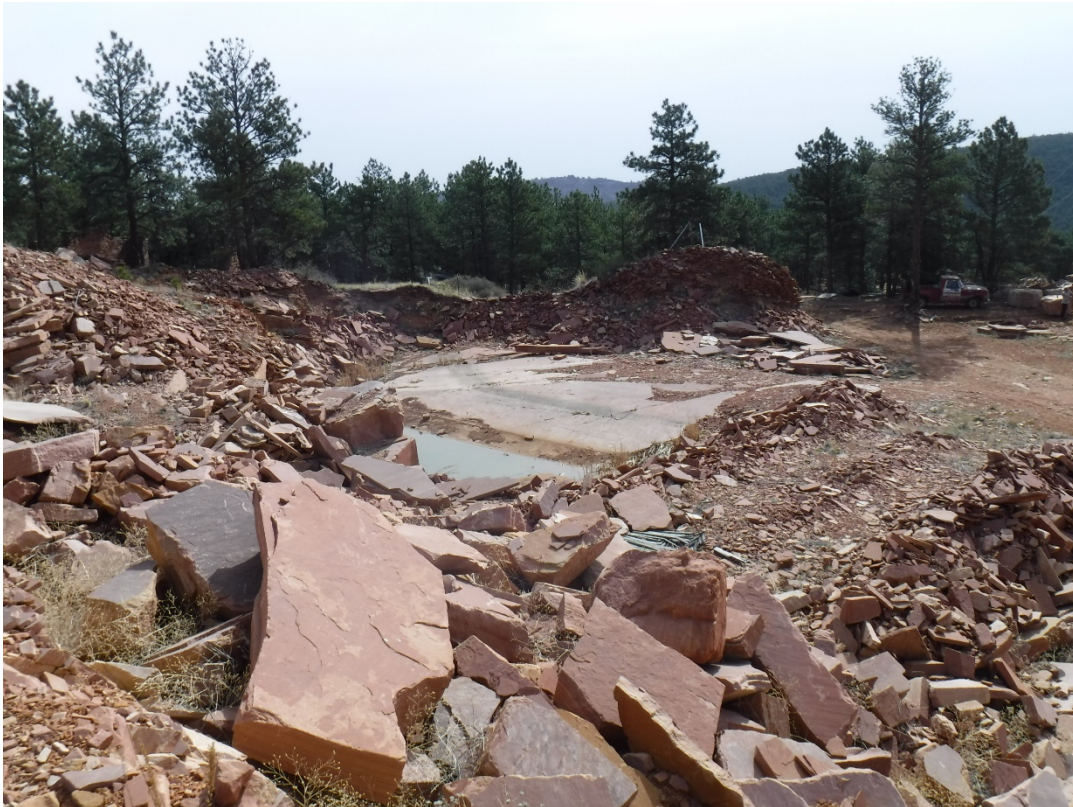
The mine was not active at the time of inspection. Mr. Vasquez stated the site is active a few times throughout the year when minor amounts of material are removed from the site. There are two pits located within the permit area. The operation completed mining and reclaimed the northern pit many years ago. The active area is located in the southern portion of the permit area. The site has been largely leveled off for future residential use. There are several benches along the western side of the southern pit area, which average approximately 4 feet in height and 3 feet in width. Volunteer trees, shrubs, grasses, and annual weeds have begun establishing across the site. Large blocks of sandstone are present along the western edge of the site. Any excess sandstone will need to be used to backfill the southern pit. An overburden/topsoil stockpile is stored along the eastern edge of the site and could also be used to backfill the pit.

Photo 6: Pit area

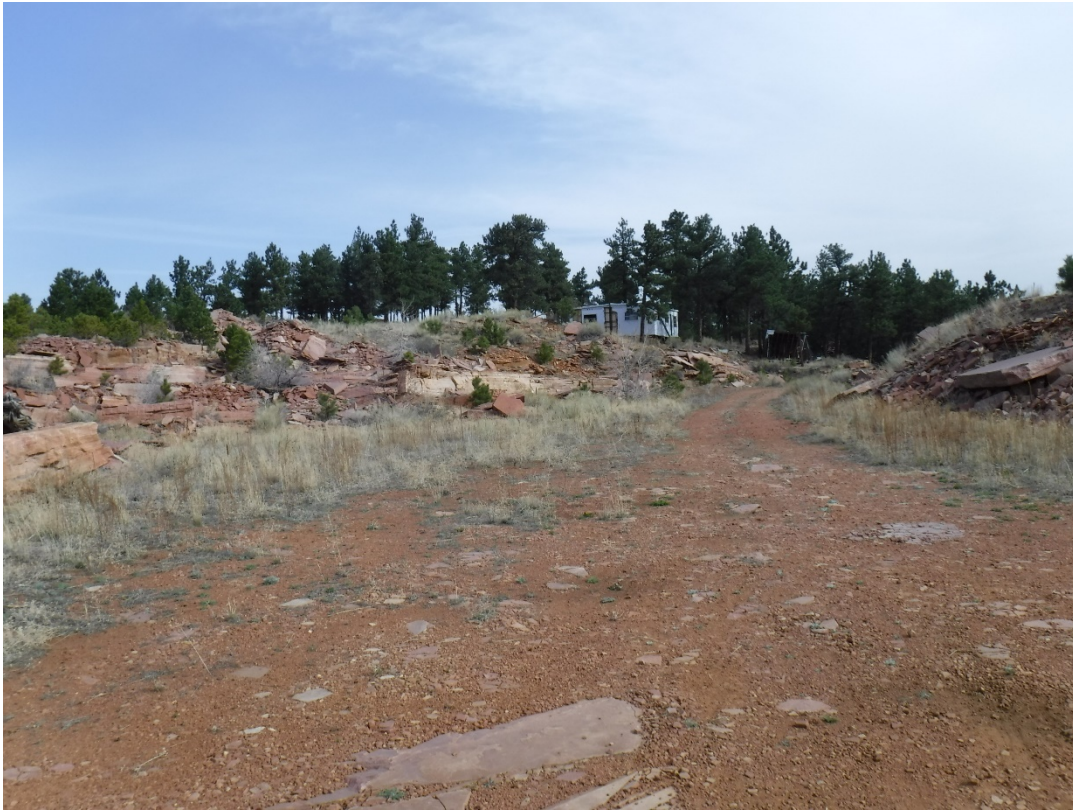
Photo 7: Flat area towards south end of permit

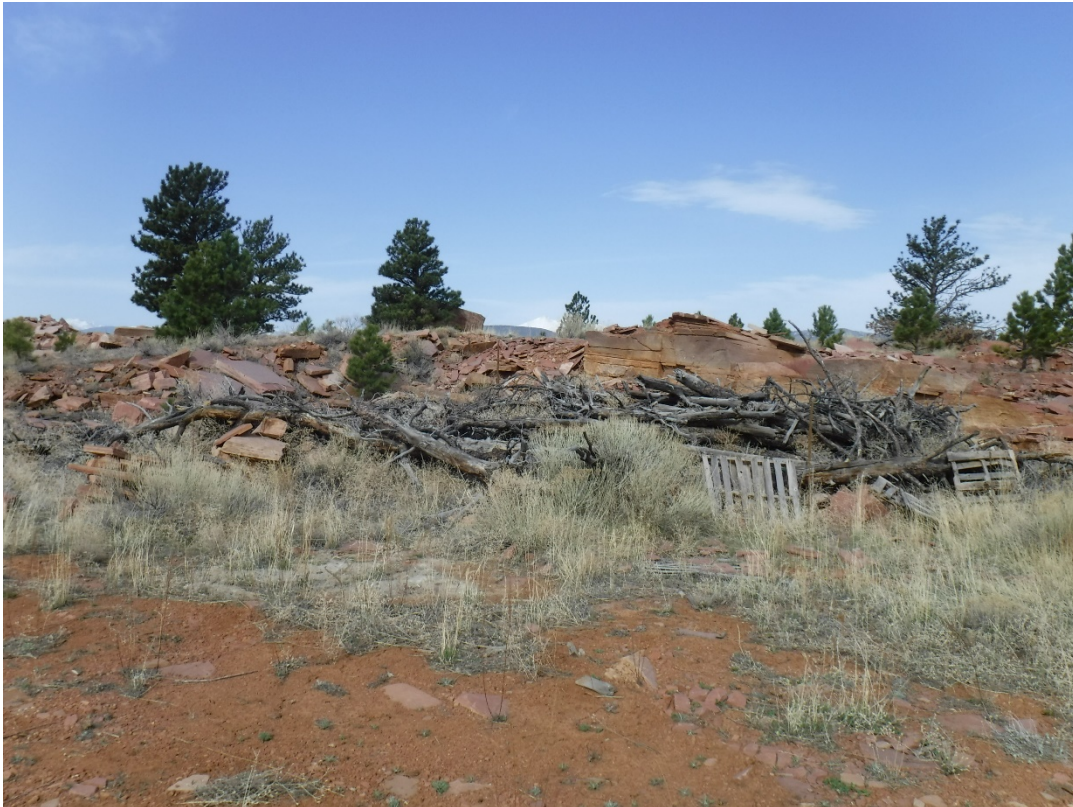
Photo 8: Typical conditions along the west area of the southern permit
