MINERALS PROGRAM INSPECTION REPORT PHONE: (303) 866-3567

MINE NAME:	MINE/PROSPECTING ID#:	MINERAL:		COUNTY:
Mineral Joe Claims	M-1977-284	Uranium and vanadium		Montrose
INSPECTION TYPE:	INSPECTOR(S):	INSP. DATE:		INSP. TIME:
Monitoring	Dustin M. Czapla	May 3, 2022		12:00
OPERATOR:	OPERATOR REPRESENTATIVE:	TYPE OF OPERATION:		
Highbury Resources, Inc.	Scott Pottorfs	110d - Designated Limited Impact		
REASON FOR INSPECTION:	BOND CALCULATION TYPE:		BOND AMOUNT:	
Normal I&E Program	None		\$35,167.30	
DATE OF COMPLAINT:	POST INSP. CONTACTS:		JOINT INSP. AGENCY:	
NA	None		None	
WEATHER:	INSPECTOR'S SIGNATURE:		SIGNATURE DATE:	
Clear	the		May 9, 2022

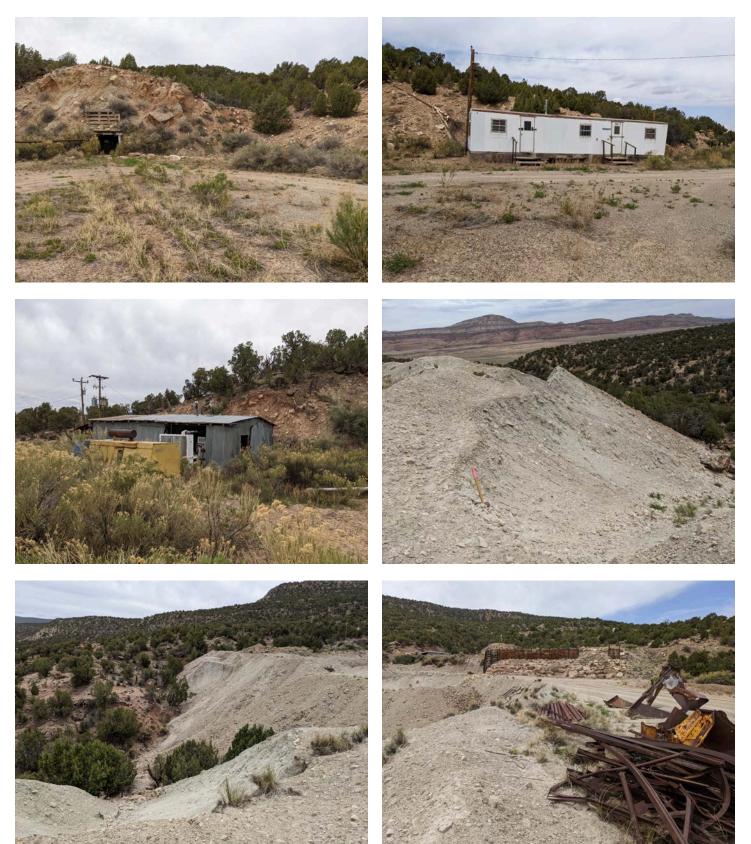
There has been no recent activity at this site. Conditions appear unchanged from previous inspections. The Duggan adit is secured with a locking gate. The office building and compressor shed remain dilapidated due to site inactivity. Stormwater control structures appeared maintained and functional.
