MINERALS PROGRAM INSPECTION REPORT
PHONE: (303) 866-3567

MINE NAME: JD-6 Mine	MINE/PROSPECTING ID#: M-1977-310	MINERAL: Uranium and vanadium	COUNTY: Montrose
INSPECTION TYPE: Monitoring	INSPECTOR(S): Dustin M. Czapla	INSP. DATE: May 3, 2022	INSP. TIME: 13:01
OPERATOR: Highbury Resources, Inc.	OPERATOR REPRESENTATIVE: Scott Pottorffs	TYPE OF OPERATION: 110d - Designated Limited Impact	
REASON FOR INSPECTION: Normal I&E Program	BOND CALCULATION TYPE: None	BOND AMOUNT: \$46,200.00	
DATE OF COMPLAINT: NA	POST INSP. CONTACTS: None	JOINT INSP. AGENCY: None	
WEATHER: Clear	INSPECTOR'S SIGNATURE:

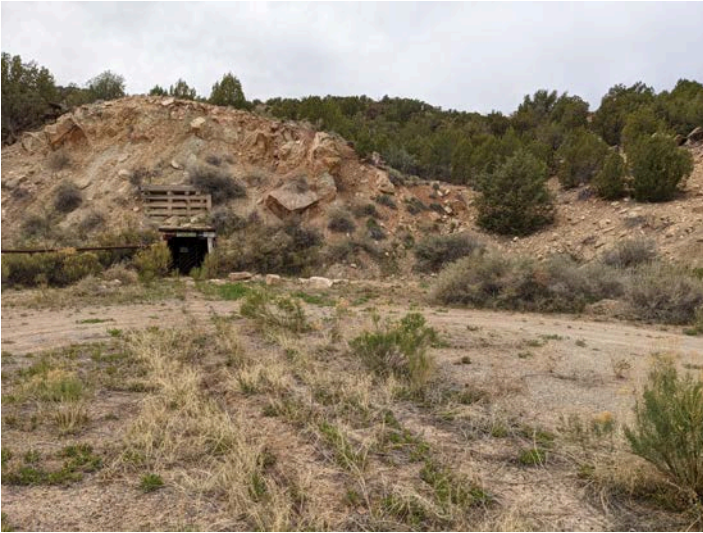
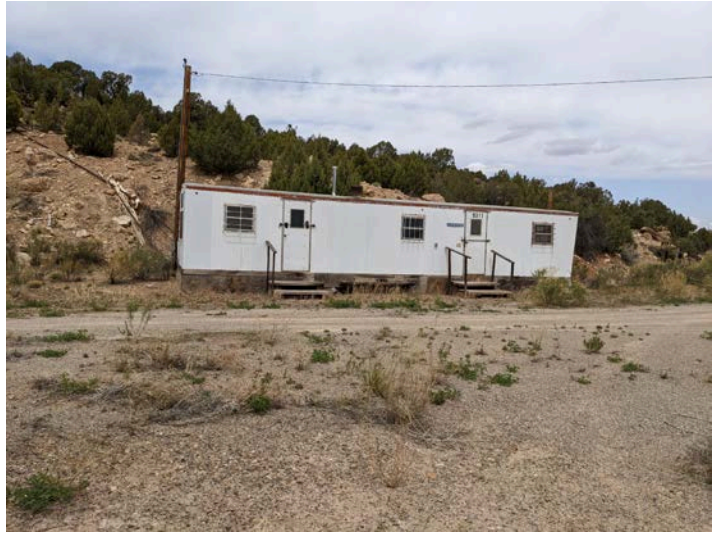
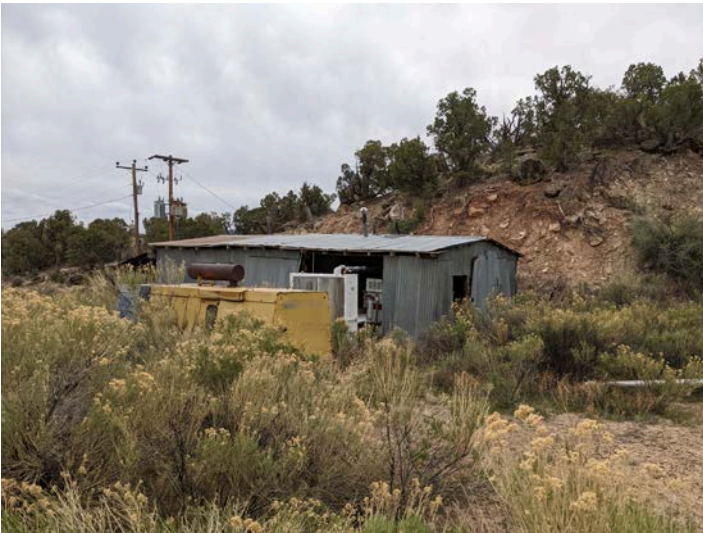
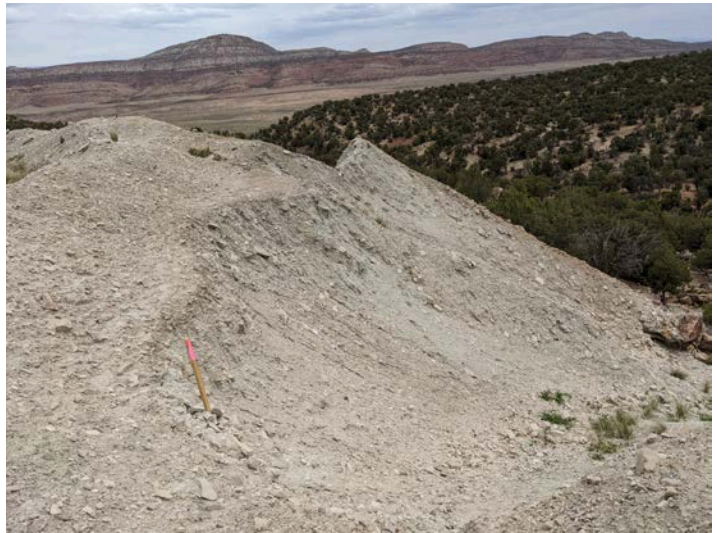
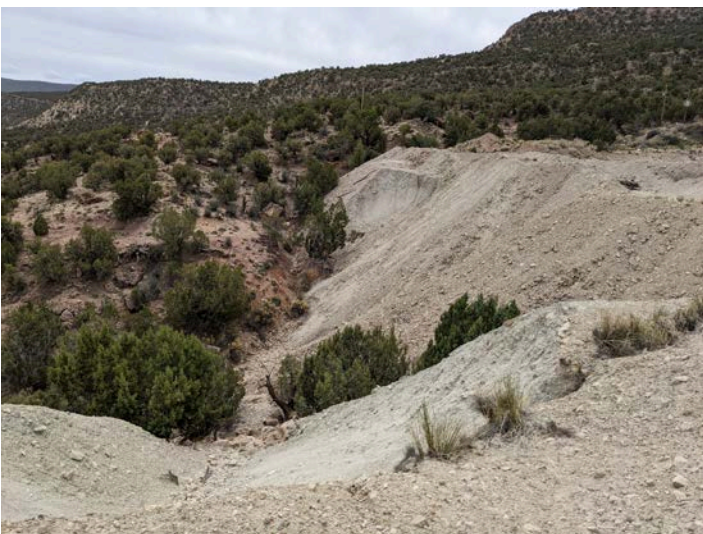
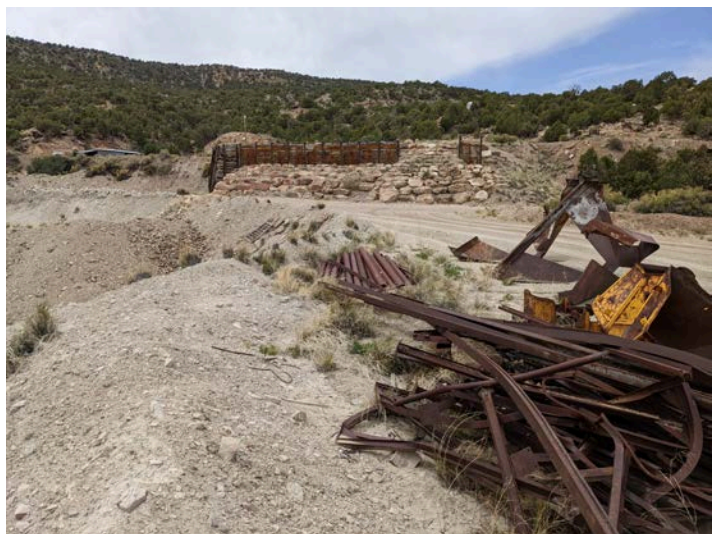
There has been no recent activity at this site. Conditions appear similar to those observed during past inspections. The repaired retaining wall continues to appear stable. Stormwater control structures appear to be maintained and functional. No problems or violations were noted during this inspection. Final reclamation has not yet commenced.
