**MINERALS PROGRAM INSPECTION REPORT**  
**PHONE: (303) 866-3567**

<b>MINE NAME:</b> Van 4 Shaft	<b>MINE/PROSPECTING ID#:</b> M-1997-032	<b>MINERAL:</b> Uranium and vanadium	<b>COUNTY:</b> Montrose
<b>INSPECTION TYPE:</b> Monitoring	<b>INSPECTOR(S):</b> Dustin Czapla	<b>INSP. DATE:</b> May 3, 2022	<b>INSP. TIME:</b> 13:30
<b>OPERATOR:</b> Pinon Ridge Mining LLC	<b>OPERATOR REPRESENTATIVE:</b> None	<b>TYPE OF OPERATION:</b> 110d - Designated Limited Impact	
<b>REASON FOR INSPECTION:</b> Normal I&E Program	<b>BOND CALCULATION TYPE:</b> None	<b>BOND AMOUNT:</b> \$75,057.00	
<b>DATE OF COMPLAINT:</b> NA	<b>POST INSP. CONTACTS:</b> None	<b>JOINT INSP. AGENCY:</b> None	
<b>WEATHER:</b> Clear	<b>INSPECTOR'S SIGNATURE:</b>

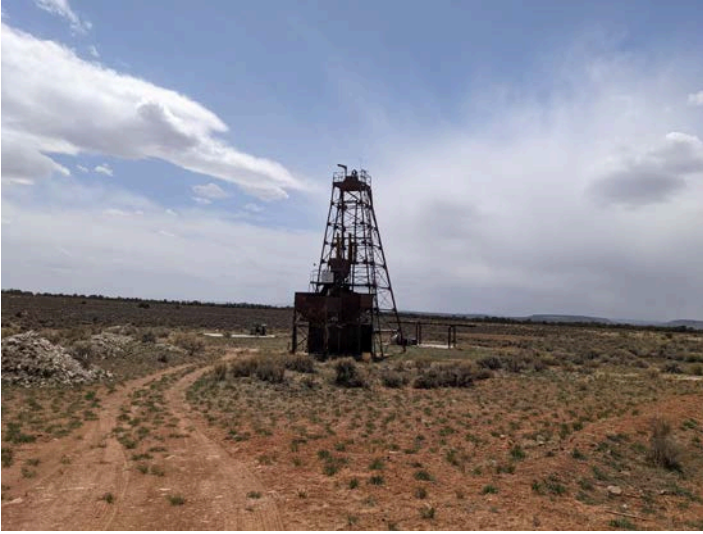
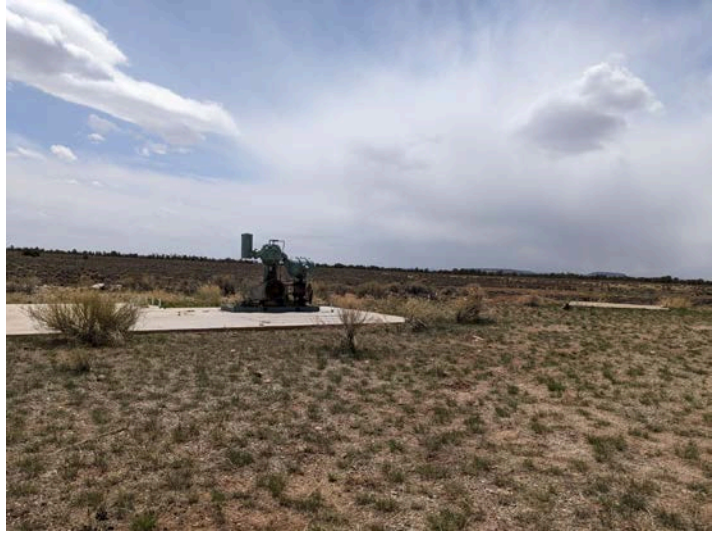
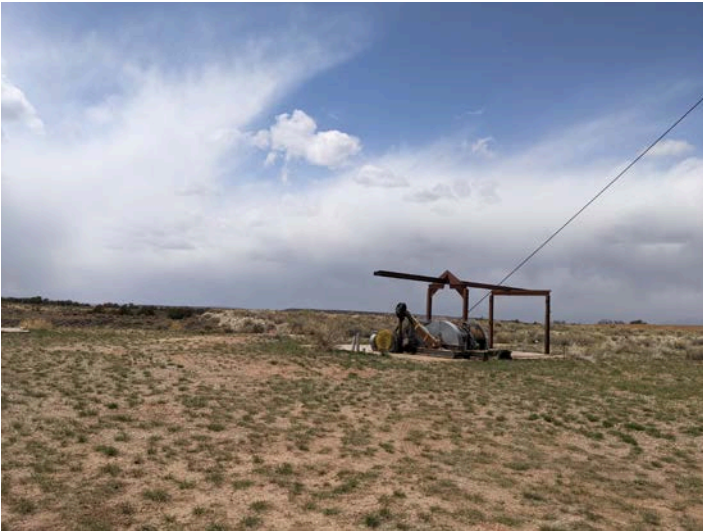
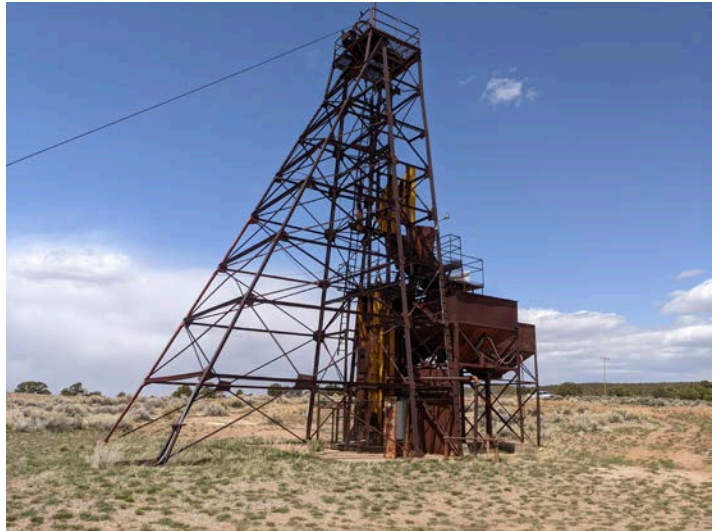
The metal shop building and shed have been removed. The slab foundation is still in place. The compressor is still attached to the slab. Most of the hoist house building has been removed. The slab containing the hoist unit, the hoist, and I-beam framing are still in place. No other reclamation progress was observed.
