MINERALS PROGRAM INSPECTION REPORT

MINE NAME: Humming Bird Mine	MINE/PROSPECTING ID#: M-2017-035	MINERAL: Gemstones, fluorine, copper	COUNTY: Mesa
INSPECTION TYPE: Monitoring	INSPECTOR(S): Amy Yeldell	INSP. DATE: April 20, 2022	INSP. TIME: 12:20
OPERATOR: Miners Mall, LLC	OPERATOR REPRESENTATIVE: Denis Schnider	TYPE OF OPERATION: 110(1) - Hard Rock Limited Impact	
REASON FOR INSPECTION: Normal I&E Program	BOND CALCULATION TYPE: Complete Bond	BOND AMOUNT: \$4,726.00	
DATE OF COMPLAINT: NA	POST INSP. CONTACTS: DRMS	JOINT INSP. AGENCY: U.S.BLM	
WEATHER: Clear	INSPECTOR'S SIGNATURE:

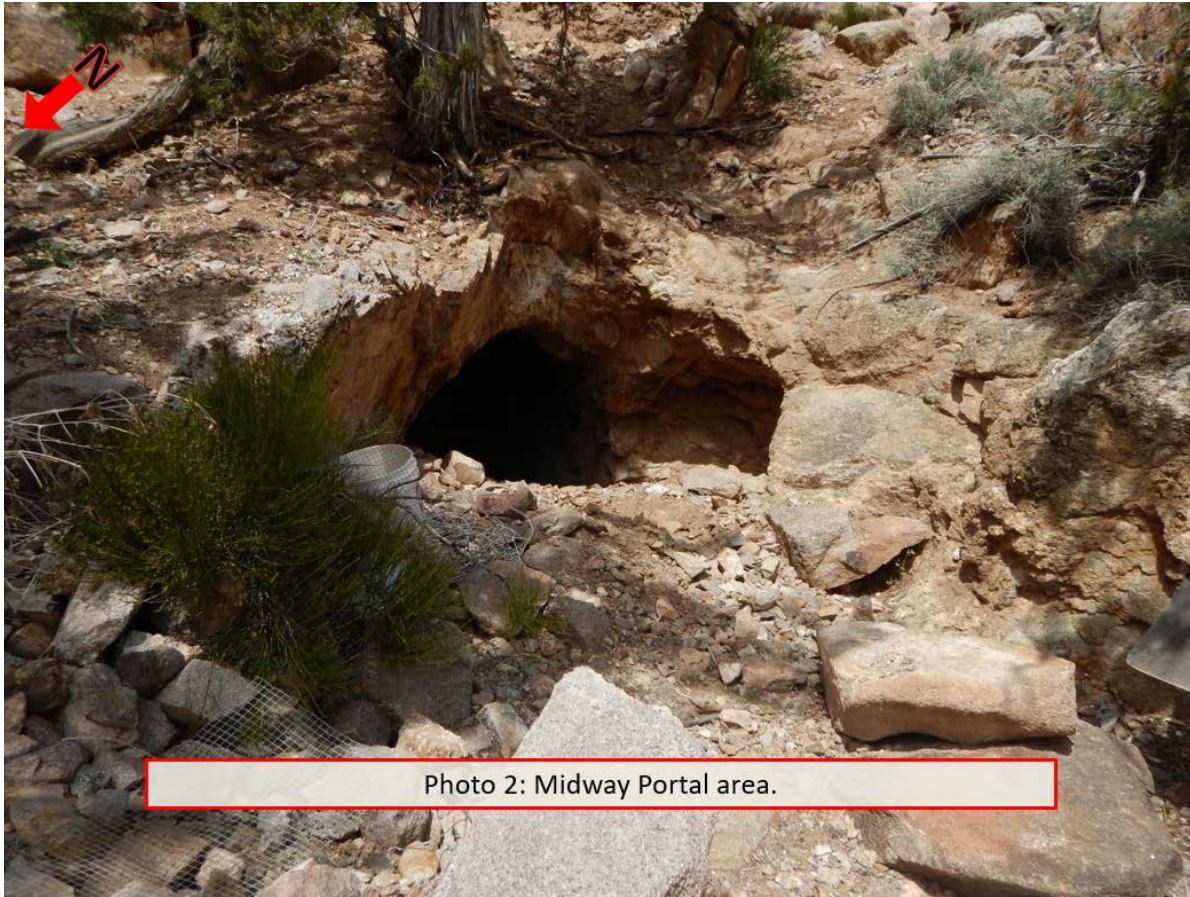
Photo 2: Midway Portal area.

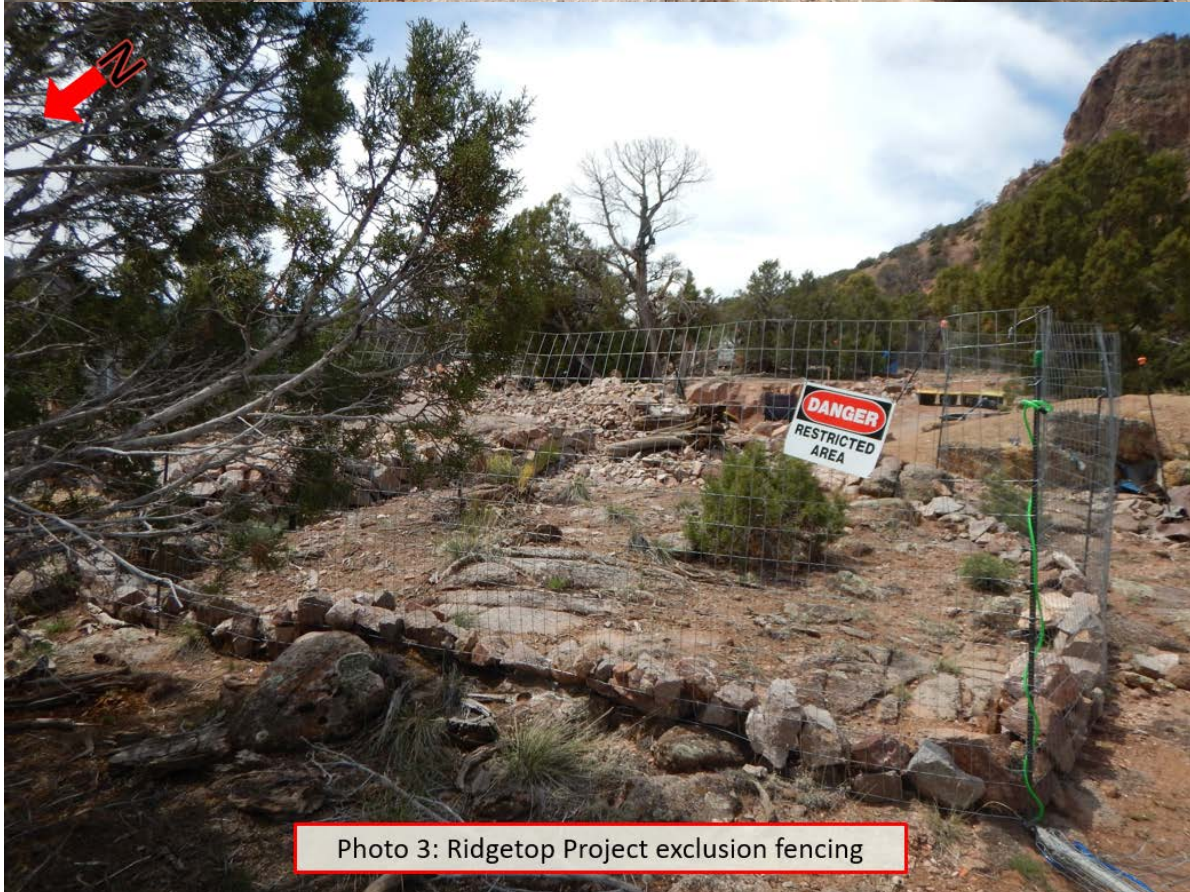
The mine sign and boundary markers remain in place and in compliance with Rule 3.1.12. Safety fencing has been installed in various locations throughout the permit boundary. The entire permit boundary is not fenced in. Misc. signs are also posted at key locations throughout the mine site.

Photo 3: Ridgetop Project exclusion fencing

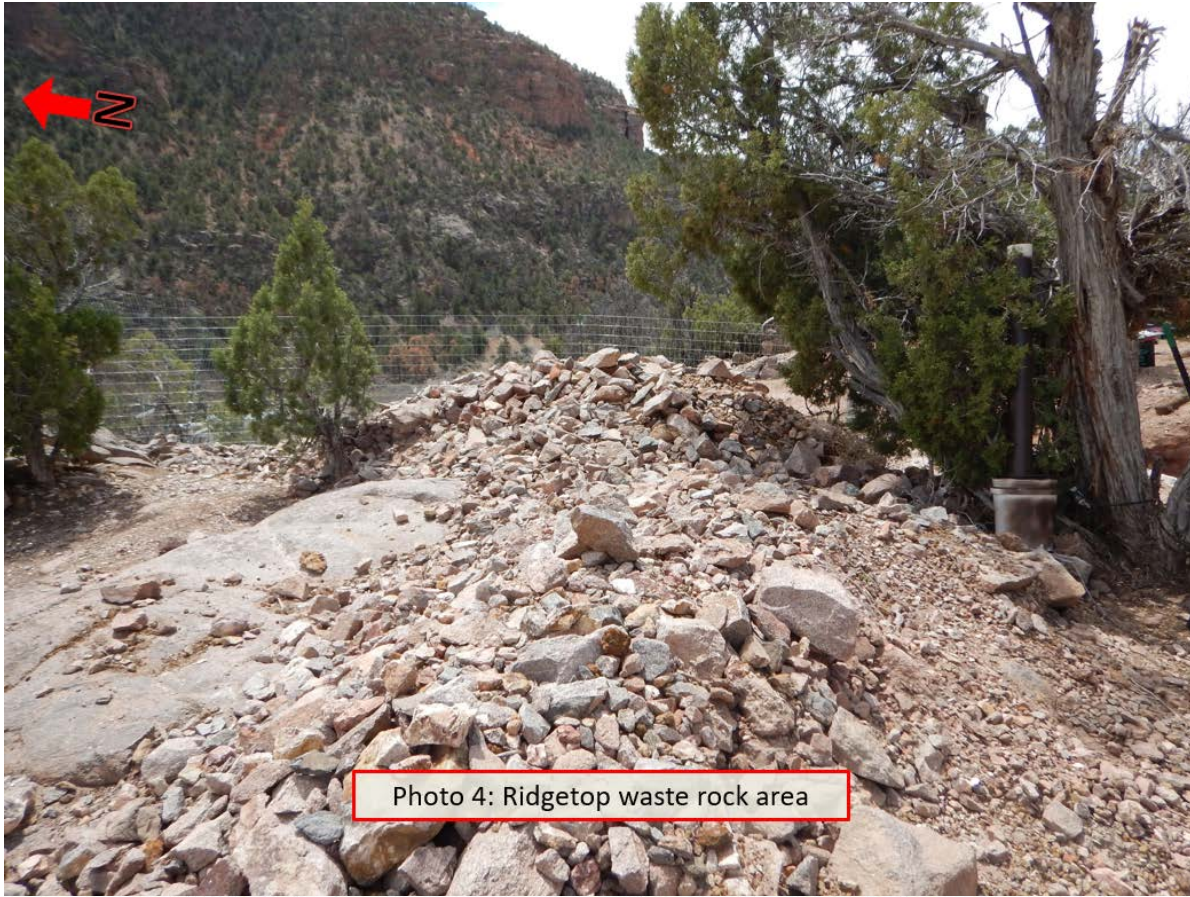
The waste rock and topsoil piles appear to be stable. There is no erosion from the piles. The topsoil has good vegetation establishment. The current topsoil pile has been expanded and a new stockpile area will soon be created from material generated at the Ridgetop. No weeds were observed. Misc tools are stored in the ridgetop project area and are neatly kept. Several locked totes with ore were being stored on site until they could be transported off site.

Photo 4: Ridgetop waste rock area

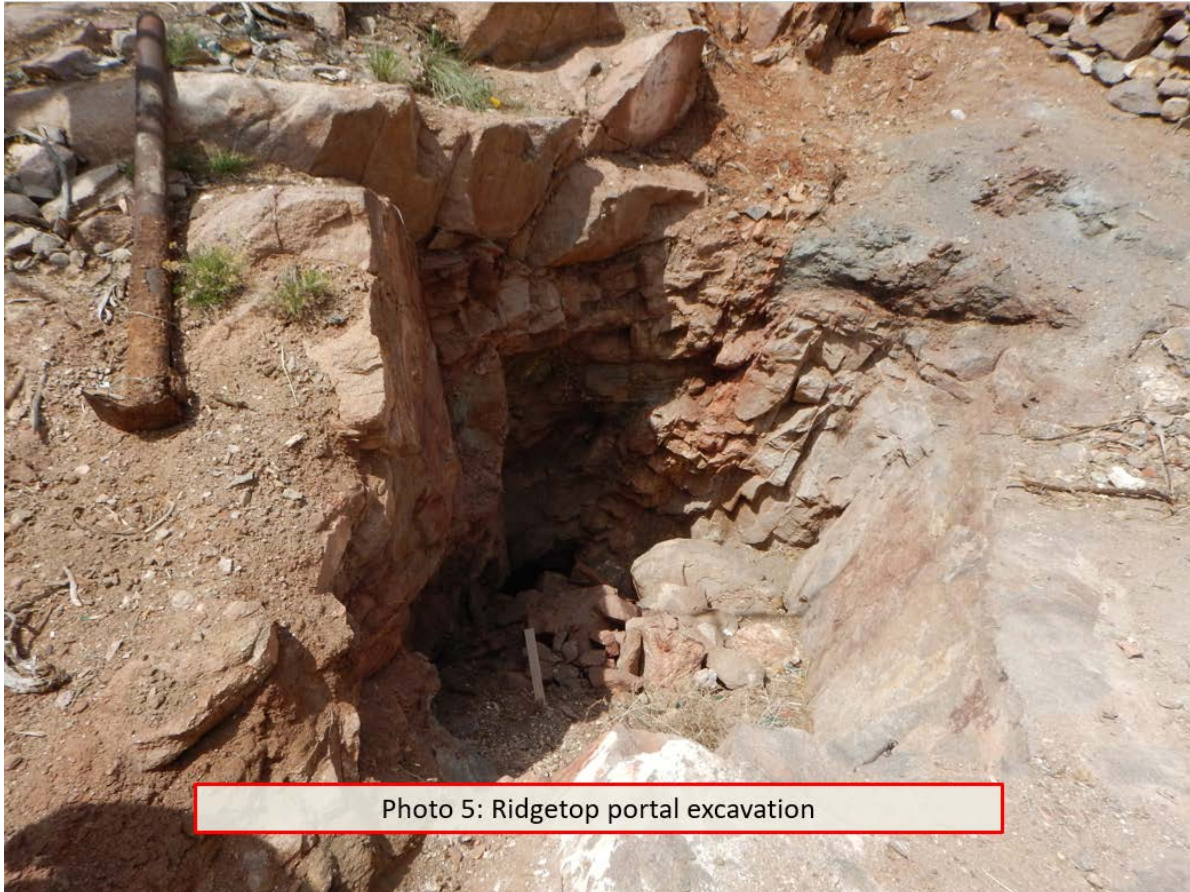
The operation is actively working in the Ridgetop Project Area and has generally progressed into phase 2 of the mining plan. The operator is in the process of excavating around the vertical ridgetop shaft in order to install the portal structure. The operation has yet to fully progress to an underground operation. Areas with vertical shafts are fenced in. The cliff separating the ridgetop and the connector project areas has been stabilized. Excess debris that was sliding downhill has been removed. Straw bales to prevent sedimentation and erosion have been placed at the cliff's edge, as well as a fence.

Photo 5: Ridgetop portal excavation

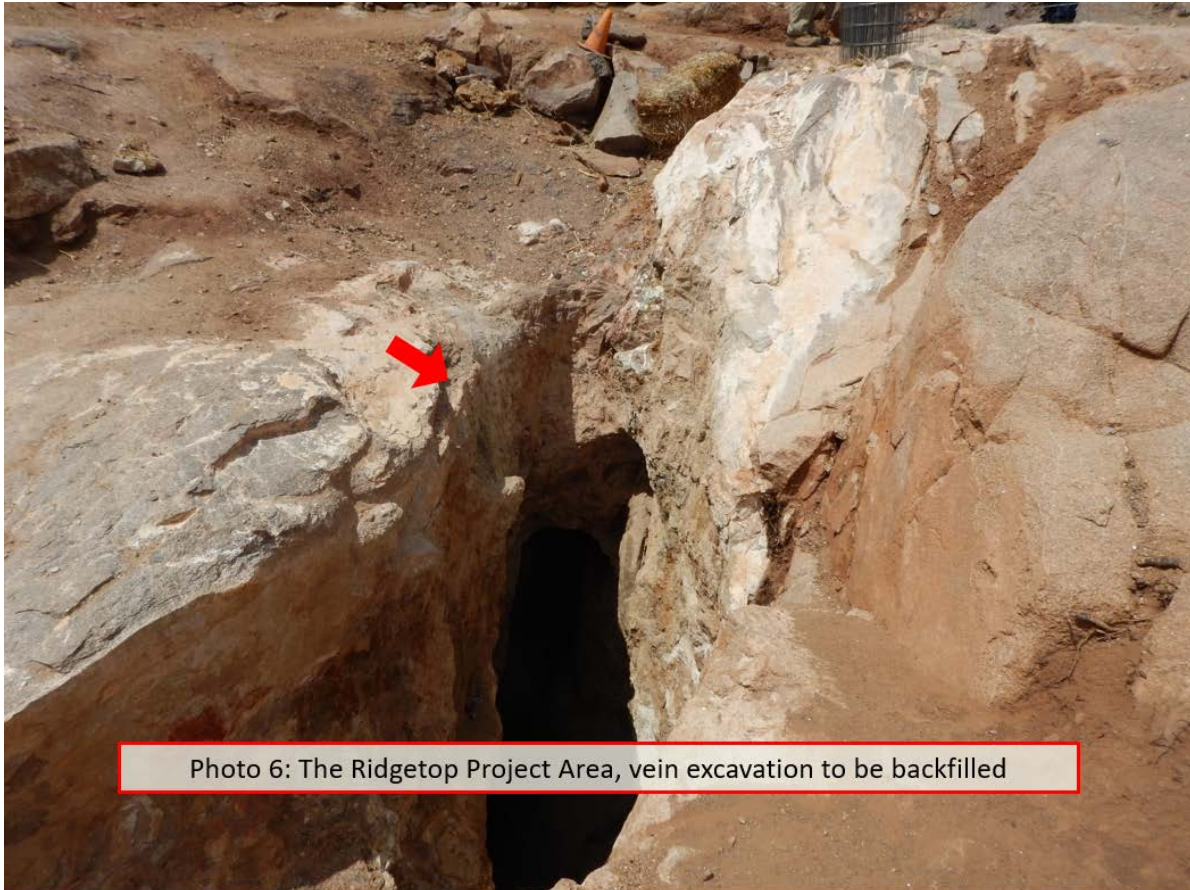
Photo 6: The Ridgetop Project Area, vein excavation to be backfilled

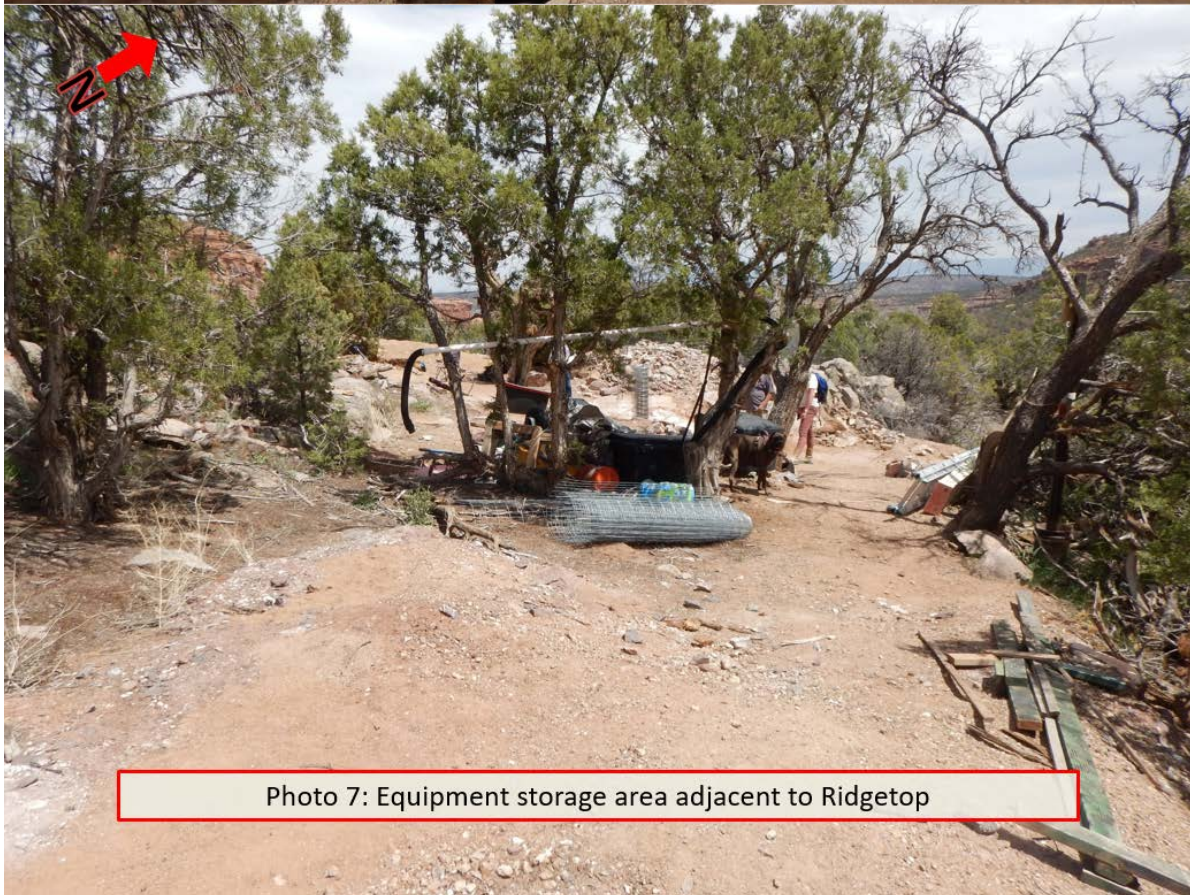
Photo 7: Equipment storage area adjacent to Ridgetop
