**MINERALS PROGRAM INSPECTION REPORT**  
**PHONE: (303) 866-3567**

<b>MINE NAME:</b> Knox Pit	<b>MINE/PROSPECTING ID#:</b> M-2017-036	<b>MINERAL:</b> Sand and gravel	<b>COUNTY:</b> Larimer
<b>INSPECTION TYPE:</b> Surety-Related Inspection	<b>INSPECTOR(S):</b> Brock Bowles	<b>INSP. DATE:</b> May 5, 2022	<b>INSP. TIME:</b> 13:30
<b>OPERATOR:</b> Loveland Ready-Mix Concrete, Inc.	<b>OPERATOR REPRESENTATIVE:</b> Stephanie Fancher-English	<b>TYPE OF OPERATION:</b> 112c - Construction Regular Operation	
<b>REASON FOR INSPECTION:</b> Surety Related	<b>BOND CALCULATION TYPE:</b> None	<b>BOND AMOUNT:</b> \$788,900.00	
<b>DATE OF COMPLAINT:</b> NA	<b>POST INSP. CONTACTS:</b> None	<b>JOINT INSP. AGENCY:</b> None	
<b>WEATHER:</b> Clear	<b>INSPECTOR'S SIGNATURE:</b>

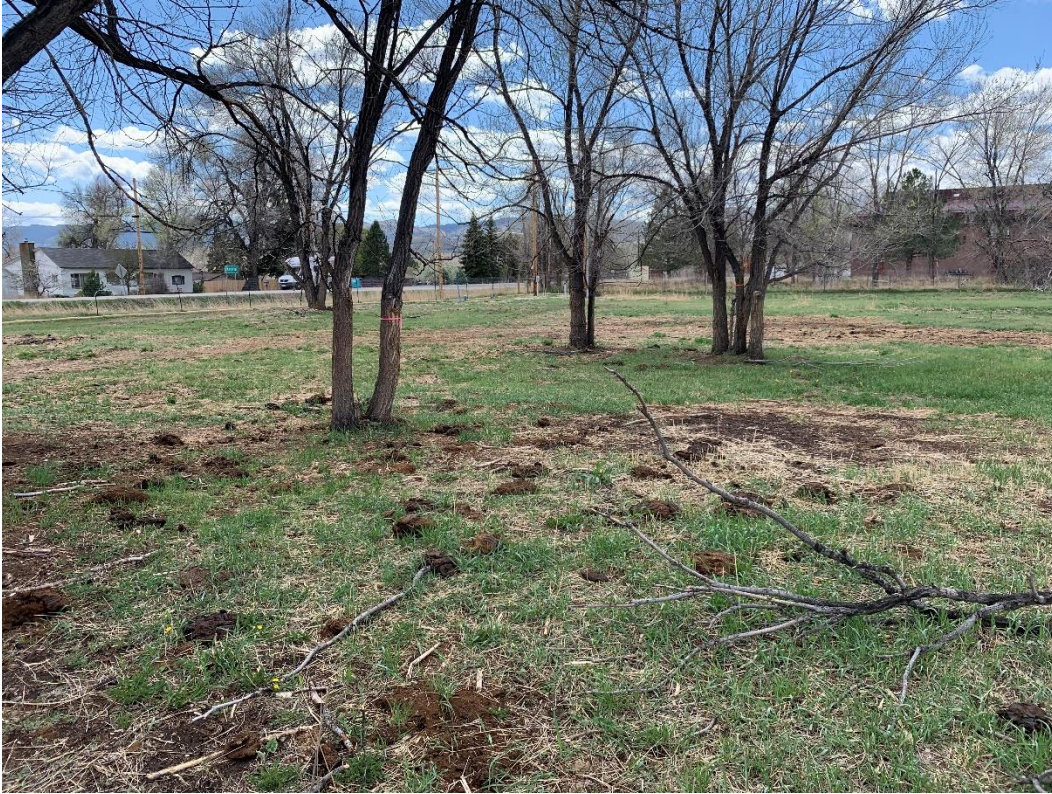
The Operator is proposing to release 2.5 acres in the southwest corner of the permit area (figure 1) and donating it to the local fire department. The area contains grasses, trees and debris from cattle, and appears to be in the same condition as the original permit description (photo 1). The proposed area has not been disturbed by mining activity and is currently being used to graze cattle. The Division has no issues with the 2.5 acres in the southwest corner being released from the permit boundary. This Division will propose its decision under separate cover.

Photo 1 – Proposed release area facing southwest

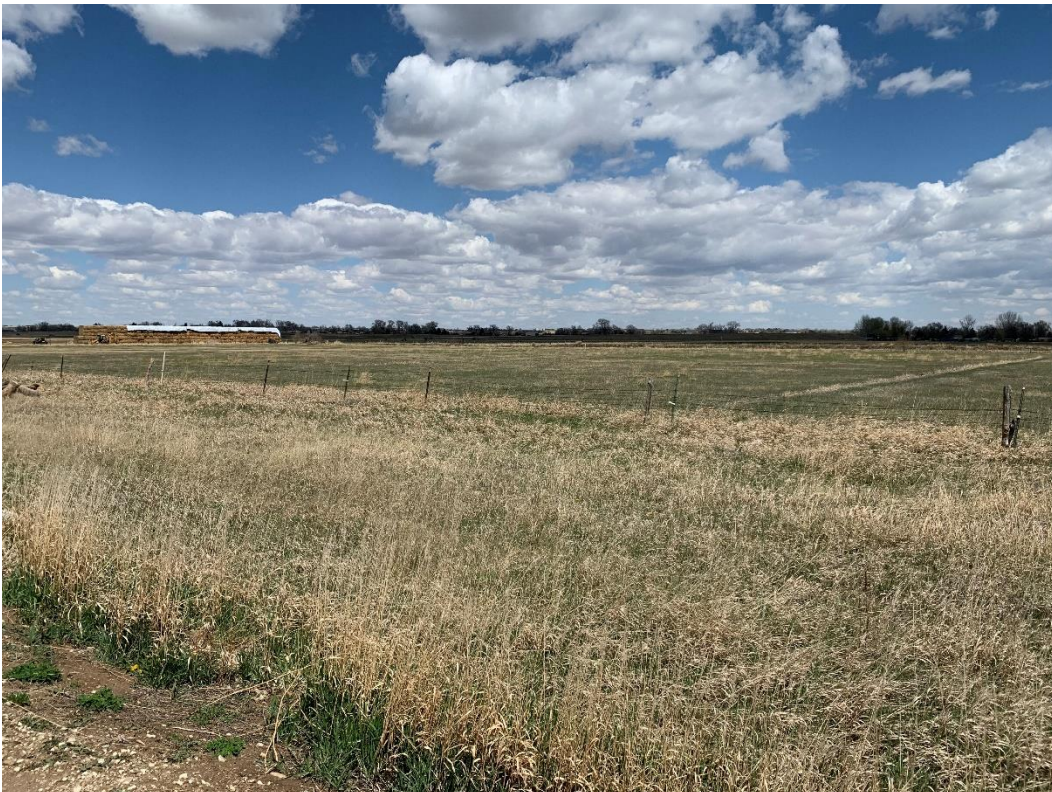
A normal routine monitoring inspection was also conducted to inspect the remainder of the site. The mine entrance sign was in place facing US 287B. The permit boundary was fenced on all four sides (photo 2). The approved haul road and entrance has not been installed yet and the detention pond in the southeast corner has not been installed (photo 3).

Photo 2 – Eastern permit boundary fenceline

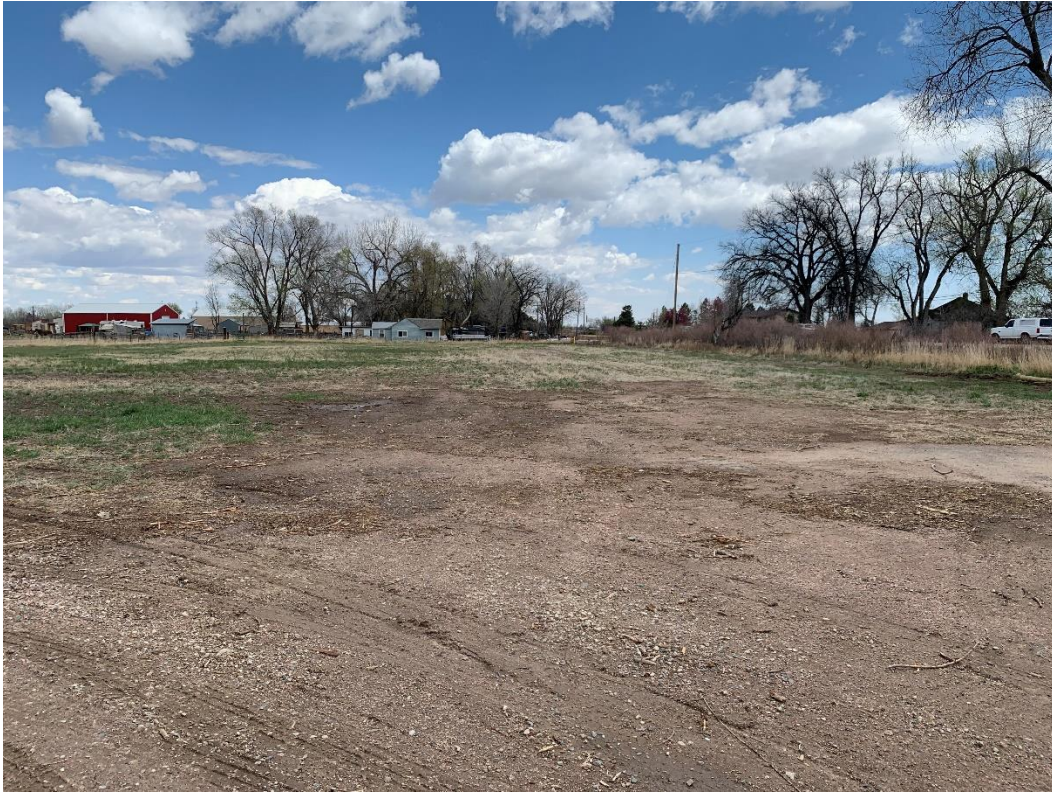
Photo 3 – Southeast corner of the permit boundary

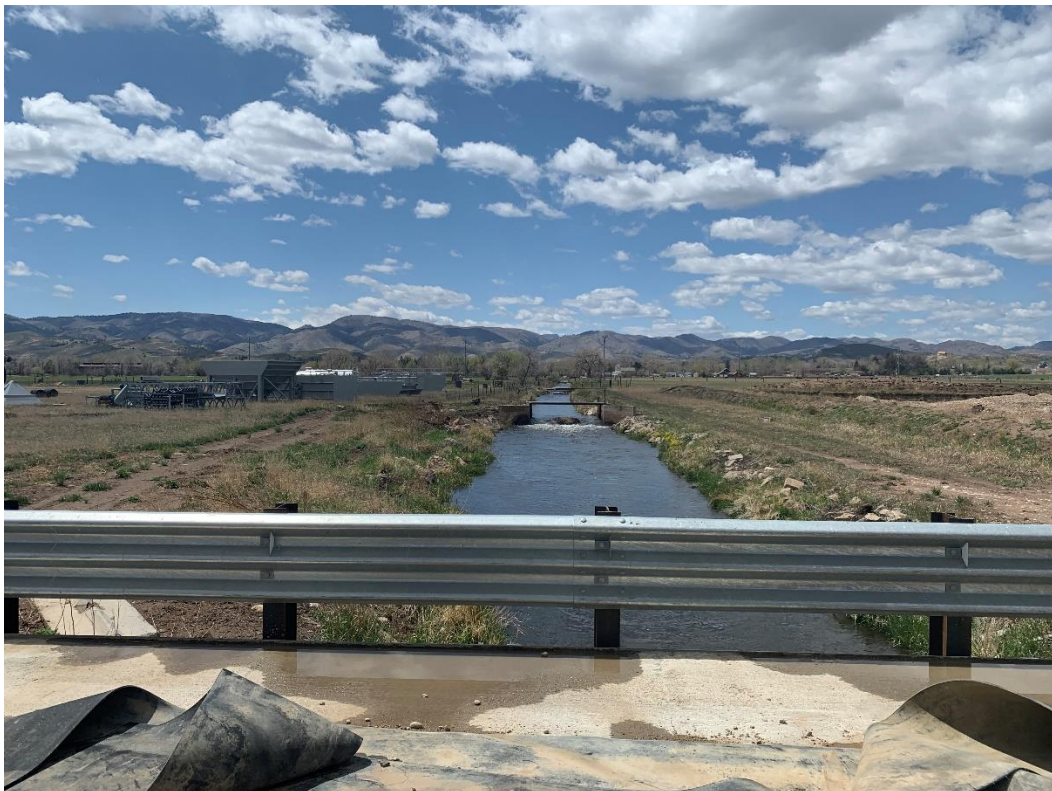
The structures for the concrete batch plant have been delivered to the site and are being stored on the south side of the Little Cache La Poudre Ditch (photo 4). Construction has begun on the water management pond in the northeast area (photo 5). A drainage ditch was constructed in the bottom of the water management pond. An electric pump was pumping the water to the southwest field (photo 6).

Photo 4 – Batch plant parts next to ditch, photo facing west.

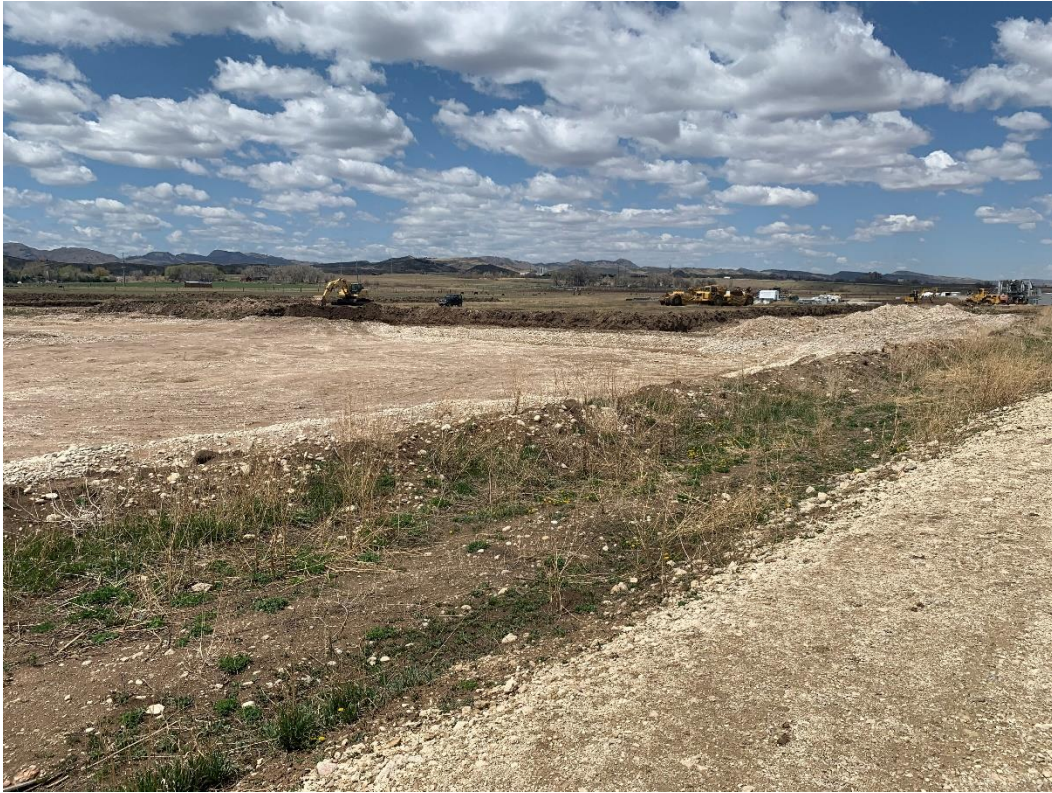
Photo 5 – Construction of the water management pond

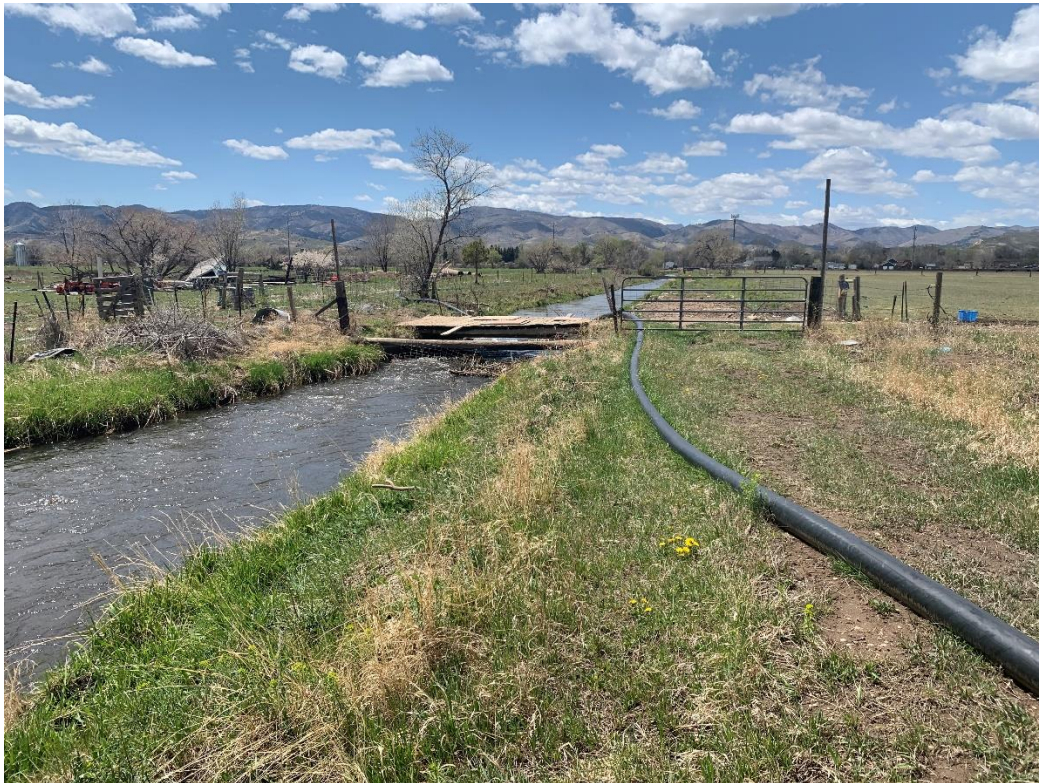
Photo 6 – Water line from water management pond to southwest field.

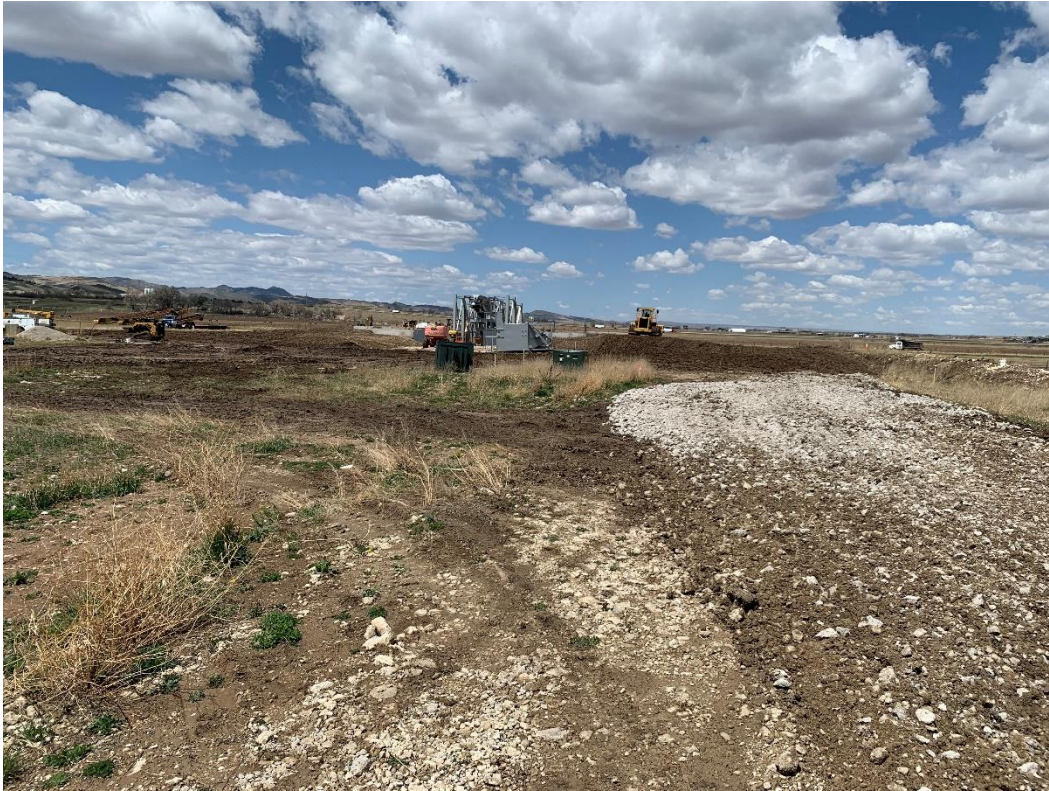
The foundation for the concrete batch plant has been poured and the lower section of the plant has been installed (photo 7).

Photo 7 – Concrete batch plant construction
