MINERALS PROGRAM INSPECTION REPORT
PHONE: (303) 866-3567

MINE NAME: T Bone Stone Quarry	MINE/PROSPECTING ID#: M-2004-030	MINERAL: Stone	COUNTY: Boulder
INSPECTION TYPE: Monitoring	INSPECTOR(S): Patrick Lennberg	INSP. DATE: May 5, 2022	INSP. TIME: 09:00
OPERATOR: T Bone Stone, Inc.	OPERATOR REPRESENTATIVE: Bill Tenore	TYPE OF OPERATION: 112c - Construction Regular Operation	
REASON FOR INSPECTION: Normal I&E Program	BOND CALCULATION TYPE: Complete Bond	BOND AMOUNT: \$68,574.00	
DATE OF COMPLAINT: NA	POST INSP. CONTACTS: None	JOINT INSP. AGENCY: None	
WEATHER: Clear	INSPECTOR'S SIGNATURE:

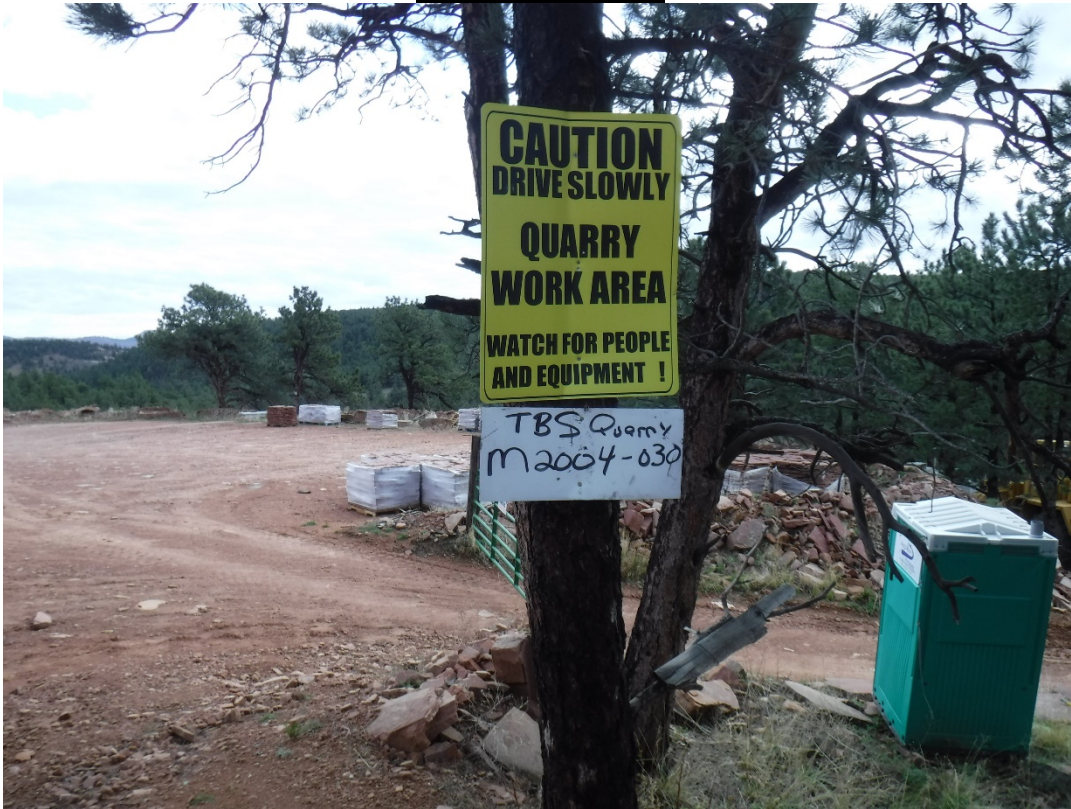
Photo 1: Mine sign at the primary mine entrance

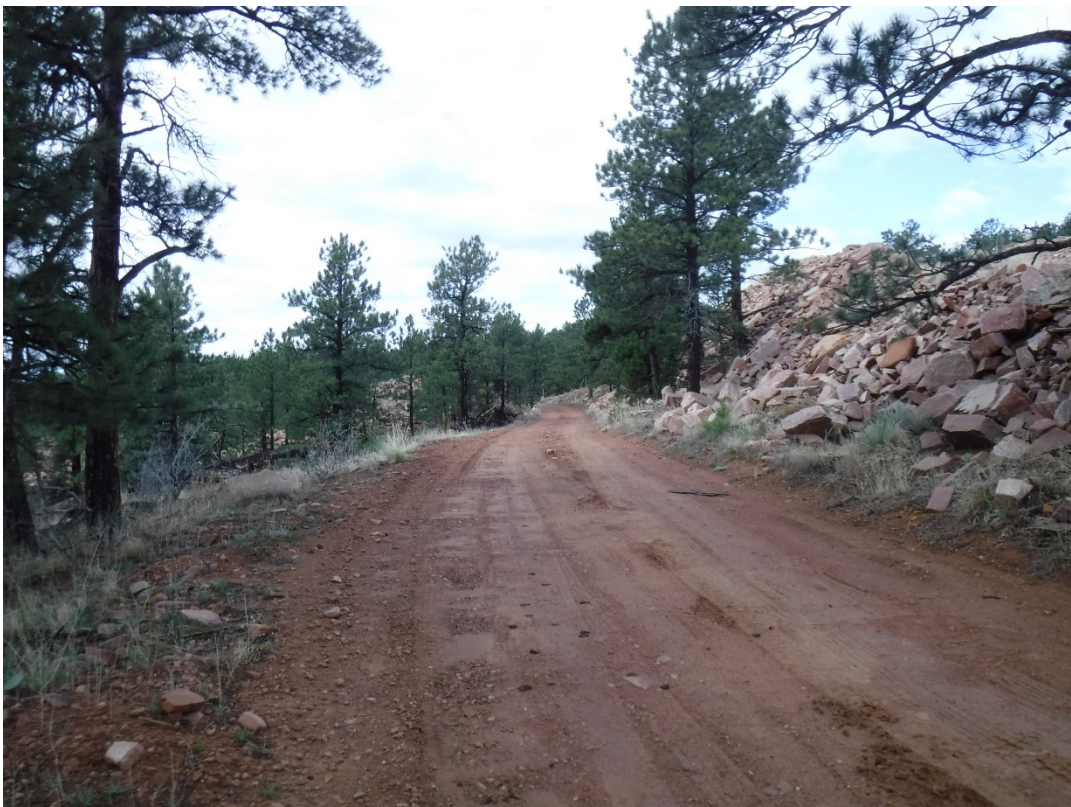
Photo 2: Road leading to mine site, looking south from mine sign

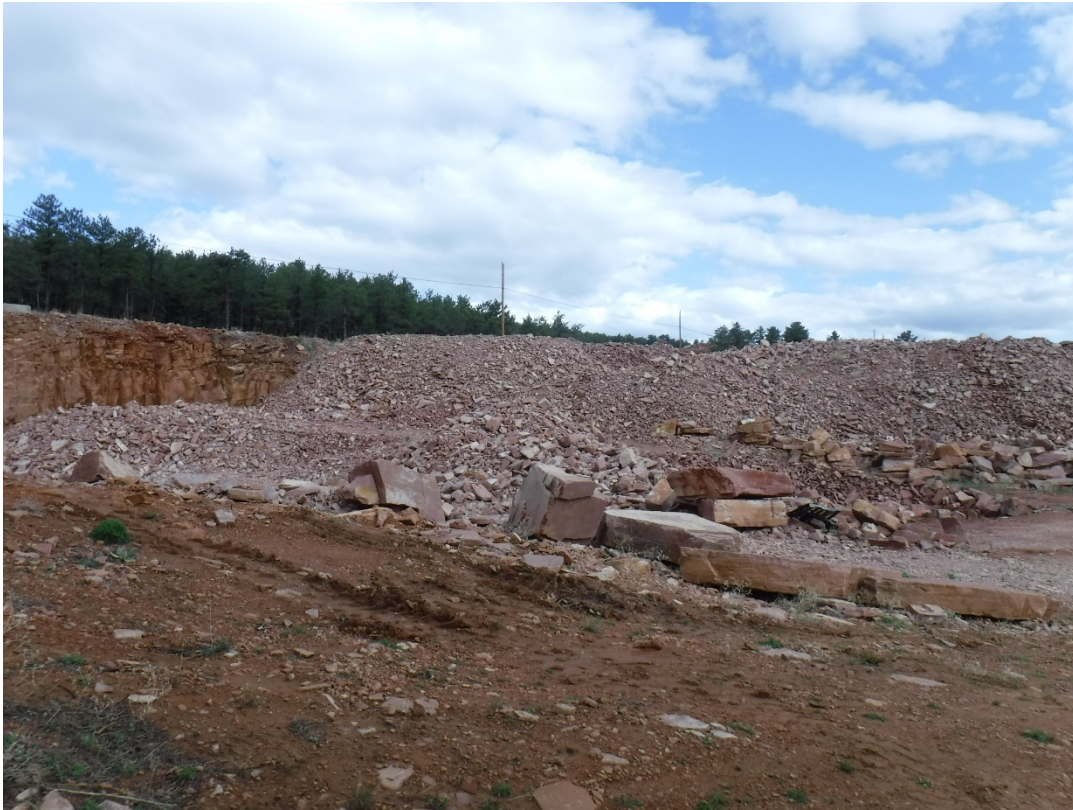
Photo 3: Looking at north quarry area, material to the north of pit available for backfill

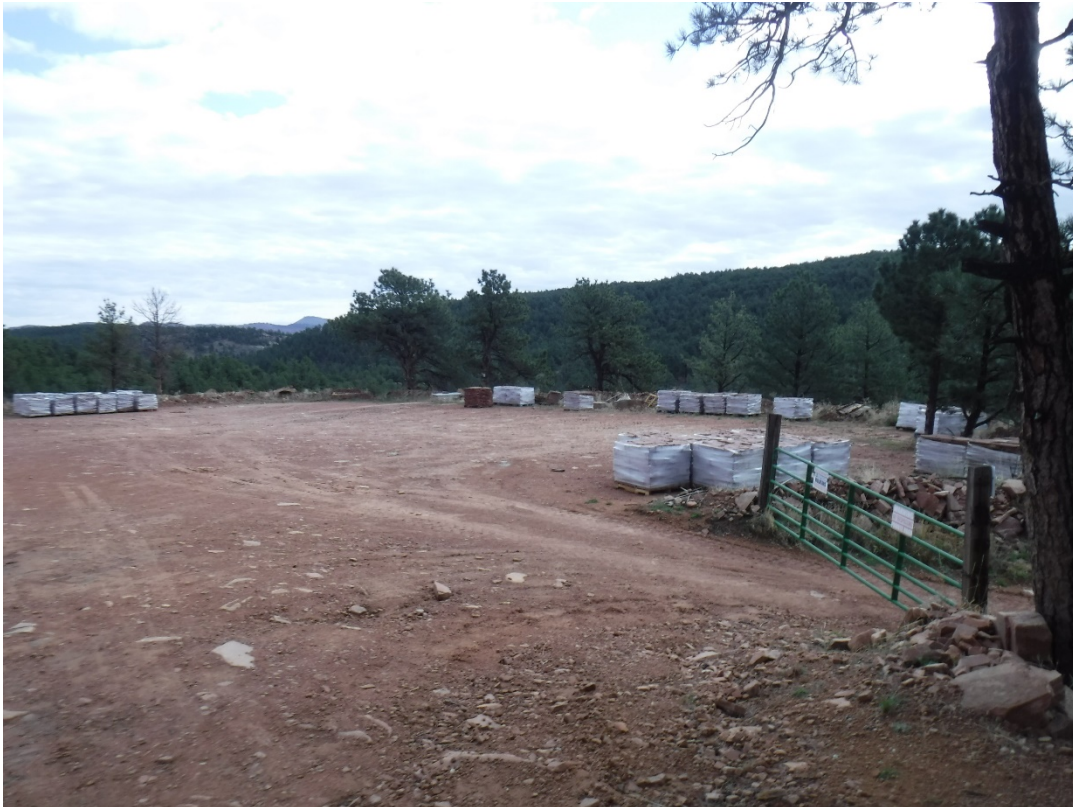
Photo 4: Storage area to the east of north quarry

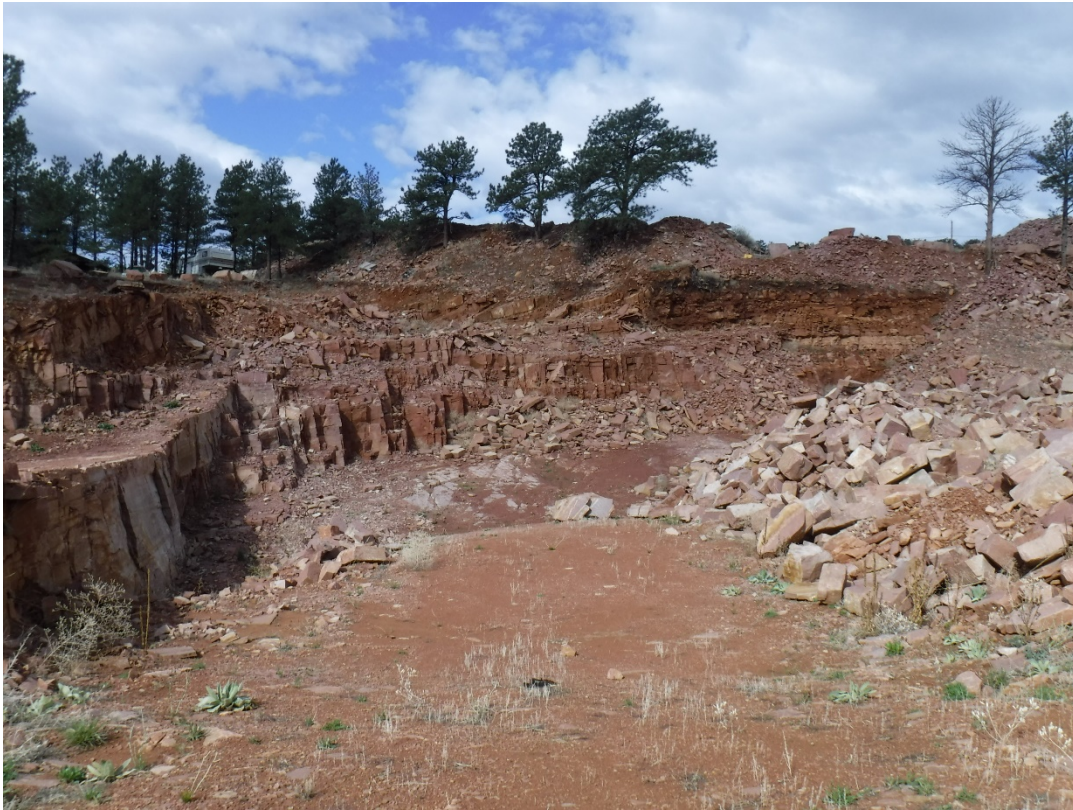
Photo 5: East quarry area

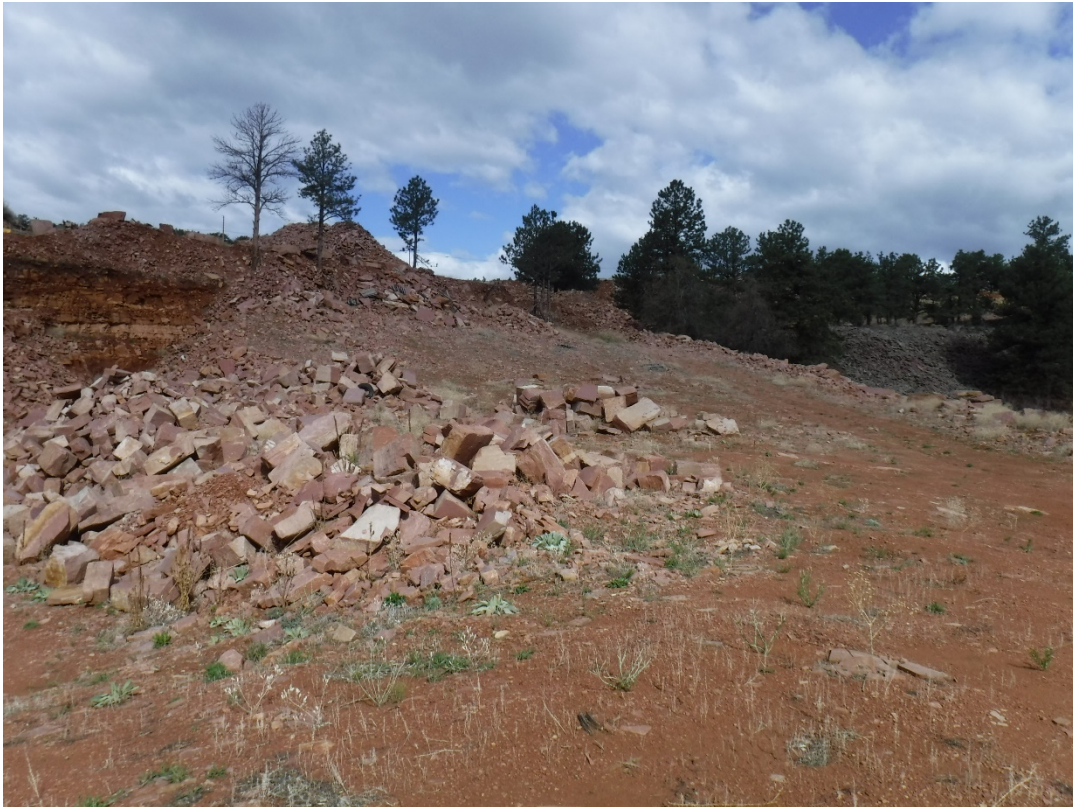
Photo 6: North of the east quarry area partially reclaimed

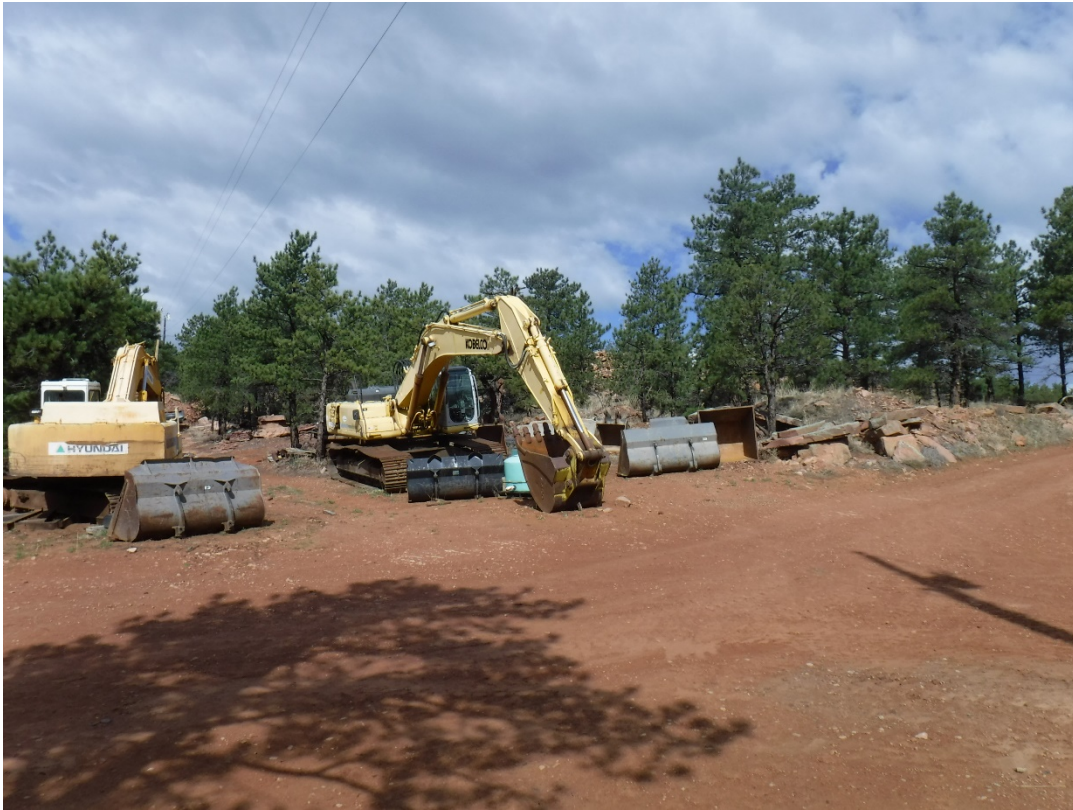
Photo 7: Equipment laydown area adjacent to south quarry area

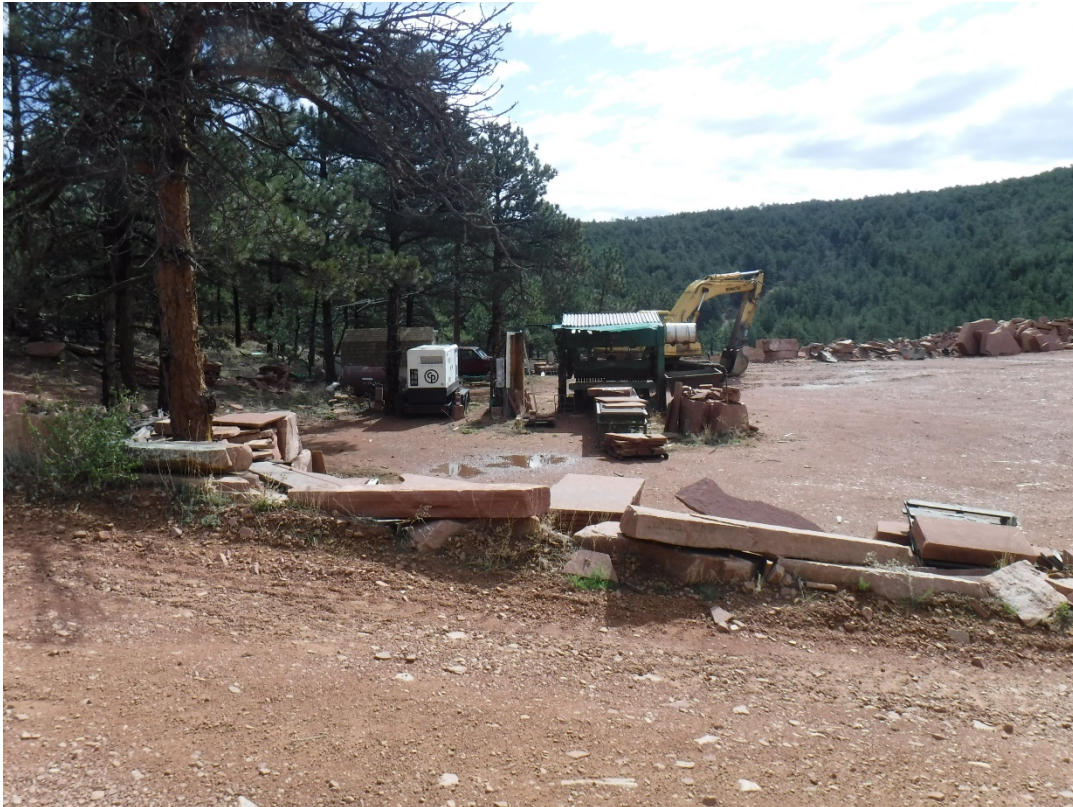
Photo 8: Stone processing area

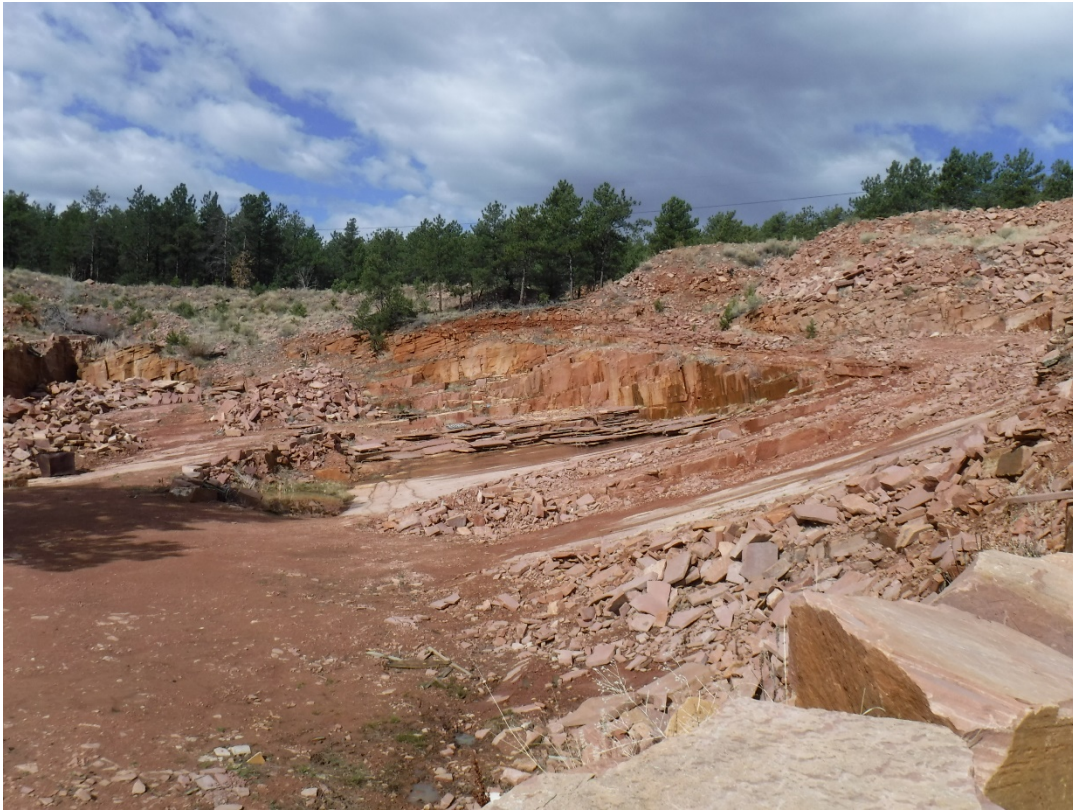
Photo 9: South quarry area

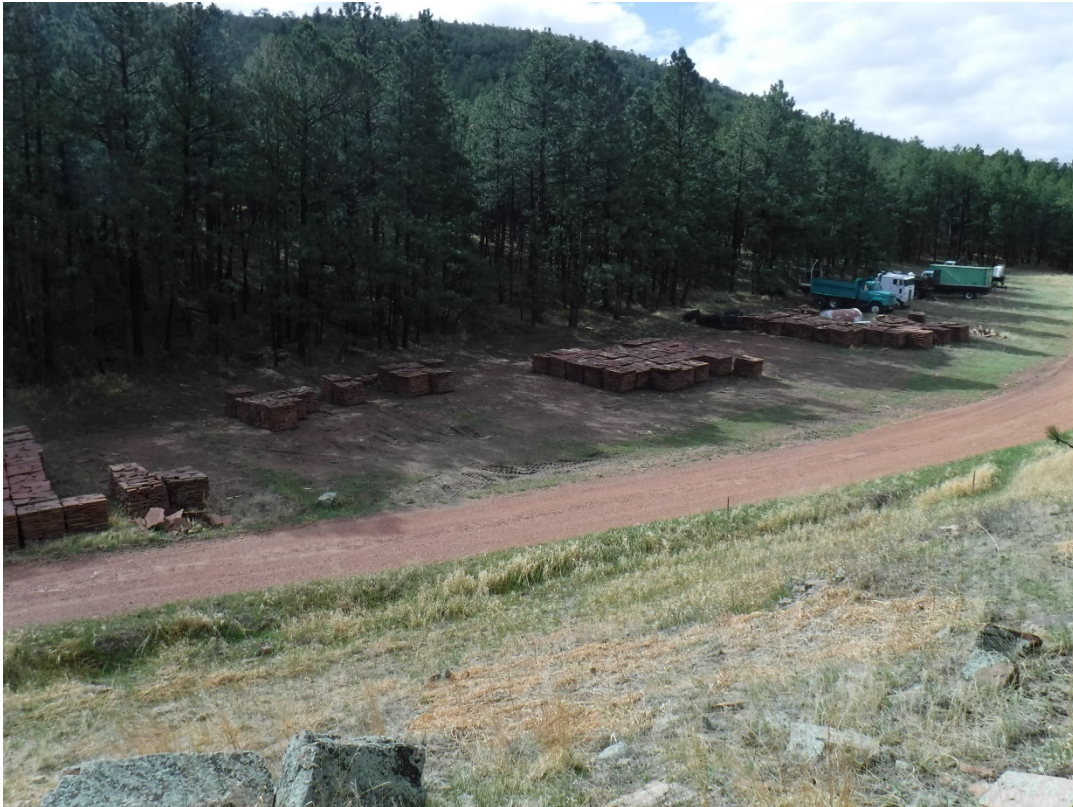
Photo 10: Product storage area located in the southeastern portion of permit area
