May 11, 2022  
Project No.: 19125

Regarding: Daniels Sand Pit 2, Permit No. M-1973-007-SG  
Slope Stability Monthly Monitoring Report

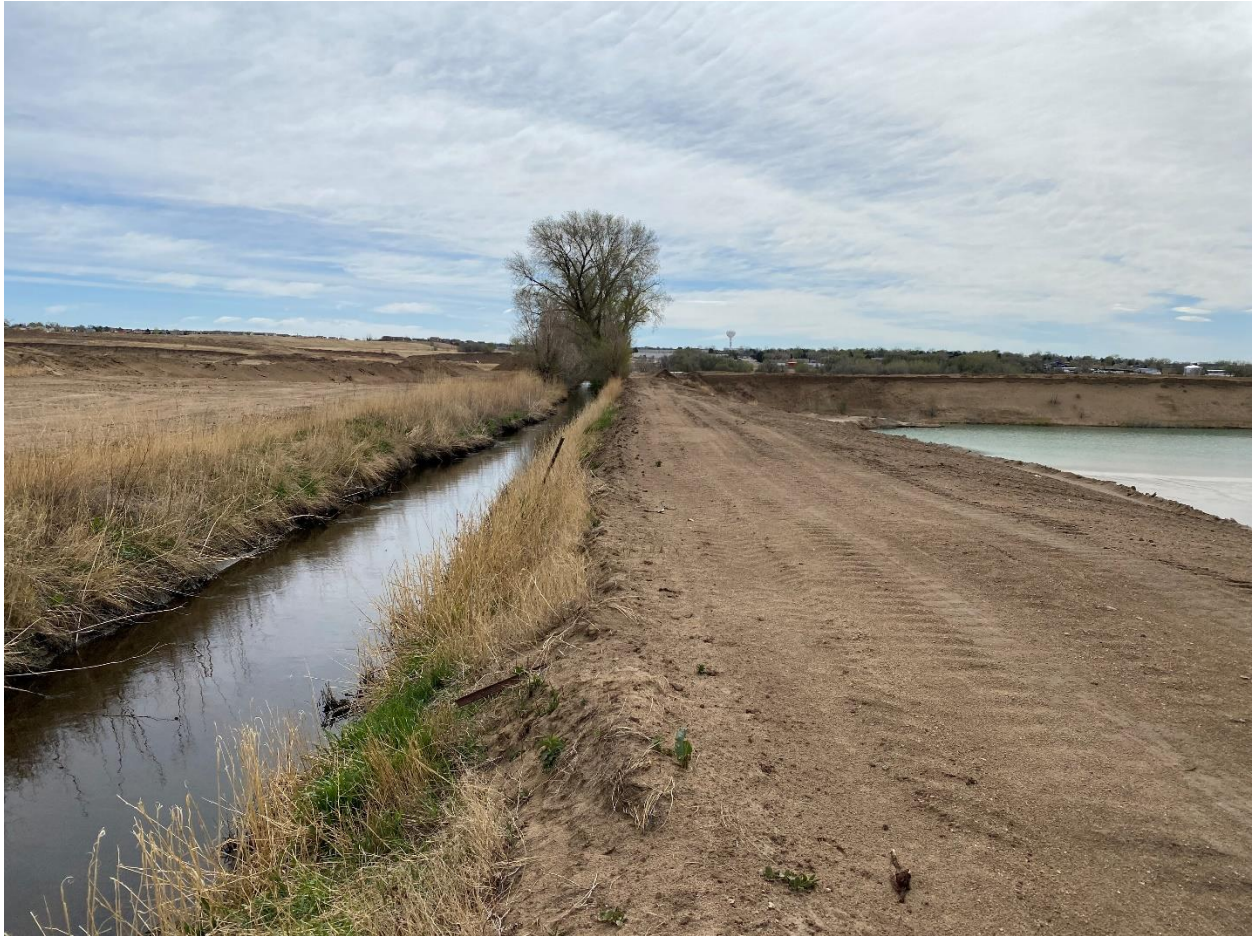
Photo 1. Fountain Mutual Ditch looking east with buttress slope

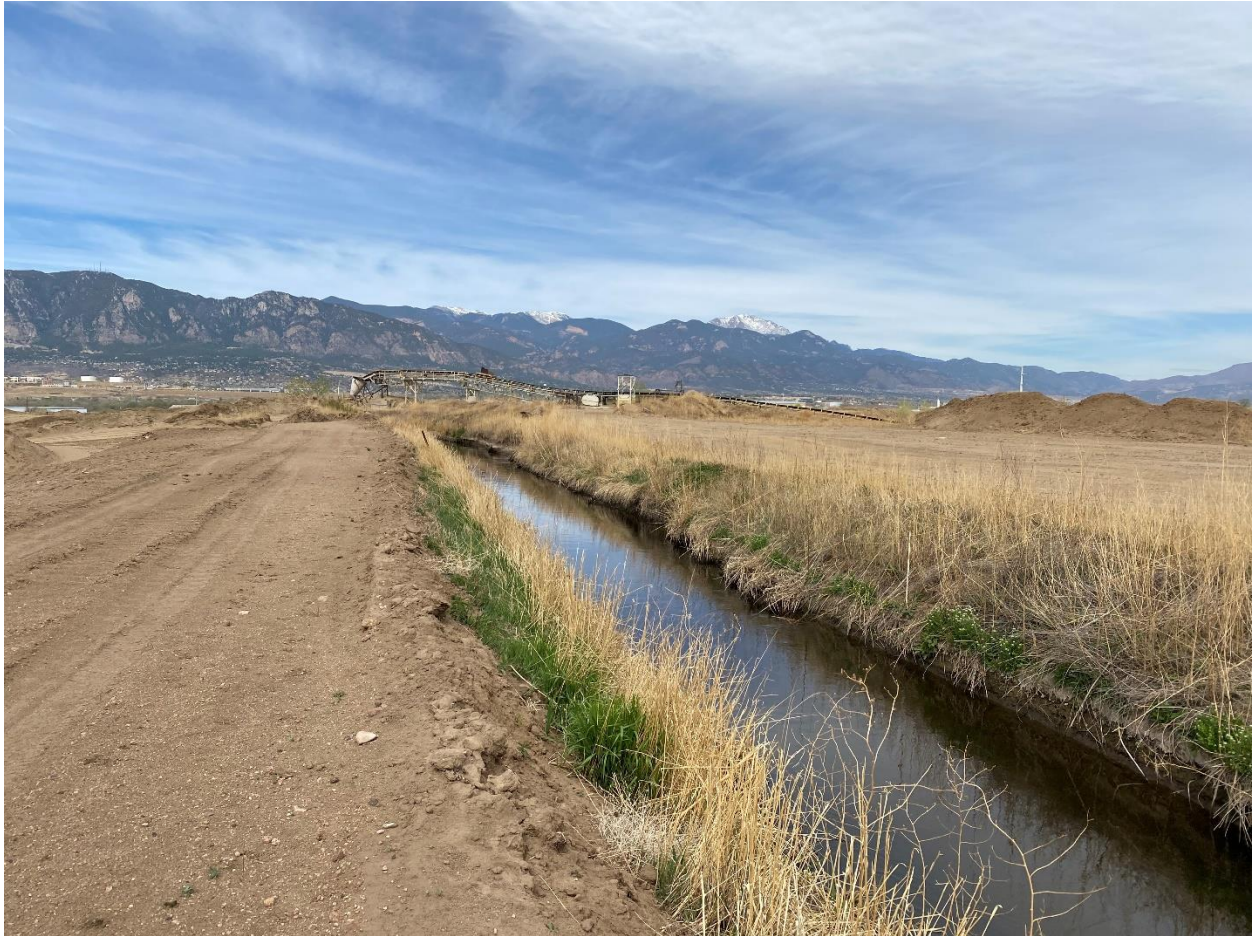
Photo 2. Fountain Mutual Ditch looking west

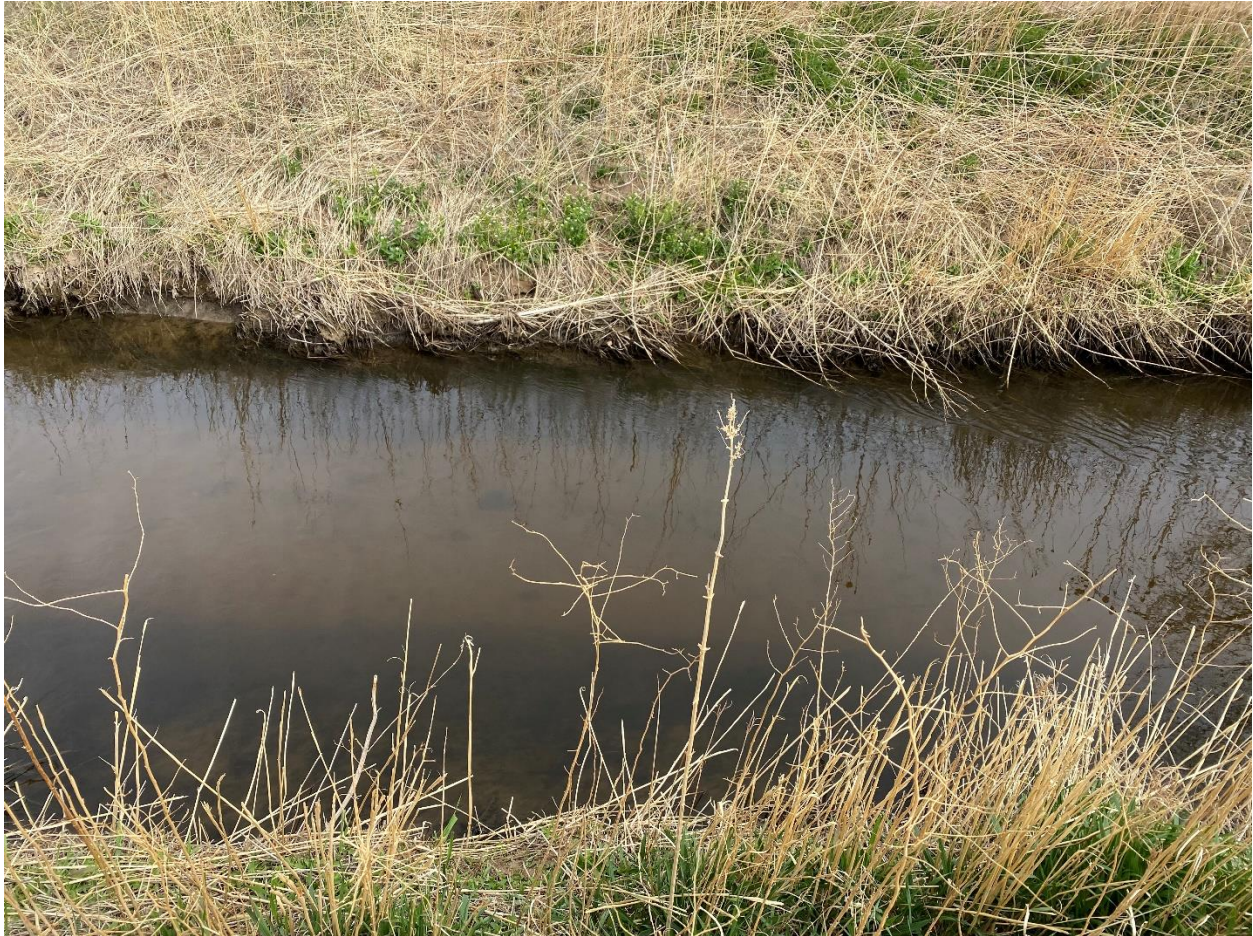
Photo 3. Fountain Mutual Ditch looking north

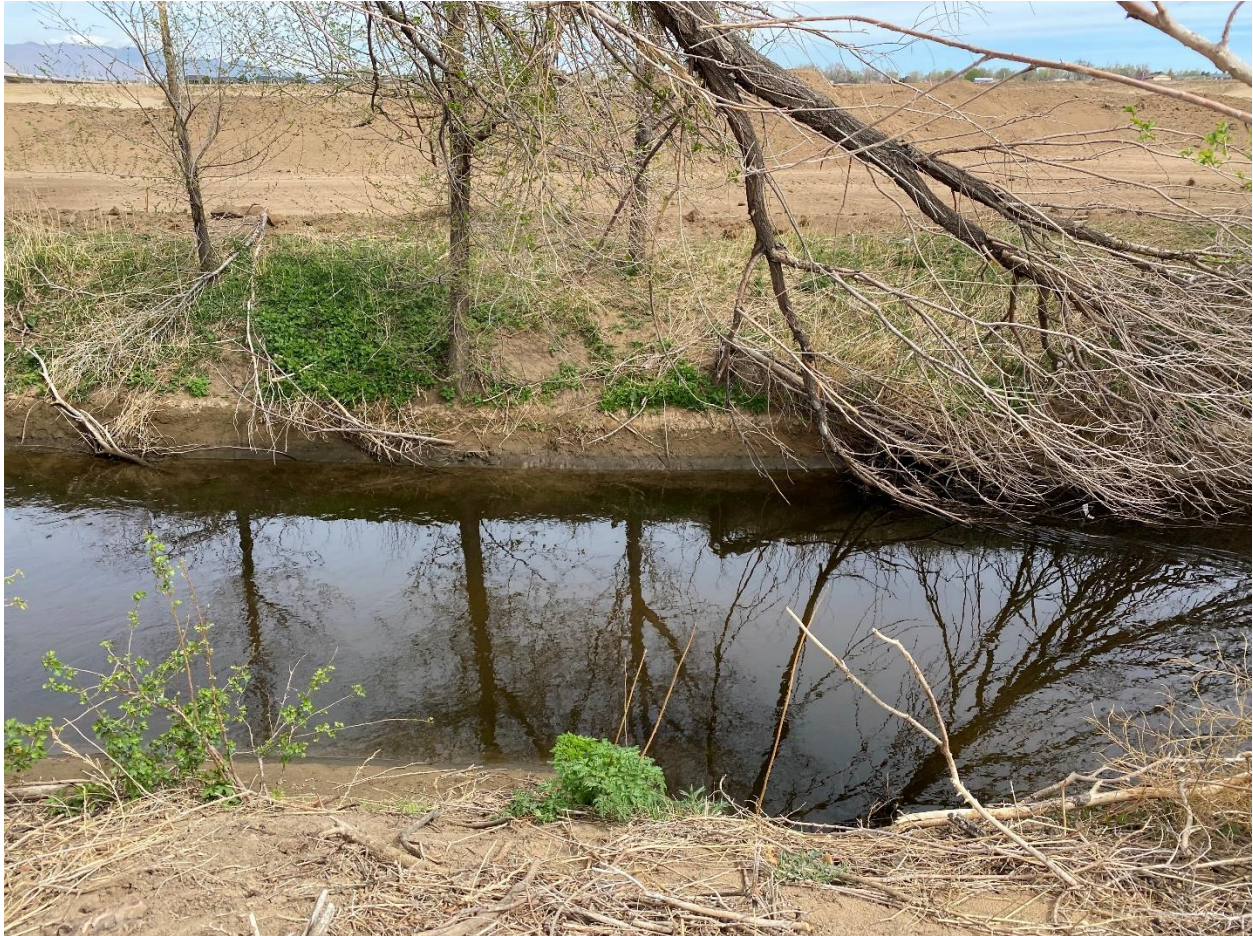
- Weather: 53-80°, sunny and clouds mixed, winds 10 mph
- Visual observation of the Fountain Mutual Ditch:
  - No tension cracks
  - No toe erosion that was visible
  - Water flowing in the ditch (~2 feet depth)
  - No sloughed slope surfaces
  - Several broken branches near crest
  - The condition of the ditch is stable

Photo 4. Fountain Mutual Ditch looking north with branches

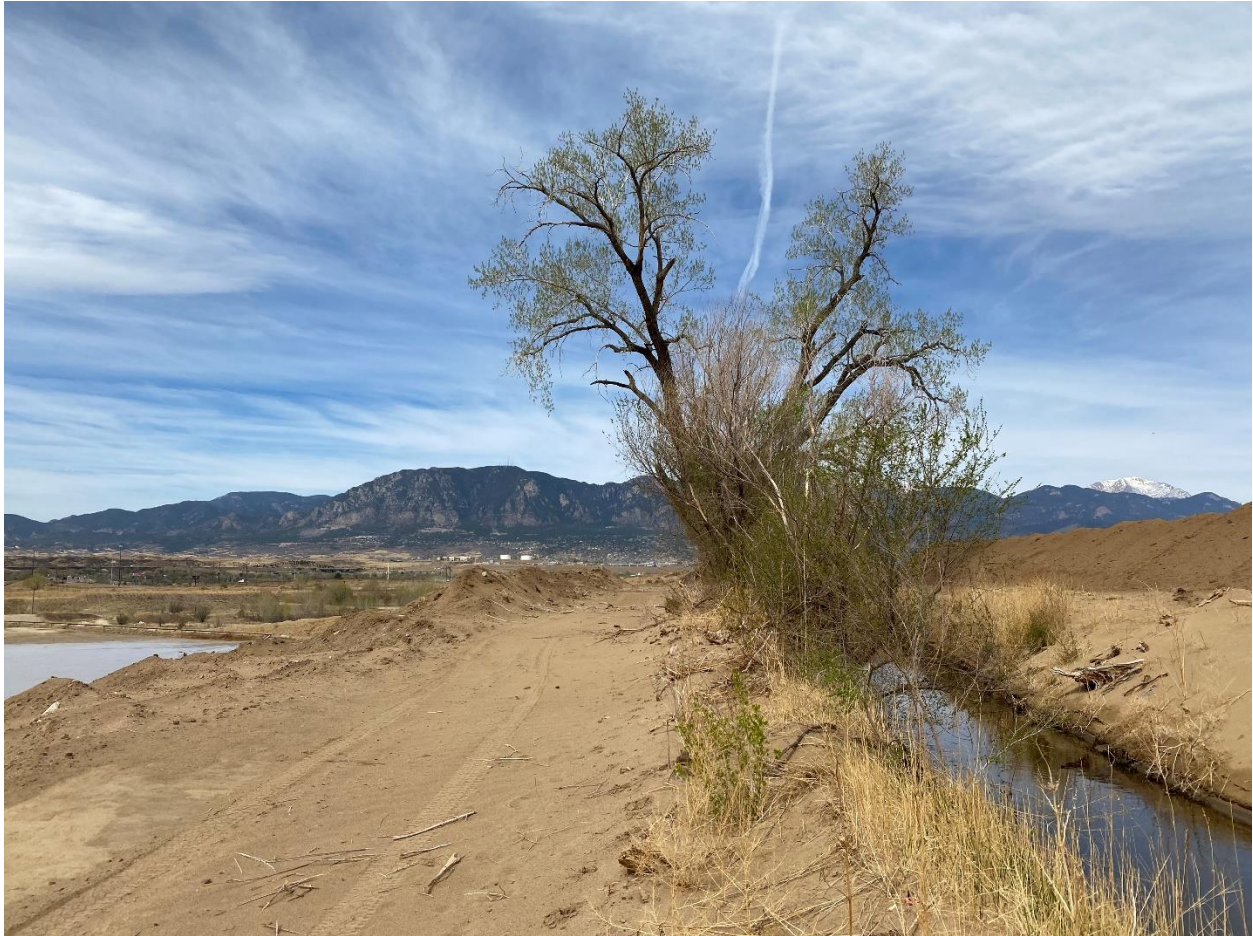
Photo 5. Buttress slope/stockpile, access road and ditch (looking west)

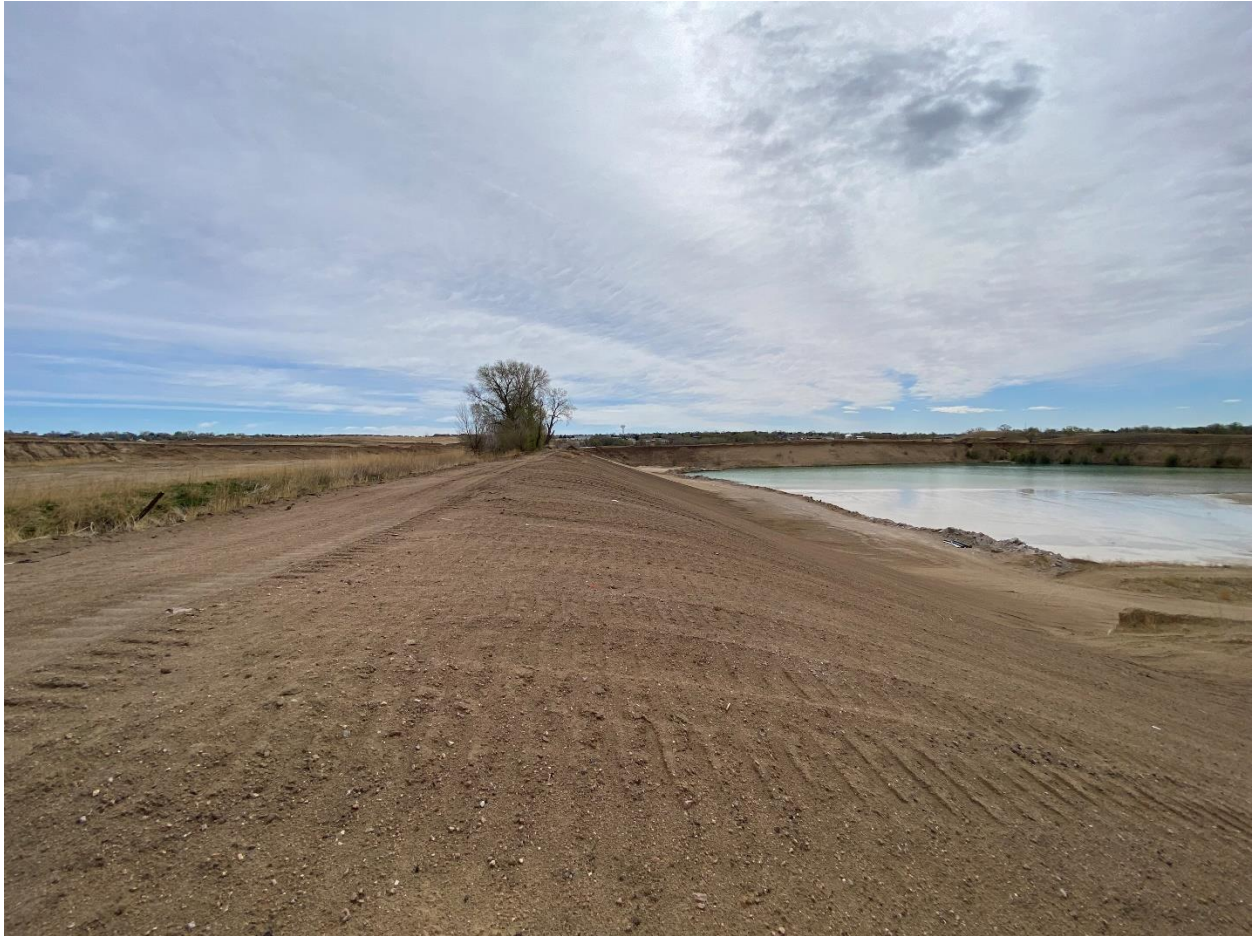
Photo 6. Buttress slope looking east from crest

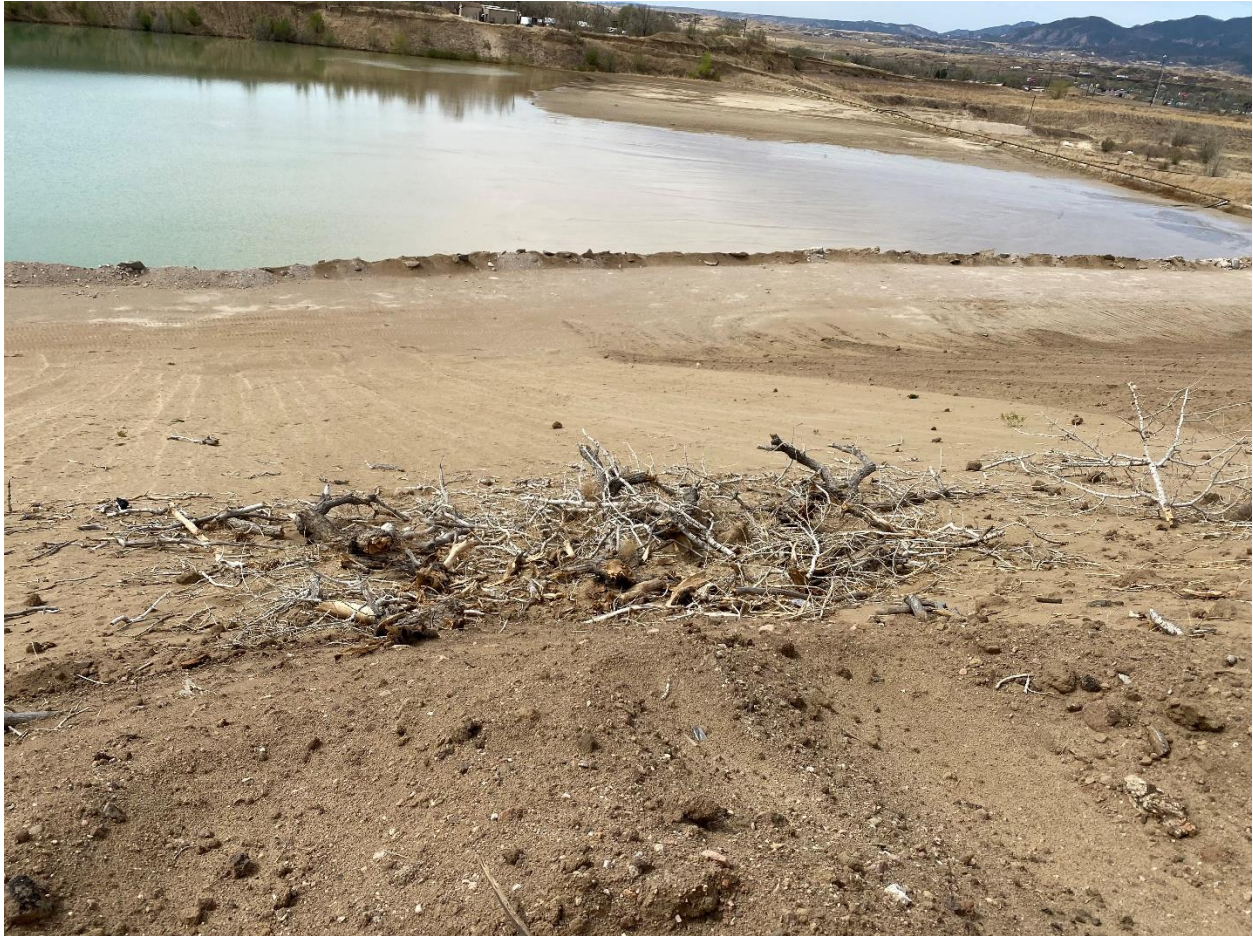
- Construction sequence
  - At this time, the buttress slope varies from 3H:1V to 4H:1V
  - Approximately 20 LF from the east needs to be placed for the final lift
  - The fallen tree has been removed from the stockpile material, however several branches remain on the eastern end of the buttress
  - Approximately 40 LF needs to be regraded near the fallen tree location

Photo 7. Butress slope looking south (note branches)

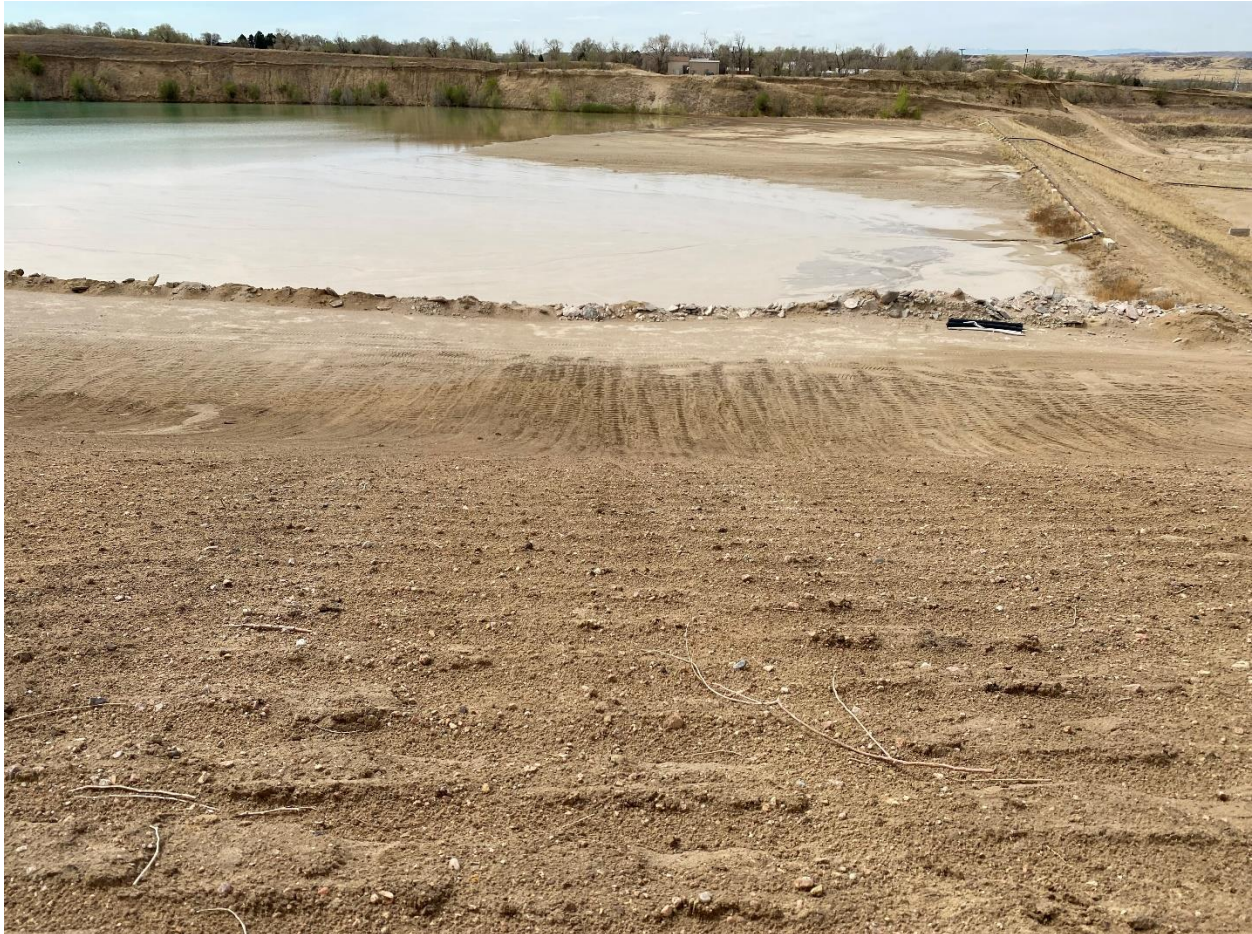
Photo 8. Buttress slope looking south

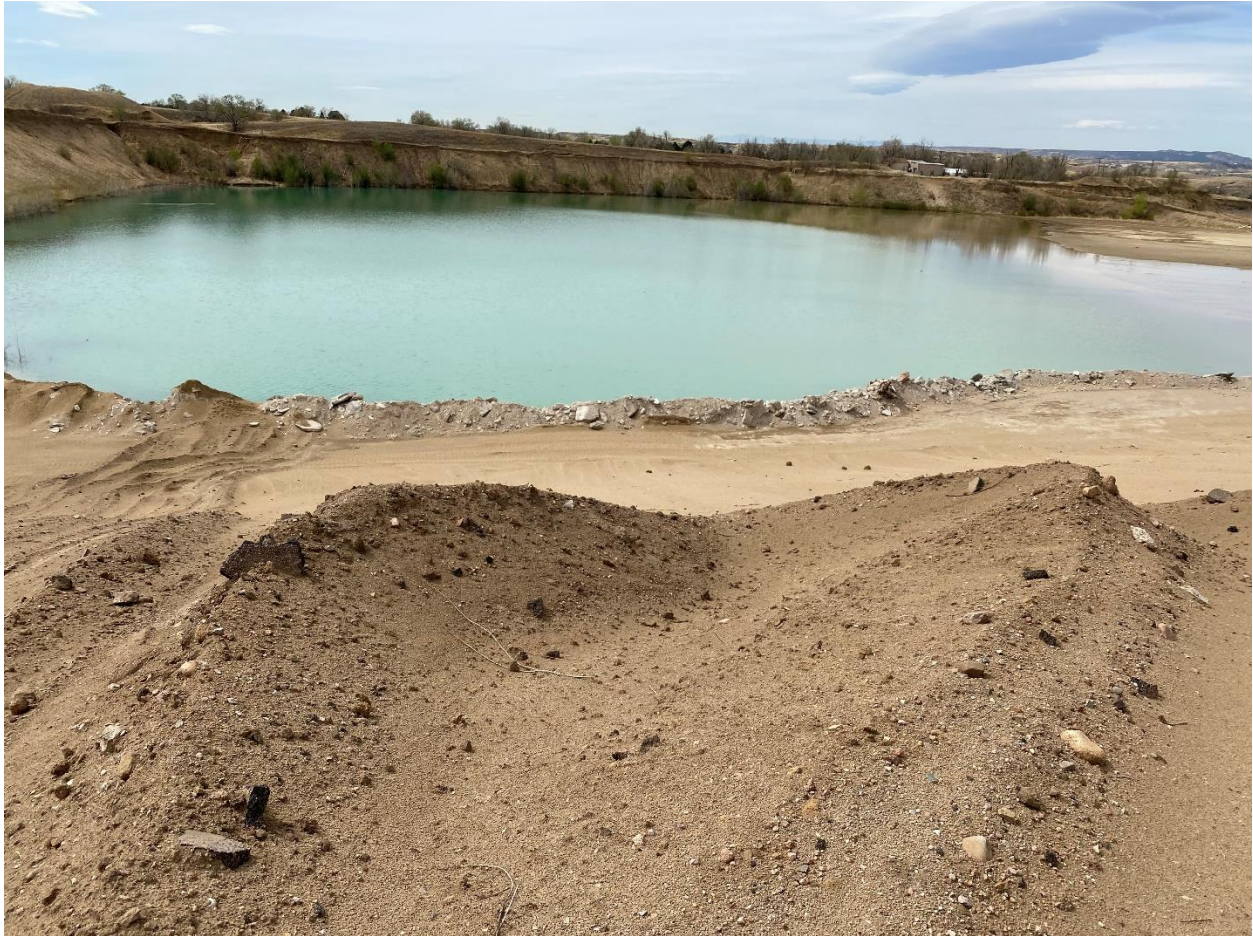
Photo 9. Butress slope looking south, area needs regrading

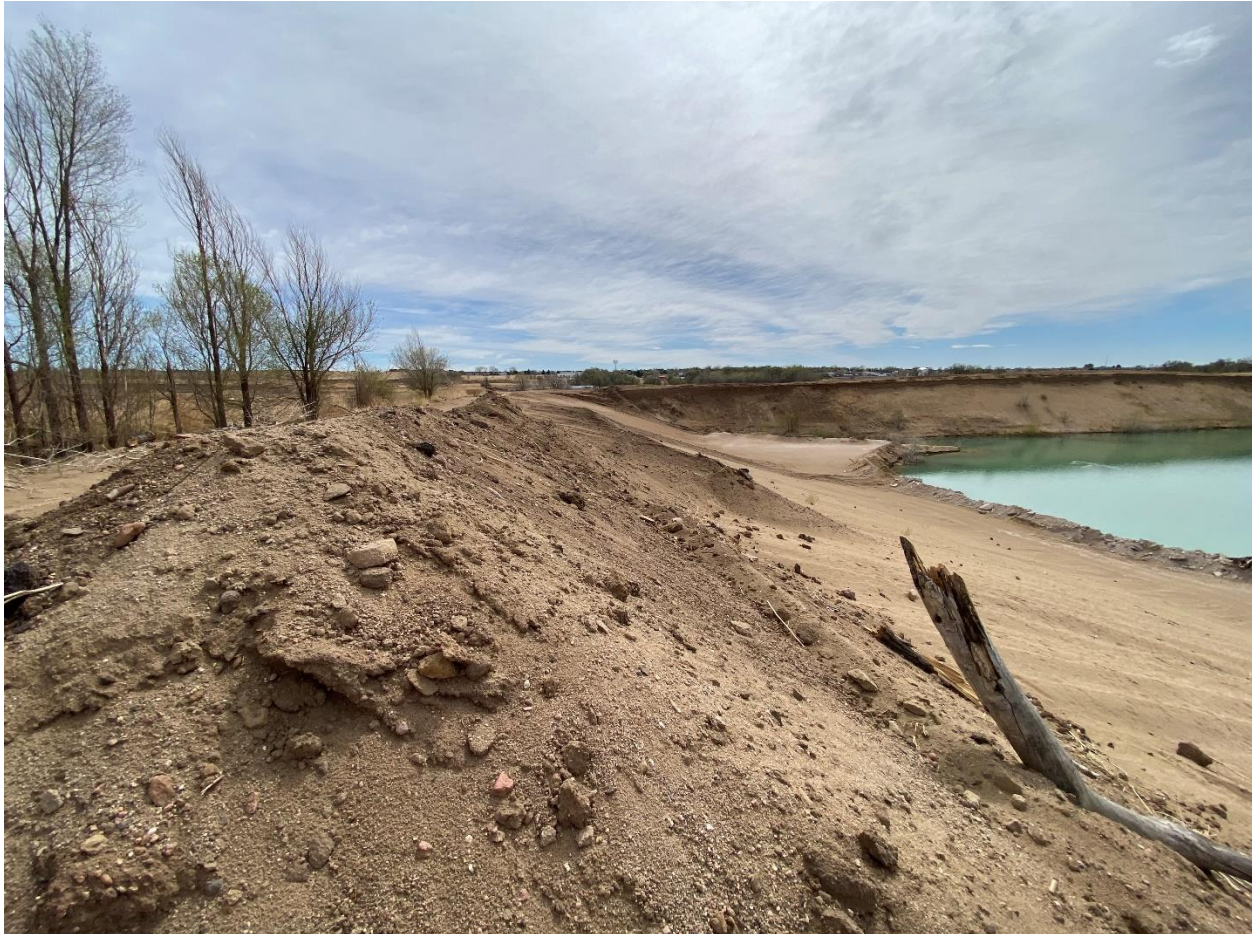
Photo 10. Buttress slope looking east, branches near stockpiled material and buttress slope
