MINERALS PROGRAM INSPECTION REPORT

MINE NAME: Del Norte West Valley Pit	MINE/PROSPECTING ID#: M-2001-069	MINERAL: Sand and gravel	COUNTY: Rio Grande
INSPECTION TYPE: Monitoring	INSPECTOR(S): Clayton Wein	INSP. DATE: May 3, 2022	INSP. TIME: 13:05
OPERATOR: Asphalt Constructors, Inc.	OPERATOR REPRESENTATIVE: Todd Stockebrand	TYPE OF OPERATION: 112c - Construction Regular Operation

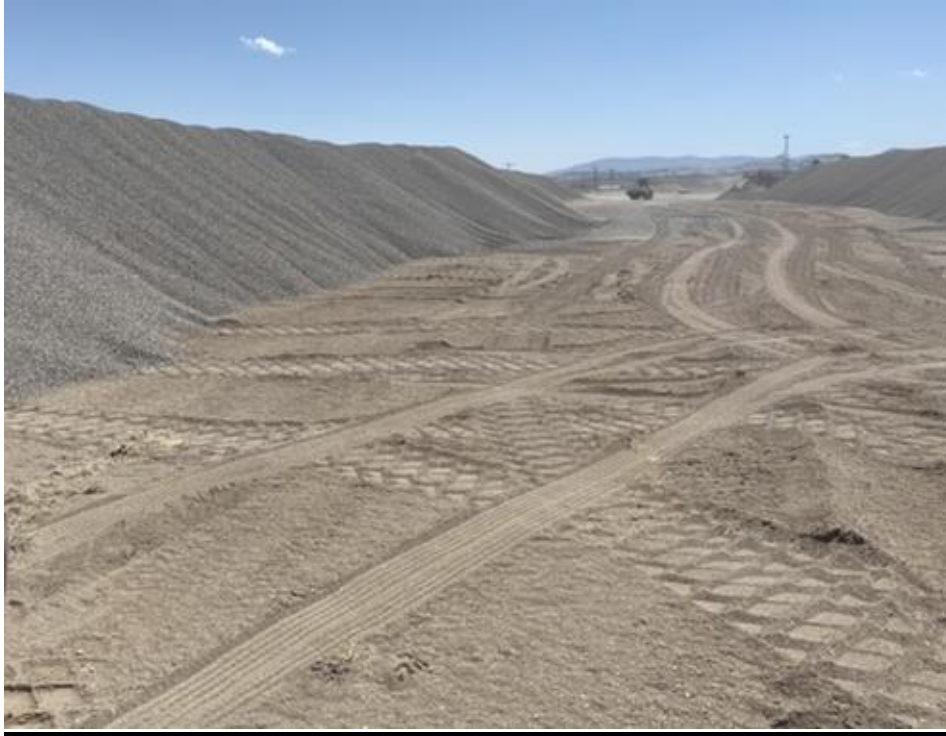
At the time of the inspection approximately 60%-70% of the Phase V mining area had been affected by stockpiled crushed material and a gravel pad placed on top of the topsoil (Photos 1 and 2). The Phase V area is 10.3 acres in size. Discussions with Mr. Stockebrand indicated that the topsoil had not been salvaged by Asphalt Paving Southern prior to the placement of the gravel pad and stockpiled materials. The stockpiled materials were placed in two large windrows extending from south to north on the Phase V area of the mine site. The stockpiles and pad stopped approximately 100 to 150 feet short of the mine permit boundaries to the north and east (Photo 3). The Phase V area of the mine site was stable and there were no indications of erosional features or off-site impacts. All mining activities observed were within the mine permit boundary. Please See Figure 1 for the location of the activities observed during the inspection.

Topsoil located on Phase V of the mine site was not salvaged and stockpiled prior to placing stockpiles of crushed materials mined from the pit.

Photo 1: The eastern windrow of stockpiled material is located on the left side of the photo. The gravel pad can be seen in between the east and west windrows. The photo was taken looking to the south.

The stockpiled crushed rock must be removed to allow topsoil to be salvaged in the Phase V area of the mine. The topsoil must be stockpiled and seeded with the approved temporary seed mix. Please submit photographic evidence to the Division of the completed corrective action no later than **June 8, 2022**. After the corrective action has been completed the operator must submit a technical revision to the Division to update the mine plan and associated maps. A new bond for the Phase V area of the mine site will be calculated and added to the bond amount for the Del Norte West Valley Pit.

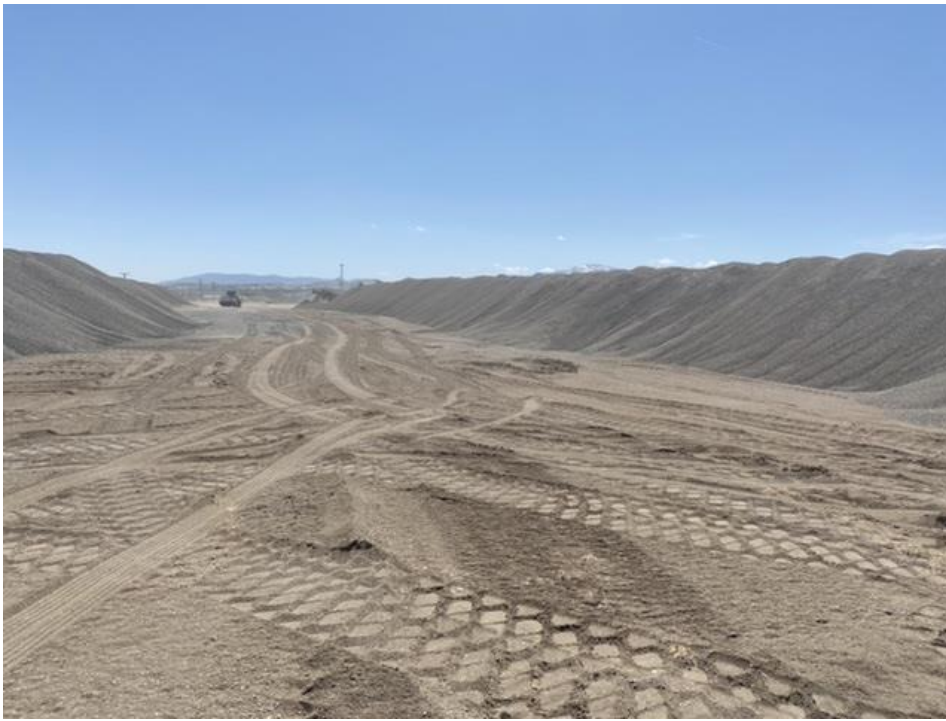
Photo 2: The western windrow of stockpiled material is located on the right side of the photo. The gravel pad noted in Photo 1 can be seen in the middle of Photo 2. The photo was taken looking to the south.

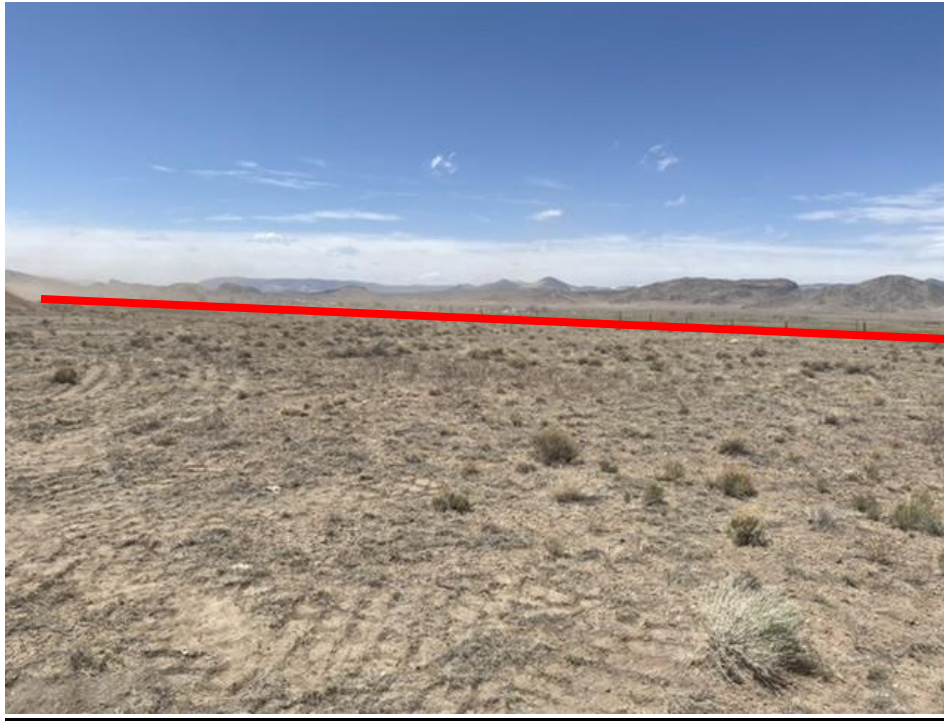
Photo 3: The Photo above was taken looking to the west-northwest at the end of the windrows on the Phase V area. The red line in the photo represents the mine site's permit boundary. There was approximately 100-150 feet of undisturbed land between the permit boundary and the disturbance created on the Phase V area of the mine site.

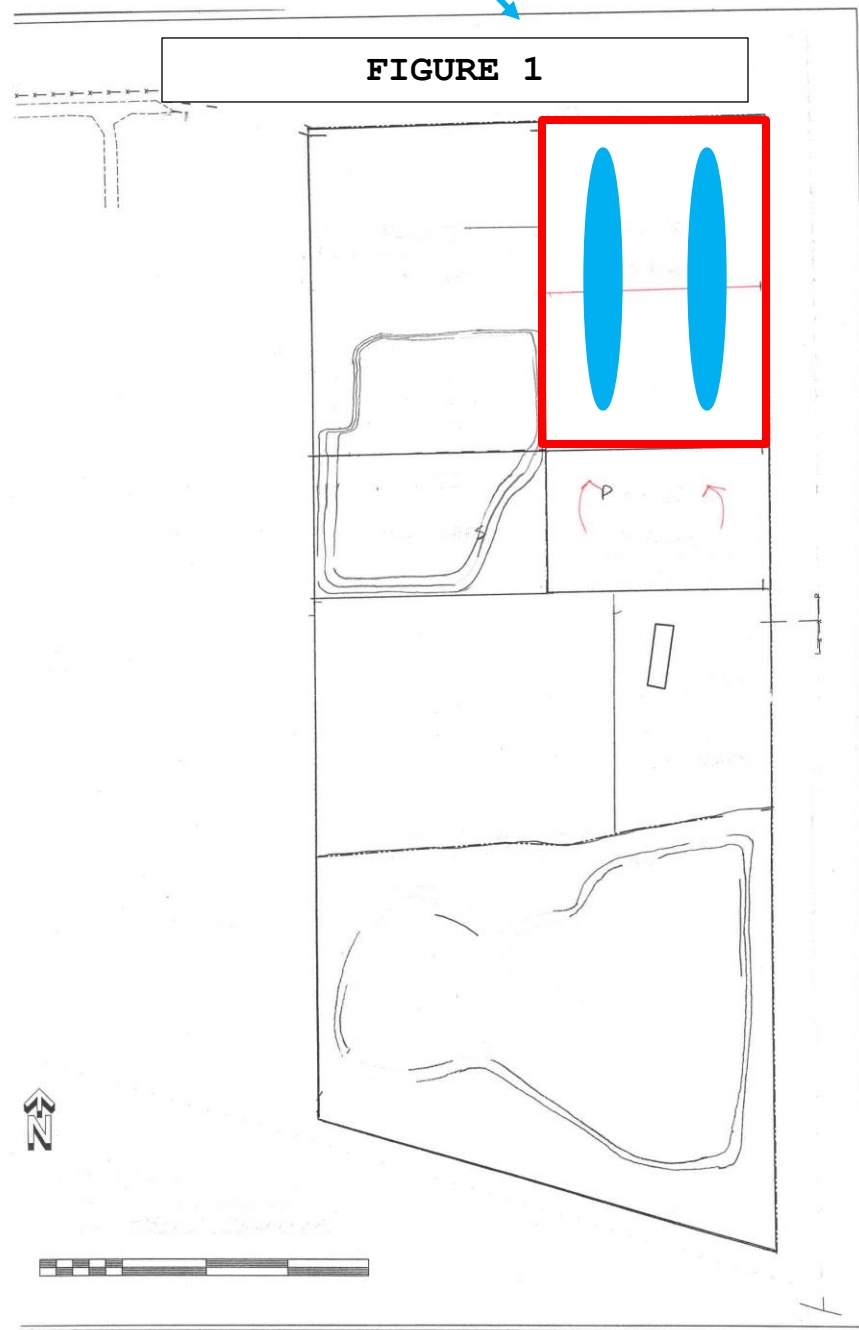
The red outline on the map below delineates the Phase V mining area. The area is 10.3 acres in size. The Blue ovals indicate the approximate location of the windrows of stockpiled material.
