PERMIT INFORMATION

Permit Number: C-1981-028					
Mine Name: Keenesburg Strip Mine	County: Weld				
Operator: Coors Energy Company	Operation Type: Surface				
Operator Address:	Permit Status: Permanent Cessation				
Mr. Ben Moline	Ownership: Private				
PO Box 4030	-				
Golden, CO 80402	Operator Representative Present:				
	None				
Operator Representative Signature: (Field Issuance Only)

INSPECTION INFORMATION

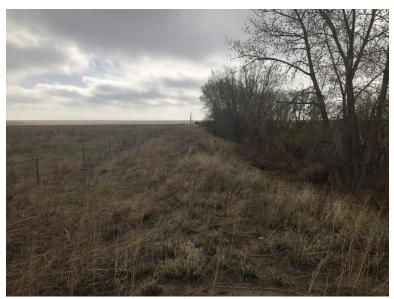
Sediment Pond 2 and the Dugout Pond contained little to no water (thick vegetation obscures the bottoms). They were not discharging during the inspection. There were no signs that either pond had discharged recently. No problems were observed.

Sediment Pond 2 embankment

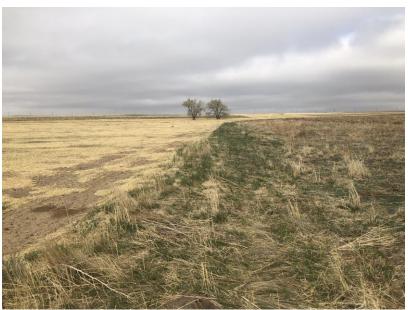
Green grass was seen emerging at several locations, including (but not limited to) Areas 37 and 42 and the Long Term Spoil Area.

Area 42 – new and older reclamation

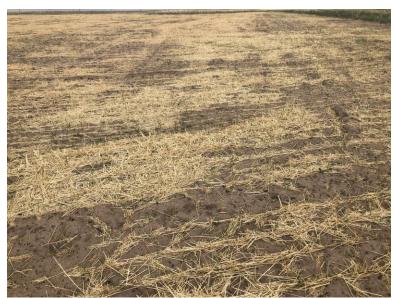
Emerging vegetation in Area 37

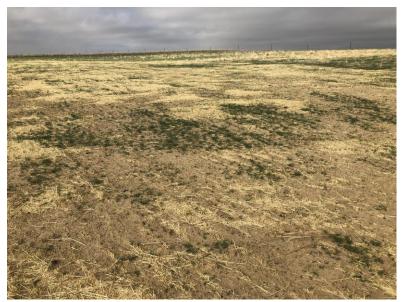
Emerging vegetation in reclaimed Long Term Spoil Area

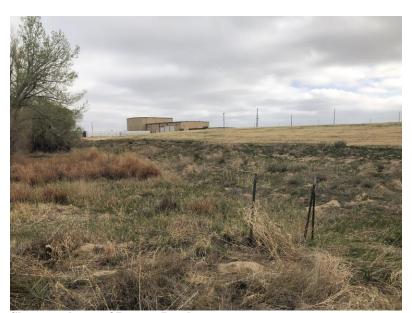
Near the southeast corner of the Dugout Pond, the relatively steep hill (where a topsand pile existed in past years) was stable, with no erosion.

Slope southeast of Dugout Pond
