MINERALS PROGRAM INSPECTION REPORT

MINE NAME: Revenue Mine	MINE/PROSPECTING ID#: M-2012-032	MINERAL: Lead, silver and gold	COUNTY: Ouray
INSPECTION TYPE: Multi Person Inspection	INSPECTOR(S): Lucas West	INSP. DATE: May 10, 2022	INSP. TIME: 10:30
OPERATOR: Ouray Silver Mines Inc.	OPERATOR REPRESENTATIVE: Poppy Staub, Todd Jesse	TYPE OF OPERATION: 112d-1 - Designated Mining Operation	
REASON FOR INSPECTION: Normal I&E Program	BOND CALCULATION TYPE: None	BOND AMOUNT: \$517,219.00	
DATE OF COMPLAINT: NA	POST INSP. CONTACTS: None	JOINT INSP. AGENCY: DRMS	
WEATHER: Clear	INSPECTOR'S SIGNATURE:

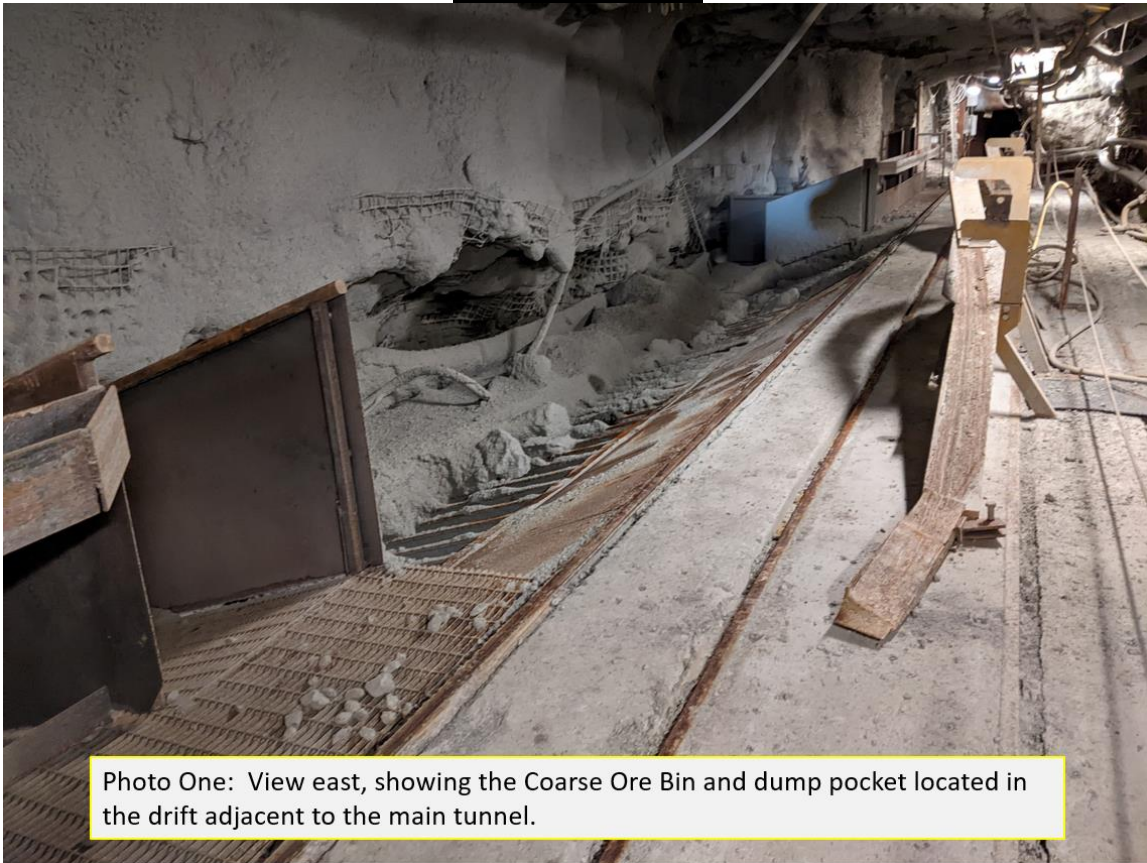
Photo One: View east, showing the Coarse Ore Bin and dump pocket located in the drift adjacent to the main tunnel.

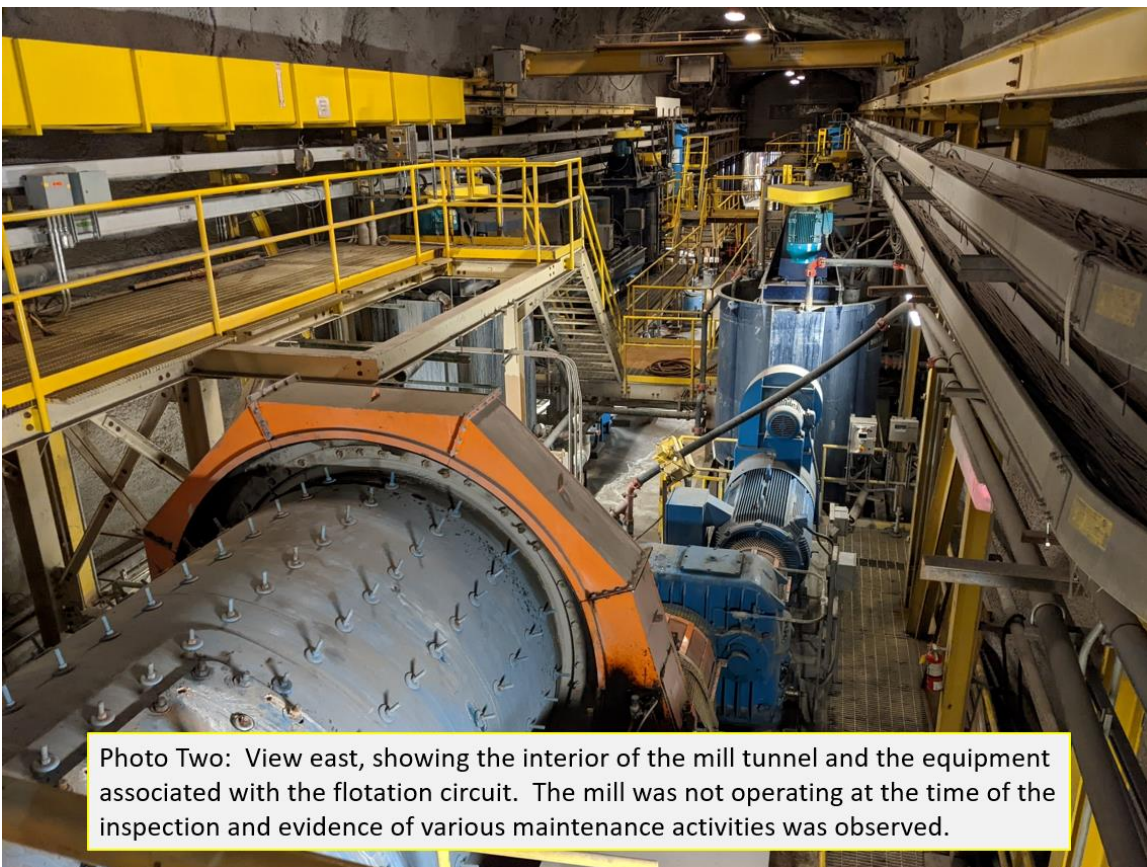
Photo Two: View east, showing the interior of the mill tunnel and the equipment associated with the flotation circuit. The mill was not operating at the time of the inspection and evidence of various maintenance activities was observed.

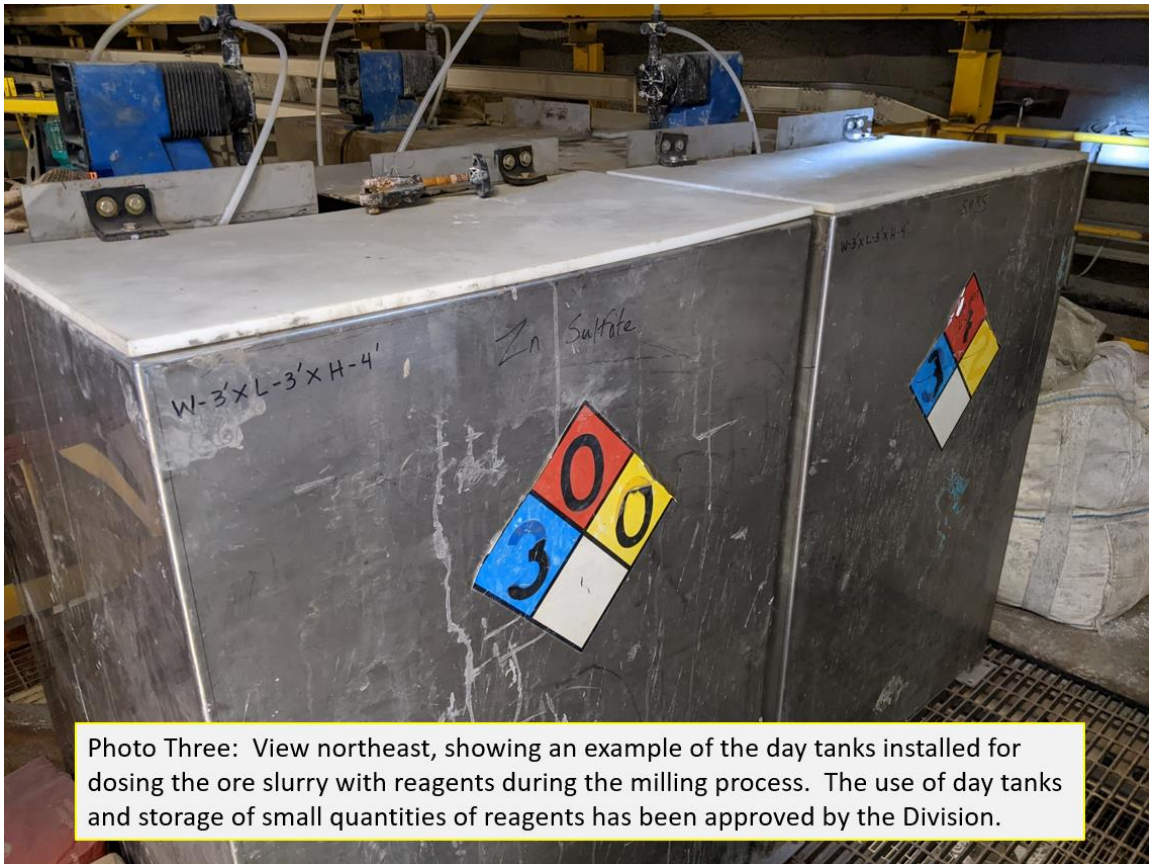
Photo Three: View northeast, showing an example of the day tanks installed for dosing the ore slurry with reagents during the milling process. The use of day tanks and storage of small quantities of reagents has been approved by the Division.

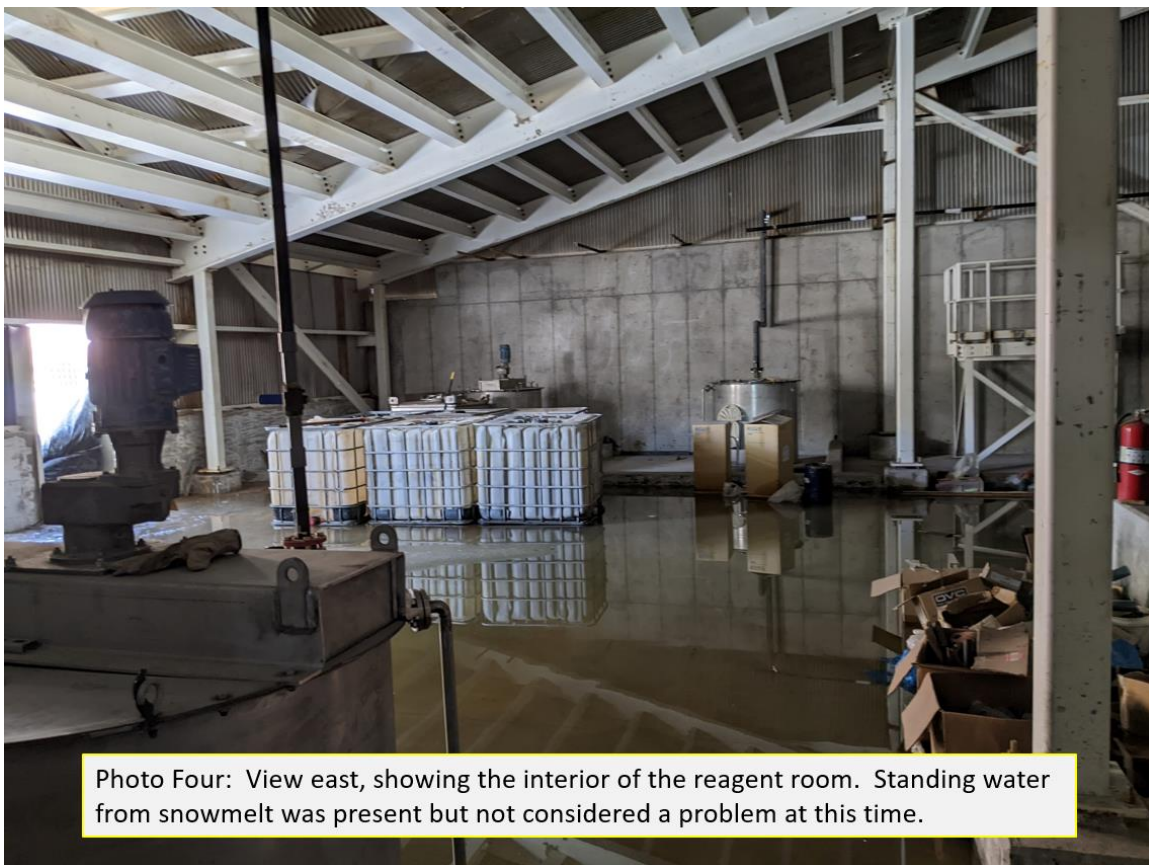
Adjacent to the mill building, the compressor room and reagent room, which is mid construction, were observed. The compressor room was neat and organized. The reagent room contained a good amount of standing water from snowmelt from the unsecured exterior of the structure. The interior of the room appeared to be in good condition despite the standing water and can be seen in Photos Four through Six. All tanks that have been set and containment devices appeared to be in good condition, and the progress of the construction remains largely unchanged, with the exception of the exterior sheeting, from the last incremental inspection conducted by the Division, report dated October 27, 2021. The exterior of the reagent room, mill building and area around the tailings thickener tank is neat and well kept. Residual snow accumulation was still present during the inspection. The exterior area can be seen in Photo Seven.

Photo Four: View east, showing the interior of the reagent room. Standing water from snowmelt was present but not considered a problem at this time.

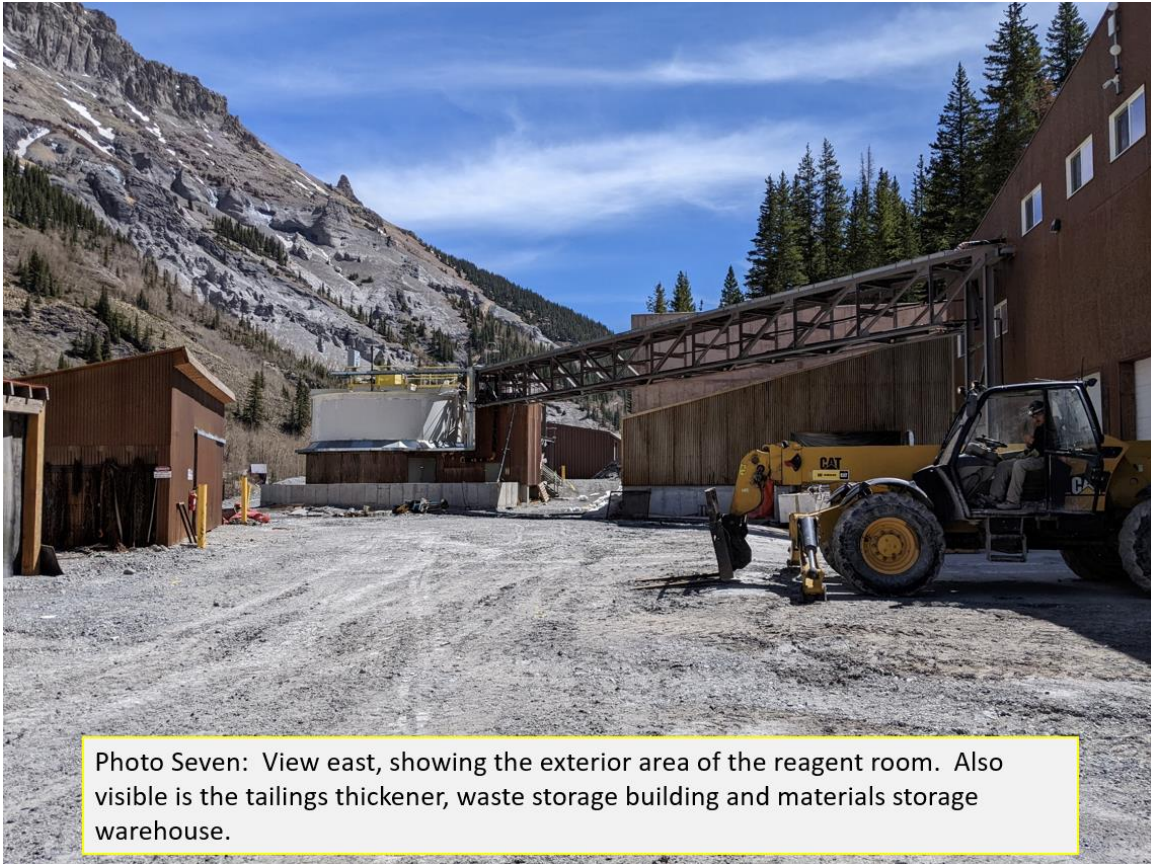
Photo Seven: View east, showing the exterior area of the reagent room. Also visible is the tailings thickener, waste storage building and materials storage warehouse.

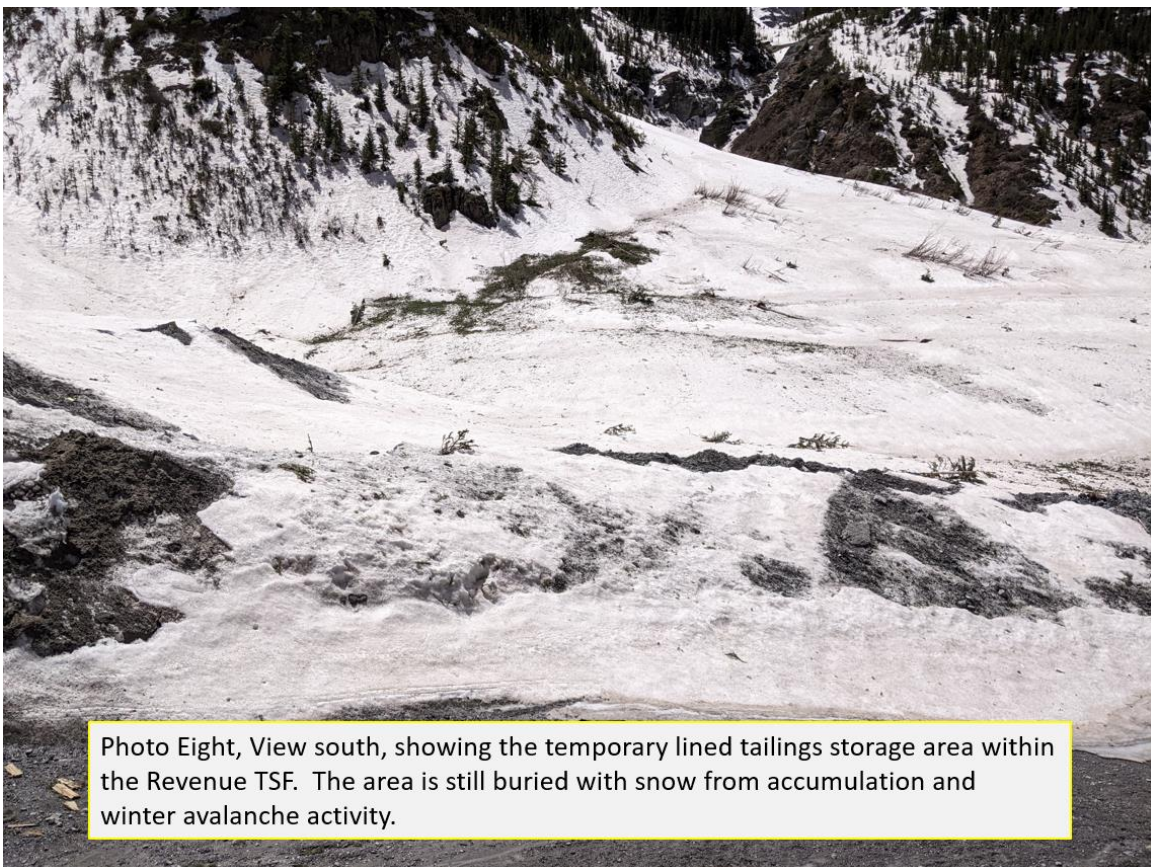
Adjacent to the admin building the Revenue Tailings Storage Facility was observed. The area is still largely covered by snow, and can be seen in Photo Eight. The laydown yard near the Revenue TSF has been cleared and or exposed by snowmelt, and all items stored in that area are neat and orderly and not considered a problem at this time. The Passive Mine Water Treatment system was flowing and functioning as designed at the time of the inspection. The ponds were free from obstruction and can be seen in Photos Nine and Ten. The groundwater monitoring wells were observed from a distance given the snow conditions.

Photo Eight, View south, showing the temporary lined tailings storage area within the Revenue TSF. The area is still buried with snow from accumulation and winter avalanche activity.

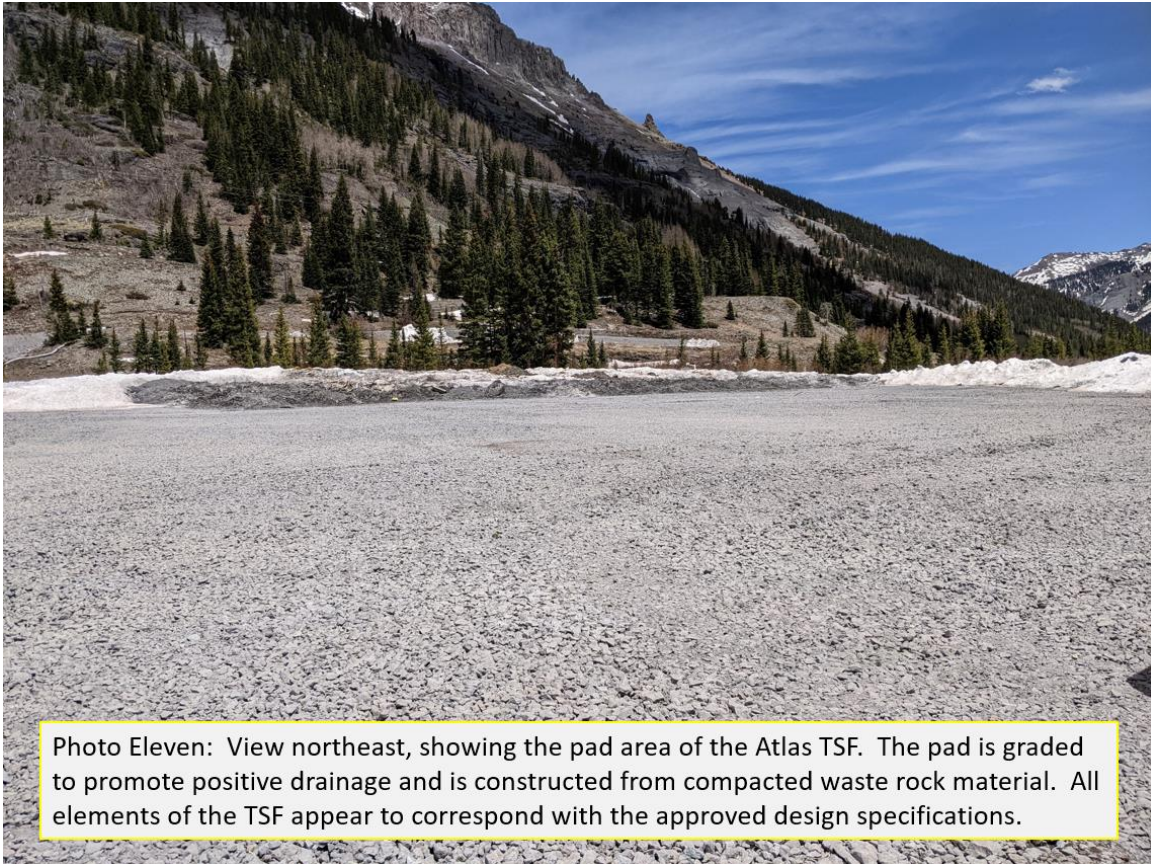
Photo Eleven: View northeast, showing the pad area of the Atlas TSF. The pad is graded to promote positive drainage and is constructed from compacted waste rock material. All elements of the TSF appear to correspond with the approved design specifications.

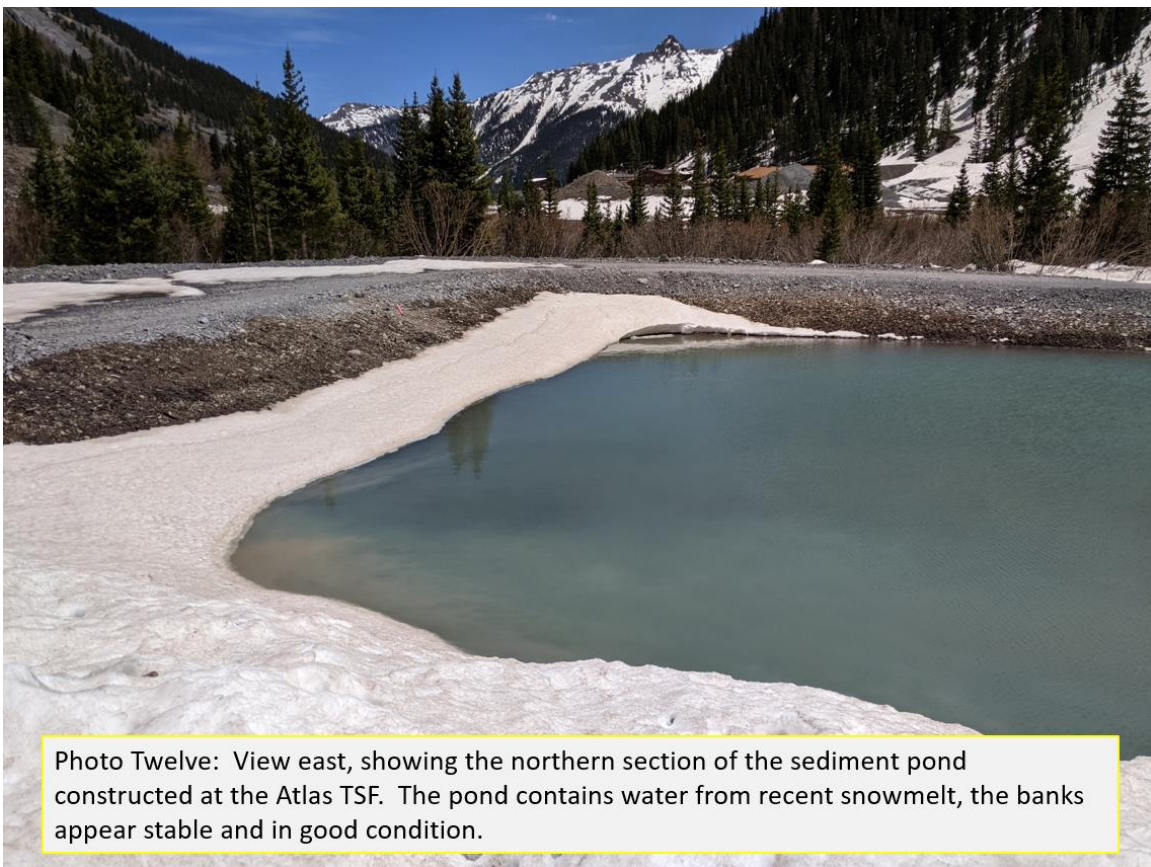
Photo Twelve: View east, showing the northern section of the sediment pond constructed at the Atlas TSF. The pond contains water from recent snowmelt, the banks appear stable and in good condition.

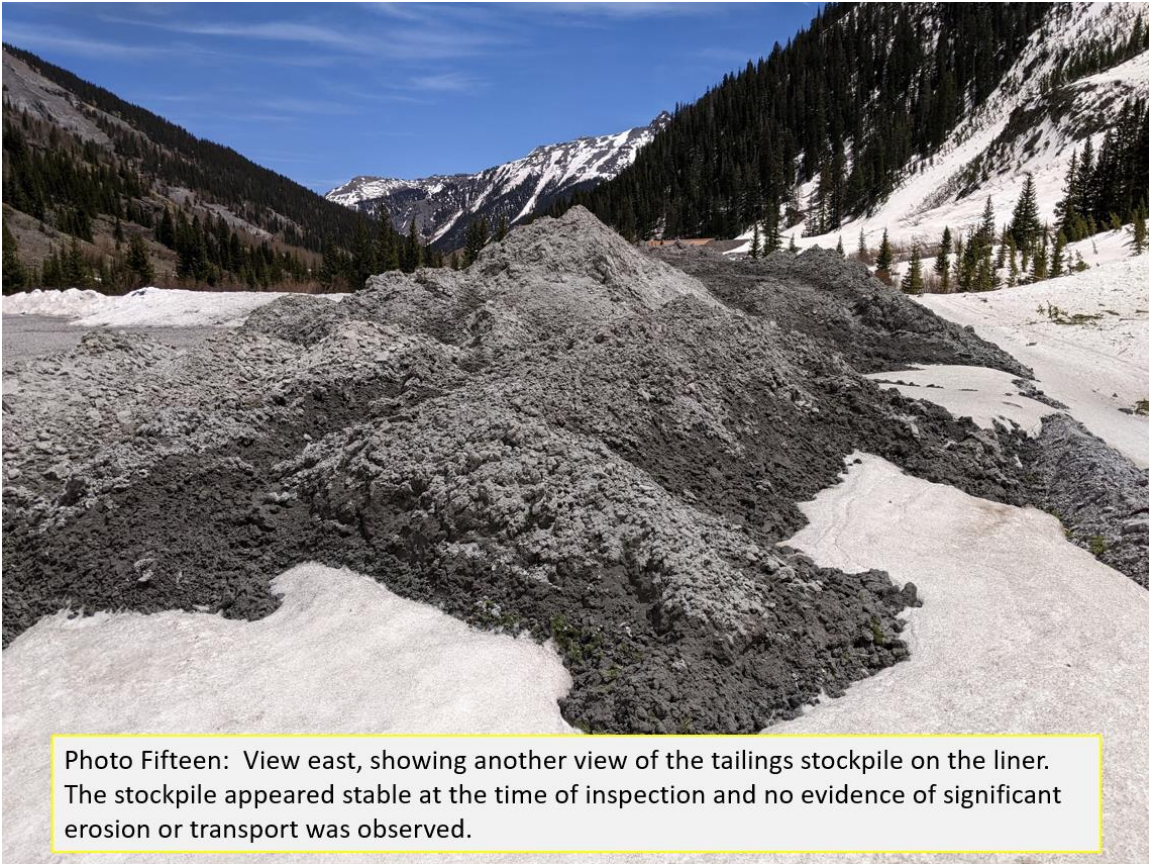
Photo Fifteen: View east, showing another view of the tailings stockpile on the liner. The stockpile appeared stable at the time of inspection and no evidence of significant erosion or transport was observed.
