MINERALS PROGRAM INSPECTION REPORT

MINE NAME: SR-11 Mine	MINE/PROSPECTING ID#: M-1977-451	MINERAL: Uranium and vanadium	COUNTY: San Miguel
INSPECTION TYPE: Multi Person Inspection	INSPECTOR(S): Lucas West	INSP. DATE: May 11, 2022	INSP. TIME: 12:00
OPERATOR: Highbury Resources Inc.	OPERATOR REPRESENTATIVE: Scott Potorff, Dana Cline	TYPE OF OPERATION: 112d-1 - Designated Mining Operation	
REASON FOR INSPECTION: Normal I&E Program	BOND CALCULATION TYPE: None	BOND AMOUNT: \$200.00	
DATE OF COMPLAINT: NA	POST INSP. CONTACTS: None	JOINT INSP. AGENCY: None	
WEATHER: Windy	INSPECTOR'S SIGNATURE:

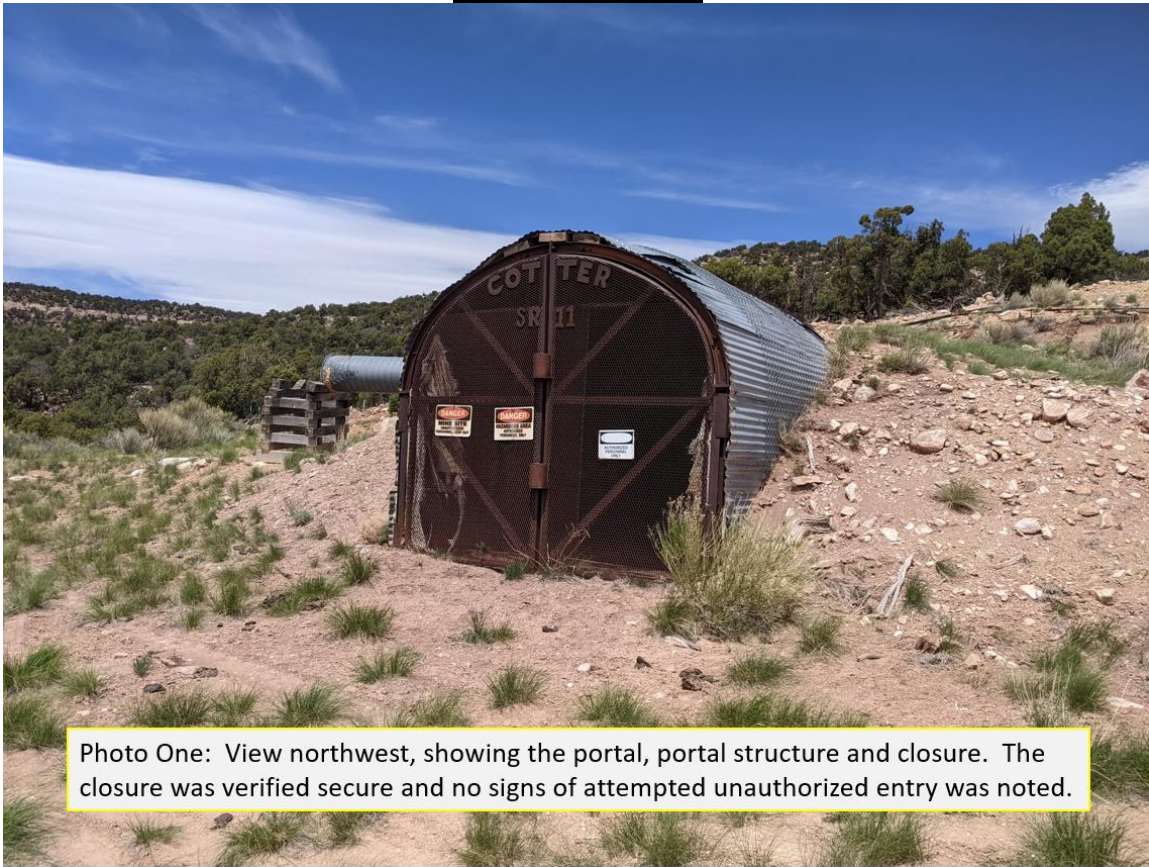
Photo One: View northwest, showing the portal, portal structure and closure. The closure was verified secure and no signs of attempted unauthorized entry was noted.

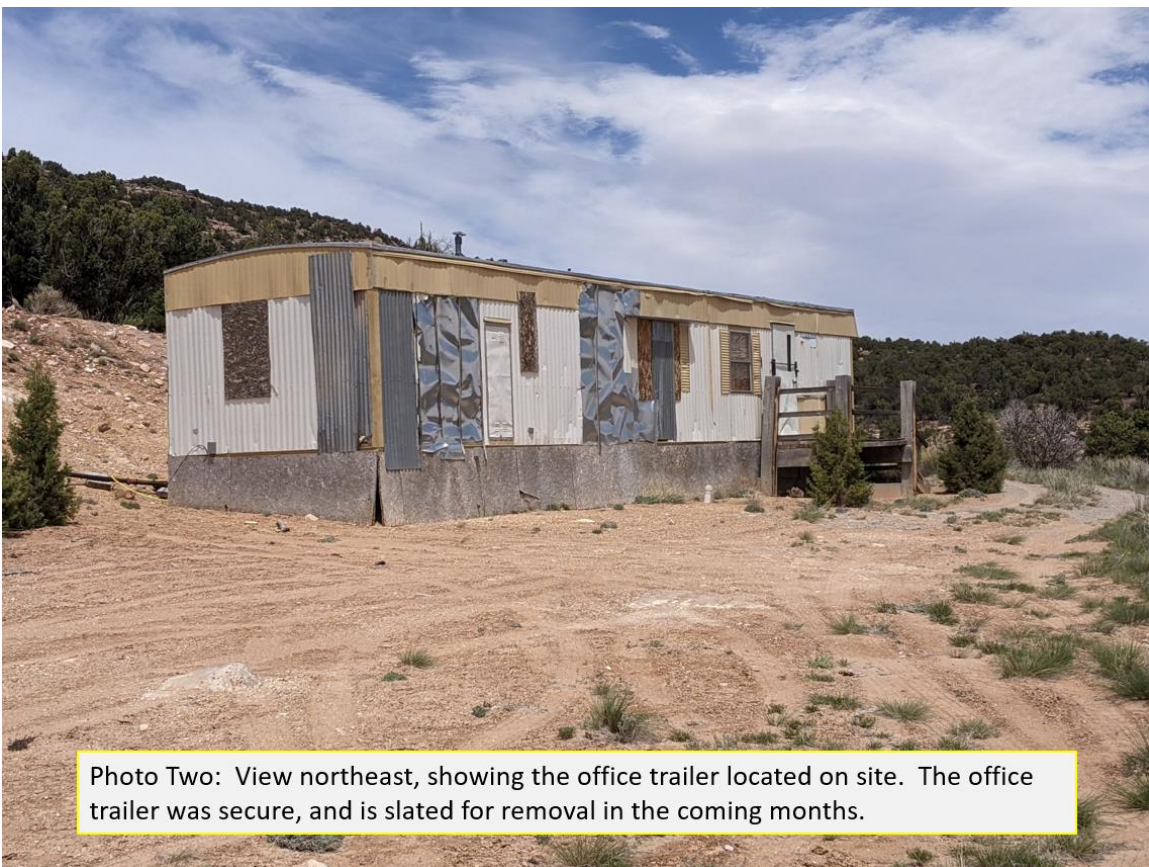
The proper mine identification signage was posted at the entrance to the site, and the permit boundaries are clearly marked. There was no equipment on site during the inspection. No activity has taken place on site since the previous inspection. This inspection was limited to the surface facilities. The portal has been secured by a locked gate shown in Photo One. The portal closure is in good condition and shows no signs of attempted unauthorized entry. Adjacent to the portal is an administrative office trailer which has also been secured. Photo Two shows the trailer, which is in good condition, the windows are all secured and the office remains vacant.

Photo Two: View northeast, showing the office trailer located on site. The office trailer was secure, and is slated for removal in the coming months.

The main focus of this inspection was to discuss the details of the reclamation activity planned for this coming year. The reclamation task slated for this year is the removal of the office trailer from the site. DOE and BLM outlined specific details required prior to the activity, all of which exceed DRMS requirements and the activity plan is in agreement with the approved DRMS Reclamation Plan.

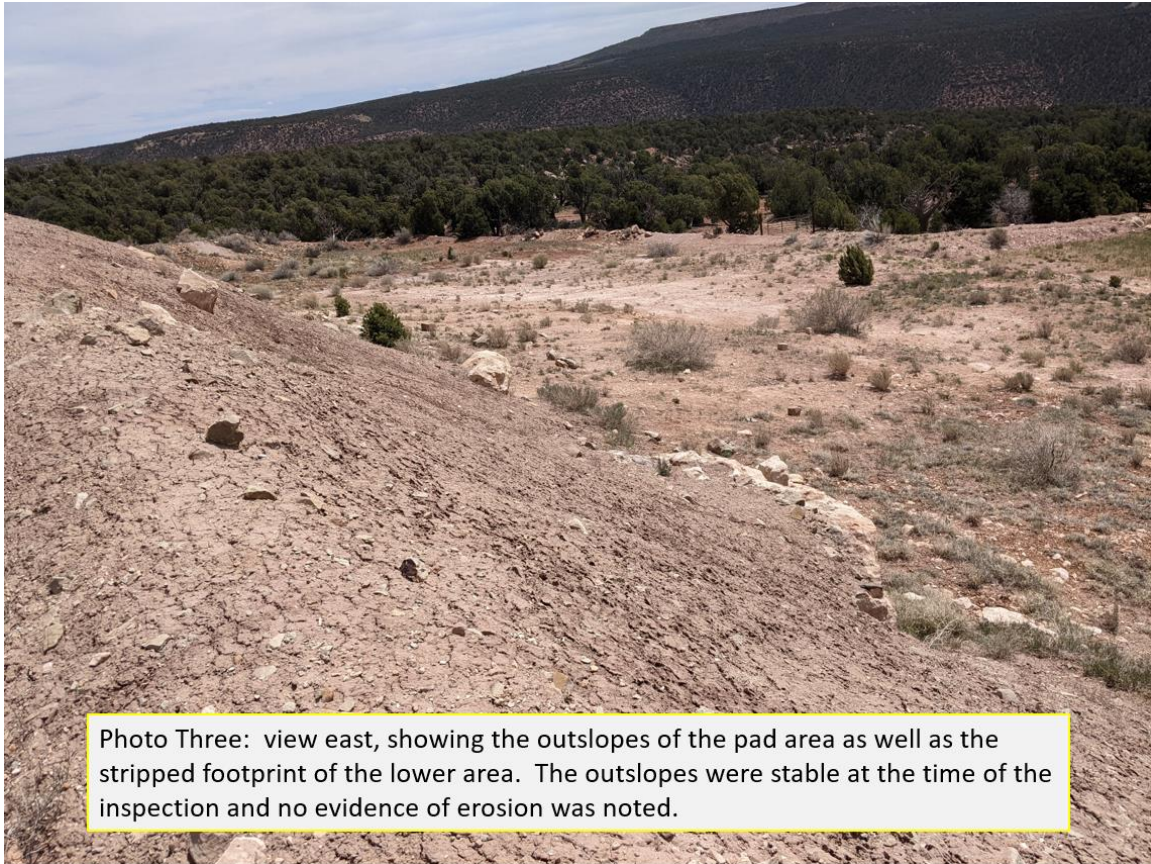
The portal pad and waste dump area consists of only development waste as the mine was never in production. The slopes of the waste dump are approximately at a 2H: 1V configuration and appear to be stable. The slopes show no evidence of erosion but it has been stabilized by the vegetation and is in good condition. At the toe of the waste dump is the stripped area that has been prepped to expand the dump when the mine reactivates. A sediment ditch runs along the base of the waste dump conveying any storm water and sedimentation to the storm water collection basin. The stripped area and outslopes of the pad can be seen in Photos Three and Four. Throughout the site, the vegetation has become well established and self-sustaining. The vegetation can be seen in all of the photos included in this report. Evidence of chemical treatment of small populations of noxious weeds was observed during the inspection.

Photo Three: view east, showing the out slopes of the pad area as well as the stripped footprint of the lower area. The out slopes were stable at the time of the inspection and no evidence of erosion was noted.

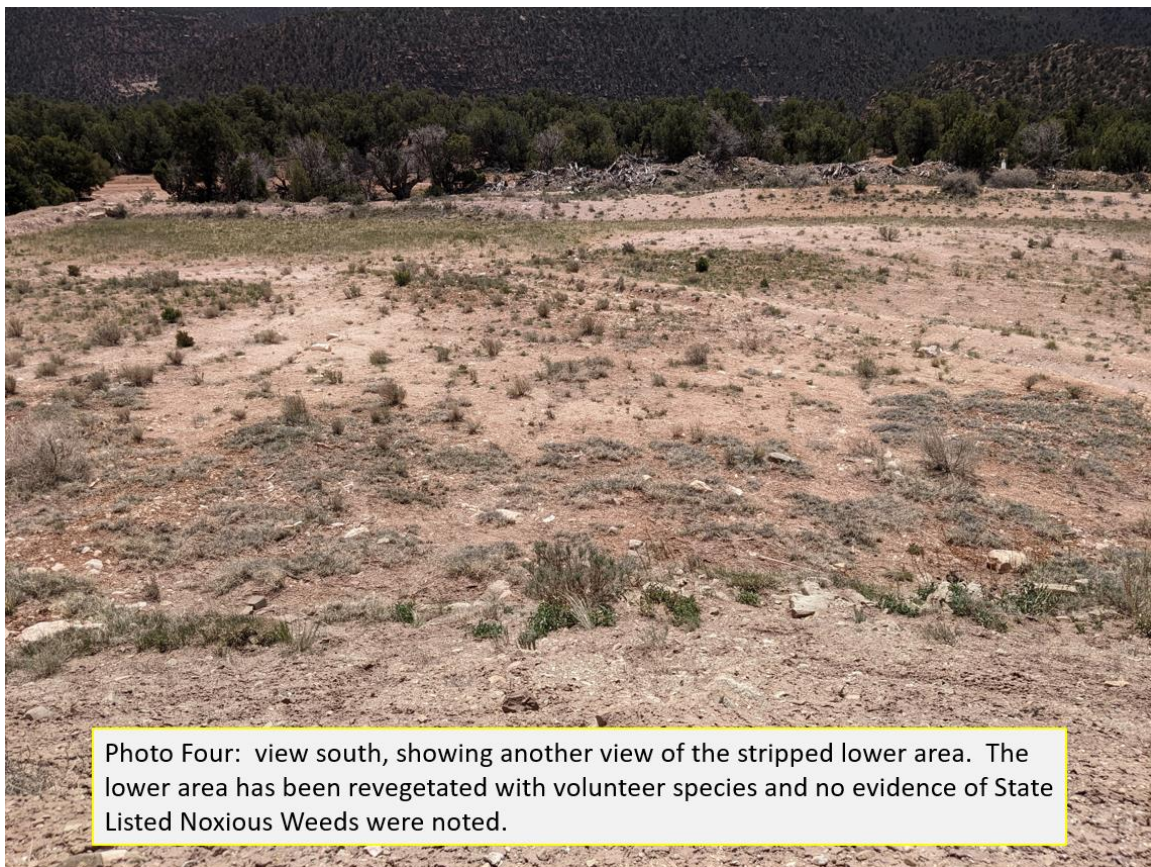
Photo Four: view south, showing another view of the stripped lower area. The lower area has been revegetated with volunteer species and no evidence of State Listed Noxious Weeds were noted.
