MINERALS PROGRAM INSPECTION REPORT
PHONE: (303) 866-3567

MINE NAME: Lazy Two Pit	MINE/PROSPECTING ID#: M-2019-001	MINERAL: Sand and gravel	COUNTY: Weld
INSPECTION TYPE: Monitoring	INSPECTOR(S): Peter Hays	INSP. DATE: April 5, 2022	INSP. TIME: 12:00
OPERATOR: Connell Resources, Inc.	OPERATOR REPRESENTATIVE: Kevin Anderson	TYPE OF OPERATION: 112c - Construction Regular Operation	
REASON FOR INSPECTION: Normal I&E Program	BOND CALCULATION TYPE: None	BOND AMOUNT: \$773,134.00	
DATE OF COMPLAINT: NA	POST INSP. CONTACTS: None	JOINT INSP. AGENCY: None	
WEATHER: Windy	INSPECTOR'S SIGNATURE:

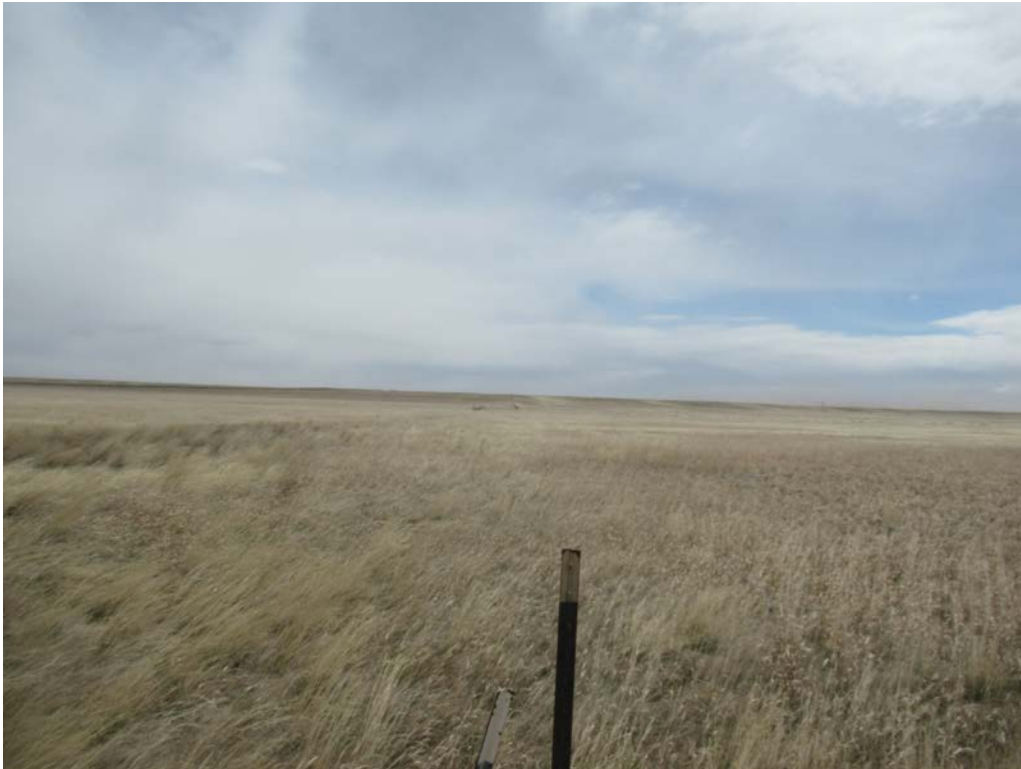
View of the site from the northwest corner looking east

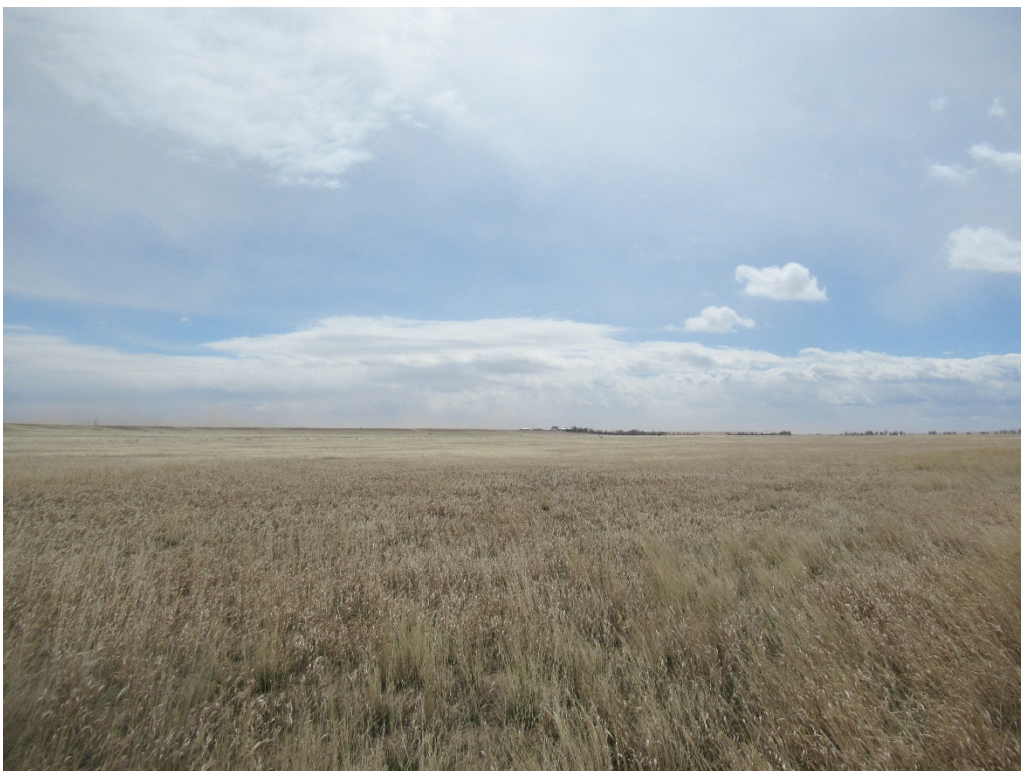
View of the site from the northwest corner looking southeast

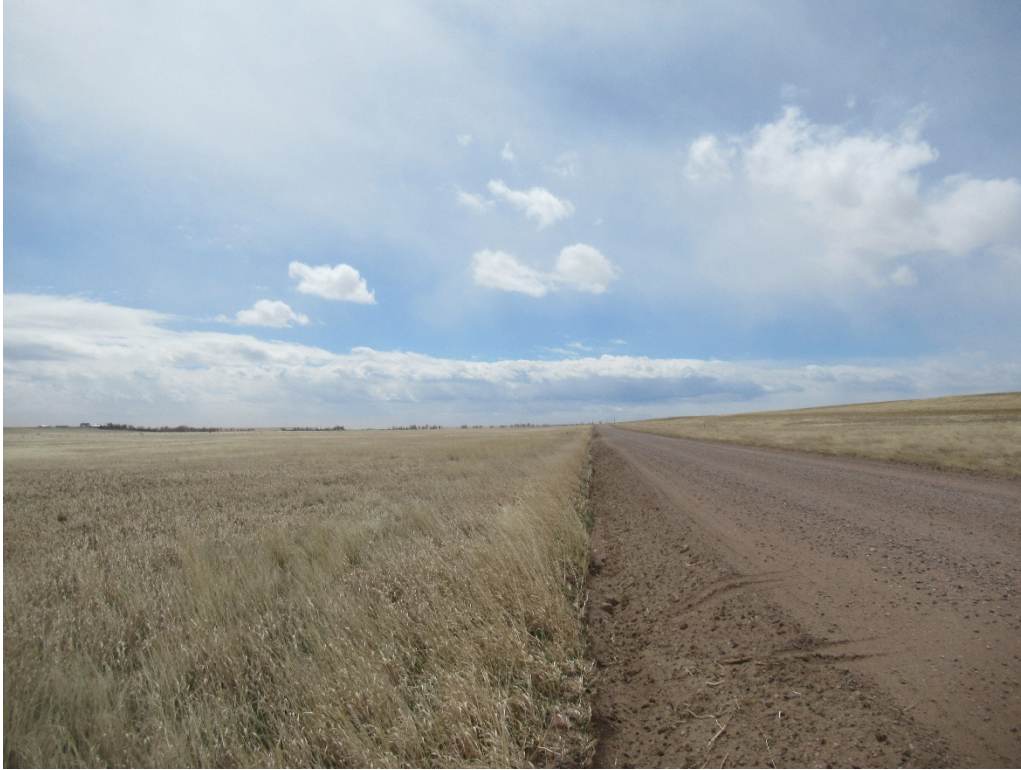
View of the site from the northwest corner looking south

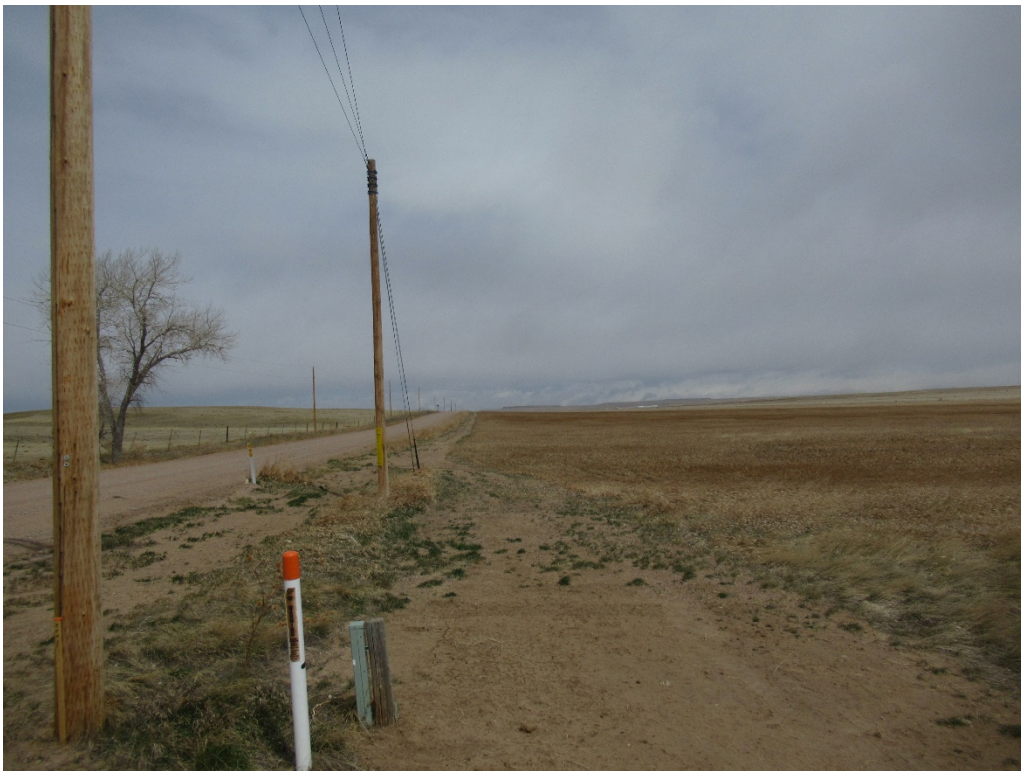
View of the site from the southwest corner looking north

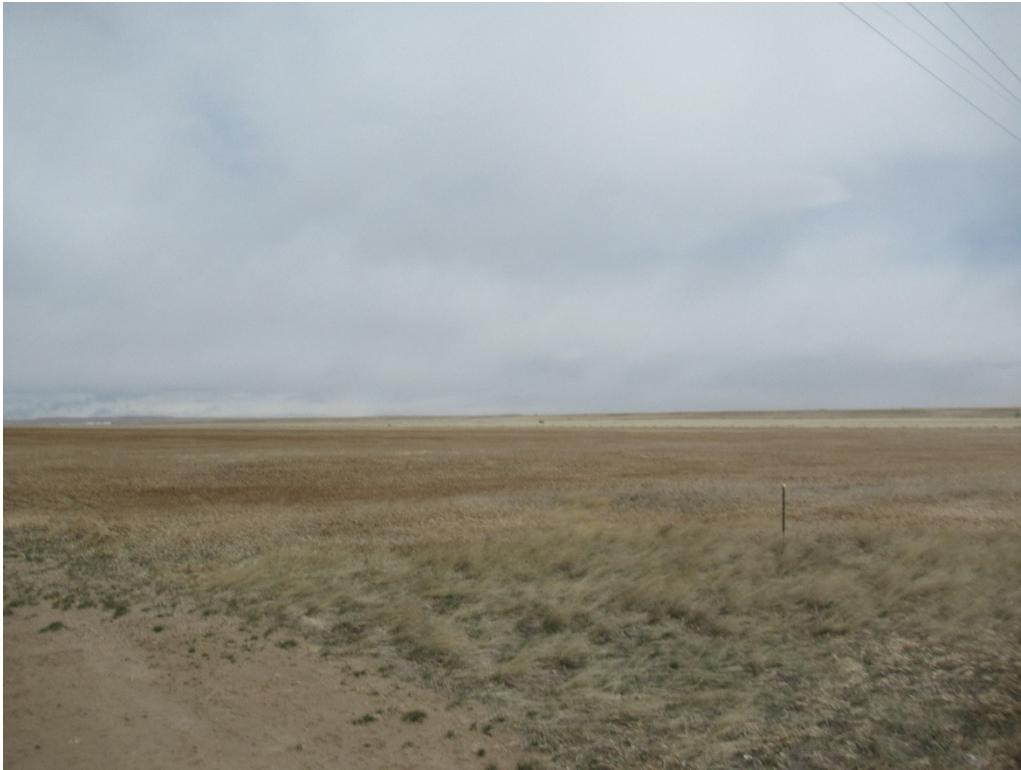
View of the site from the southwest corner looking northeast

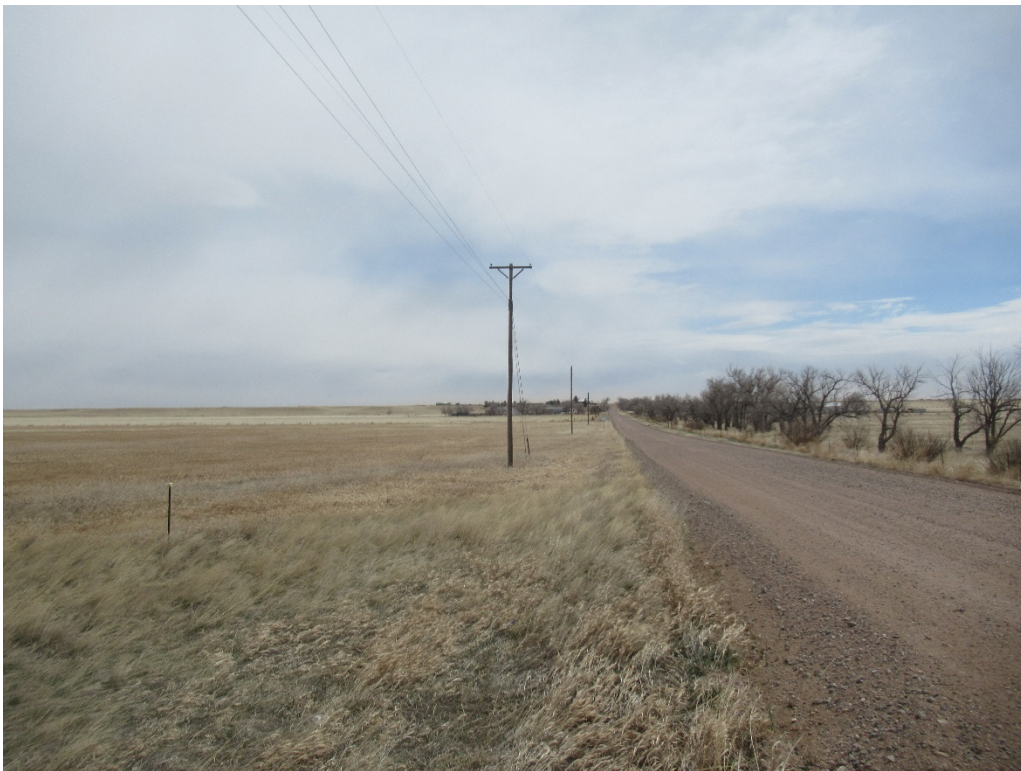
View of the site from the southwest corner looking east
