**MINERALS PROGRAM INSPECTION REPORT**  
**PHONE: (303) 866-3567**

<b>MINE NAME:</b> Peroulis Brothers Snake River Pit	<b>MINE/PROSPECTING ID#:</b> M-2009-079	<b>MINERAL:</b> Gravel and sand	<b>COUNTY:</b> Moffat
<b>INSPECTION TYPE:</b> Surety Release Inspection	<b>INSPECTOR(S):</b> Zach Trujillo	<b>INSP. DATE:</b> April 20, 2022	<b>INSP. TIME:</b> 09:00
<b>OPERATOR:</b> Precision Excavating, Inc.	<b>OPERATOR REPRESENTATIVE:</b> David Zehner	<b>TYPE OF OPERATION:</b> 112c - Construction Regular Operation	
<b>REASON FOR INSPECTION:</b> Surety Release Requested	<b>BOND CALCULATION TYPE:</b> None	<b>BOND AMOUNT:</b> \$199,600.00	
<b>DATE OF COMPLAINT:</b> NA	<b>POST INSP. CONTACTS:</b> None	<b>JOINT INSP. AGENCY:</b> None	
<b>WEATHER:</b> Clear	<b>INSPECTOR'S SIGNATURE:</b>

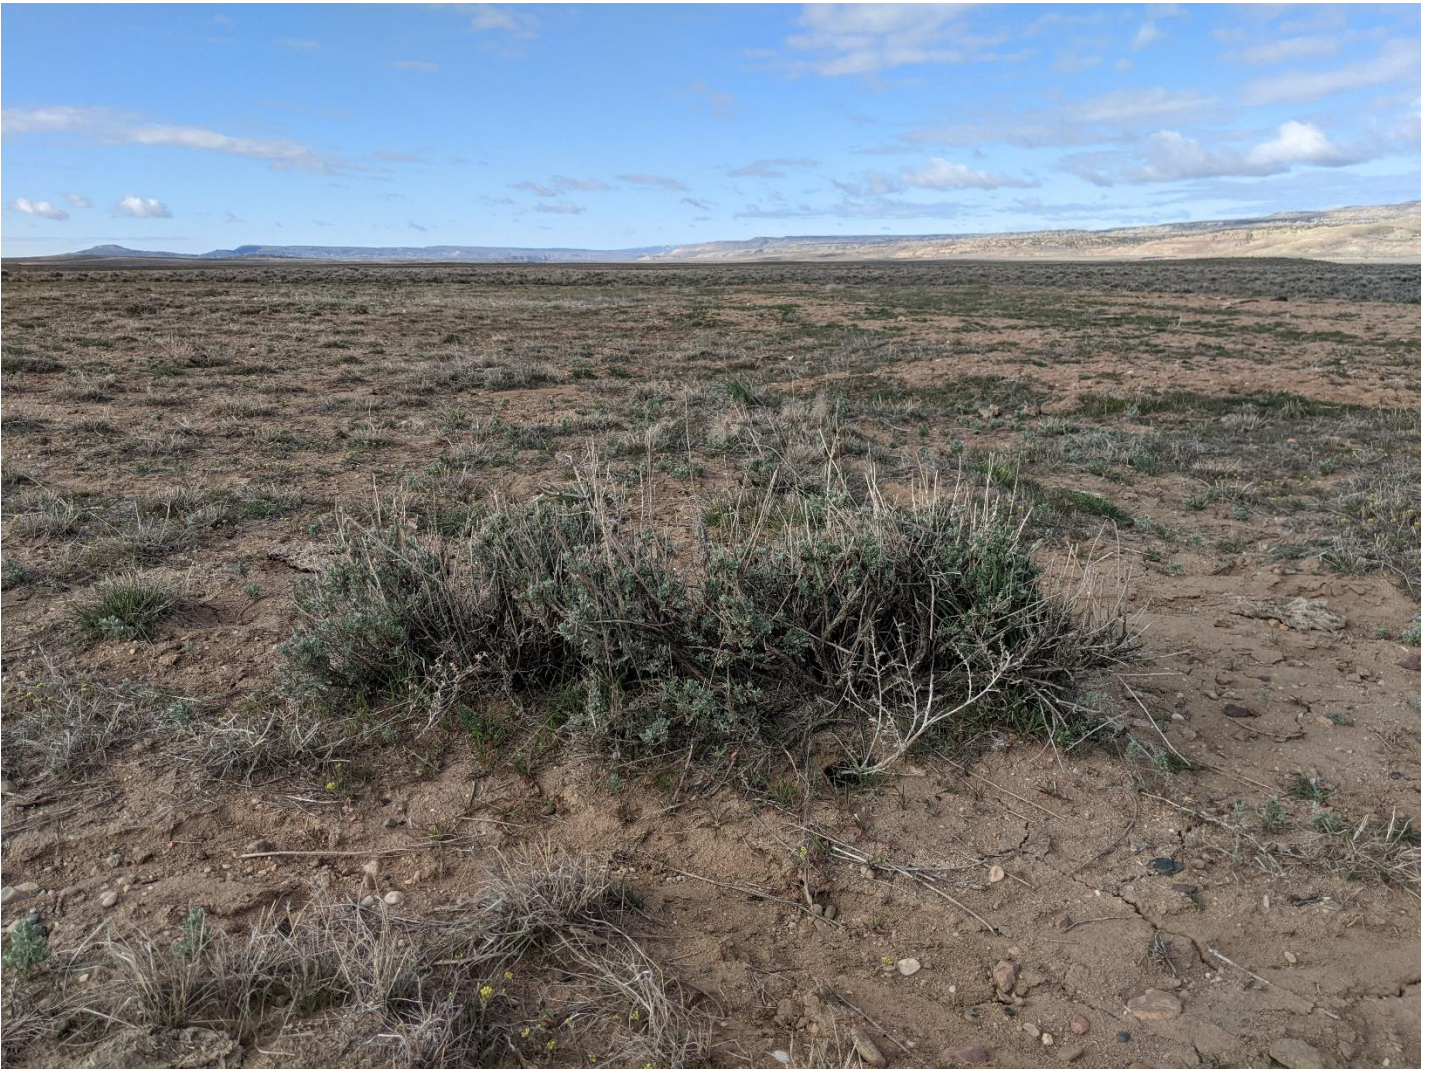
Shrub and vegetation establishment along eastern perimeter of disturbance (looking south).

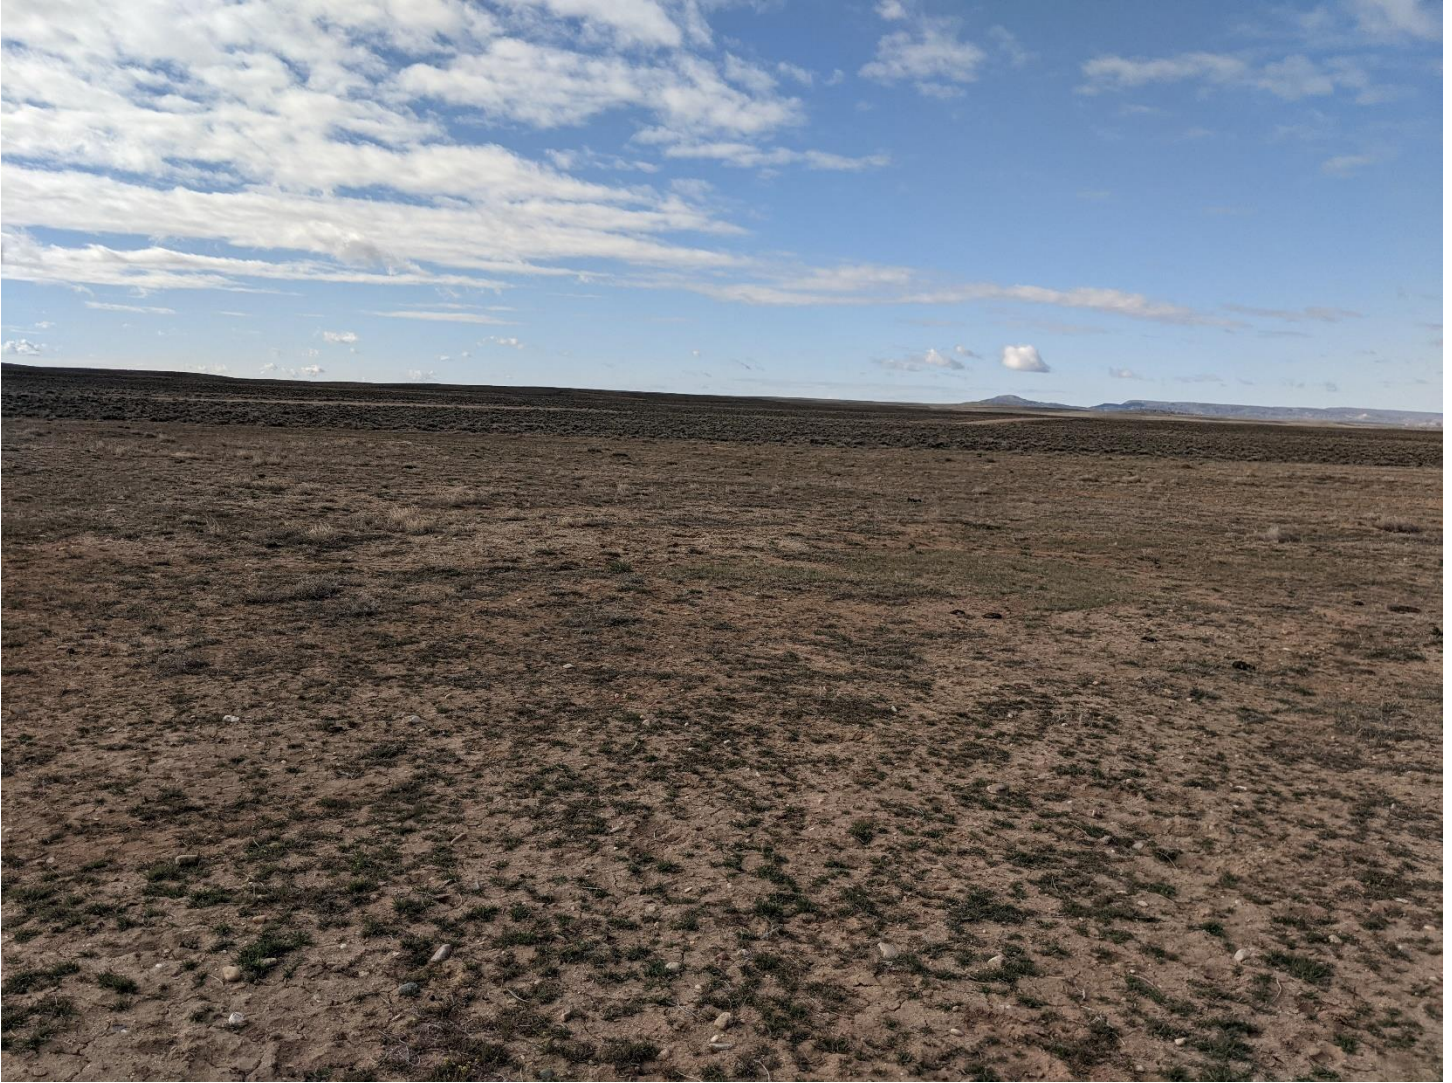
Vegetation establishment along southern portion of disturbance (looking south).

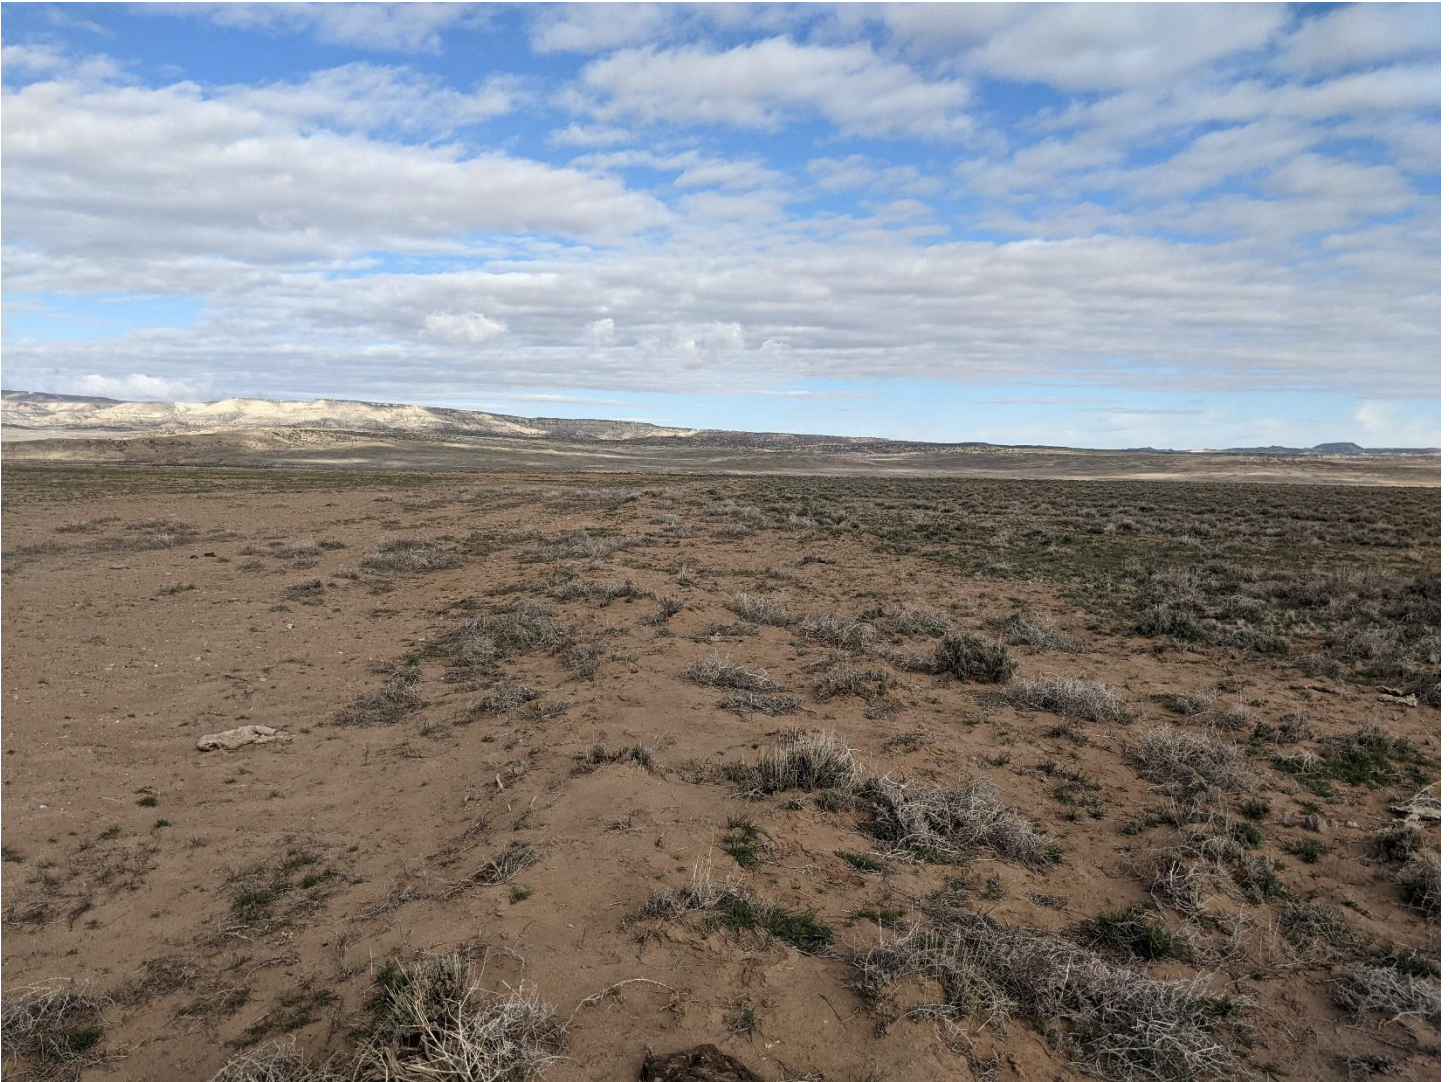
Vegetation comparison along northern disturbance boundary. (Undisturbed to the right in picture and disturbed to the left)

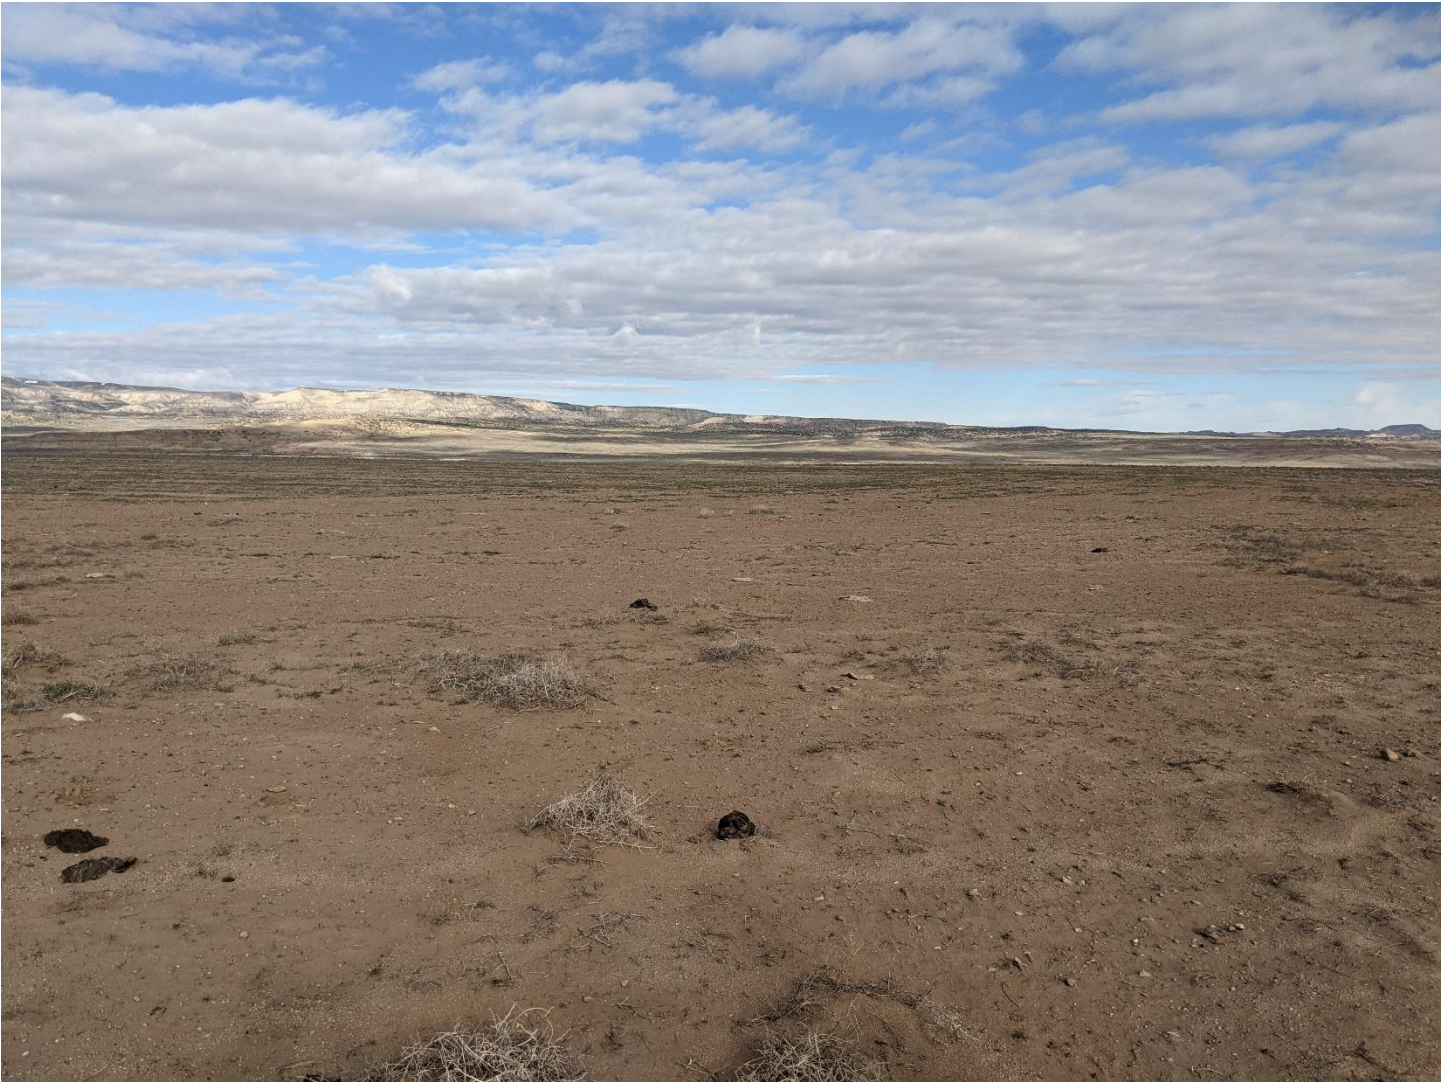
Vegetation on site was inspected. The Operator stated that reseeding activities occurred in 2019 and finalized in 2020. Established grasses such as wheatgrass and brome in addition to sagebrush were evident along the perimeter of the disturbed area mostly along the southern and eastern disturbance boundaries. Vegetation observed is consistent with the approved seed mixture within Exhibit E of the approved SRP permit. The disturbed areas located centrally and adjacent to County Road 21 still remained mostly bare. It is estimated that approximately a third of the disturbed area at the SRP shows little to no vegetation establishment. The Operator stated these areas are more windblown due to their relative elevations to the surrounding area resulting in less vegetation establishment. Difference between the native adjacent vegetation and vegetation establishment along these identified reclaimed bare areas were extremely evident.

Per Rule 3.1.10(1), "in those areas where revegetation is part of the Reclamation Plan, land shall be revegetated in such a way as to establish... ..at least equal in extent of cover to the natural vegetation of the surrounding area." At the time of the SL-1 inspection, the representative revegetation at the SRP does not equal the extent of cover to the natural vegetation of the surrounding area. As such, Rule 3.1.10(1) has not been satisfied and the Division will Deny the full release of the permit as requested under SL-1. The Division will still maintain the financial and performance warranties currently held in the amount of \$119,600.00

Bare area located centrally within the disturbed area. (Looking east).

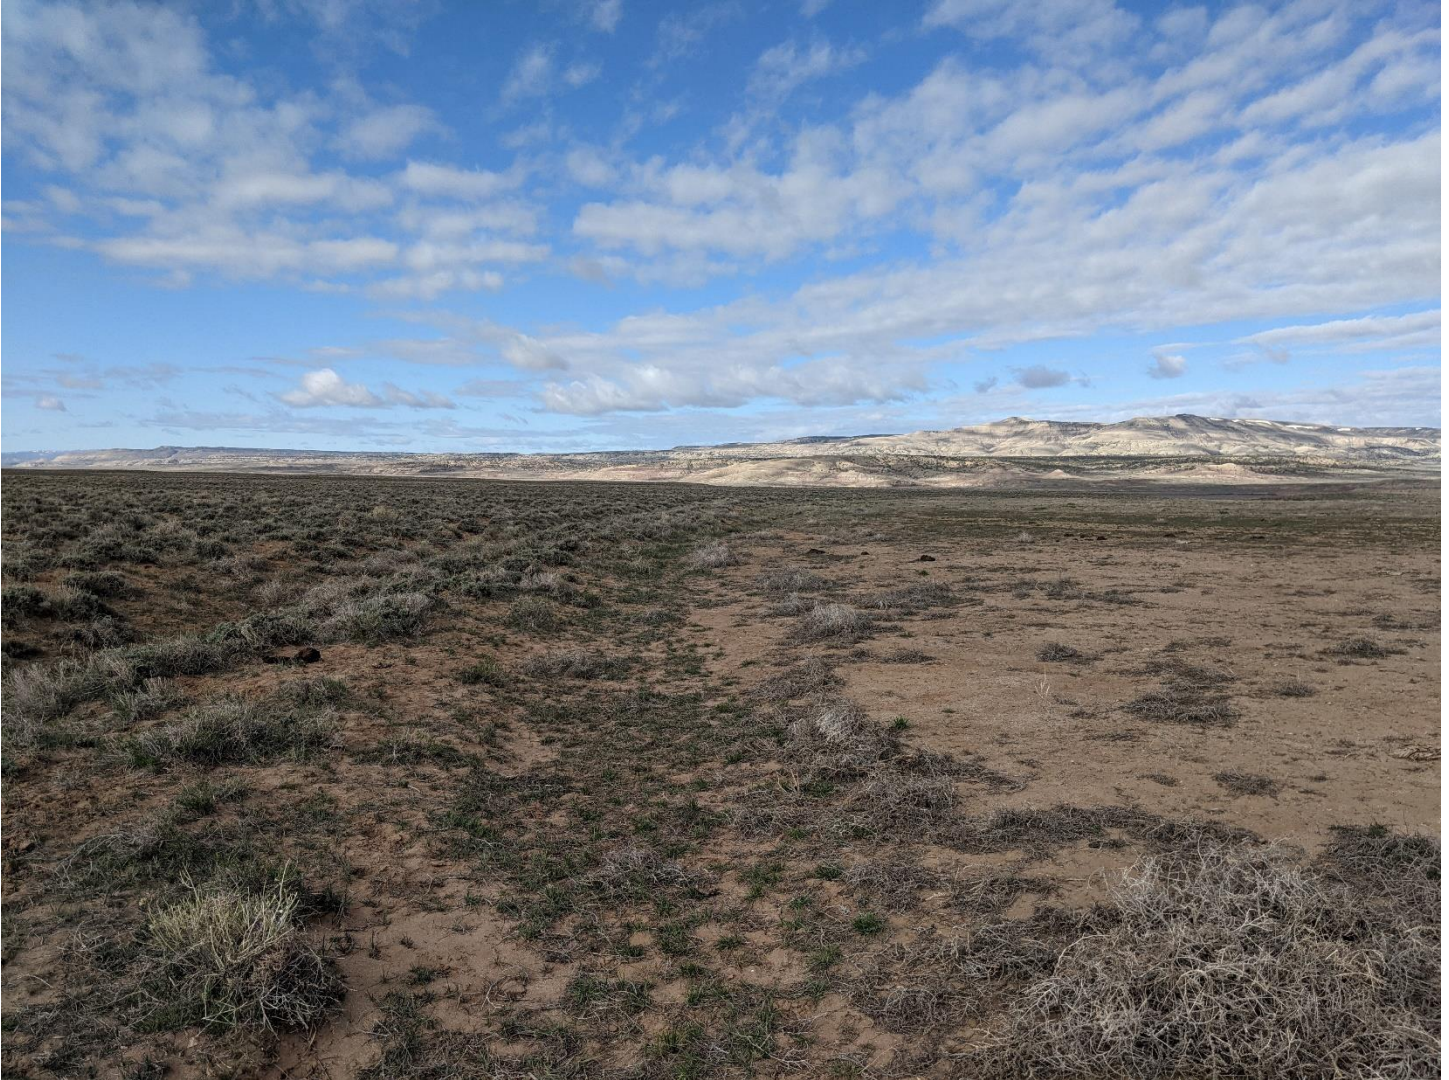
Vegetation comparison along southern disturbance boundary. (Undisturbed to the left in picture and disturbed to the right)
