**MINERALS PROGRAM INSPECTION REPORT**  
**PHONE: (303) 866-3567**

<b>MINE NAME:</b> Climax Mine	<b>MINE/PROSPECTING ID#:</b> M-1977-493	<b>MINERAL:</b> Molybdenum	<b>COUNTY:</b> Lake, Summit
<b>INSPECTION TYPE:</b> Monitoring	<b>INSPECTOR(S):</b> Lucas West	<b>INSP. DATE:</b> May 17, 2022	<b>INSP. TIME:</b> 09:00
<b>OPERATOR:</b> Climax Molybdenum Company	<b>OPERATOR REPRESENTATIVE:</b> Eric Detmer	<b>TYPE OF OPERATION:</b> 112d-3 - Designated Mining Operation	
<b>REASON FOR INSPECTION:</b> Normal I&E Program	<b>BOND CALCULATION TYPE:</b> None	<b>BOND AMOUNT:</b> \$91,011,850.00	
<b>DATE OF COMPLAINT:</b> NA	<b>POST INSP. CONTACTS:</b> None	<b>JOINT INSP. AGENCY:</b> None	
<b>WEATHER:</b> Clear	<b>INSPECTOR'S SIGNATURE:</b>

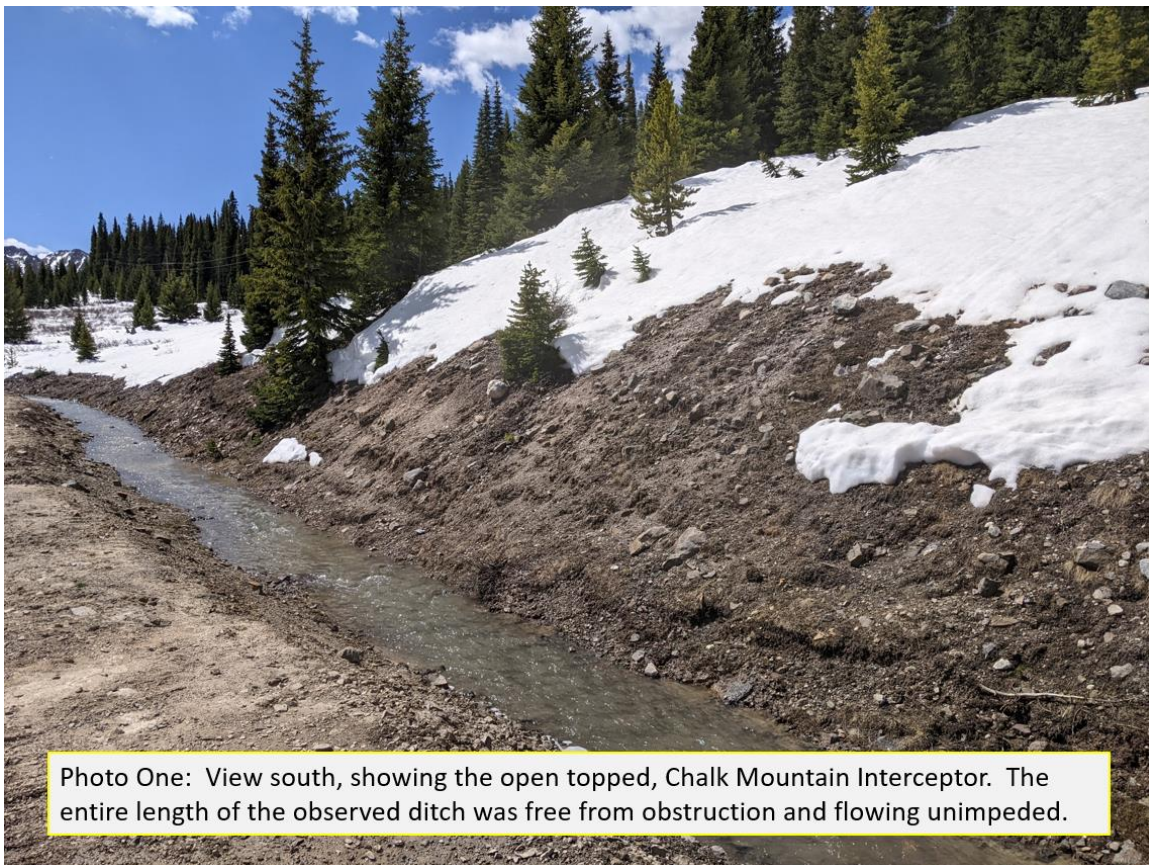
During the inspection the Chalk Mountain, West and East Interceptors were observed. The function of the interceptor is to prevent run on from snow melt or storm water sheet flows to become impacted and require treatment. The Chalk Mountain Interceptor is an open top ditch running generally along the southwest portion of the site. The Interceptor was flowing in response to snowmelt and recent precipitation events. The entire length of the Interceptor that was observed was flowing unimpeded and was in good condition. An example of the Chalk Mountain Interceptor can be seen in Photo One.

Photo One: View south, showing the open topped, Chalk Mountain Interceptor. The entire length of the observed ditch was free from obstruction and flowing unimpeded.

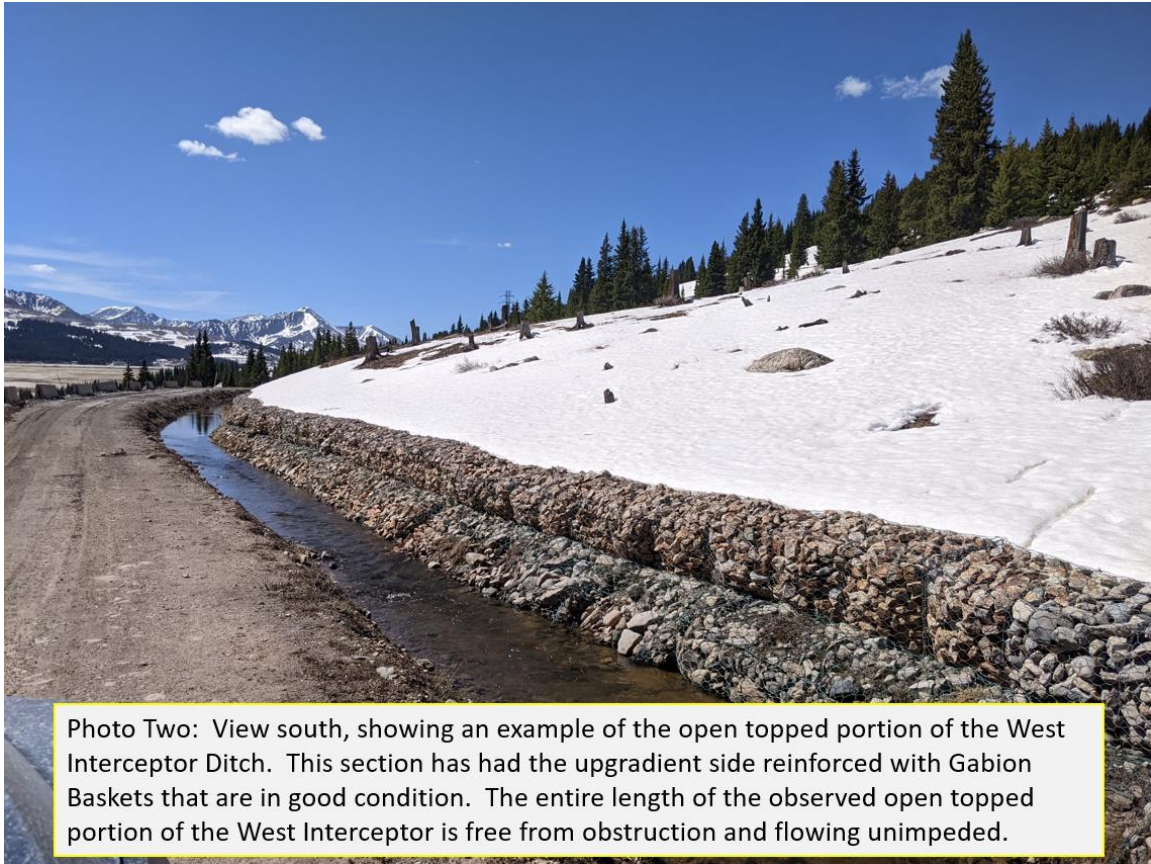
Photo Two: View south, showing an example of the open topped portion of the West Interceptor Ditch. This section has had the upgradient side reinforced with Gabion Baskets that are in good condition. The entire length of the observed open topped portion of the West Interceptor is free from obstruction and flowing unimpeded.

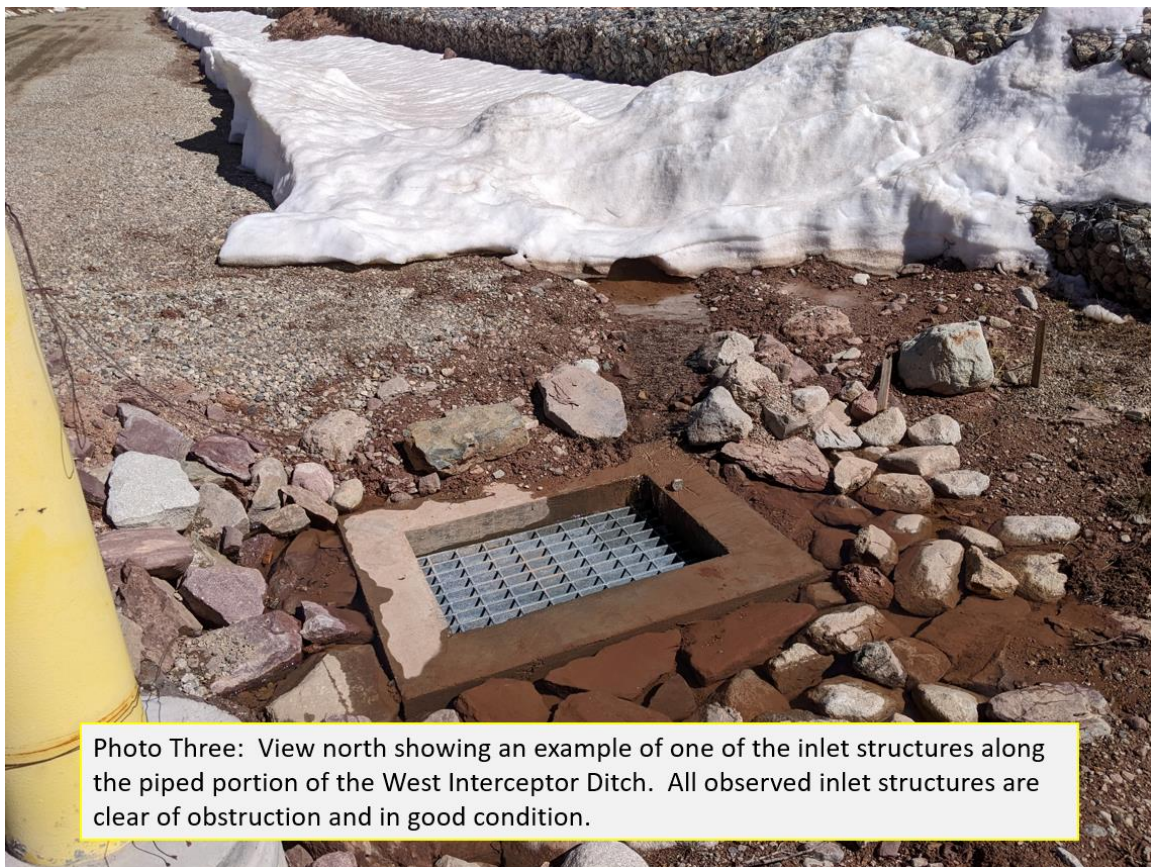
Photo Three: View north showing an example of one of the inlet structures along the piped portion of the West Interceptor Ditch. All observed inlet structures are clear of obstruction and in good condition.
