PERMIT INFORMATION

Permit Number: C-1981-038 Mine Name: Bowie No. 1 Mine Operator: Bowie Resources, LLC Operator Address: Mr. Basil R Bear P.O. Box 1488 Paonia, CO 81428	County: Delta Operation Type: Underground Permit Status: Active Ownership: Private
	Operator Representative Present: None
Operator Representative Signature: (Field Issuance Only)

Inspection Start Date: May 18, 2022 Inspection Start Time: 10:30 Inspection End Date: May 18, 2022 Inspection End Time: 12:20		Inspection Type: Coal Complete Inspection Inspection Reason: Normal I&E Program Weather: Clear	
Joint Inspection Agency: None		Joint Inspection Contacts: 	
Post Inspection Agency: None		Post Inspection Contacts: 	
Inspector(s): Robert Zuber, P.E.	Inspector's Signature: <i>Robert D. Zuber</i>		Signature Date: 5/19/2022

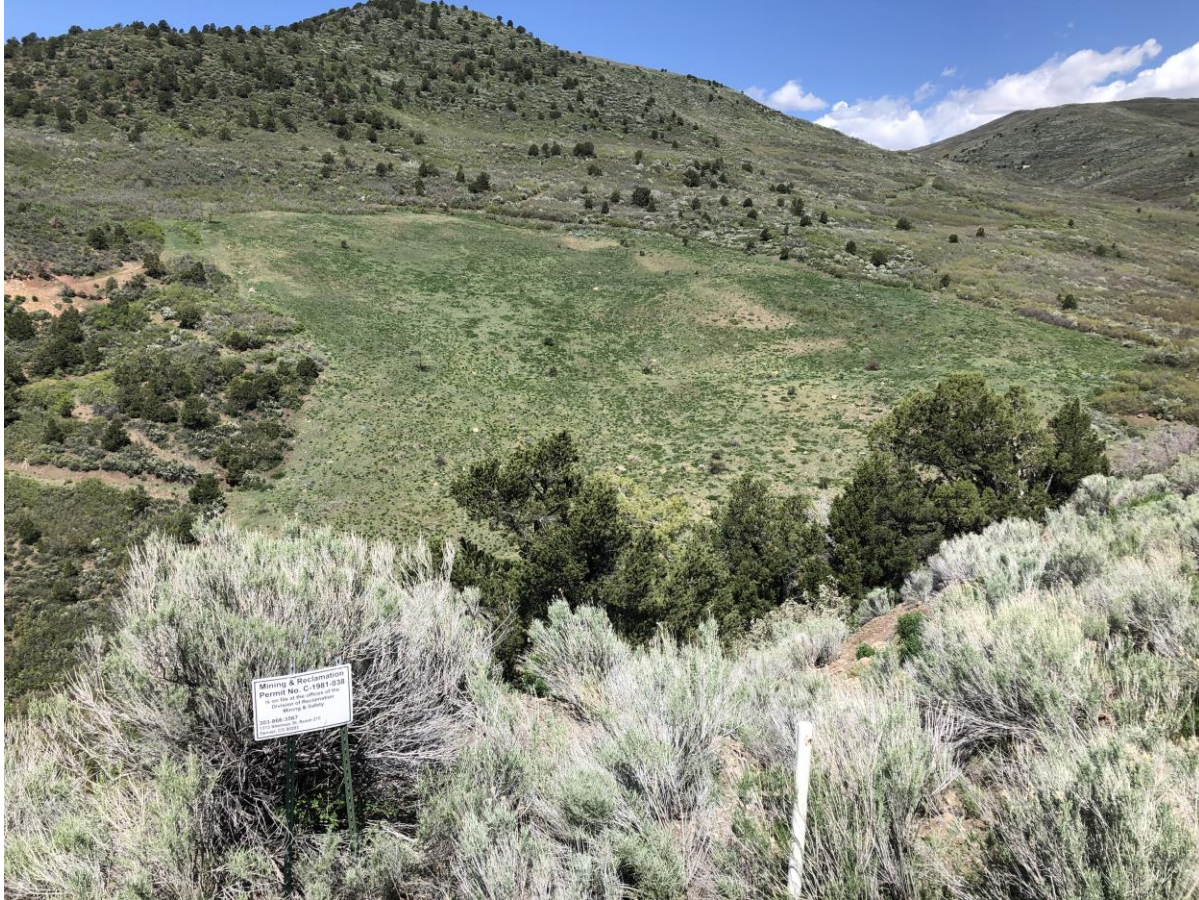
The ponds at the loadout, the Coal Storage Area (near Black Bridge Road), and the West Mine were dry, and no problems were identified with these ponds. Riprap ditches at the East Mine are stable.

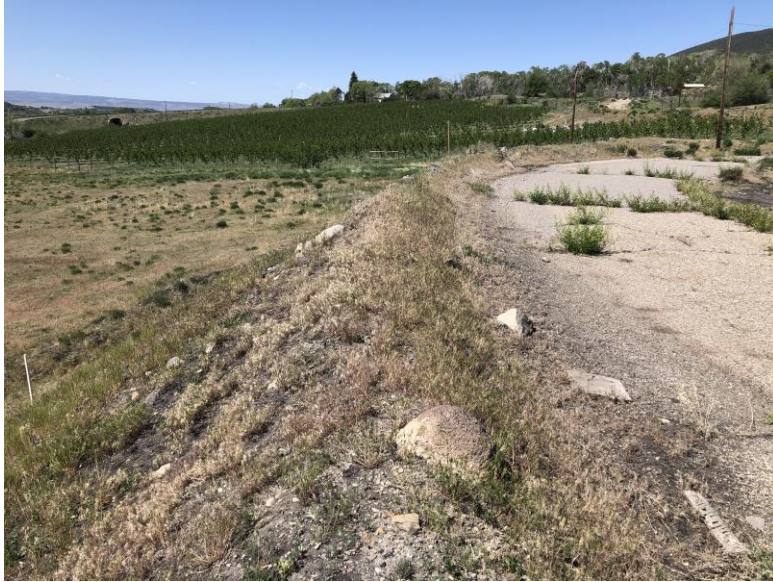
The slope below the Loadout is stable. No erosion or other problems were seen there.

Slope at western side of loadout, looking southwest

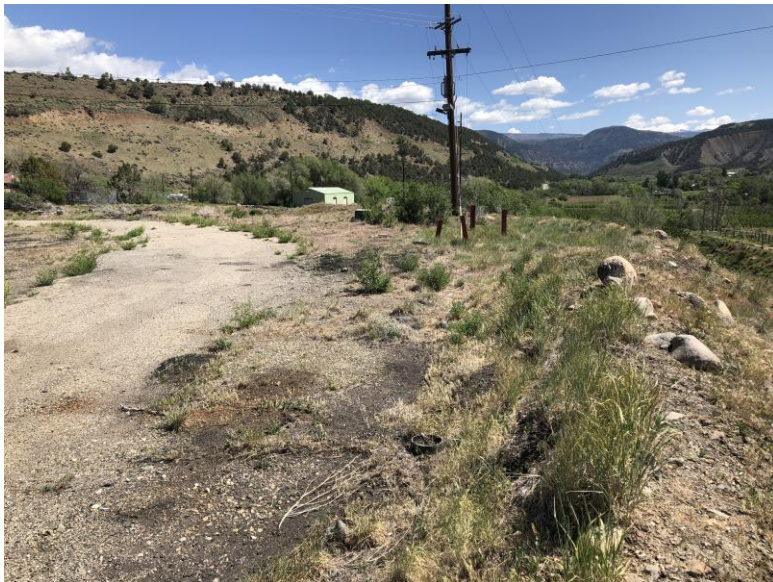
Western side of loadout, looking northeast

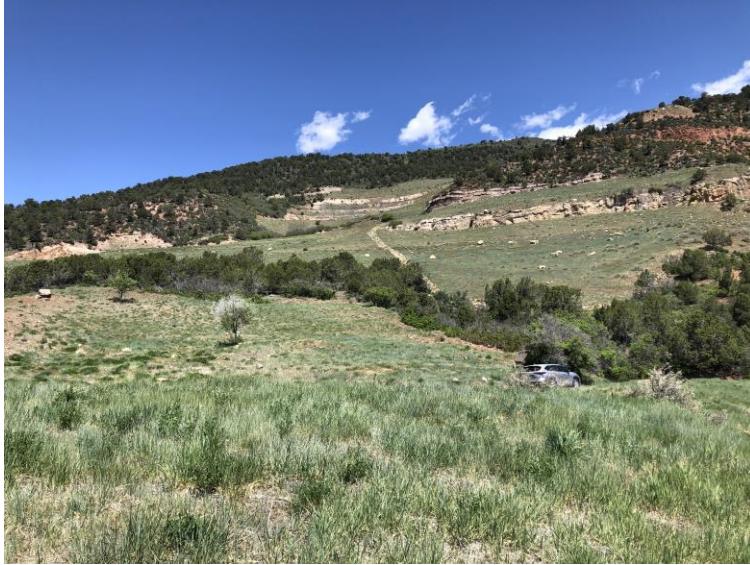
No erosion was seen at the reclaimed areas of the East Mine, including:

- The main area along the haul road and around the old portals
- The RDA
- The Old Waste Disposal Area
- The drainage where the reclaimed ponds (Ponds 1 – 4) are located.

East Mine, from Old Waste Disposal Area

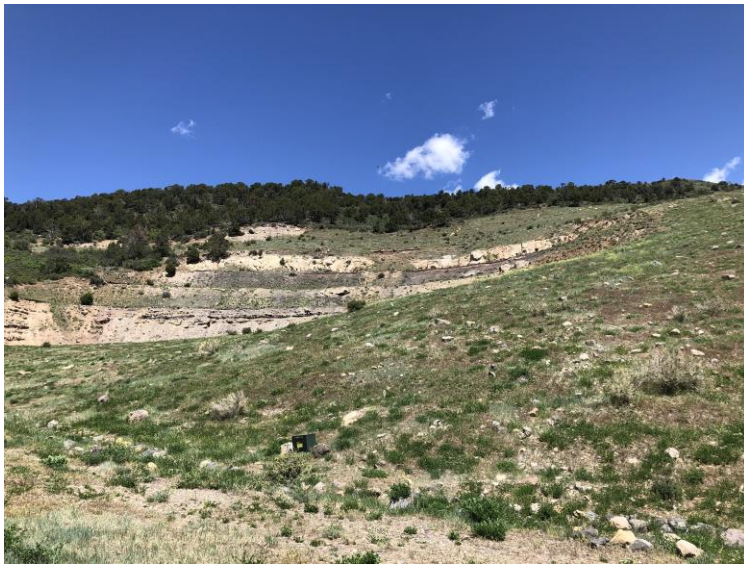
The slope around the fallen fence at the upper part of the East Mine was stable.

Upper portion of East Mine

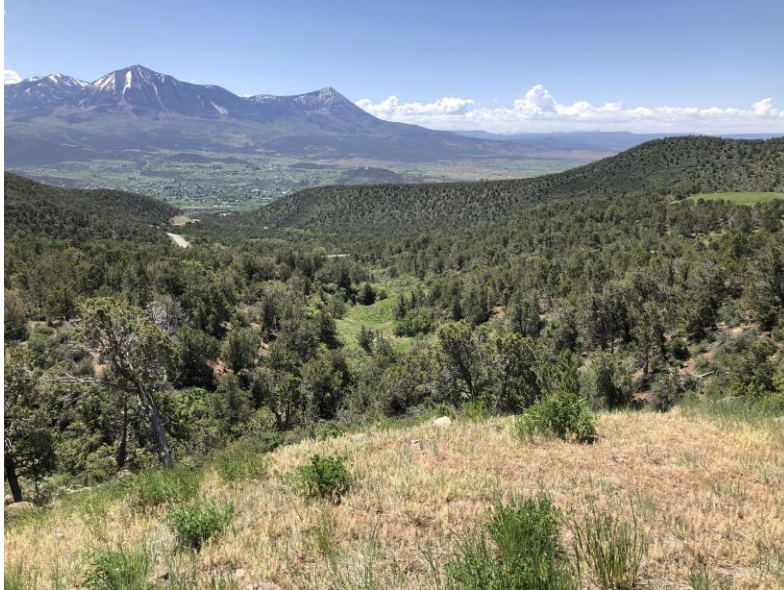
Drainage below the Old Waste Disposal Area

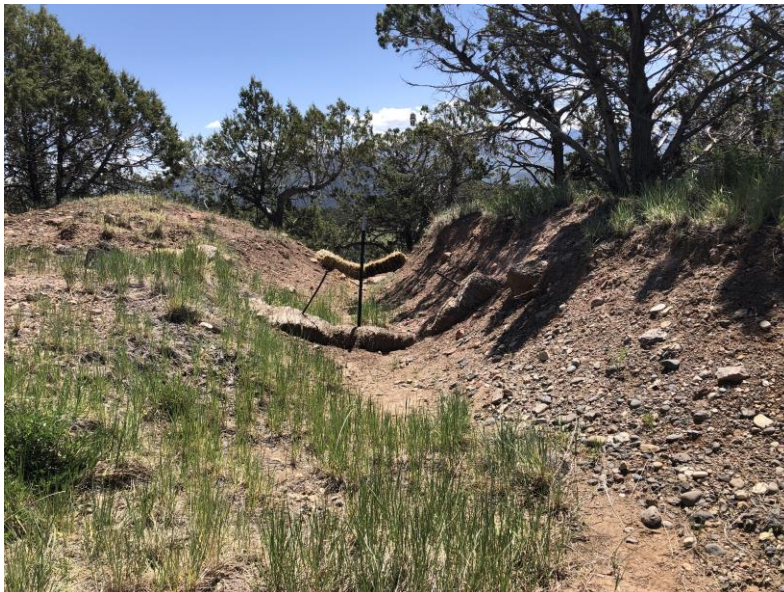
Best Management Practices southeast of the RDA
