**PERMIT INFORMATION**

<b>Permit Number:</b> C-1996-083 <b>Mine Name:</b> Bowie No. 2 Mine <b>Operator:</b> Bowie Resources, LLC <b>Operator Address:</b> Mr. Basil Bear P.O. Box 1488 Paonia, CO 81428	<b>County:</b> Delta <b>Operation Type:</b> Underground <b>Permit Status:</b> Active <b>Ownership:</b> Private
	<b>Operator Representative Present:</b>  None
<b>Operator Representative Signature: (Field Issuance Only)</b>

<b>Inspection Start Date:</b> May 18, 2022 <b>Inspection Start Time:</b> 08:00 <b>Inspection End Date:</b> May 18, 2022 <b>Inspection End Time:</b> 10:30		<b>Inspection Type:</b> Coal Complete Inspection <b>Inspection Reason:</b> Normal I&E Program <b>Weather:</b> Clear	
<b>Joint Inspection Agency:</b>  None		<b>Joint Inspection Contacts:</b>  	
<b>Post Inspection Agency:</b>  None		<b>Post Inspection Contacts:</b>  	
<b>Inspector(s):</b>  Robert Zuber, P.E.	<b>Inspector's Signature:</b>  <i>Robert D. Zuber</i>		<b>Signature Date:</b>  5/19/2022

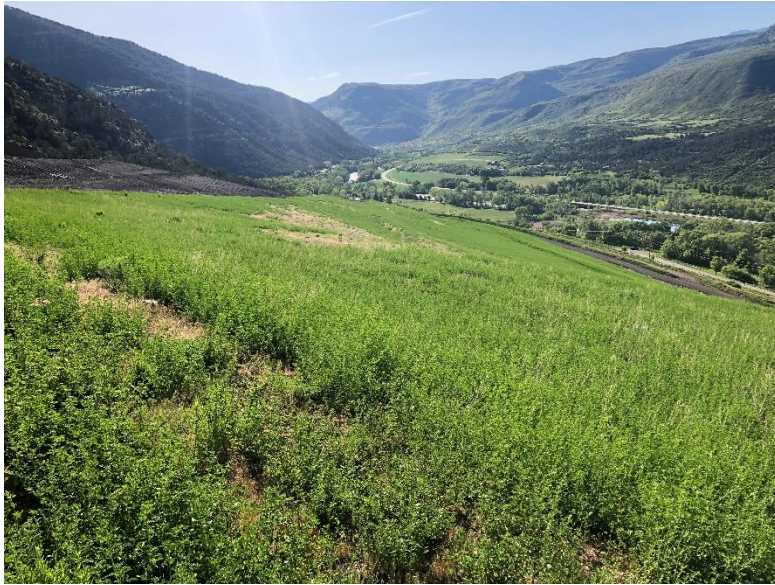
**Gob Pile #2**

Rills were visible on the upper (bare) slopes of Gob Pile #2, but they are small. No puddles or other problems were observed on the upper, flat portion of this pile. The lower slopes of this pile were mostly covered with green vegetation, much of which appeared to be yellow sweet clover.

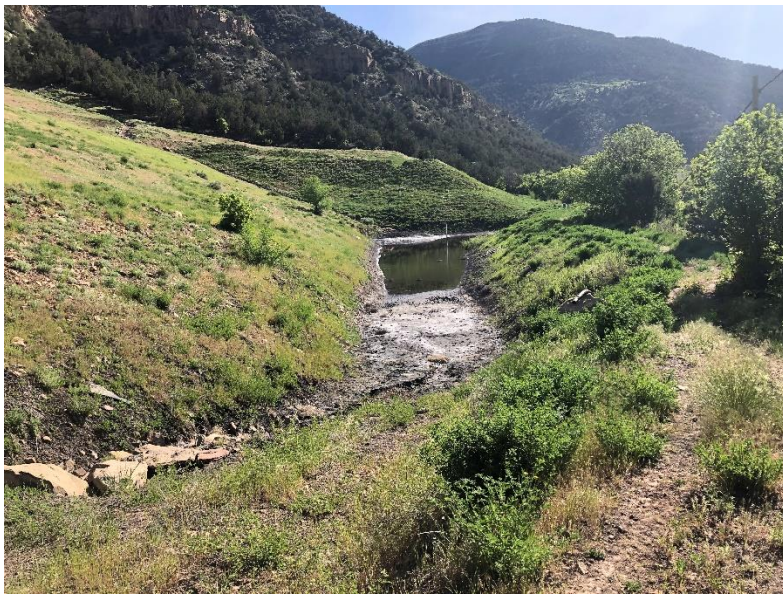
**Pond F**

Six sediment ponds were inspected: B, C, D, F, J, and K. None of the ponds were discharging. Many of the ponds contained water, but none of the ponds were close to full. No significant problems were identified with embankments, spillways, inlet channels, or other features of the ponds.

No problems were found with ditches. The ditch that flows into Pond F from the west (Ditch F7) has been cleaned recently.

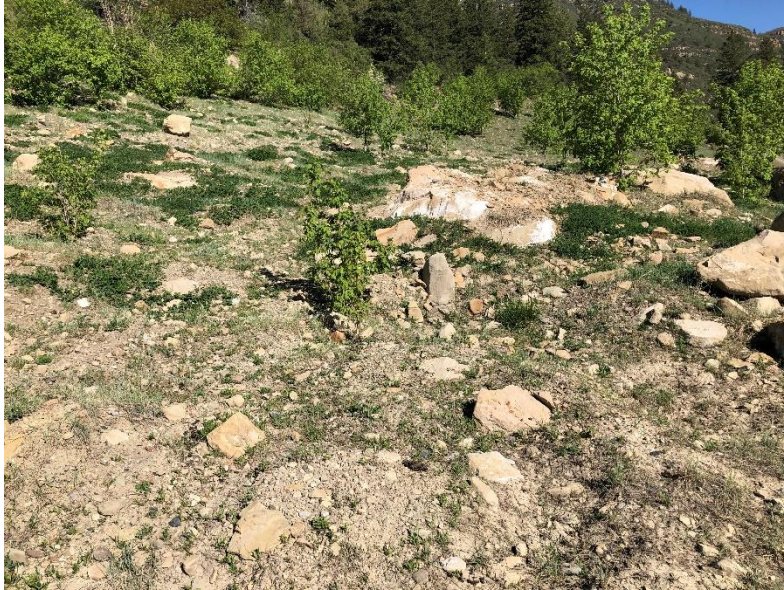
The grass and other ground vegetation is sparse at the reclaimed pad for the former Hubbard Creek Vent Shaft. Feces in this area suggest that the area has been grazed by sheep.

**Reclaimed pad for the former Hubbard Creek Vent Shaft**

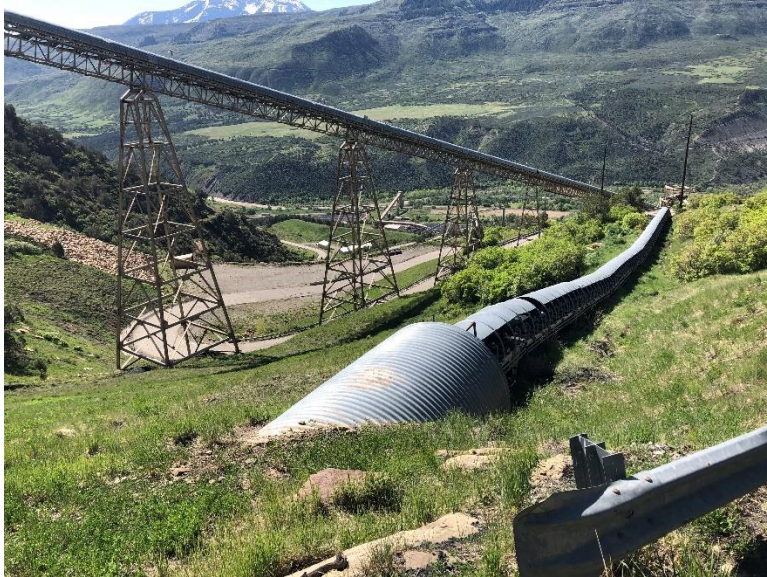
All benches appeared stable with no signs of erosion. These include the pads for the Utility Bench, B Portal bench and the D Portal bench. Other comments on facilities:

**Slopes below the D Portal pad**

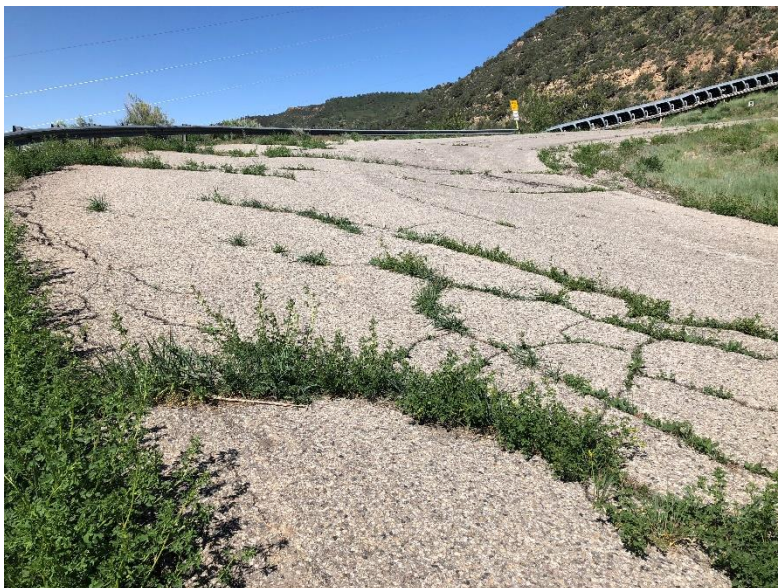
No significant problems were seen with the road to the portals, although some areas of the road may require repairs of cracks in the next year or two to prevent larger problems. The hillsides above and below this road were generally stable.

**Cracks on road to portals (Curve 5)**
