MINERALS PROGRAM INSPECTION REPORT
PHONE: (303) 866-3567

MINE NAME: Fedinec Pit	MINE/PROSPECTING ID#: M-1977-057	MINERAL: Crushed stone material	COUNTY: Moffat
INSPECTION TYPE: Monitoring	INSPECTOR(S): Zach Trujillo	INSP. DATE: May 12, 2022	INSP. TIME: 08:00
OPERATOR: Pioneer Sand Company, Inc.	OPERATOR REPRESENTATIVE: None	TYPE OF OPERATION: 112c - Construction Regular Operation	
REASON FOR INSPECTION: Normal I&E Program	BOND CALCULATION TYPE:	BOND AMOUNT: \$57,900.00	
DATE OF COMPLAINT: NA	POST INSP. CONTACTS: None	JOINT INSP. AGENCY: None	
WEATHER: Windy	INSPECTOR'S SIGNATURE:

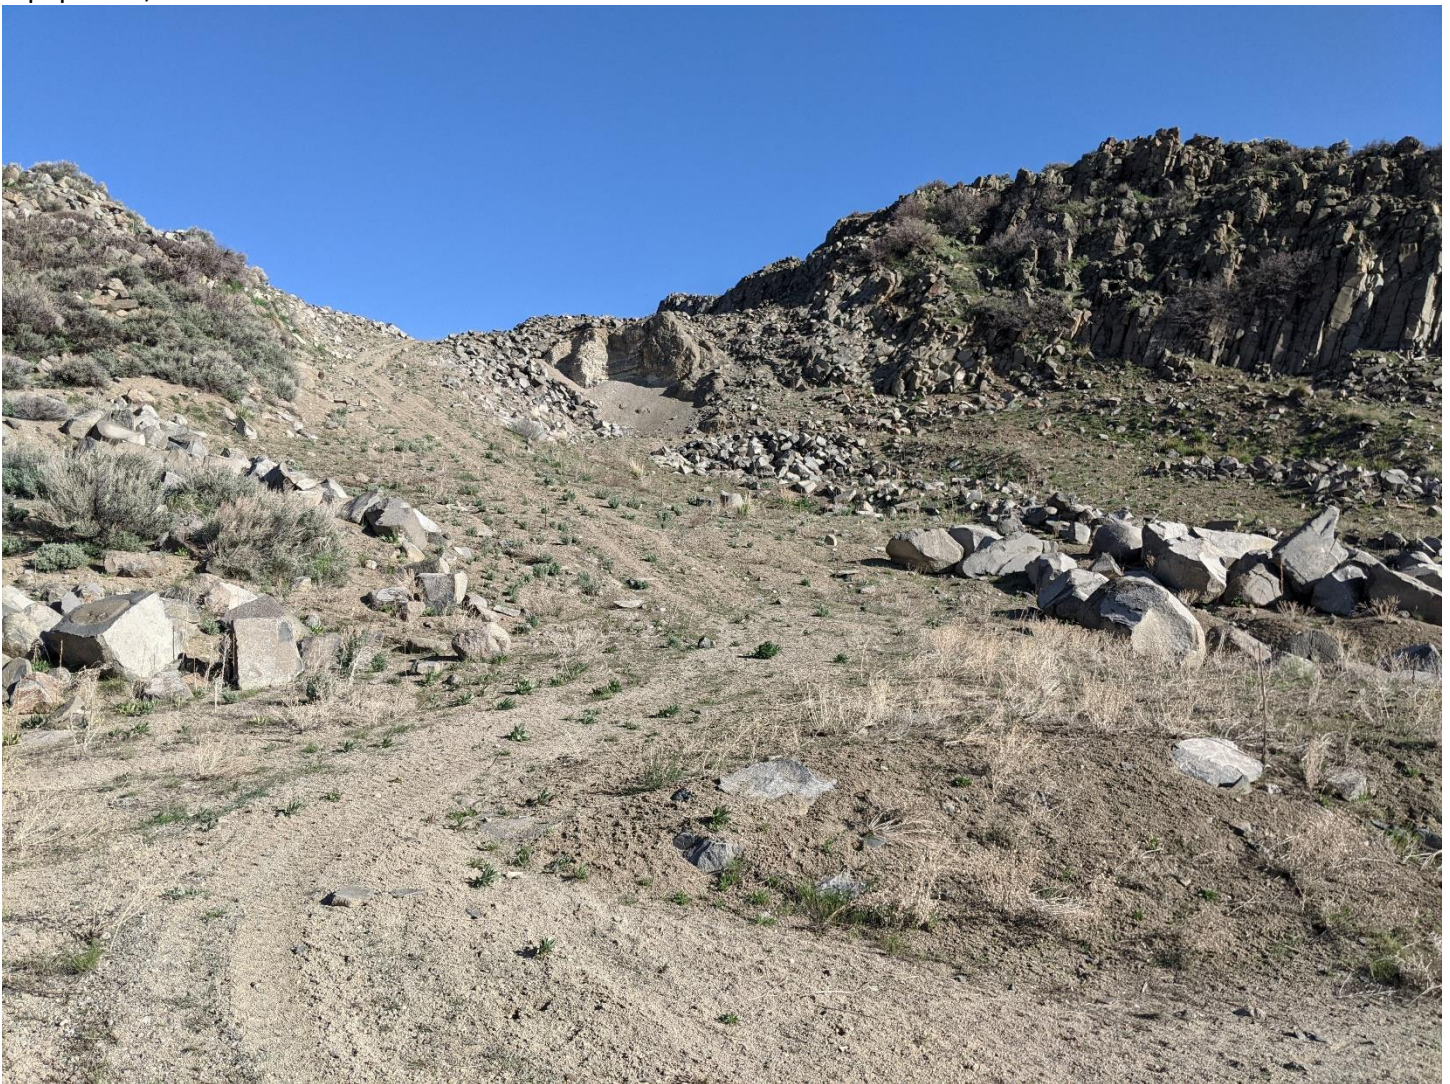
Excavated area and access road from below.

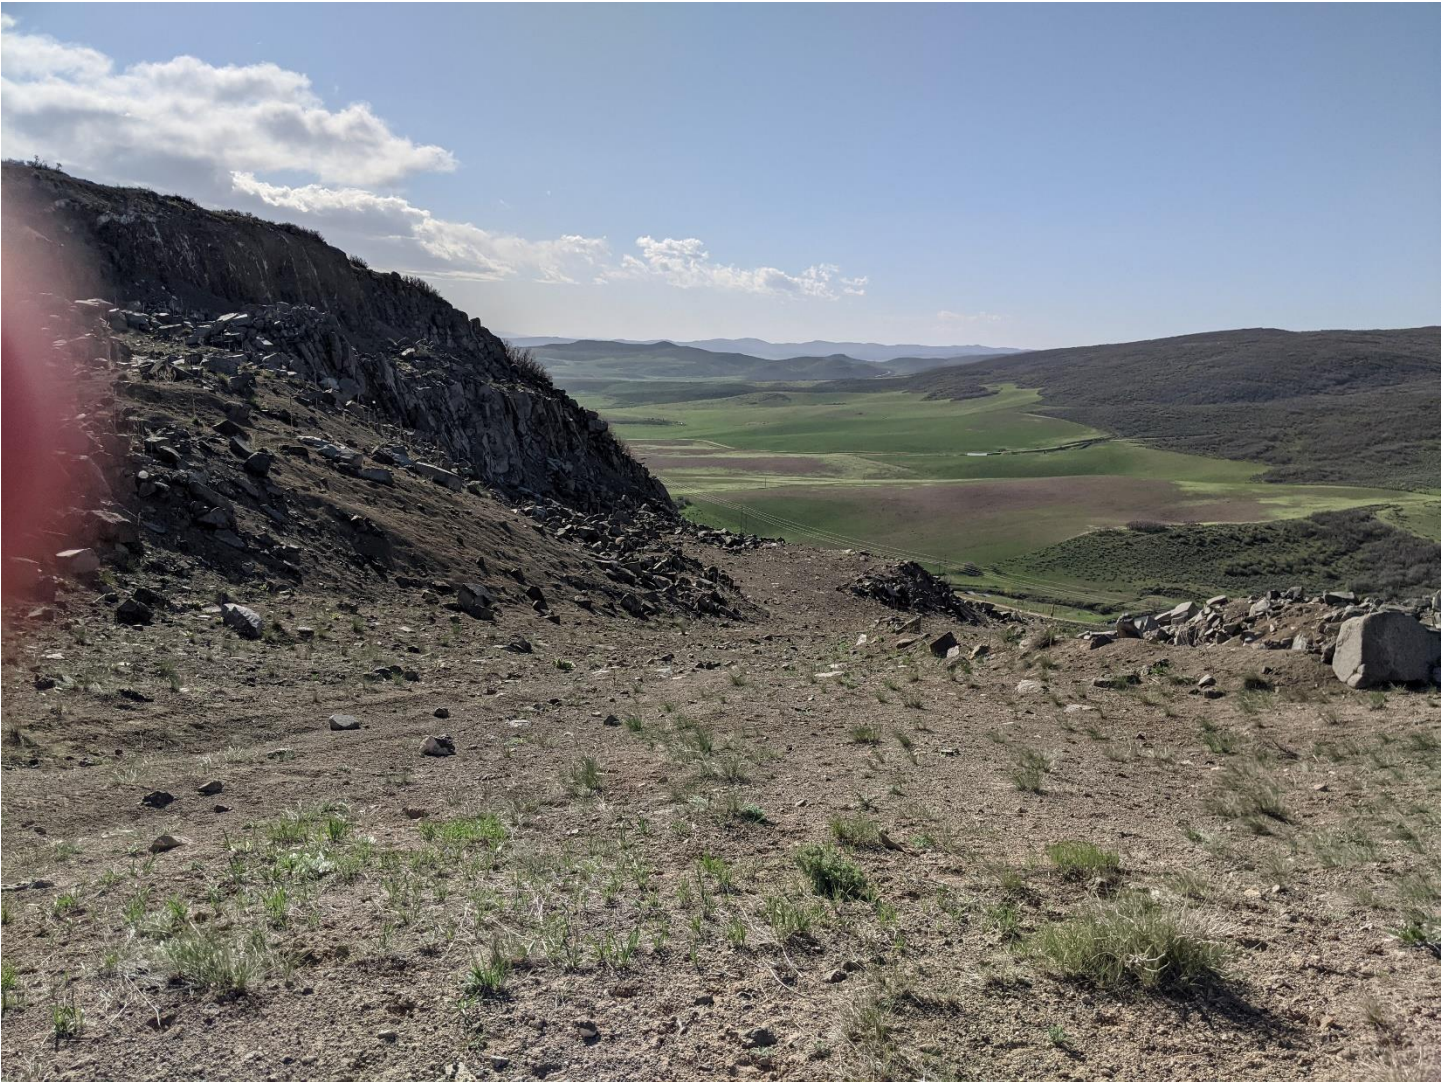
Excavated area from above.

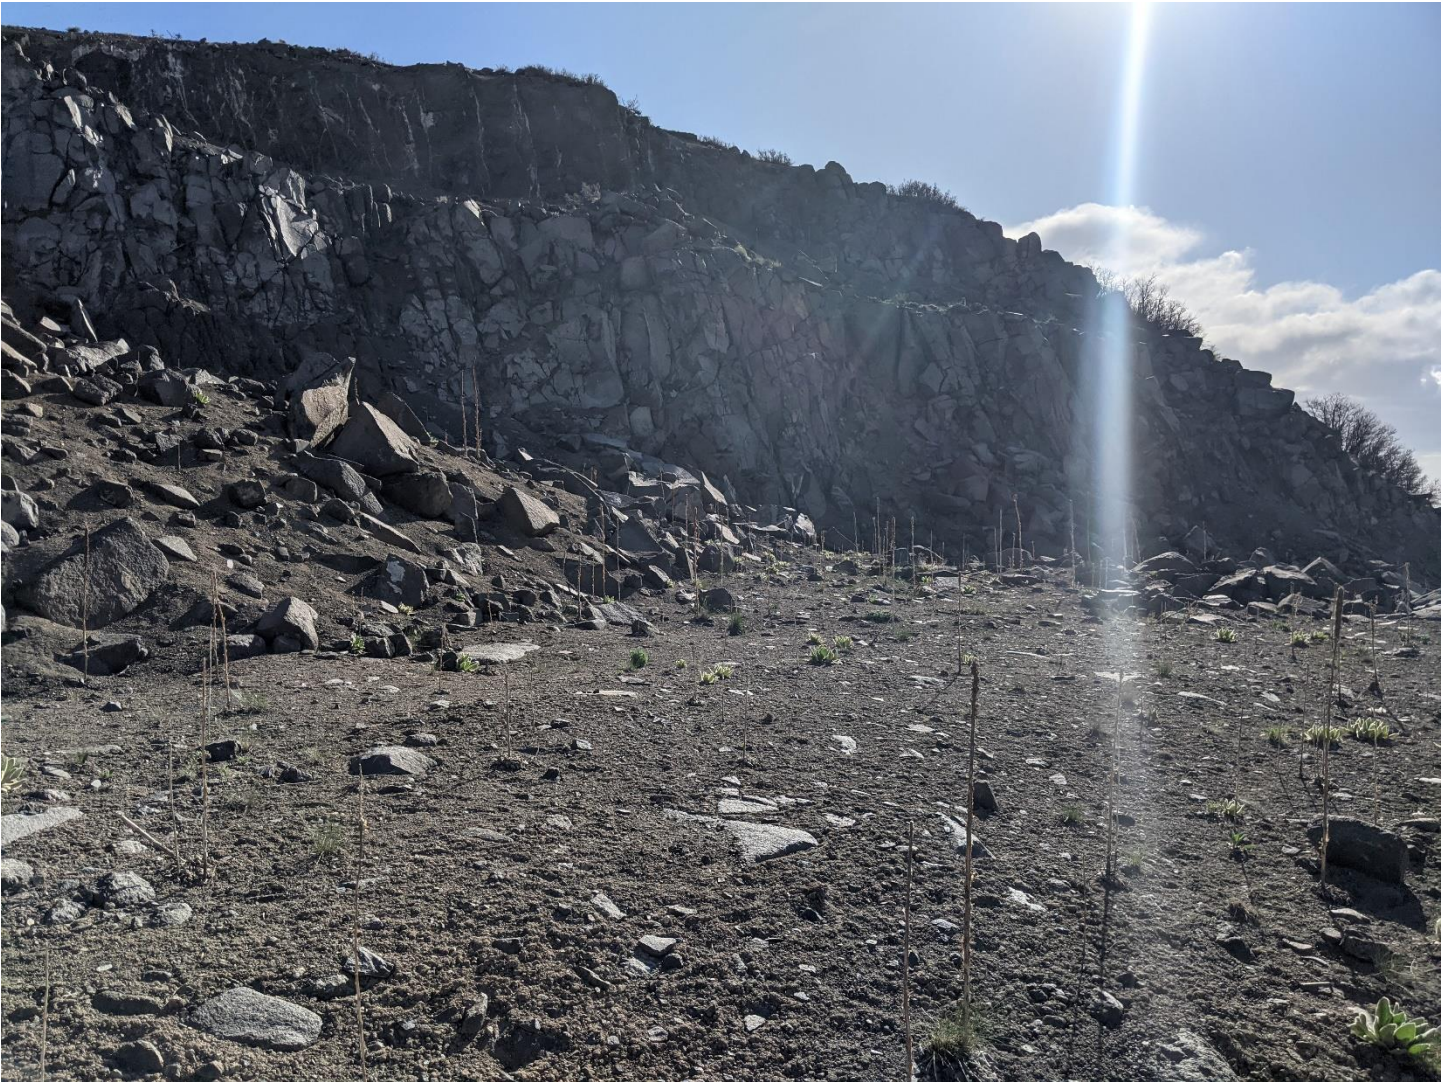
Vegetation establishment within the affected area of the permit due to lack of site activity is evident. Hounds tongue was observed along the upper mining bench below the excavated rock outcrop. Wilted hounds tongue was observed from previous years of weed spraying. Continual monitoring and application of the approved weed control plan along the site, most notably in this area, should continue.

Hounds tongue along upper mining bench.

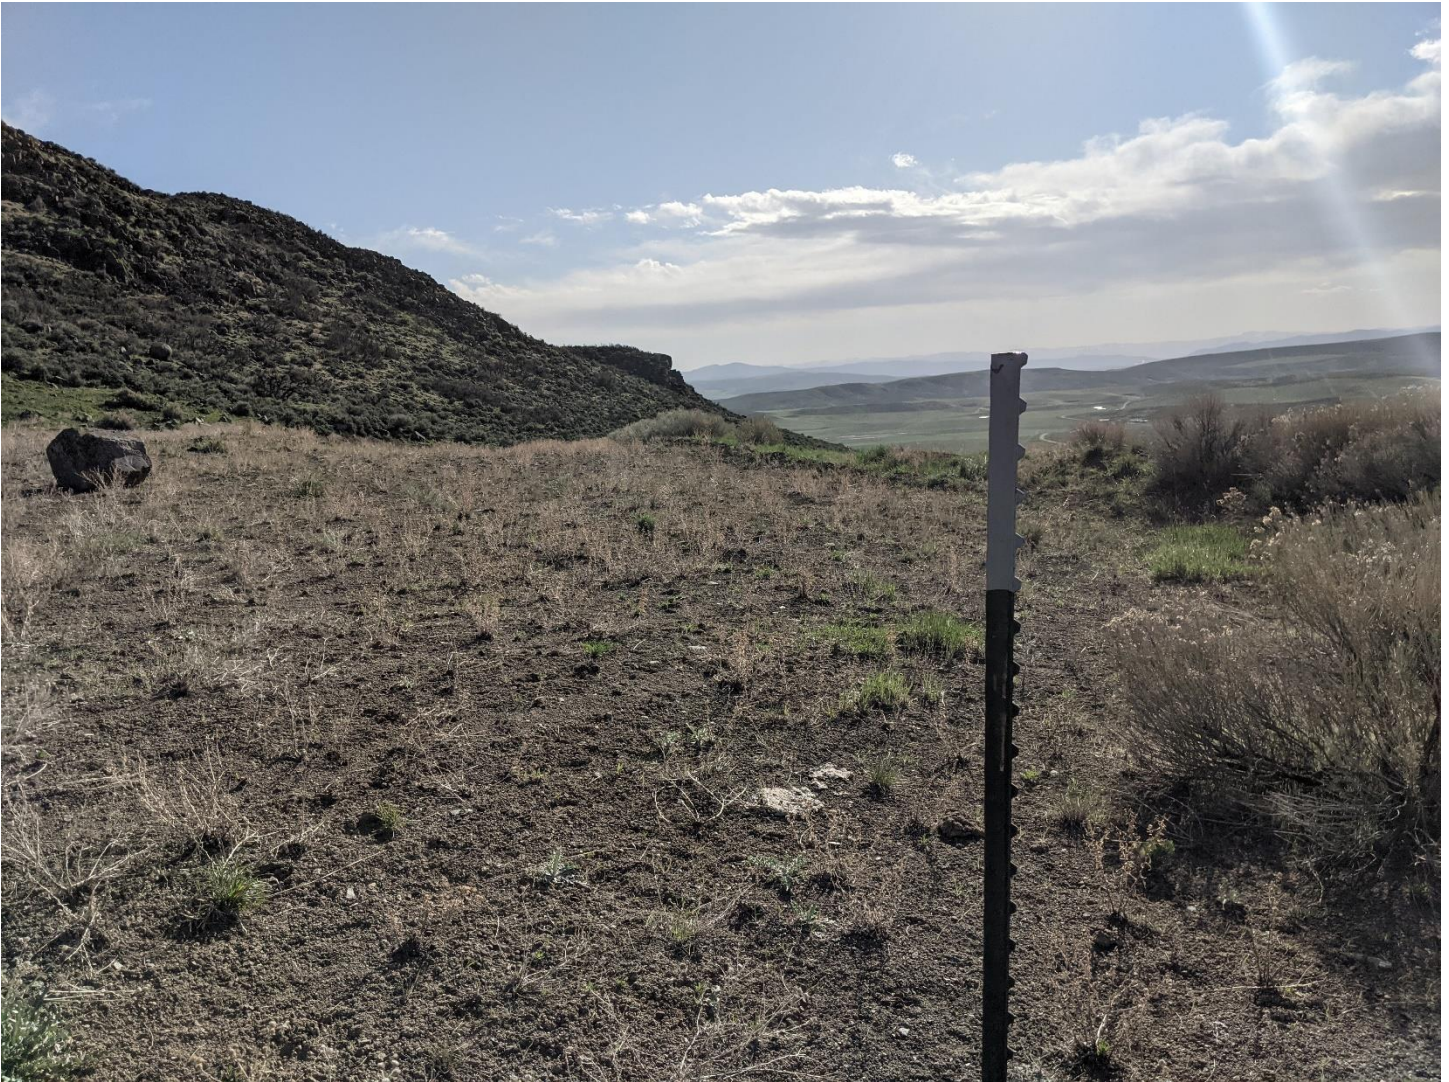
Affected land boundary markers were observed. T-posts clearly delineated the area of disturbance.

Affected boundary marker.
