MINERALS PROGRAM INSPECTION REPORT
PHONE: (303) 866-3567

MINE NAME: Breeze Basin Sand & Gravel Pit	MINE/PROSPECTING ID#: M-2008-022	MINERAL: Sand and gravel	COUNTY: Moffat
INSPECTION TYPE: Monitoring	INSPECTOR(S): Zach Trujillo	INSP. DATE: May 12, 2022	INSP. TIME: 09:00
OPERATOR: Oldcastle SW Group, Inc. dba United Compai	OPERATOR REPRESENTATIVE: None	TYPE OF OPERATION: 112c - Construction Regular Operation	
REASON FOR INSPECTION: Normal I&E Program	BOND CALCULATION TYPE:	BOND AMOUNT: \$55,000.00	
DATE OF COMPLAINT: NA	POST INSP. CONTACTS: None	JOINT INSP. AGENCY: None	
WEATHER: Windy	INSPECTOR'S SIGNATURE:

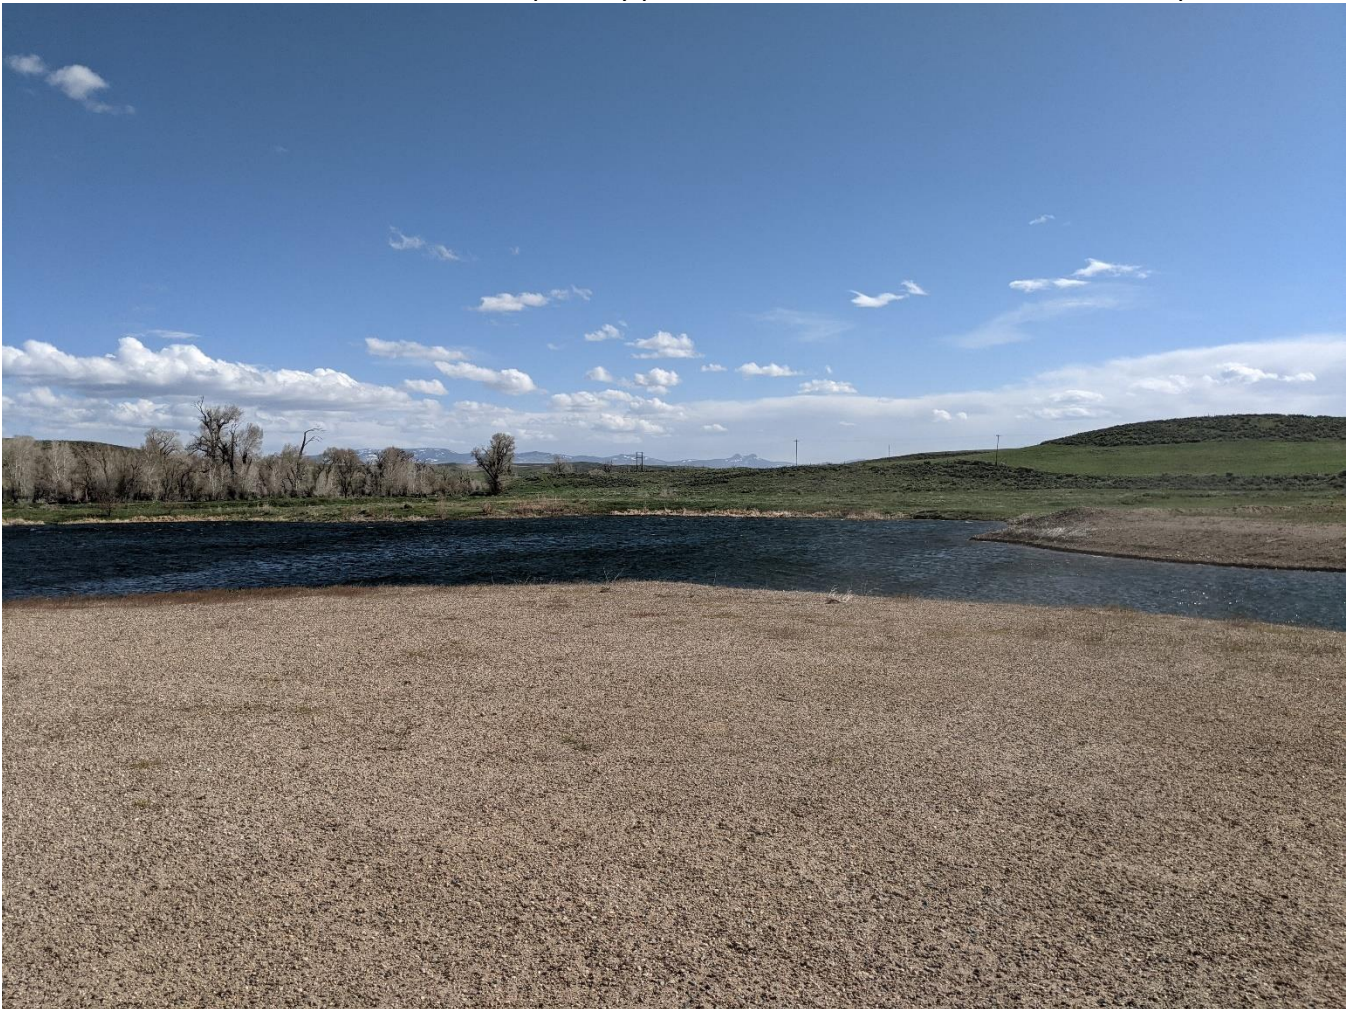
The excavated pit hold groundwater. The current pit area consists of a primary area with a finger that extends south from the south eastern end of the primary pit area. All water is maintained with the pit.

Excavated pit area.

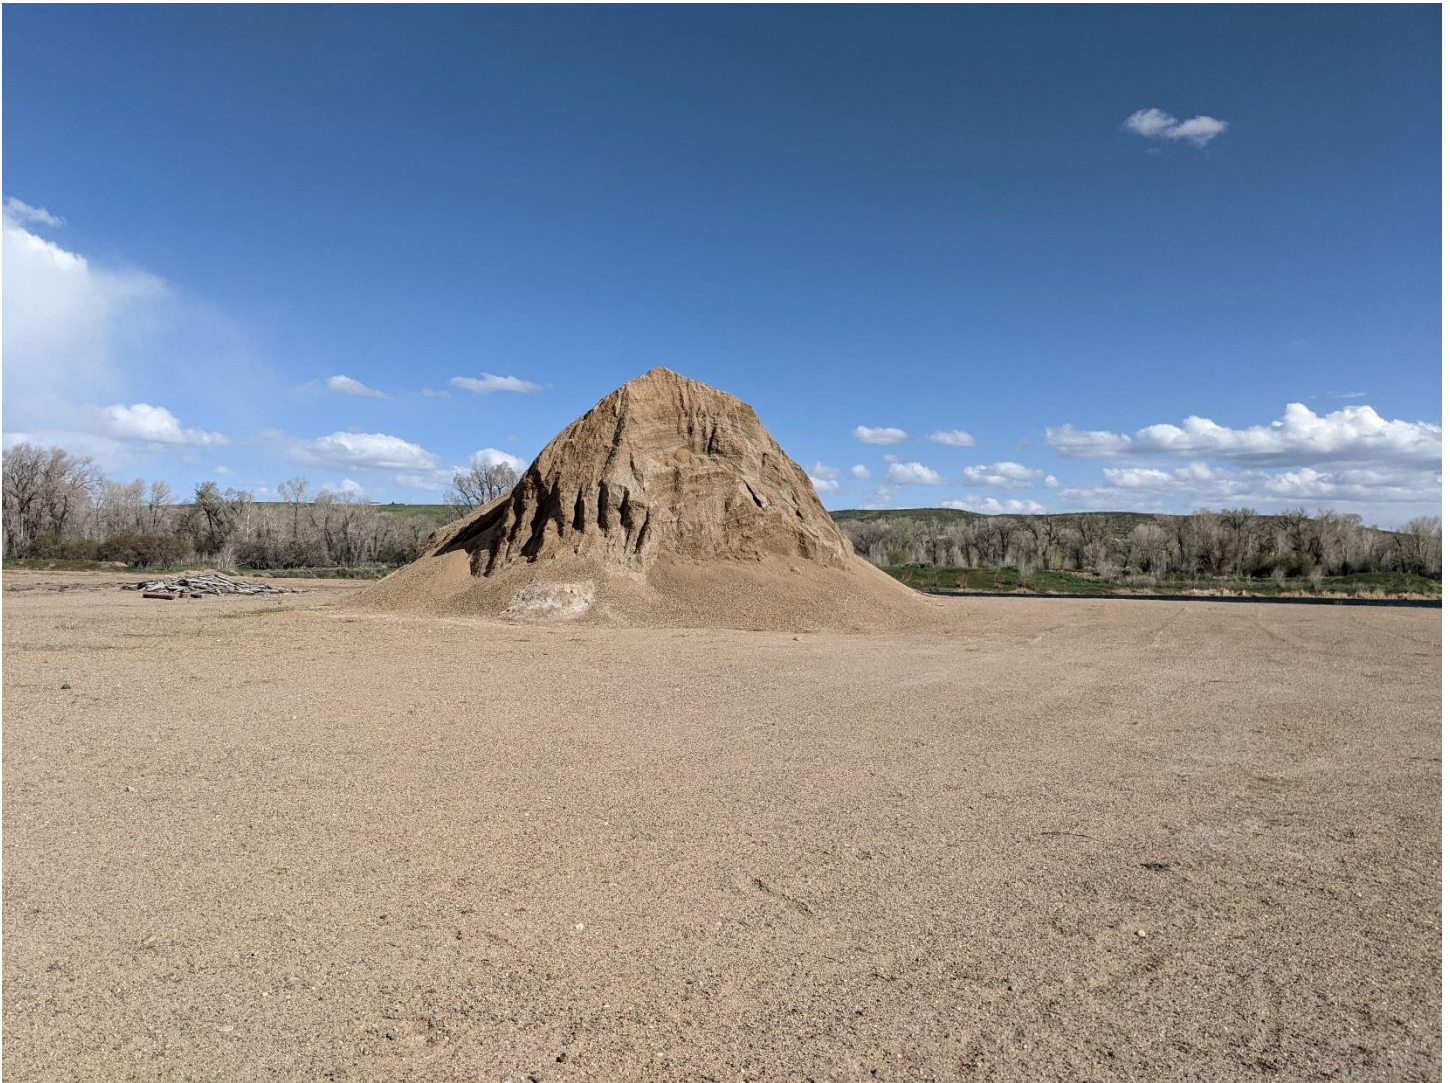
Excavated material has been stockpiled in the center of the affected area next to the pit. No equipment or facilities were on site at the time of the inspection.

Stockpiled material.

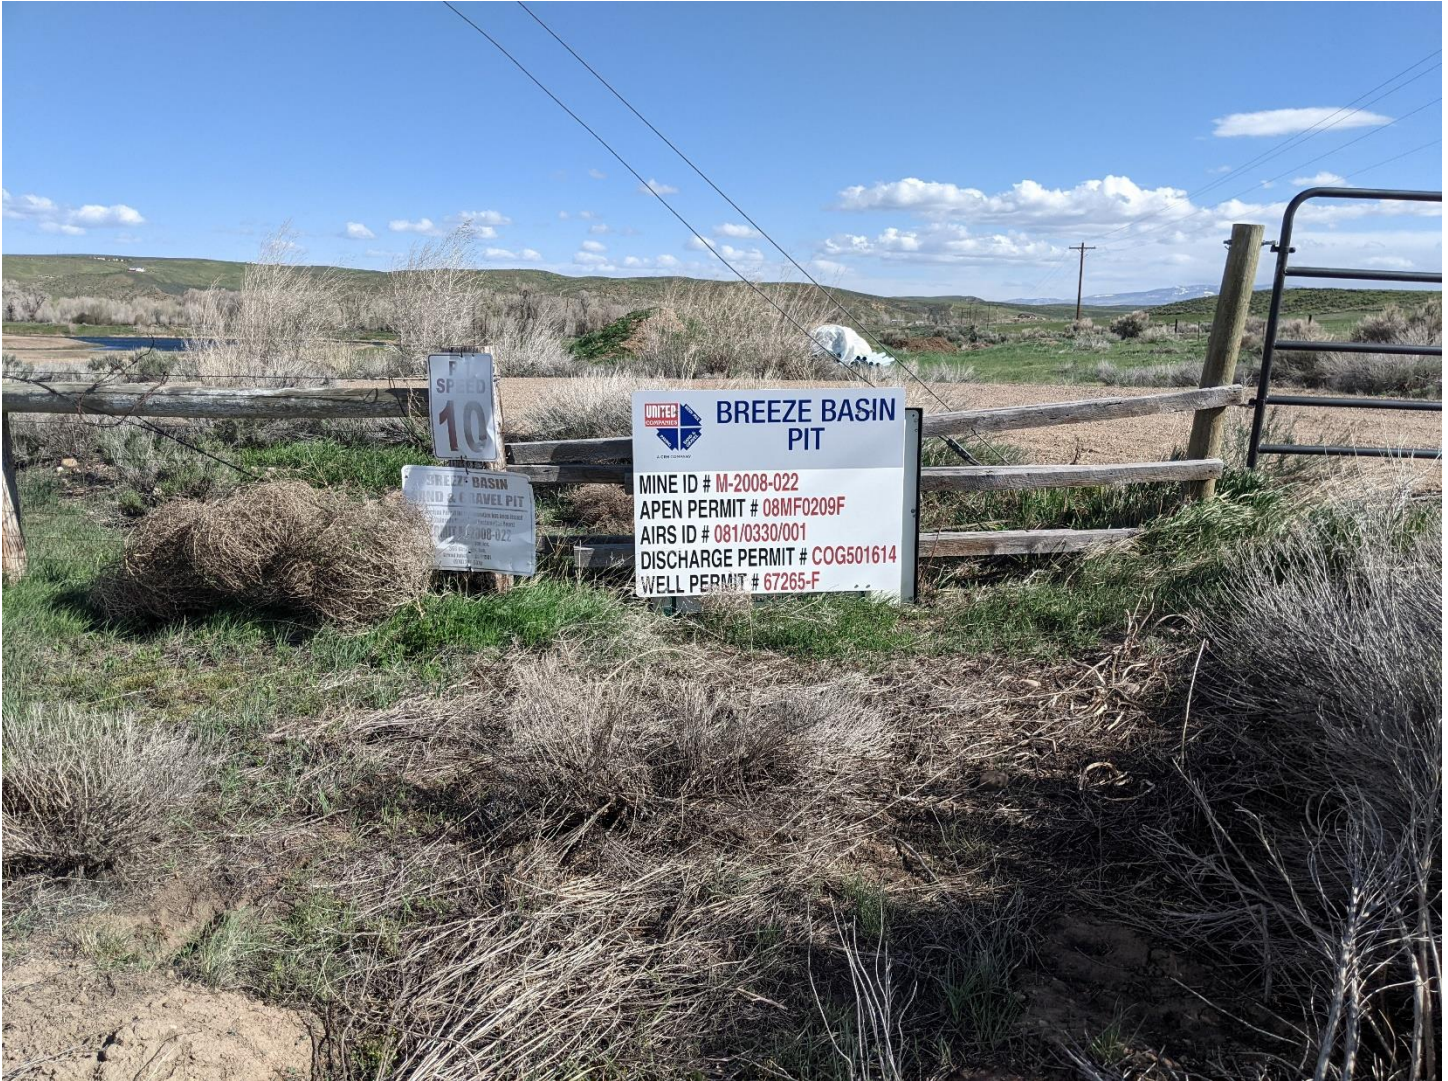
The mine identification sign is located at the entrance of the permit boundary. All information for compliance with Rule 3.1.12 was present. North of the pit area along the Yampa River has undisturbed buffer zone along with a wetland area within the permitted area. These areas were marked off to ensure no disturbance occurs.

Mine identification sign.

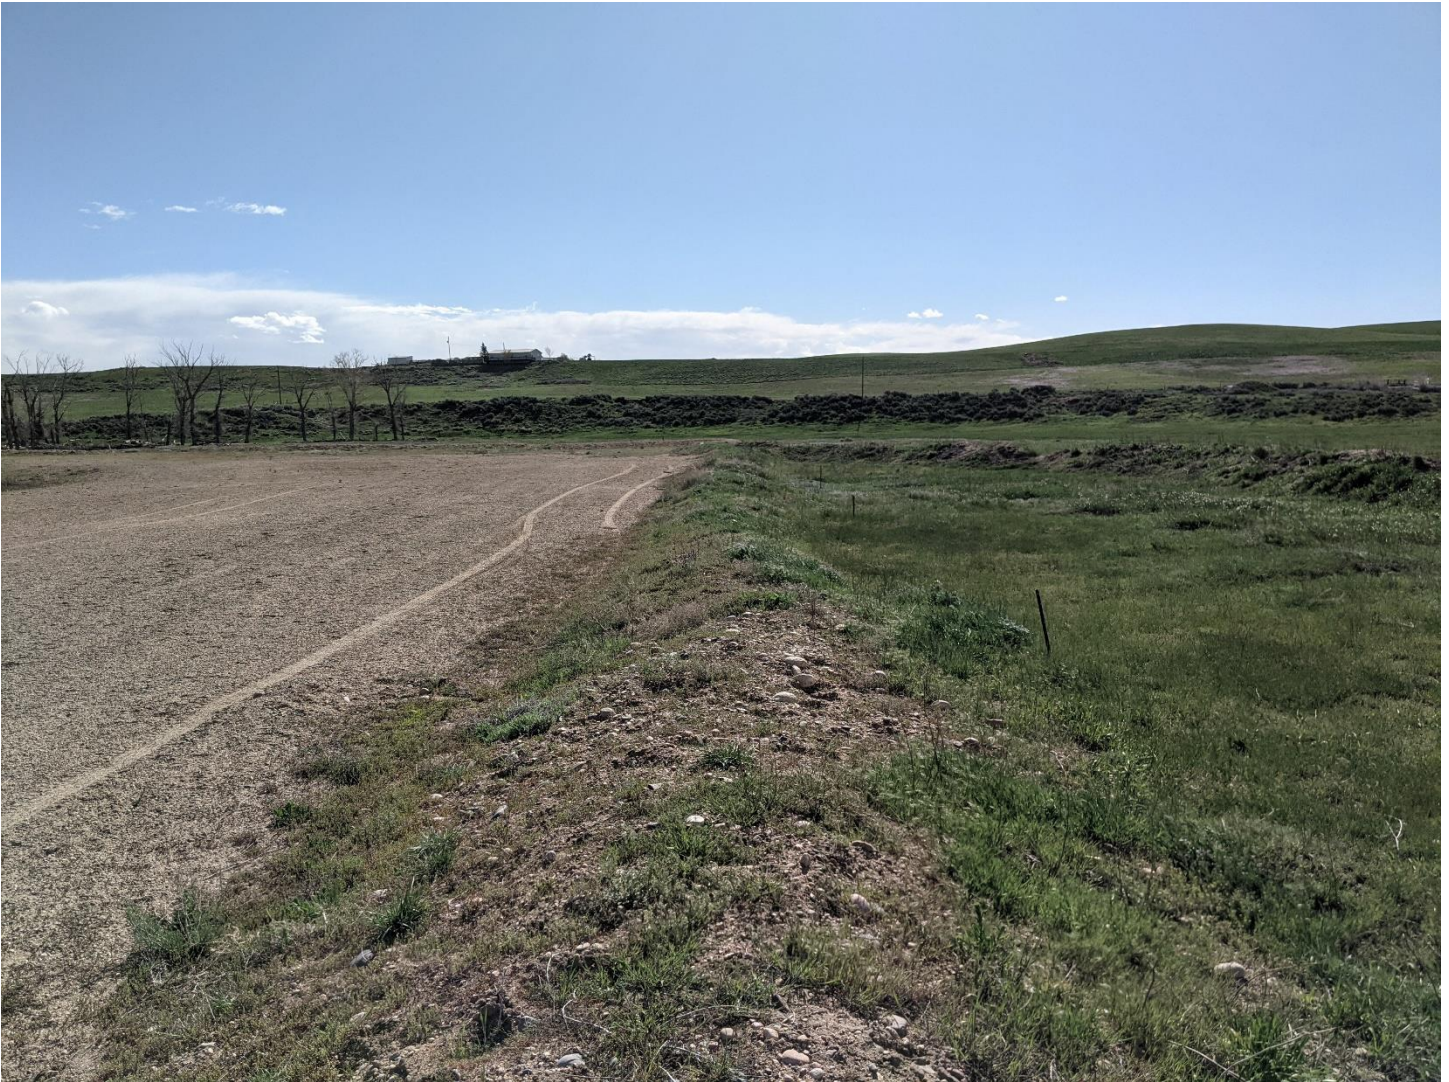
The affected area is surrounded by a containment berm to ensure surface runoff stays within the affected area footprint.

Bermed area with disturbance boundary marker right of berm.
