MINERALS PROGRAM INSPECTION REPORT
PHONE: (303) 866-3567

MINE NAME: Wagner Rock Pit	MINE/PROSPECTING ID#: M-1999-018	MINERAL: Gravel	COUNTY: Moffat
INSPECTION TYPE: Monitoring	INSPECTOR(S): Zach Trujillo	INSP. DATE: May 12, 2022	INSP. TIME: 08:30
OPERATOR: Wagner Construction Inc.	OPERATOR REPRESENTATIVE: None	TYPE OF OPERATION: 112c - Construction Regular Operation	
REASON FOR INSPECTION: Normal I&E Program	BOND CALCULATION TYPE: Complete Bond	BOND AMOUNT: \$71,428.00	
DATE OF COMPLAINT: NA	POST INSP. CONTACTS: None	JOINT INSP. AGENCY: None	
WEATHER: Windy	INSPECTOR'S SIGNATURE:

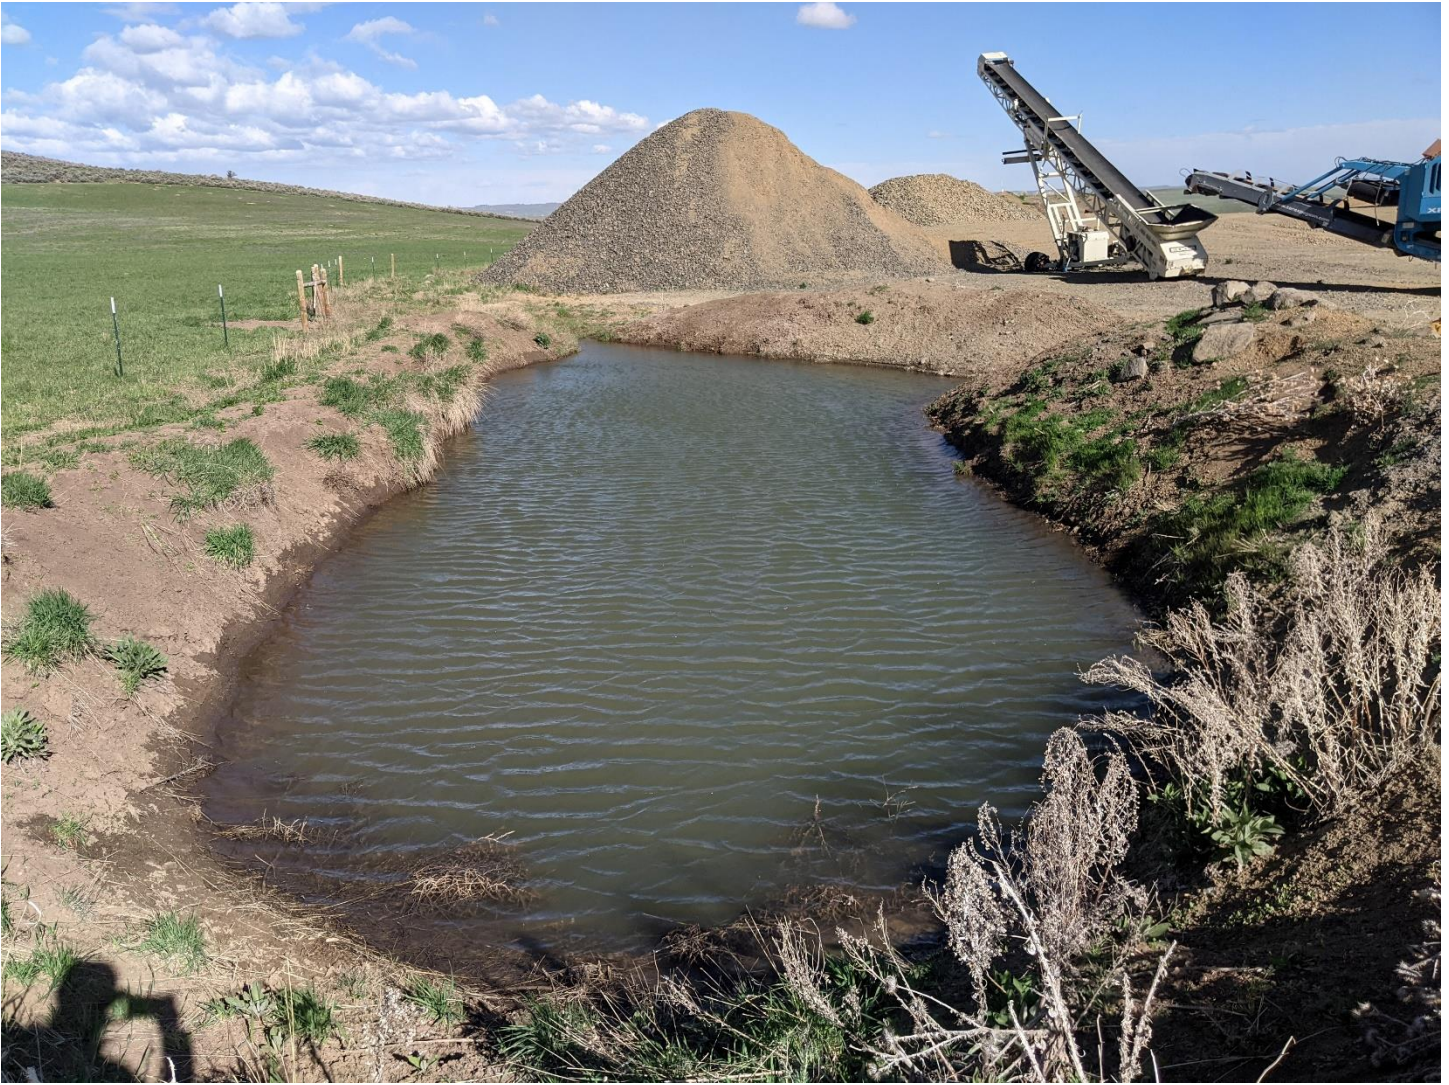
The sump located along the southern boundary of the permit was inspected. The sump held water and was not discharging.

Sump along southern end of affected area.

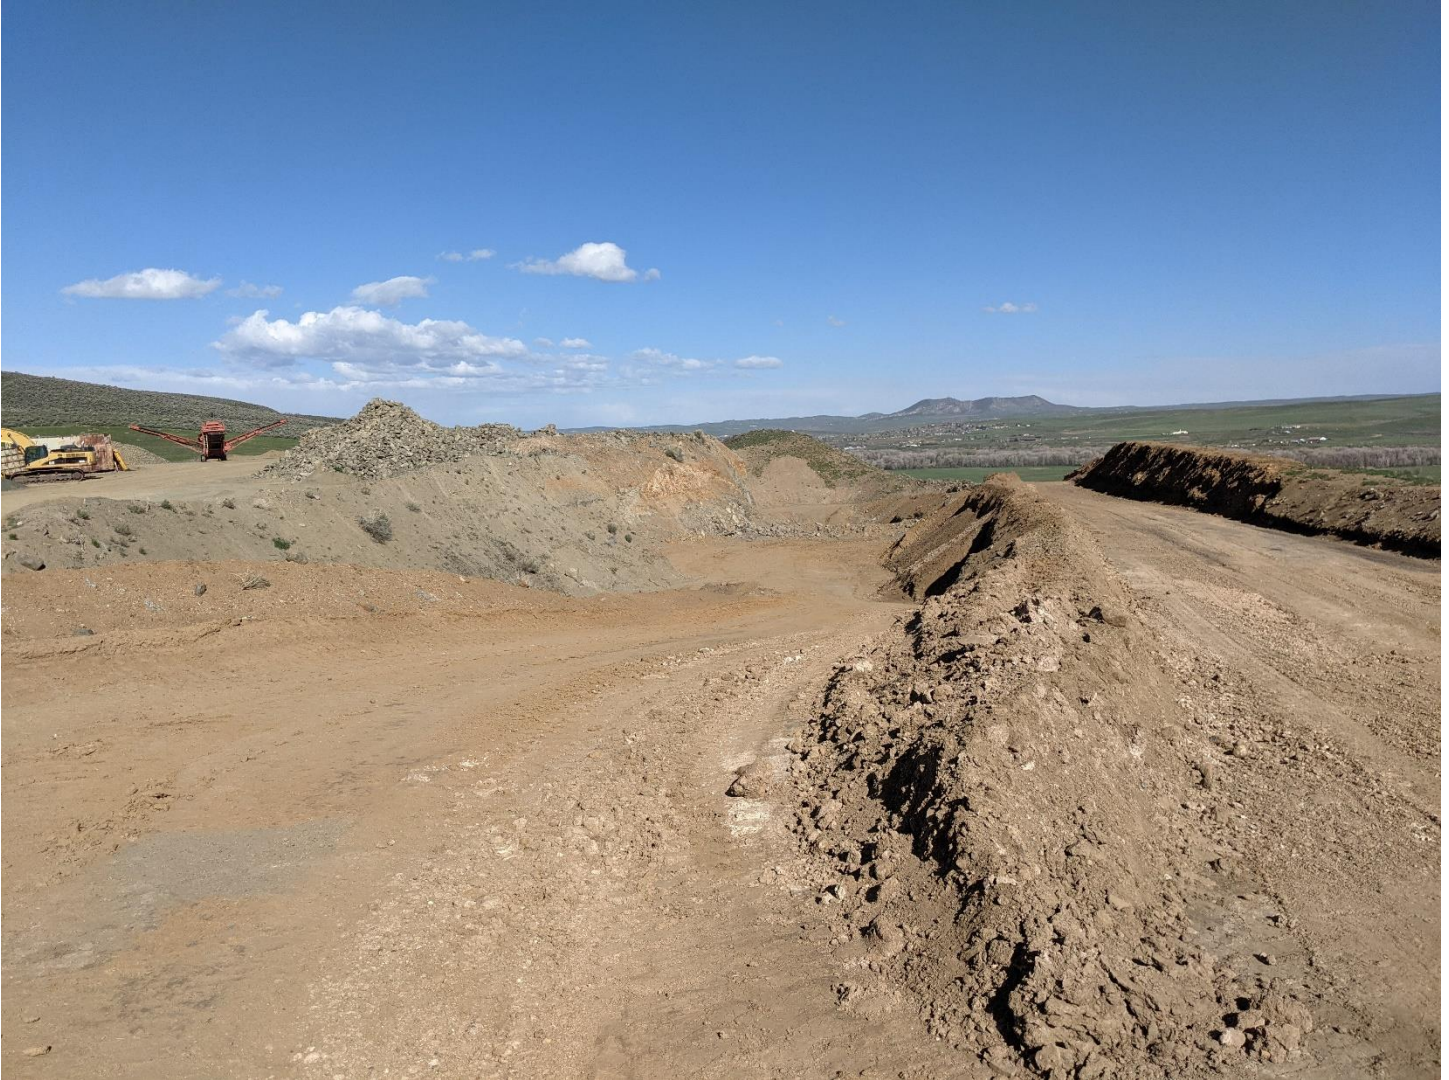
Mining activities were not active at the time of the inspection. Personnel was on site and haul trucks were observed accessing the site at the end of the inspection. Mining is continuing to progress in the box cut with multiple stepped levels ranging approximately between 30 - 60 feet deep. Current progression appears to be in the lower level moving to the east.

Upper level of pit.

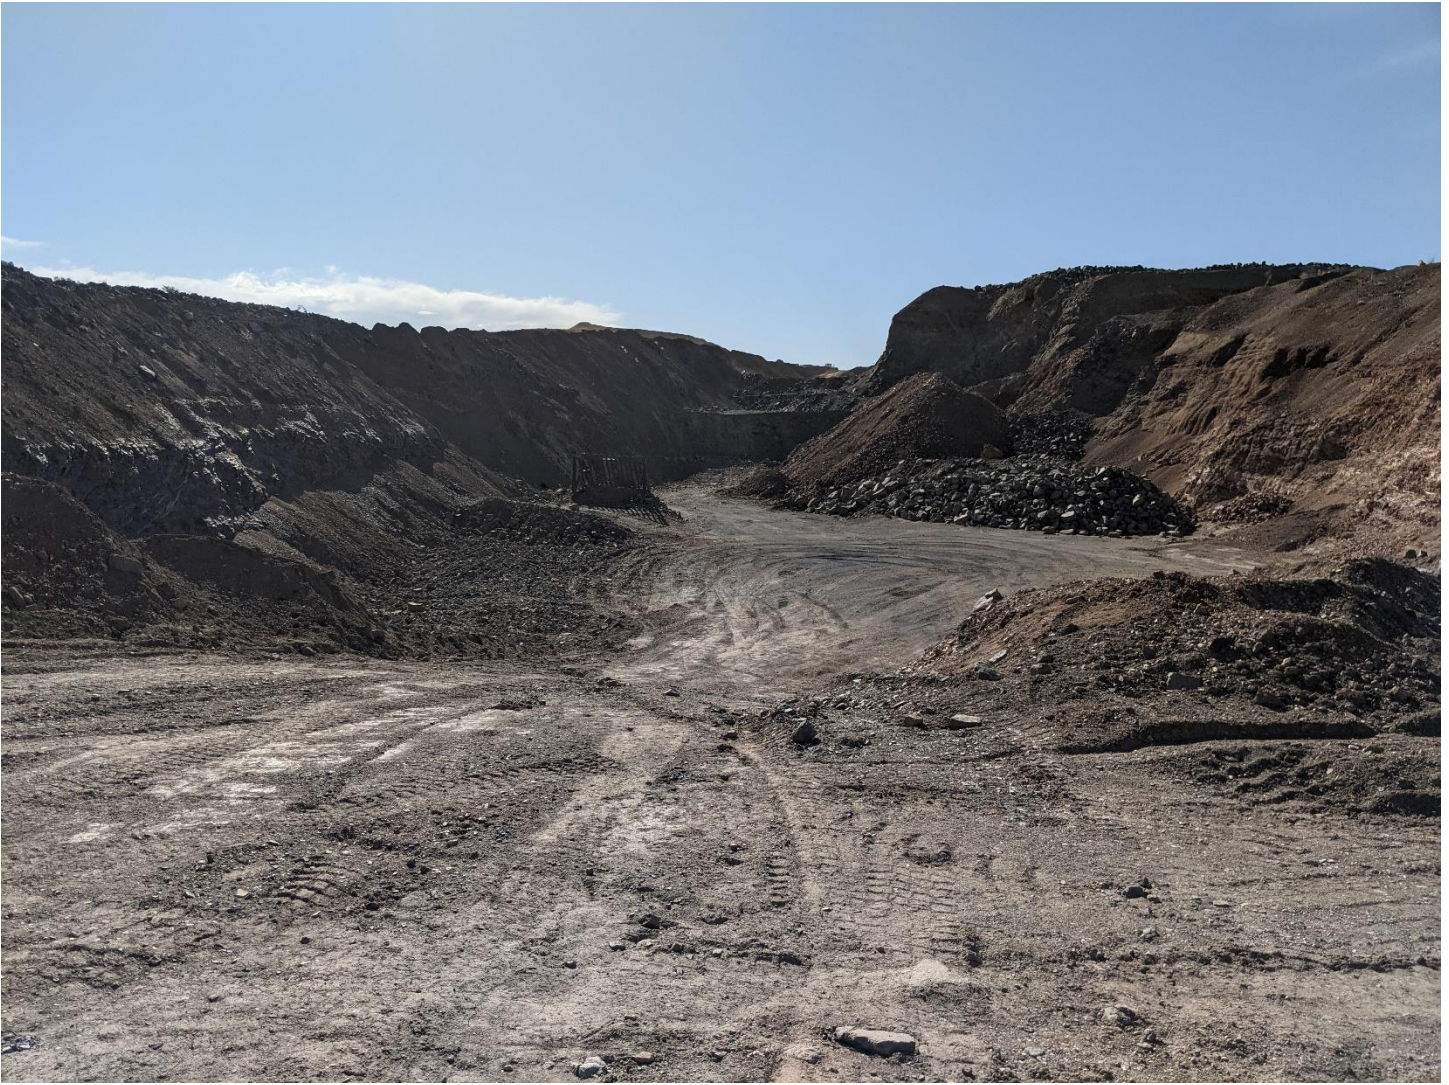
Lower level of pit.

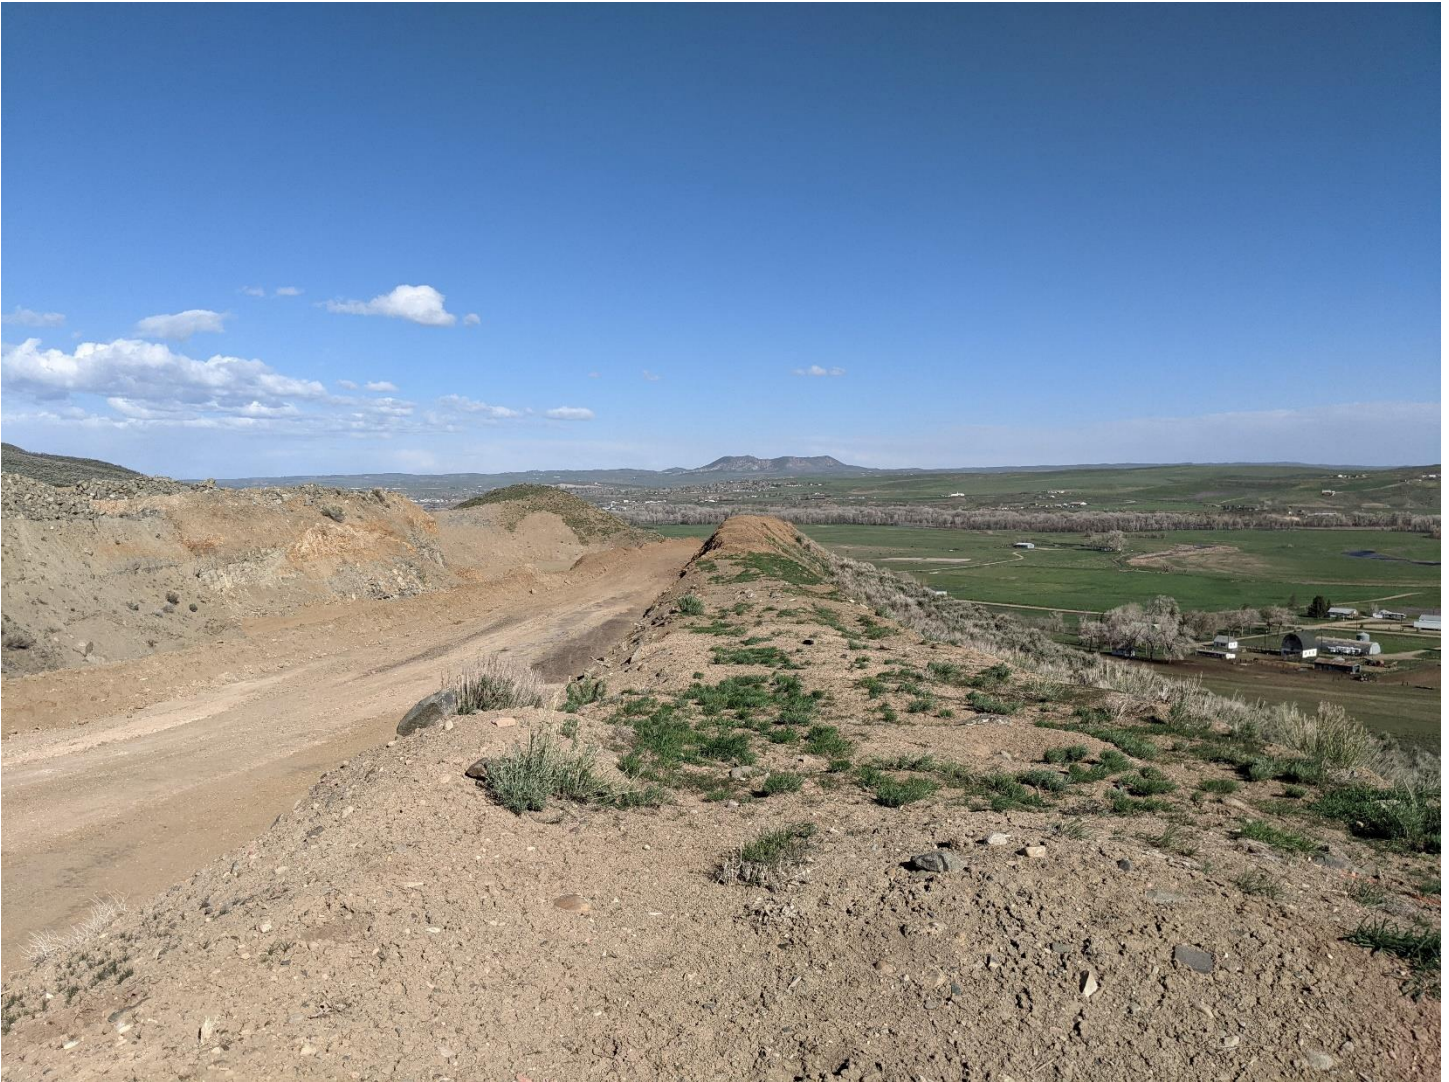
The site has containment berms located around most of the affected boundary. The berms lead to a sump located to the southern end of the site. No signs of erosion was observed throughout the site.

Containment berm north of pit area.

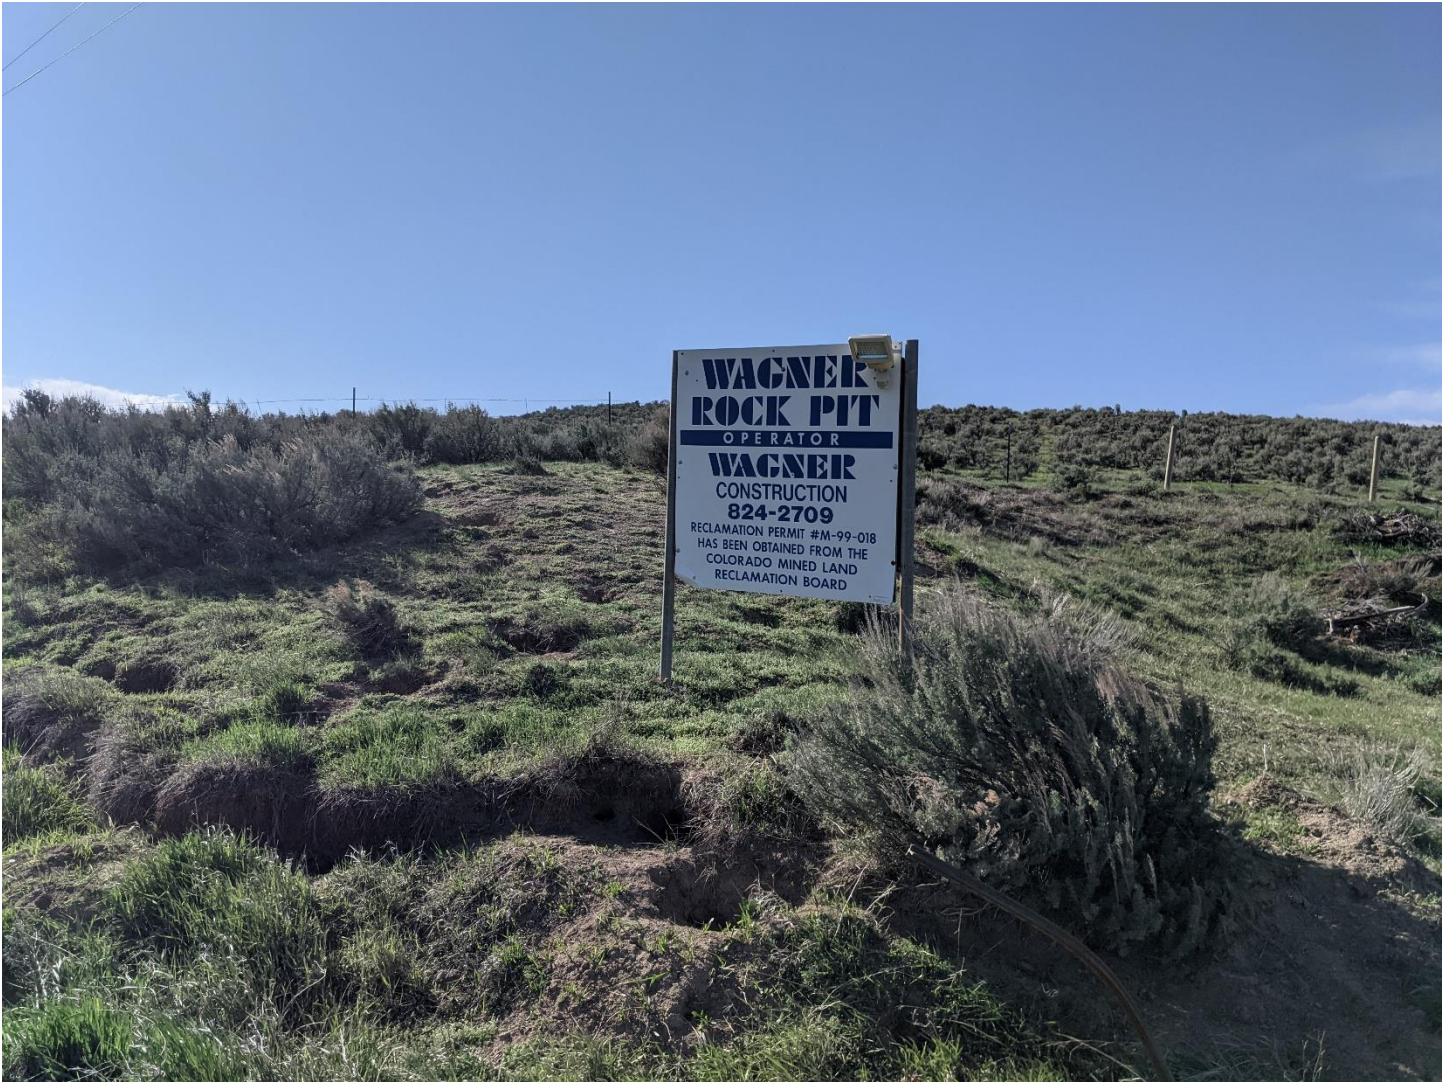
The mine identification sign and affected area boundary markers are in place and in compliance with Rule 3.1.12. The sign is located at the entrance to the permit boundary along County Road 394. The permit boundary is delineated by t-posts.

Mine identification sign.
