## MINERALS PROGRAM INSPECTION REPORT

<b>MINE NAME:</b> Burton Farms LLLP	<b>MINE/PROSPECTING ID#:</b> M-2022-012	<b>MINERAL:</b> Aggregate and grave	<b>COUNTY:</b> Rio Grande
<b>INSPECTION TYPE:</b> Preoperation Inspection	<b>INSPECTOR(S):</b> Clayton Wein	<b>INSP. DATE:</b> May 3, 2022	<b>INSP. TIME:</b> 11:30
<b>OPERATOR:</b> Burton Farms LLLP	<b>OPERATOR REPRESENTATIVE:</b> The Burtons	<b>TYPE OF OPERATION:</b> 110c - Construction Limited Impact	
<b>REASON FOR INSPECTION:</b> Preoperation Inspection	<b>BOND CALCULATION TYPE:</b> Complete Bond	<b>BOND AMOUNT:</b> No Bond Held	
<b>DATE OF COMPLAINT:</b> NA	<b>POST INSP. CONTACTS:</b> None	<b>JOINT INSP. AGENCY:</b> None	
<b>WEATHER:</b> Clear and Windy	<b>INSPECTOR'S SIGNATURE:</b>

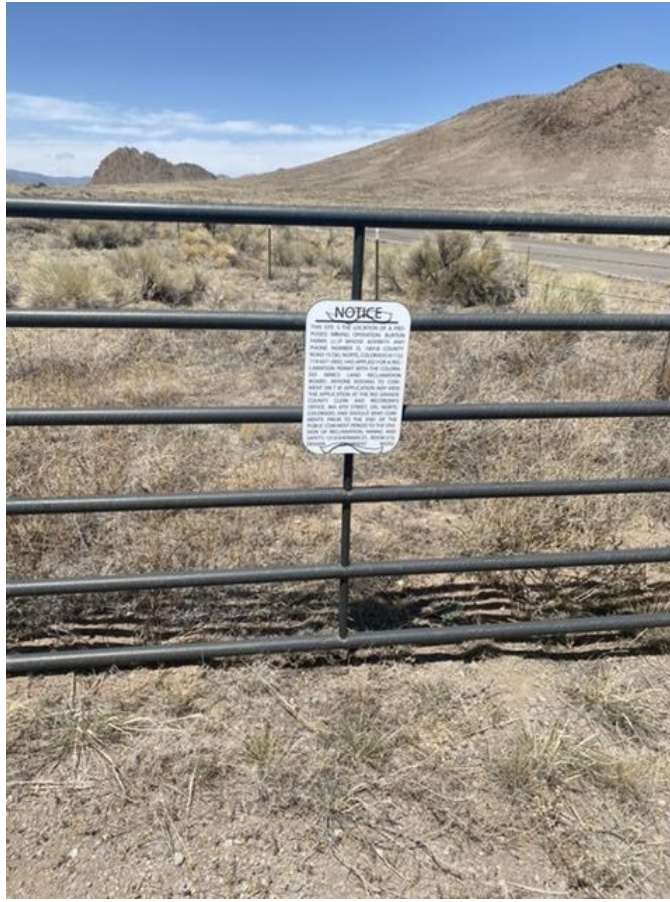
The entrance to the site is an access road off of County Road 15. The entrance has a gate with the required identification sign on it (Photo 1). The permit boundary was walked to check the site for the required permit boundary markers. The markers were installed and each marker could be easily seen from one marker to another. The site was stable with no erosional concerns. The pit highwall is located at the northern portion of the site (Photo 2). The highwall was created as a part of the previous 112c Burton Pit. The current operator plans to mine the resource on the site in the direction of west/northwest. The highwall was approximately 25 feet tall. The reclamation of the highwall will produce a backfilled slope no steeper than 2H:1V. Conditions at the site reflect that this reclaimed slope is feasible. The topsoil pile was located to the east of the highwall. The topsoil pile had vegetative cover on the top of the pile. The vegetation on the sides of the pile was more sparsely covered. Stockpiled material was located between the topsoil pile and the highwall was a raw mined material pile (Photo 3). The material was stable. Stockpiles of final product were located at the southern portion of the permit area (Photo 4). This area will also be the location for the crusher. Just to the north of these stockpiles, a portable truck scale will be placed.

The required notification sign was posted on the gate at the entrance to the access road. The information posted on the sign meets the requirements of Addendum 2 of the permit application. Throughout the inspection of the site, the permit boundary markers were identified. Markers were placed in line-of-sight from one another (Photo 5).

**Photo 1:** The required sign posted on the entrance to the site.

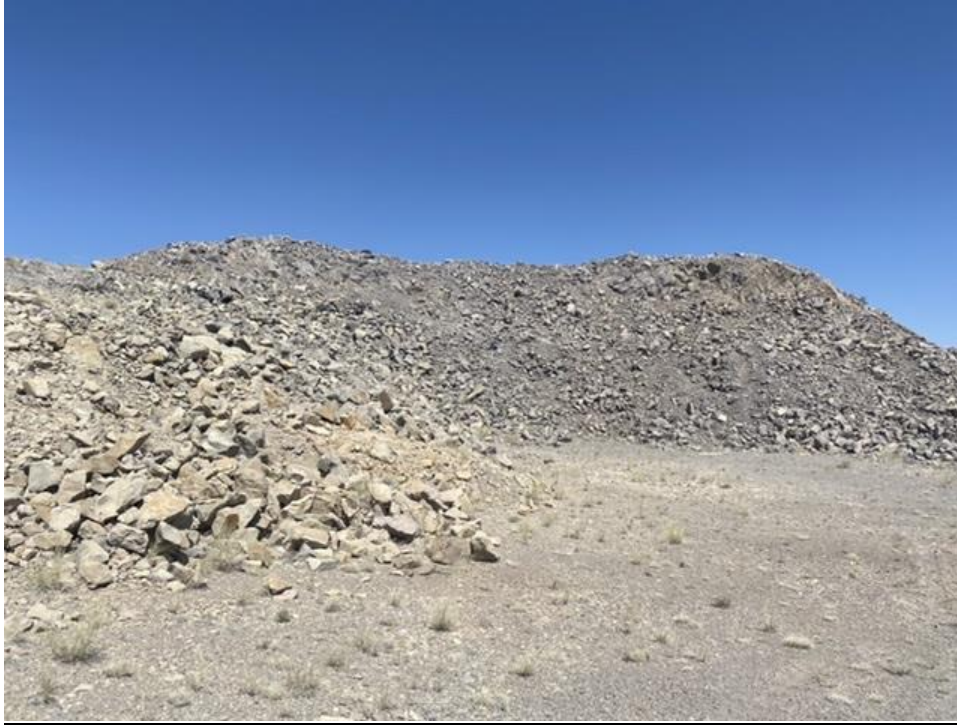
**Photo 2:** The highwall at the Burton Farms Gravel Pit.

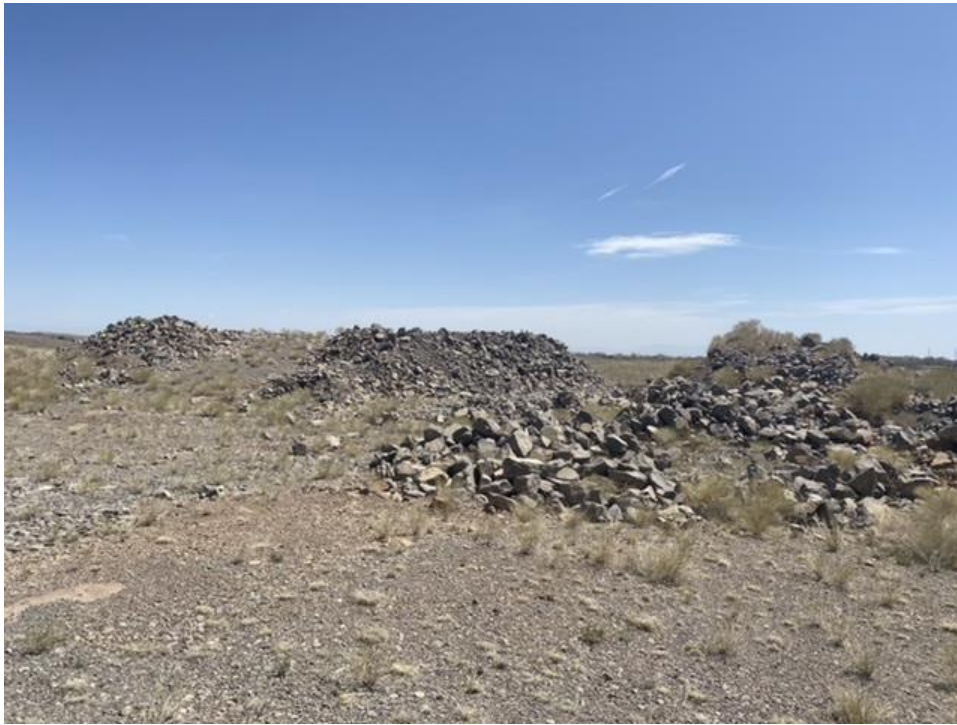
**Photo 3:** The stockpiled raw mined material to the east of the highwall.

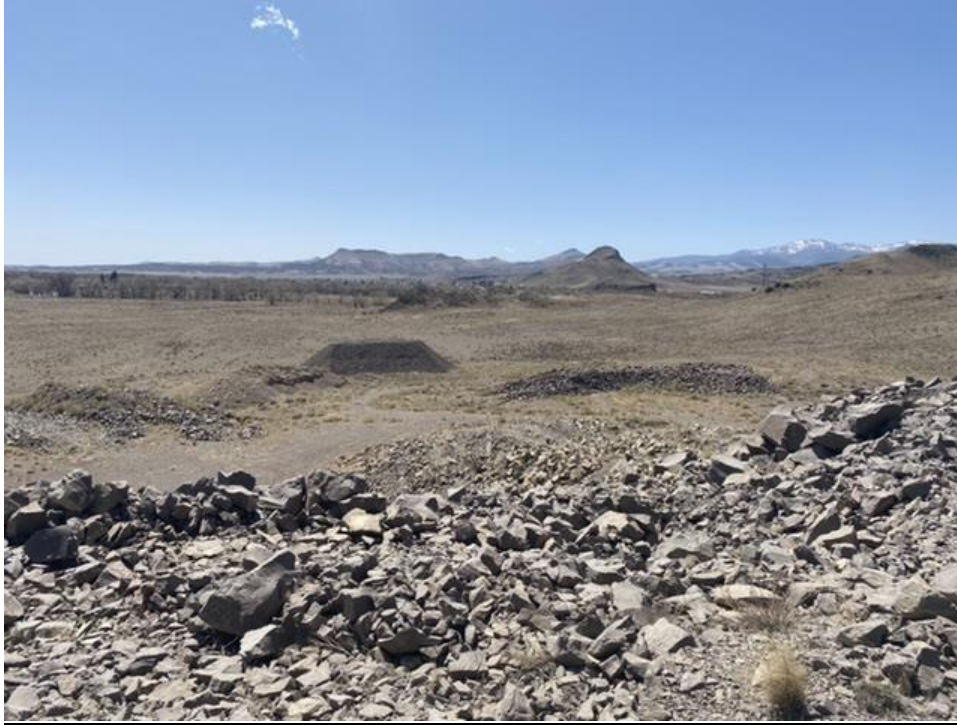
**Photo 4:** The stockpiled product located at the southern portion of the permit area. The photo was taken from above the highwall looking to the south.

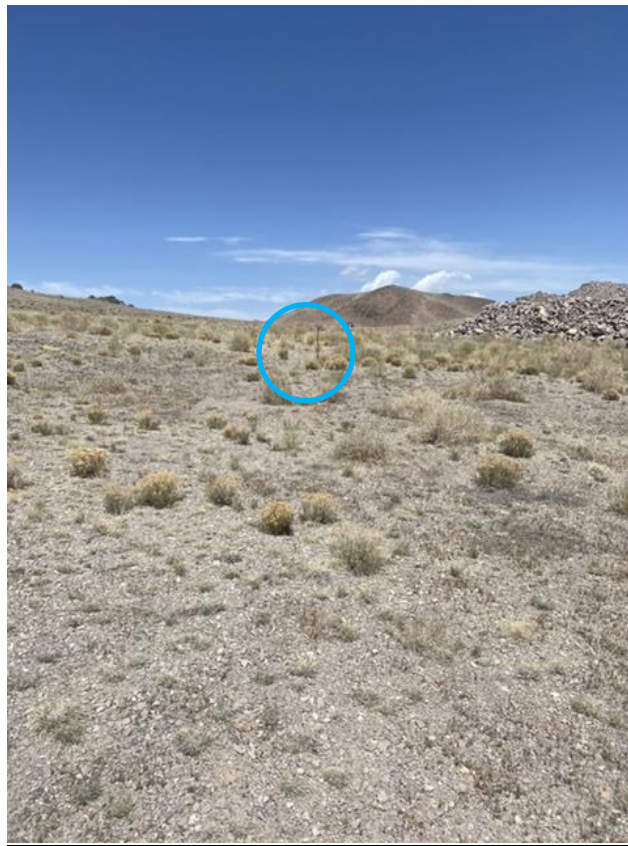
**Photo 5:** One of the permit boundary markers at the Burton Farms Gravel Pit. The photo of the marker outlined in blue was taken from one of the other boundary markers.

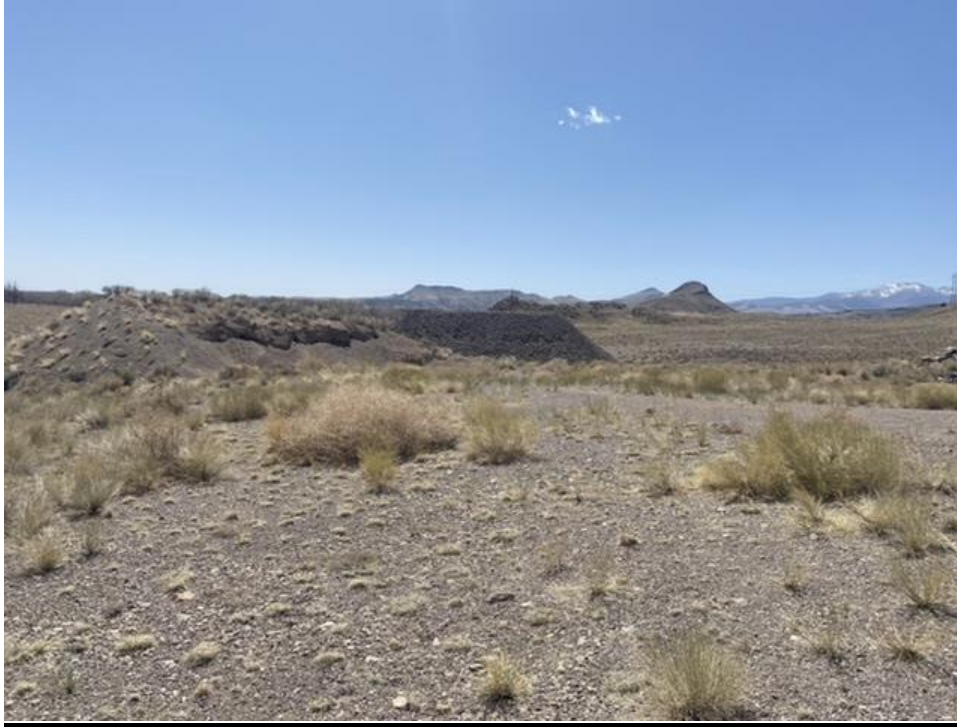
The topsoil resource for the site had been previously salvaged and stockpiled during the activities that occurred during the 112c Burton Pit permit. The topsoil was stockpiled at the eastern portion of the site, just east of the raw mined materials stockpile (Photo 6). The topsoil pile was stable with vegetative cover on top of the pile. The slopes of the pile had sparse vegetative cover. There did not appear to be any significant loss of the topsoil resource during the inspection.

**Photo 6:** The topsoil stockpile at the east end of the site. The photo was taken looking to the southeast.
