MINERALS PROGRAM INSPECTION REPORT
PHONE: (303) 866-3567

MINE NAME: Deakins Pit	MINE/PROSPECTING ID#: M-2001-060	MINERAL: Sand and gravel	COUNTY: Moffat
INSPECTION TYPE: Monitoring	INSPECTOR(S): Zach Trujillo	INSP. DATE: May 12, 2022	INSP. TIME: 10:00
OPERATOR: 3B Enterprises, LLC	OPERATOR REPRESENTATIVE: None	TYPE OF OPERATION: 112c - Construction Regular Operation	
REASON FOR INSPECTION: Normal I&E Program	BOND CALCULATION TYPE: Complete Bond	BOND AMOUNT: \$71,160.00	
DATE OF COMPLAINT: NA	POST INSP. CONTACTS: None	JOINT INSP. AGENCY: None	
WEATHER: Windy	INSPECTOR'S SIGNATURE:

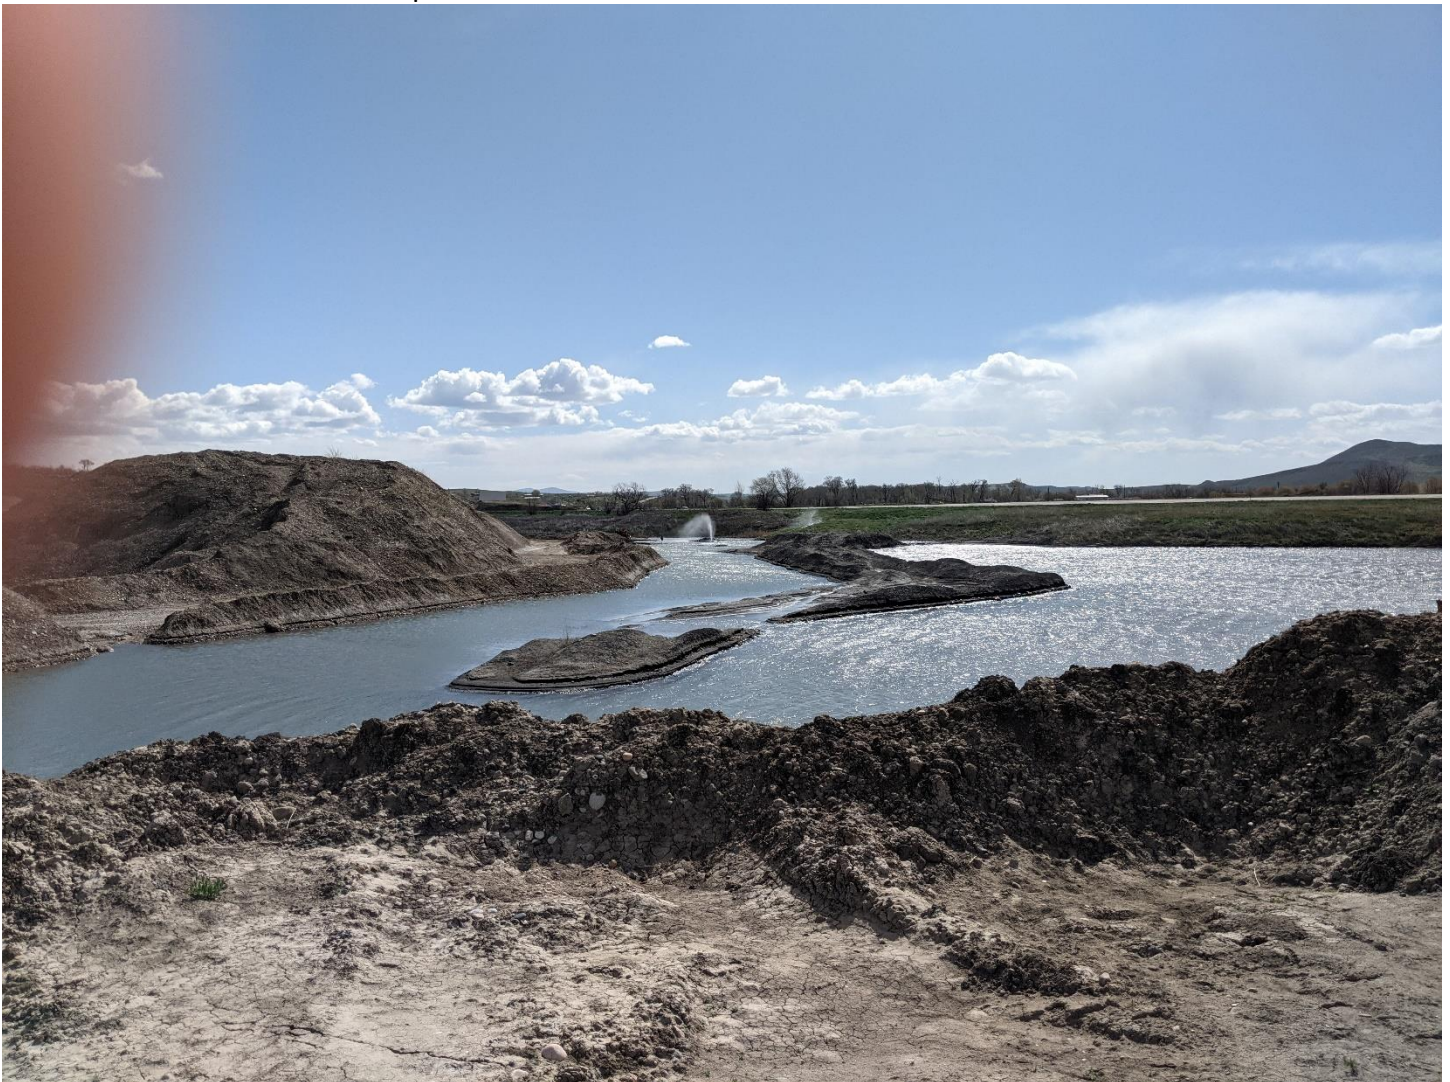
Both pit areas have exposed ground water. Based on the elevation and grade of both pits, all surface runoff is maintained within the affected pit areas.

East pit.

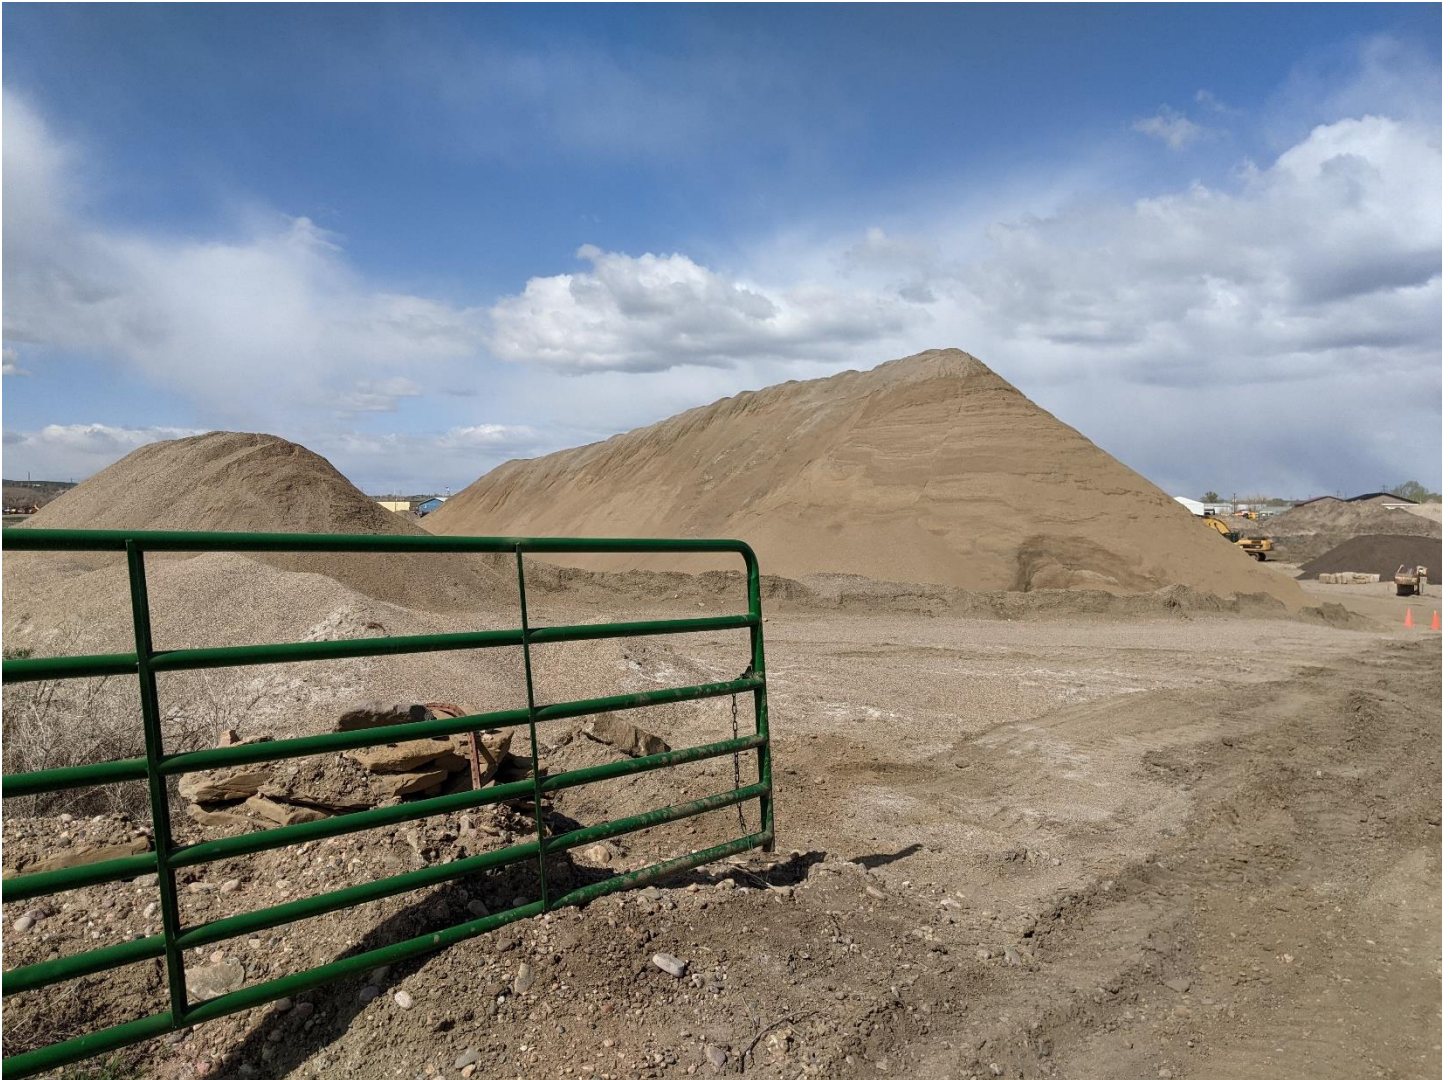
The permit is divided into two pits, the east and west pit. The two pits are divided by 1st Street. The site was operating at the time of the inspection in both the east and west pits. Active mining is occurring within the east pit. Loader operations were taking sand and gravel from the east of the pit to a processing area. The west pit had no active mining going on but multiple stockpiles are located within the pit.

Stockpiles in west pit.

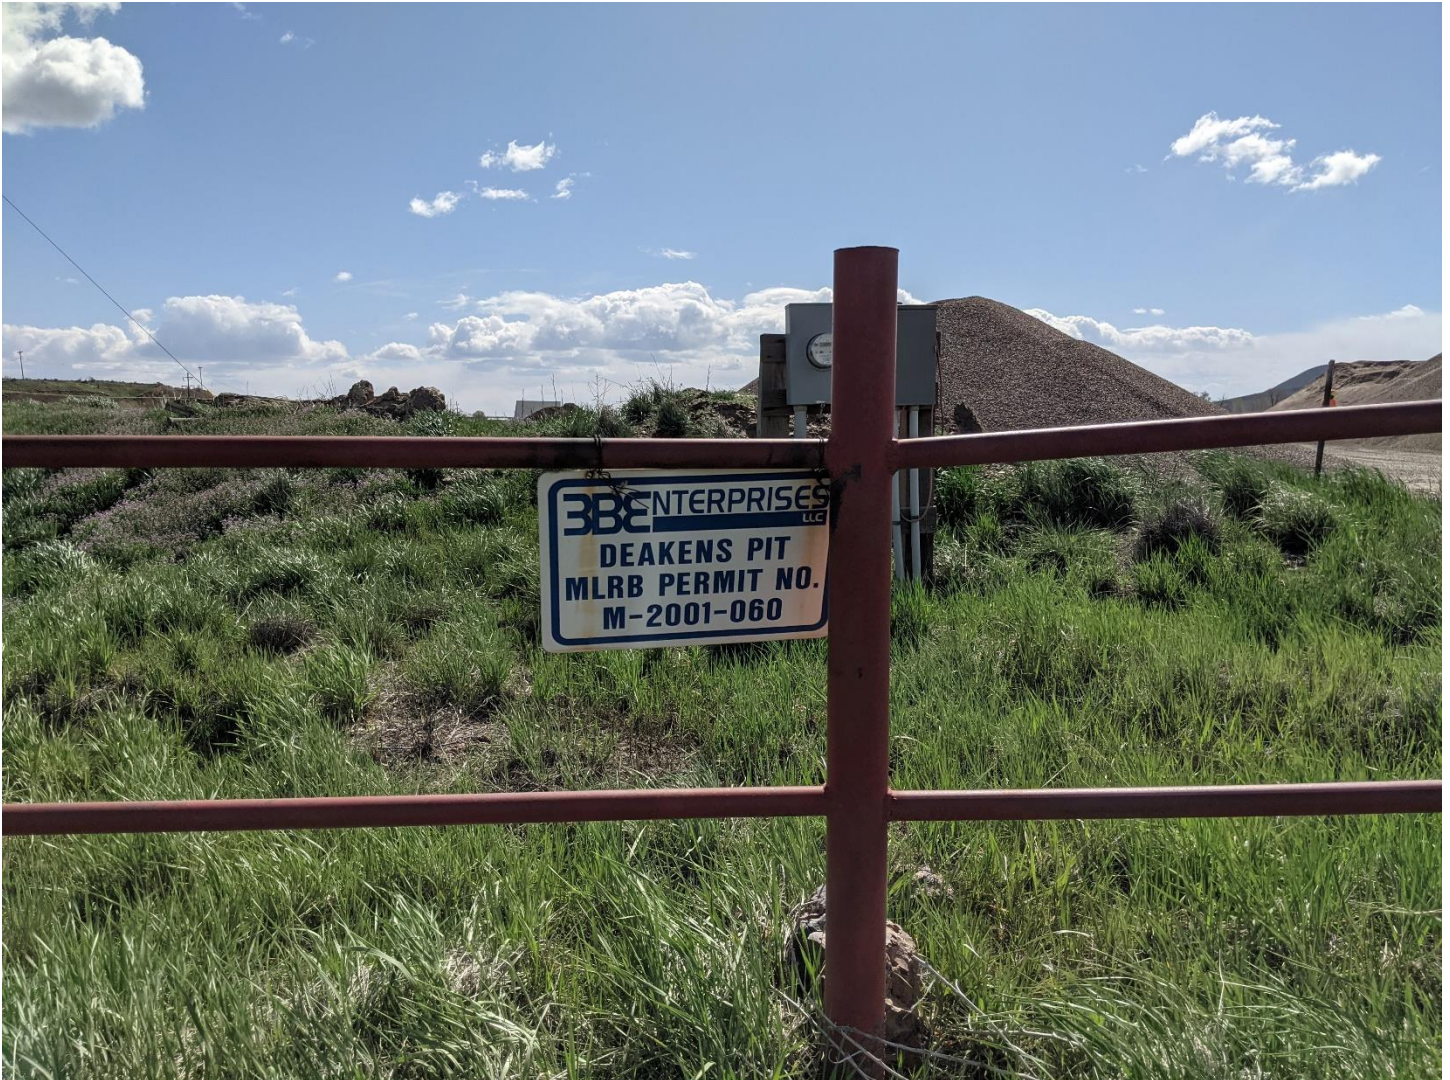
The mine identification sign and affected area boundary markers are in place and in compliance with Rule 3.1.12. The sign is located at the entrance of the permit boundary on the east side including all information for compliance.

Mine identification sign.
