PERMIT INFORMATION

Permit Number: C-1981-041 Mine Name: Roadside Portals Operator: Snowcap Coal Company, Inc. Operator Address: MS Tonya Hammond P.O. Box 1430 Palisade, CO 81526	County: Mesa Operation Type: Underground Permit Status: Active Ownership: Private Operator Representative Present: Tonya Hammond
Operator Representative Signature: (Field Issuance Only)

Inspection Start Date: May 19, 2022 Inspection Start Time: 11:30 Inspection End Date: May 19, 2022 Inspection End Time: 12:45		Inspection Type: Coal Partial Inspection Inspection Reason: Normal I&E Program Weather: Cloudy	
Joint Inspection Agency: Colo. Wildlife		Joint Inspection Contacts: Molly West, NW Region Land Use Coordinator	
Post Inspection Agency: None		Post Inspection Contacts: None	
Inspector(s): Clayton Wein Amy Yeldell	Inspector's Signature: <i>Clayton Wein</i>		Signature Date: 5/20/2022

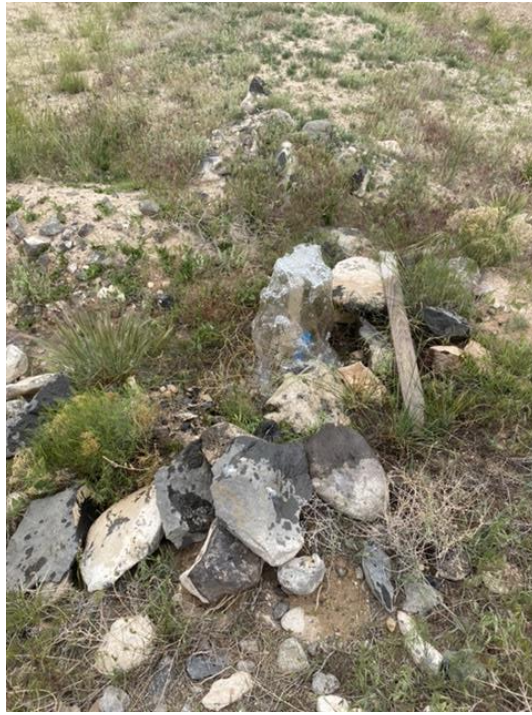
During the inspection of the Roadside Mine, it was observed that two of the landowner's riser pipes on Tract 70 were flowing (Photo 1). Both of the risers observed to be flowing were immediately south of the landowner's 112c Minerals Permit Boundary. This 112c mining permit overlies the C-1981-041 coal mine permit. Both Risers flowing are located on the middle/southern portion of Tract 70. Water flowing from the risers was flowing in trenches that trend to the east (Photo 2) and then sheet flowed northeast out of the trenches (Photo 3). There were no surface features identified in the areas saturated with water. The water flowing to the northeast had not yet reached the boundary of the 112c permit. If water continues to be applied to this area, it will flow into the

Photo 1: One of the two riser pipes flowing on Tract 70.

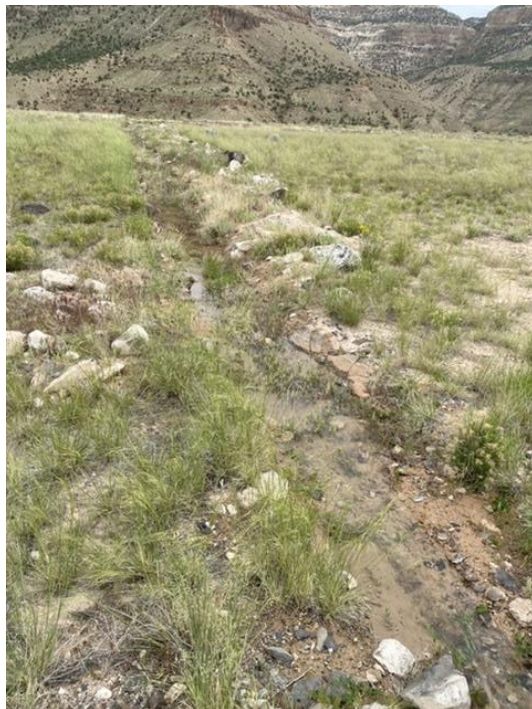
Photo 2: Water observed flowing from the risers in the trenches to the east.

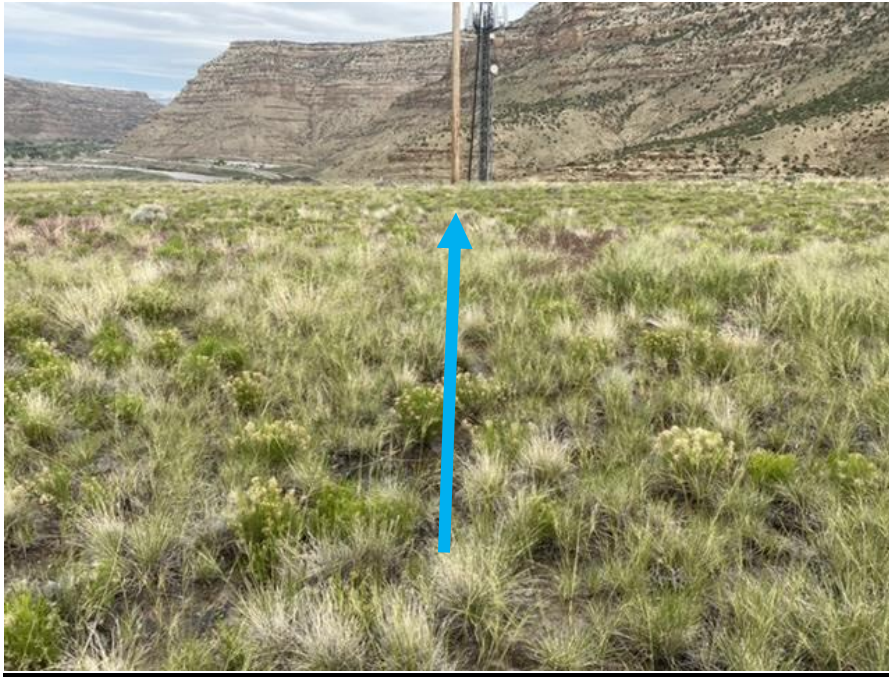
Photo 3: The water was flowing to the northeast from the trenches. The direction of the flow is represented in Photo 3 with a blue arrow.

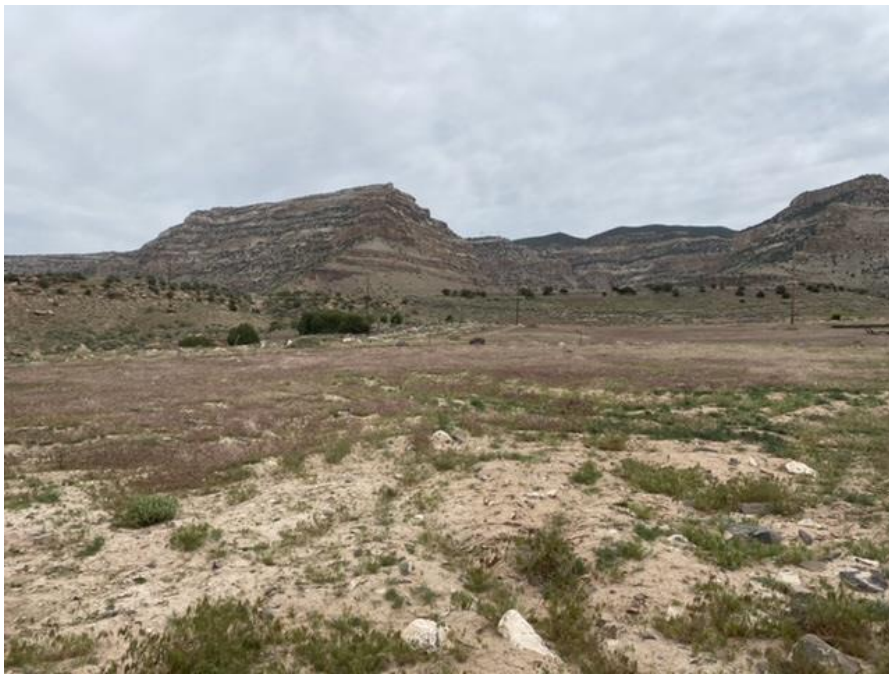
The remaining 0.4 acres of reclaimed disturbance that remain within the permit of the Roadside Mine are associated with the work approved under Technical Revision No. 69. The reclamation work and reseeding was completed in November of 2019. The Site was stable with vegetative cover (Photo 4). There were no erosional features identified during the inspection. Favorable plant species such as scarlet globemallow, shadscale, and fourwing saltbrush were observed at the site. Cheatgrass on the site is consistent with the surrounding undisturbed areas. The post mining land use is rangeland and wildlife habitat. CPW was interested in observing the conditions of the site as they are near winter range for wildlife species. Tonya Hammond notified the Division during this part of the inspection that a set of tire tracks was observed traversing the reclaimed area. Tonya Hammond had observed the tracks on a routine sit inspection on April 27, 2022. The tracks were not created by the operator. The tracks were not present during the Division's April 21, 2022 inspection (Photo 5 and 6). The tracks ran from the northeast portion of the reclaimed site to the southwest. The tracks crossed the sediment waddles and left the boundary of the disturbed area (Photo 7 and 8). During this inspection, the tracks had faded, but could still be identified. Tonya Hammond provided the Division with Photos of her April 27th site visit. The tracks did not appear to have affected the reclamation on the site and the straw waddles were intact. No off site impacts were observed.

Photo 4: The reclamation at the TR-69 repair area.

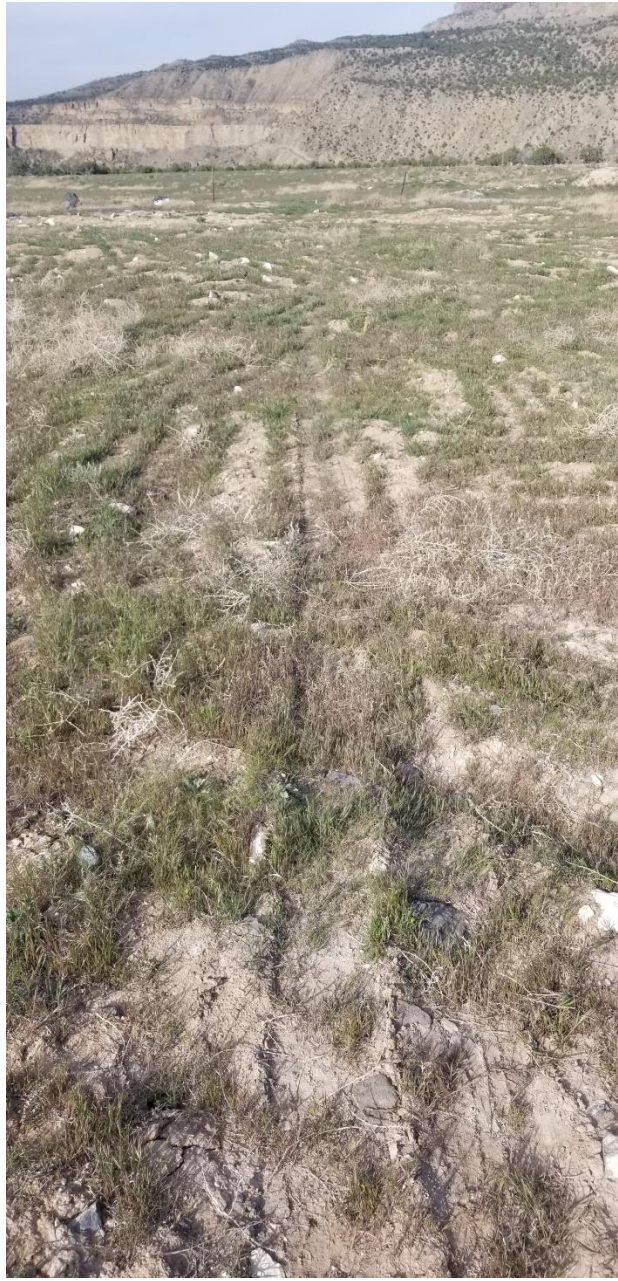
Photo 5: One of the April 27th photos showing the tire tracks on the TR-69 repair area.

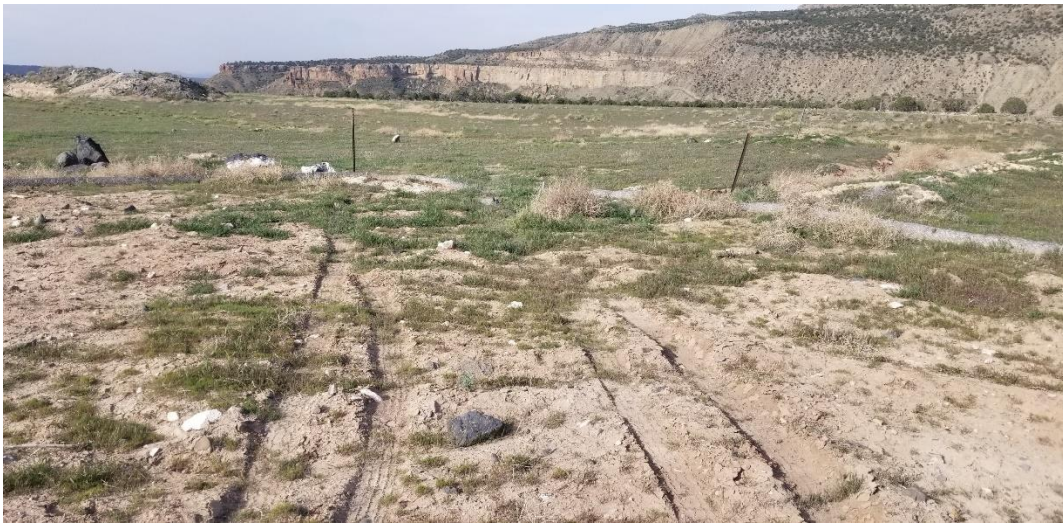
Photo 6: Another photo provided by SCC to the Division showing tire tracts on the west end of the TR-69 repair area.

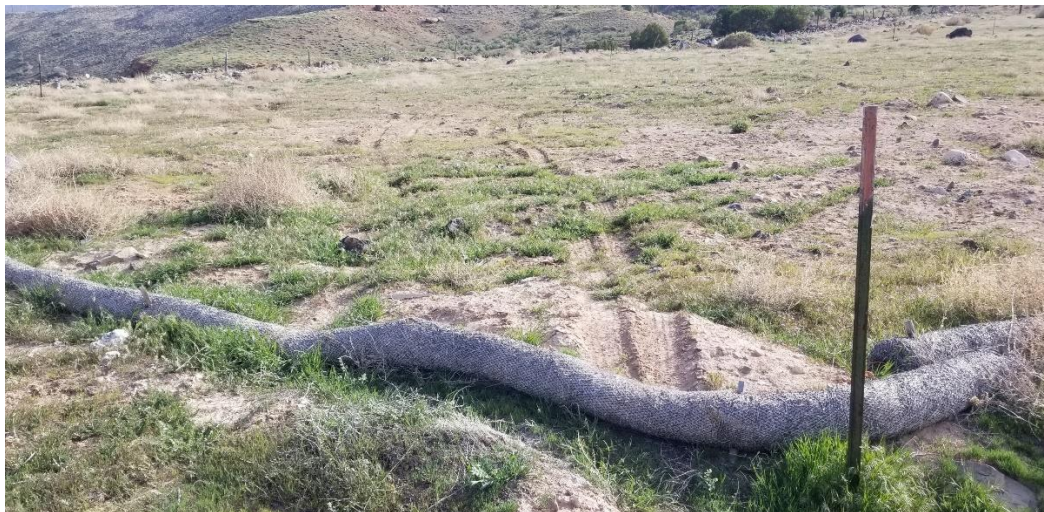
Photo 7: The tire tracks leaving the TR-69 repair area at the southwest edge on April 27th. The tracks run over the straw waddles. The photo was taken facing the northeast.

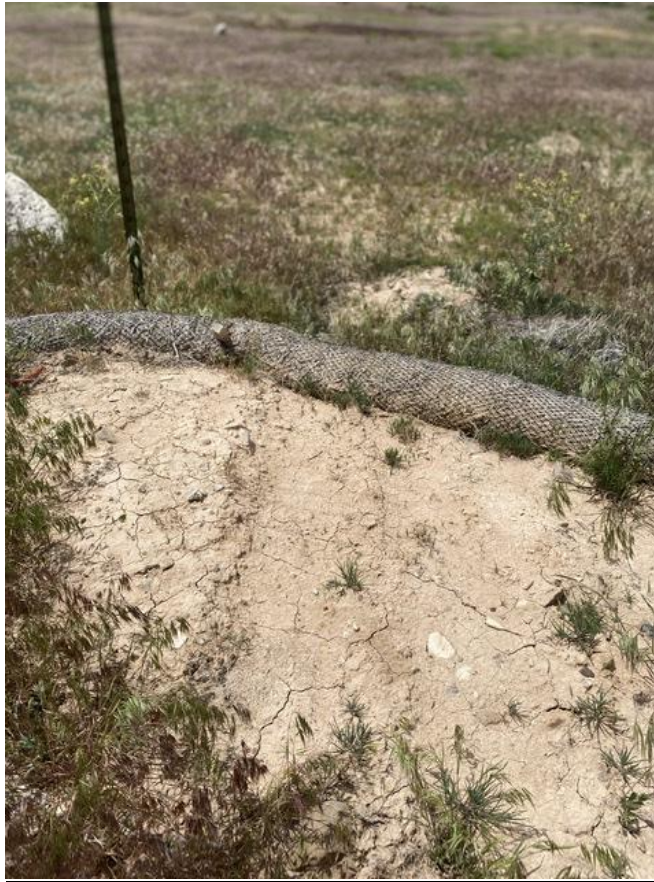
Photo 8: The Division's photo of the same location as Photo 7. This photo was taken looking to the southwest. The tire tracks were still visible on May 19th; however, they had begun to dissipate.
